**Section 2.2.4
Second Floor Conditions Assessment
Historic Structures Report**

MINNESOTA STATE CAPITOL
HISTORIC STRUCTURES REPORT
VOLUME 2.2.5

THIRD FLOOR SPACE INVENTORY AND CONDITIONS

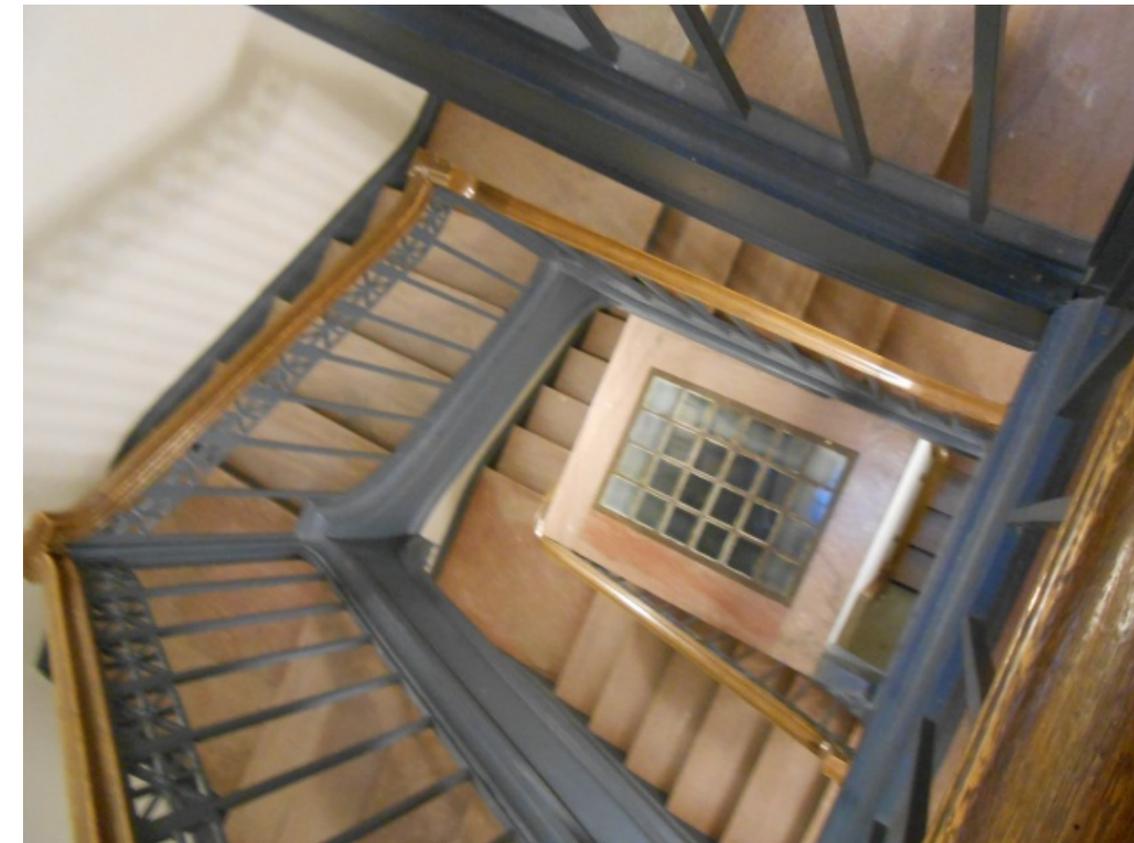
The Senate Stairs give access to the Senate Gallery. There are two of them on either side of the Senate Chamber and are identical. The stair structure is iron, with wooden handrails. Each one has a laylight. The treads are Pink Tennessee Marble. A notable feature is a small kiosk in the center of each one at the Second Floor Level. Each Kiosk has a glass block ceiling that admits light.

Building Element:	Description	Condition of Original Material
Floor	Tennessee marble	Intact
Walls	Plaster	Damaged
Ceiling/Cornice	Plaster with laylight	Some damage
Doors/Frame:	Original wood	Intact, Type
Hardware	Brass Lever/knobs	Not original/original
Light Fixtures	Ceiling mounted fixtures	Not original
Artwork	None	None
Mechanical	None	None
Trim	Wood/iron	Intact

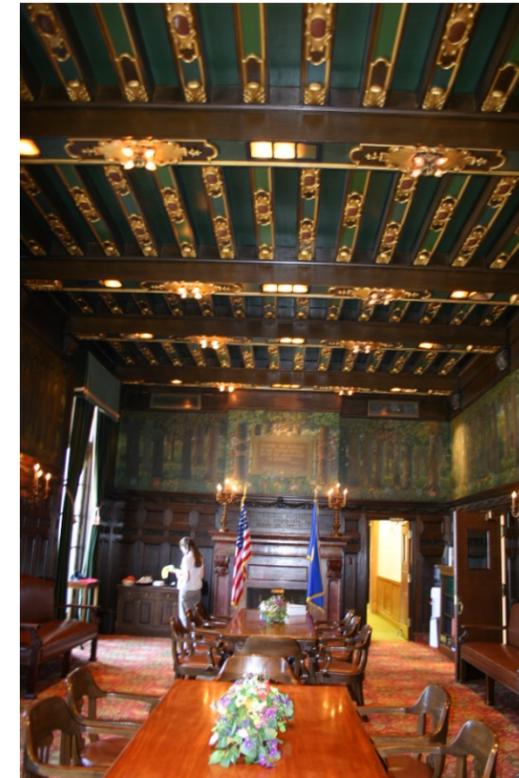
Same as above. See significant alterations.

Building Element:	Description	Condition of Original Material
Floor	Wood/carpet	Intact/carpet replica
Walls	Wood Wainscot/plaster	Intact
Ceiling/Cornice	Decorative plaster	Intact
Doors/Frame:	Original wood, leather covered	Intact, with light wear
Hardware	Brass push plate/pull handles	Intact
Light Fixtures	Historic chandeliers,	Intact
Artwork	Murals, decorative plaster painting	Intact
Mechanical	Bronze decorative grilles	Intact
Trim	Oak	Intact

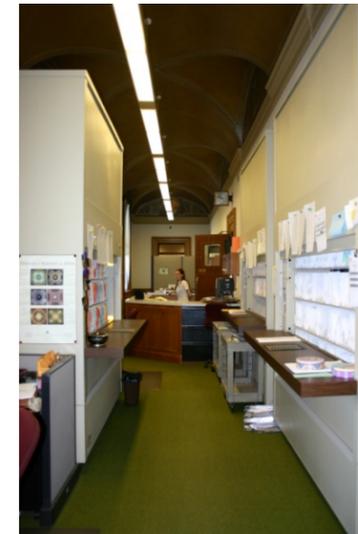
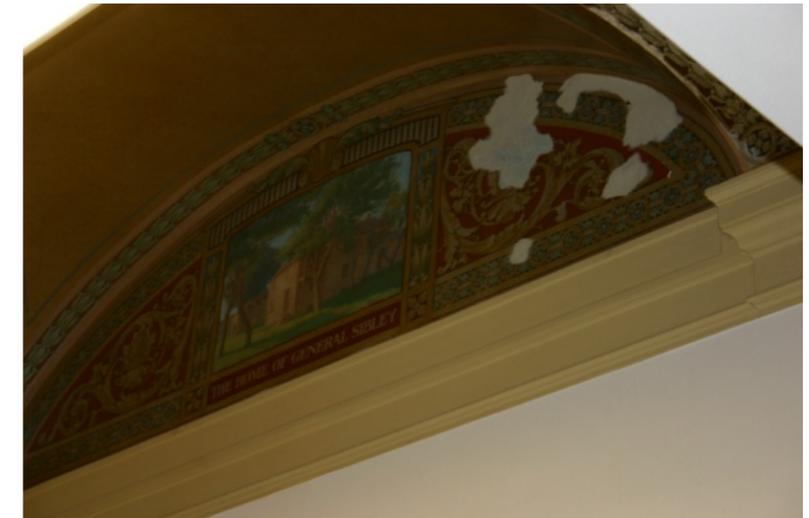
Area has been converted to office space. Floor is carpeted, and walls are covered with vinyl wall covering. Wooden counter and electric filling machine installed in west minor corridor. c.1920 ceiling and lunettes extant in both minor corridors.

Building Element:	Description	Condition of Original Material
Floor	Marble, concrete, both carpeted	Unknown/destroyed
Walls	Plaster, marble base	Intact
Ceiling/Cornice	Decorative plaster	Intact
Doors/Frame:	Original wood, leather covered	Intact, with light wear
Hardware	Brass push plate/pull handles	Intact
Light Fixtures	Pendant fixtures,	Not original
Artwork	Murals,	Some show water damage
Mechanical	Bronze decorative grilles	Intact
Trim	Plaster/Oak	Intact

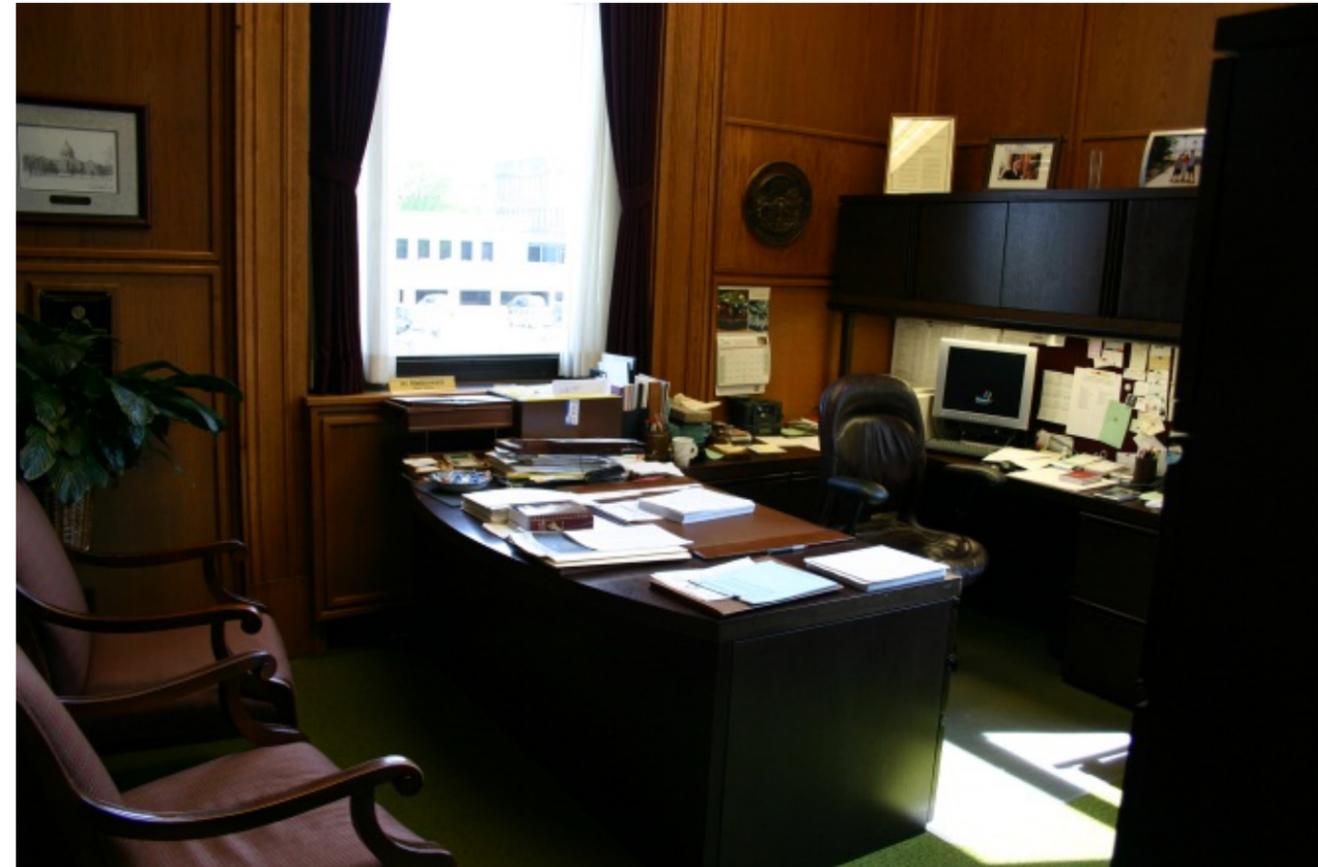
This office was subdivided in the second renovation, and was lined with paneling. Originally, there was no pass-through hallway.

Building Element:	Description	Condition of Original Material
Floor	Concrete/carpet	Destroyed
Walls	Wood paneling/plaster	Not original/unknown
Ceiling/Cornice	ACT over plaster	Unknown
Doors/Frame:	Original wood	Intact
Hardware	Brass push plate/pull handles	Intact
Light Fixtures	Lay in	Not original
Artwork	None	None
Mechanical	Stamped Louver	Not original
Trim	Plaster/Oak	Intact.

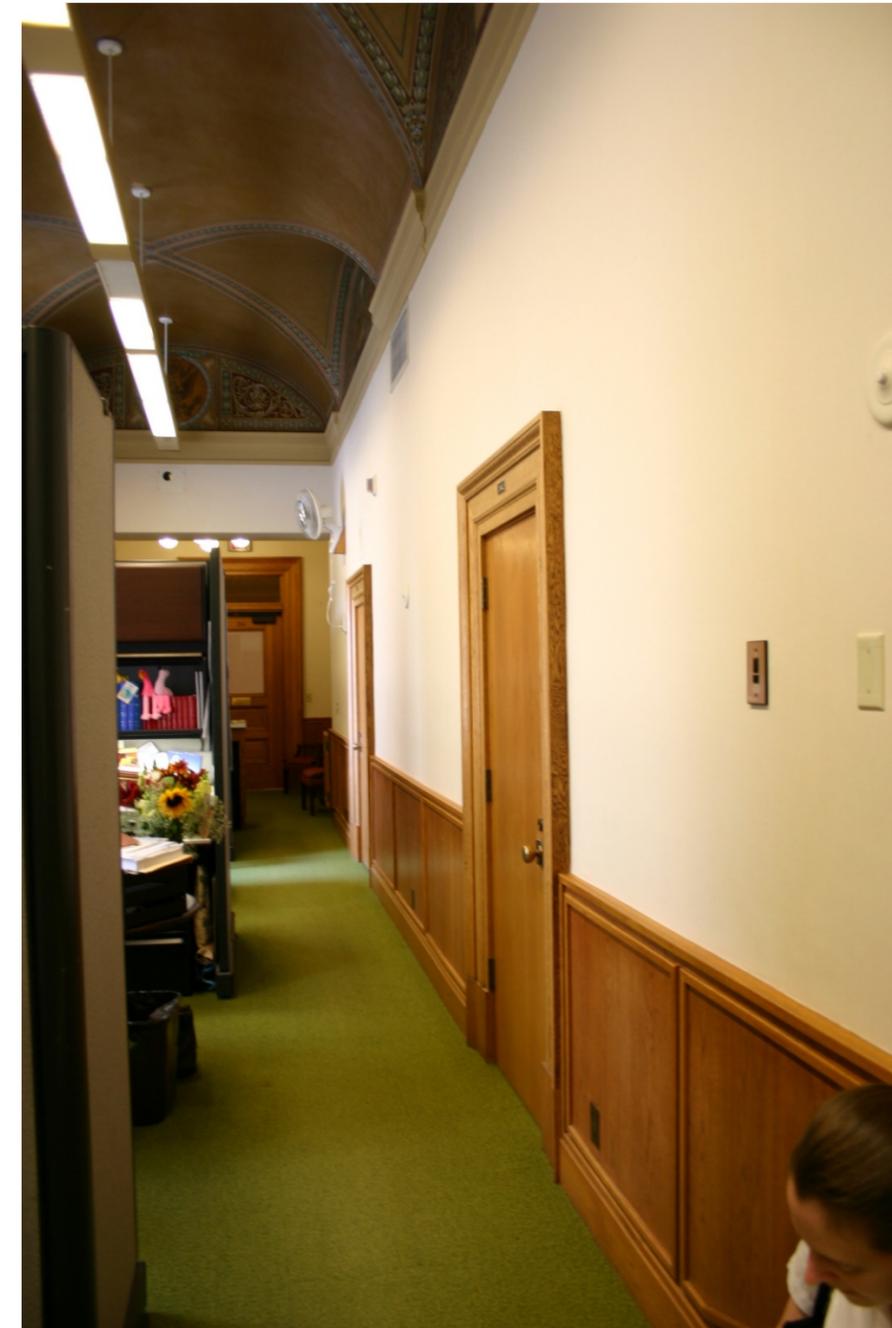
There are also a series of paintings on the wall shared with the House Chamber, in each wall niche, depicting naturalistic scenes and buildings of Minnesota. Some of these paintings are damaged.

Building Element:	Description	Condition of Original Material
Floor	Marble, concrete, both carpeted	Unknown/destroyed
Walls	Plaster, marble base	Intact
Ceiling/Cornice	Decorative plaster	Intact
Doors/Frame:	Original wood, leather covered	Intact, with light wear
Hardware	Brass push plate/pull handles	Intact
Light Fixtures	Pendant fixtures,	Not original
Artwork	Murals,	Some show water damage
Mechanical	Bronze decorative grilles	Intact
Trim	Plaster/Oak	Intact

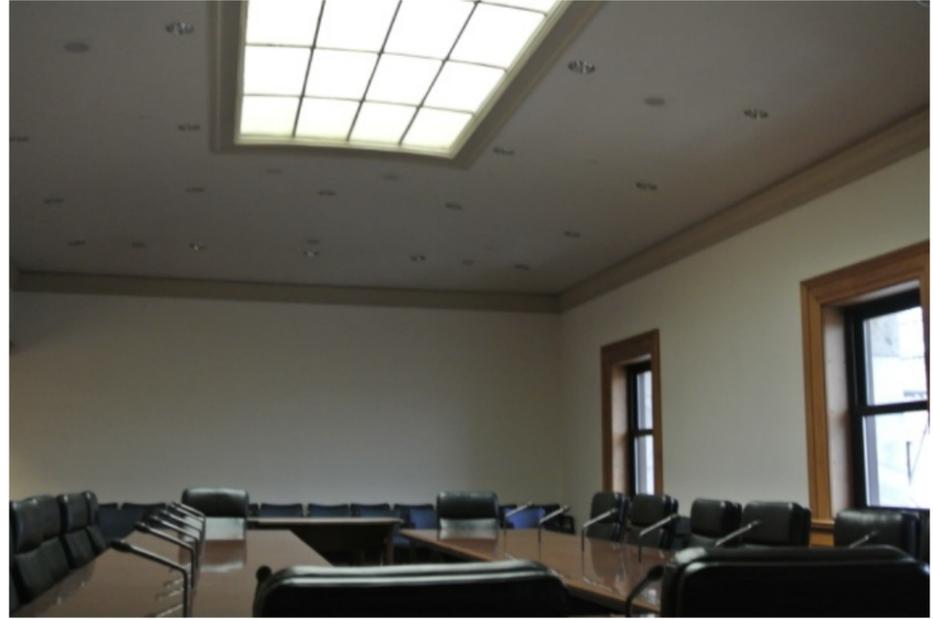
Conference room 316
 Formerly Law Library
 316
 Treatment Level: 2

This is a Large Conference Room with a skylight. It was formely a Law Library. There is no wall between it and the minor corridor and there was none originally.

Building Element:	Description:	Condition of Material:
Floor	Carpeted	Unknown
Walls	Plaster	Modified
Ceiling/Cornice	Plaster	Modified
Doors/Frame:	Wood	Not original
Hardware	ADA Lever	Not original
Light Fixtures	Can lights	Not original
Artwork	Hung painting	Intact
Mechanical	Aluminum louver	Not original
Trim	Wood	Not original

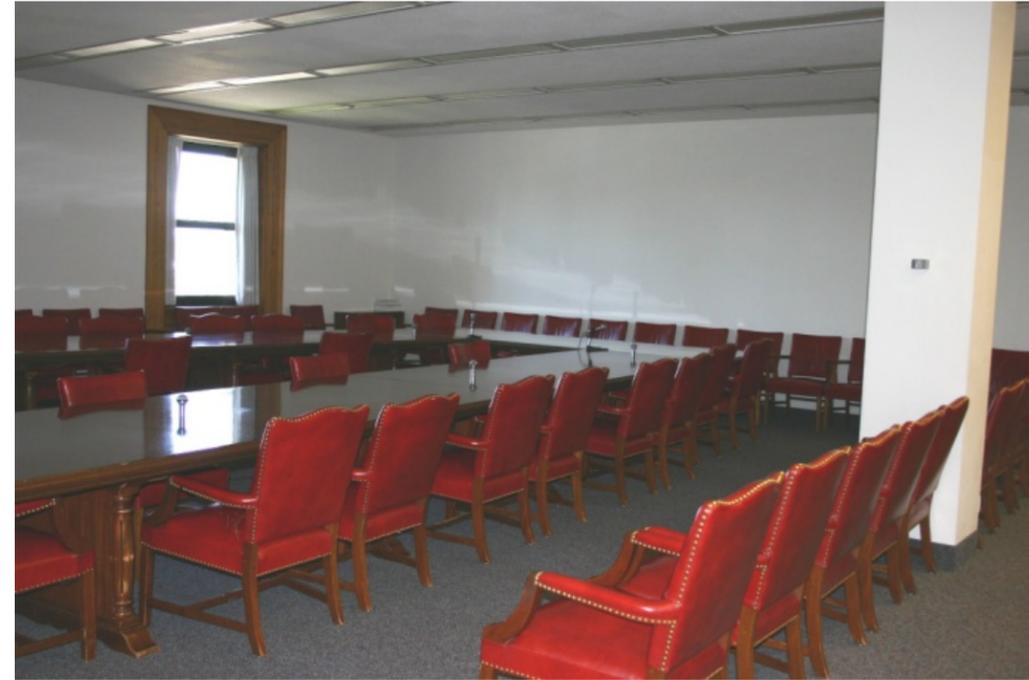
Conference Room.

There was a skylight above Conference Room 318 and adjacent offices but it has been covered. Skylights were replaced in 1994, so the skylight above should be functional

Building Element:	Description:	Condition of Material:
Floor	Carpeted	Unknown
Walls	Plaster/gyp	Modified
Ceiling/Cornice	ACT	Unknown
Doors/Frame:	Wood/Hollow metal	Not original
Hardware	ADA Lever	Not original
Light Fixtures	Lay in	Not original
Artwork	None	None
Mechanical	Ceiling distribution	Not original
Trim	Wood/vinyl	Not original

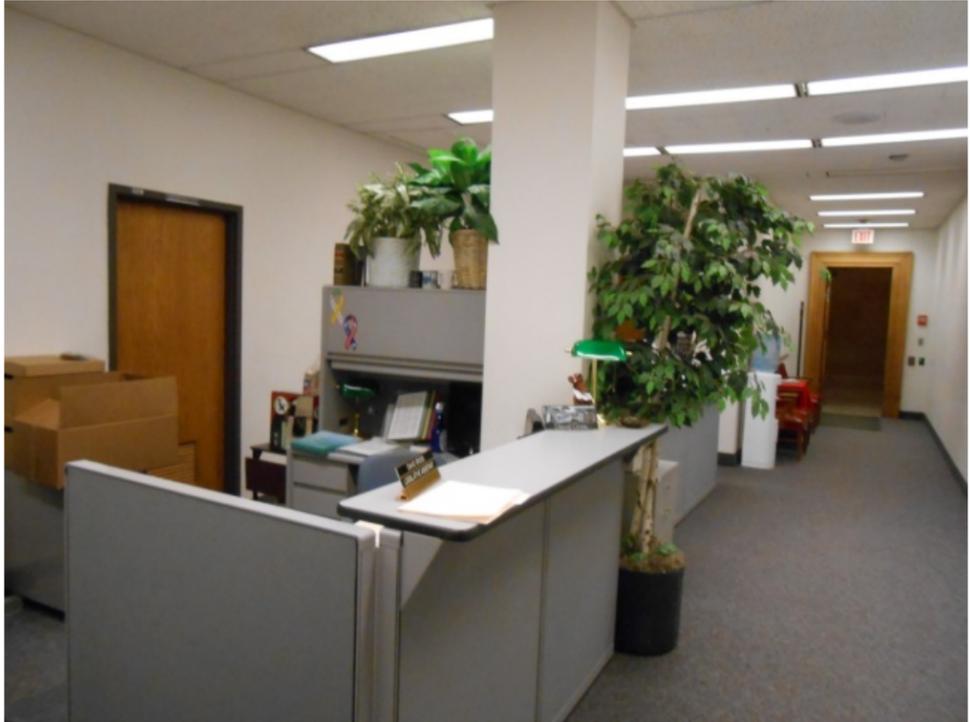
There were two skylights above Training Room 320 but they have been covered.

Building Element:	Description:	Condition of Material:
Floor	Carpeted	Unknown
Walls	Plaster/gyp	Modified
Ceiling/Cornice	ACT	Unknown
Doors/Frame:	Wood/Hollow metal	Not original
Hardware	ADA Lever	Not original
Light Fixtures	Lay in	Not original
Artwork	None	None
Mechanical	Ceiling distribution	Not original
Trim	Wood/vinyl	Not original
