CENTENNIAL OFFICE BUILDING Investigation of Exterior Building Envelope

658 Cedar Avenue
St. Paul, MN 55155

Draft Report
March 17, 2015
WJE No. 2014.5607.0

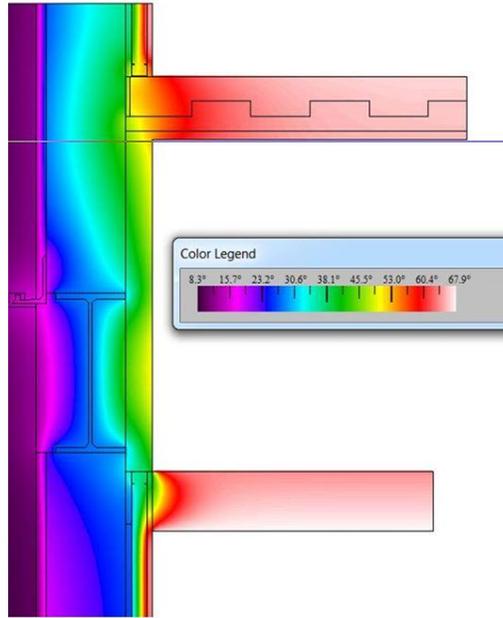
Illustration 2. THERM simulation of the existing granite panel joint condition at exterior air temperature of 7°F.

2. The THERM simulation conducted at the existing panel joint condition and shown in Illustration 2 above indicates that condensation on the surfaces of the structural steel was not a major concern, however thermal bridging was allowing energy transfer through the wall assembly. Based on previously documented IR scan images, uncontrolled air flow through the panel joints was also a contributor to building heat loss at this location. Based on these findings, WJE modified the as-built detail to include SPF insulation in the air cavity and beam pockets between the structural steel / back-up wall assembly and the granite panel cladding. This detail was modeled using THERM to compare to the existing wall performance.

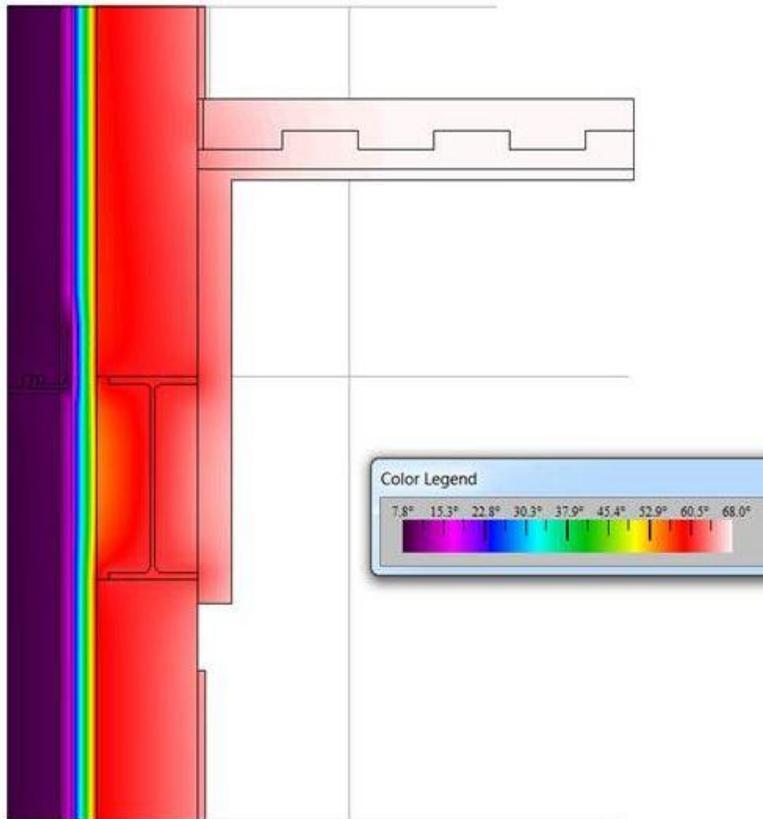
Illustration 3. Adding SPF insulation in the air cavity and beam pockets behind the granite cladding reduces air flow and thermal transfer through the exterior wall assembly.

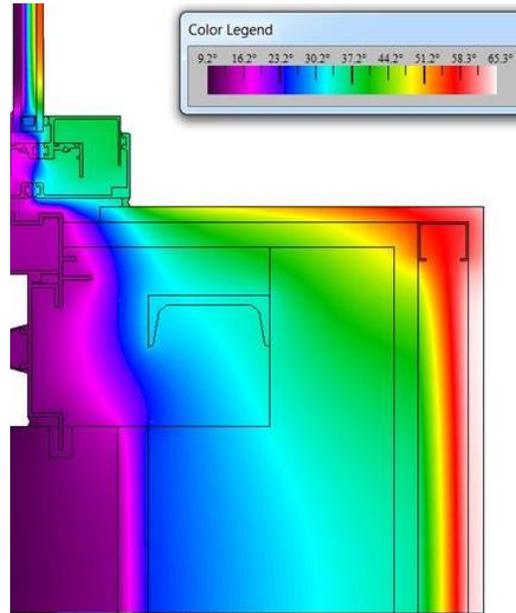
As indicated by the simulation, thermal bridging occurs through the window frame because the IGU and the frame isolator bar are not aligned with the wall insulation. While the new window is thermally broken, the adjacent decorative aluminum track is not, and in conjunction with the uninsulated jamb of the backup wall, creates an open cavity for thermal transfer.

Illustration 5. THERM simulation of existing upper floor window jamb at the average low exterior air temperature for St. Paul, MN in the month of January.

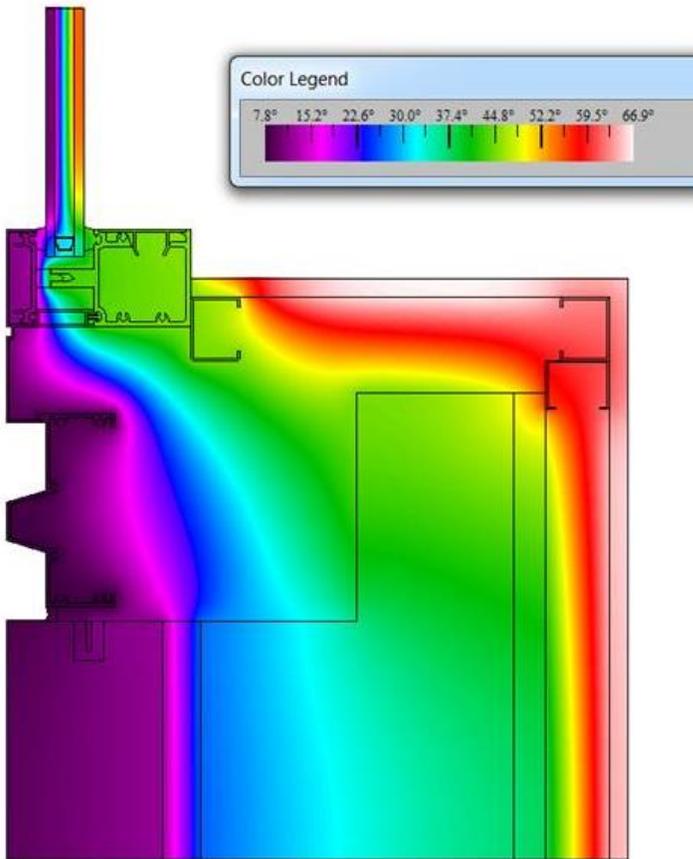
Illustration 6. Replacement of the existing glazing with a curtain wall system and adding SPF insulation to the jambs and wall cavity resulted in a small improvement in overall energy performance.

4. A revised detail was created by WJE to examine the benefits of replacing the exterior windows of floors 2 through 5 with a high performing aluminum framed curtain wall and adding SPF insulation in the air cavity between the granite cladding and the back-up masonry. The intent of the added SPF was to align the insulation with the IGU and the isolator bar in the curtain wall frame to reduce thermal bridging. As shown in the revised THERM simulation below, the results of this modification resulted in only slight improvement of the glazing and frame performance; however the overall thermal resistance of the wall assembly is improved by the addition of insulation behind the decorative jamb trim and in the wall cavity.

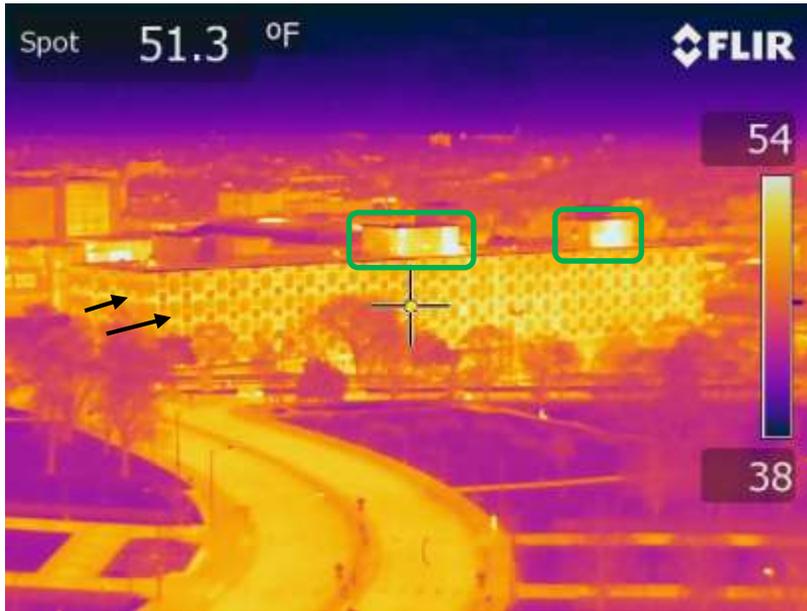
Figure 9. Overall IR scan of the COB taken from the northwest, reveals heat loss through the central and south rooftop penthouses (green boxes) and also at the window frames, and the granite panel joint locations (black arrows).

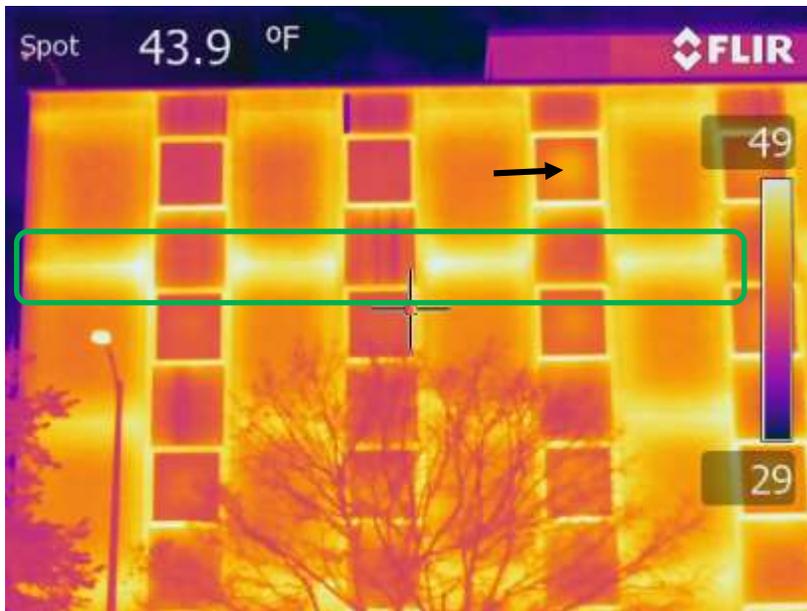
1. The primary source of heat loss is thermal transfer through the steel panel anchors and air leakage through the sealant filled joints of the granite wall cladding (Figure 10). The granite panels span from floor to floor, bearing on wide flange steel beams that support the floor structure. Because they interrupt the masonry back-up walls and are directly aligned with the panel joints, the beams provide a fairly direct pathway through the enclosure for the exfiltration of conditioned interior air to the exterior.

Figure 10. Heat loss at the panel joints beneath the fifth floor level are evident in this IR scan (green box). Elevated IGU heat loss was noted in 5 of the 9 windows visible in this scan, most notably at the fifth floor window on the right (black arrow).

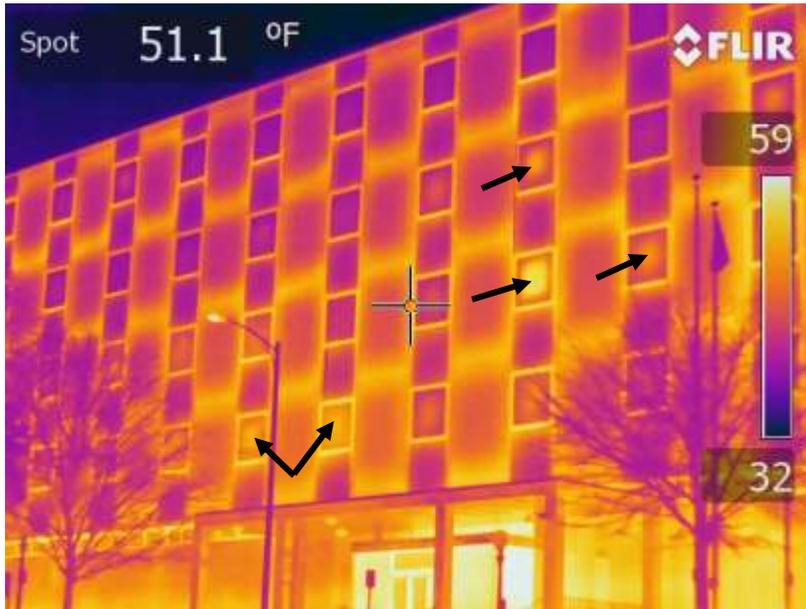
Figure 11. Heat loss was detected at the window frames, which appear bright yellow in color. Heat loss also was identified in over half of the IGU's visible in this image, indicated by the glowing spot at the center area of the windows. IGU seal failure is likely in cases where the heat loss is elevated (black arrows).

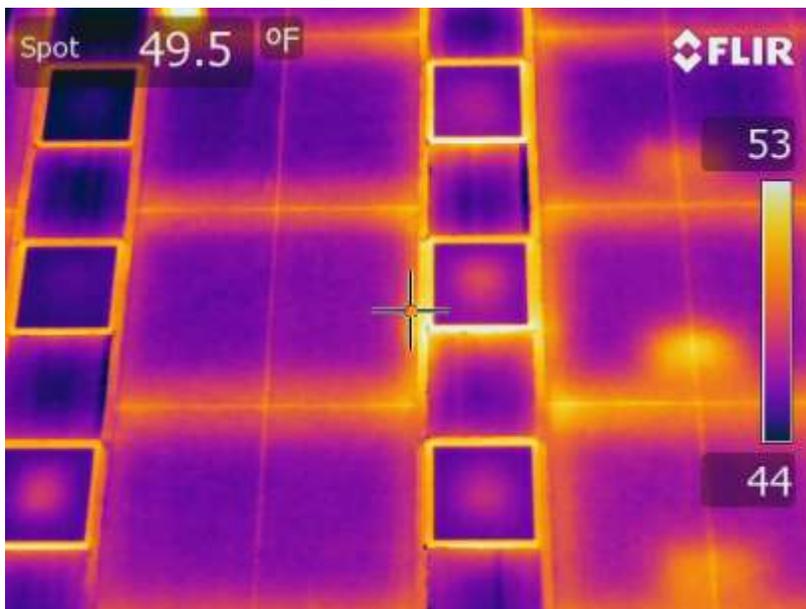
Figure 12. This image shows heat loss through the aluminum window and spandrel panel frames, and also at 4 of the 6 IGU's shown.

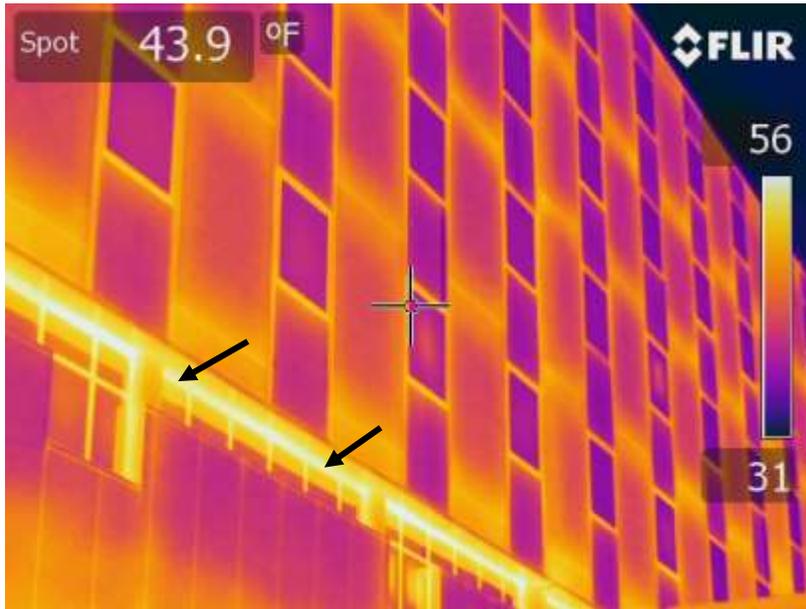
Figure 13. Heat loss was detected by this IR scan of the east elevation at the clerestory windows just below the first level ceilings (arrows).

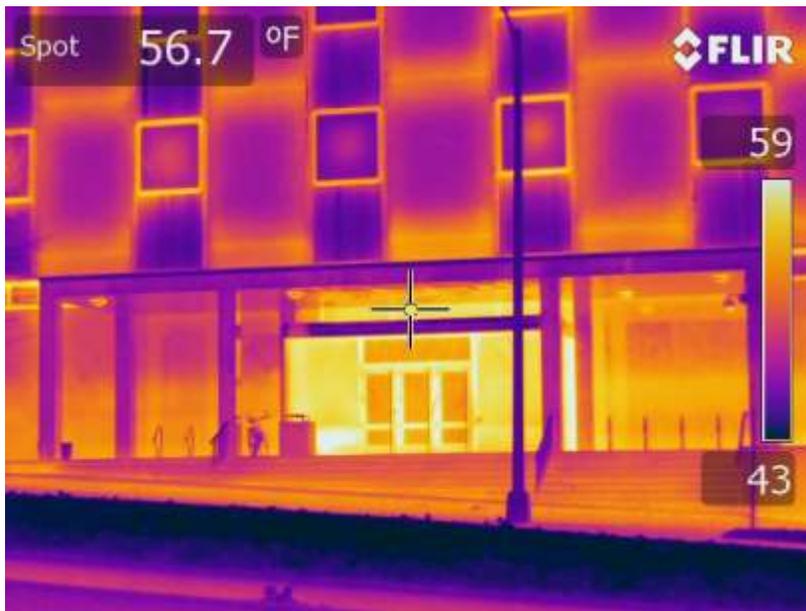
Figure 14. Heat loss was detected at the west entry vestibule, which features the original construction, single pane glazing.

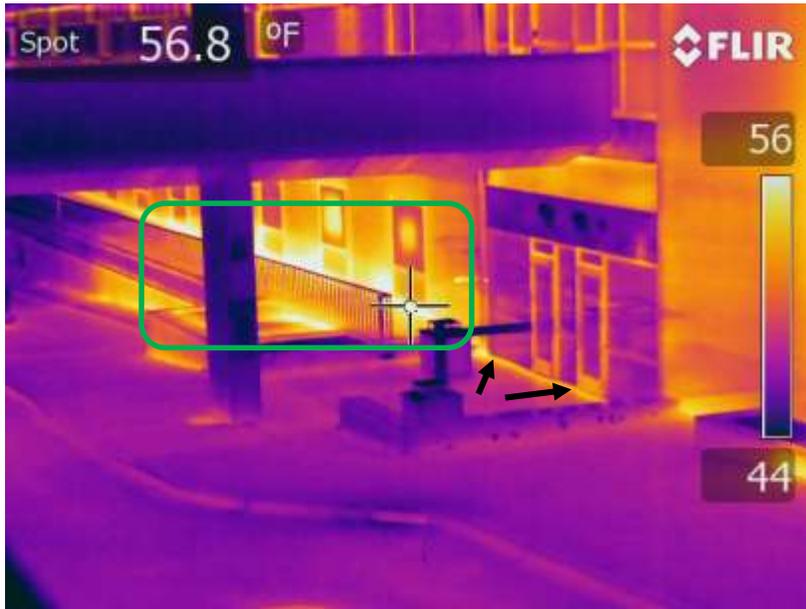
Figure 15. The east vestibule glazing is more efficient than the original glazing intact at the west entry; however localized heat loss was detected beneath the vestibule sills (arrows). Significant heat loss was also noted along the east terrace (green box).

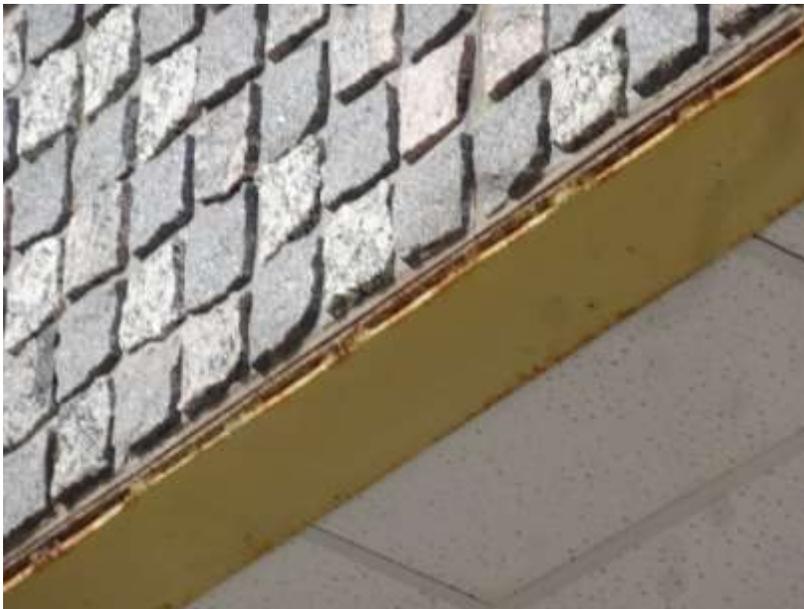
Figure 16. Corrosion was present along both edges of the steel lintel above the loading dock opening. Type E precast panels are shown above the yellow lintel.

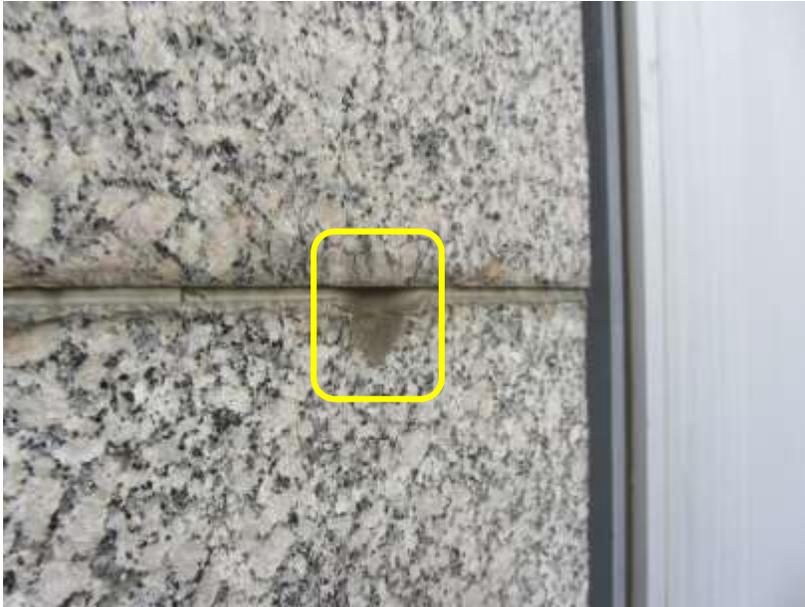
Figure 17. A missing spall that measured about 2 inches square had been filled with sealant on the fifth floor level of the west elevation (yellow box)..

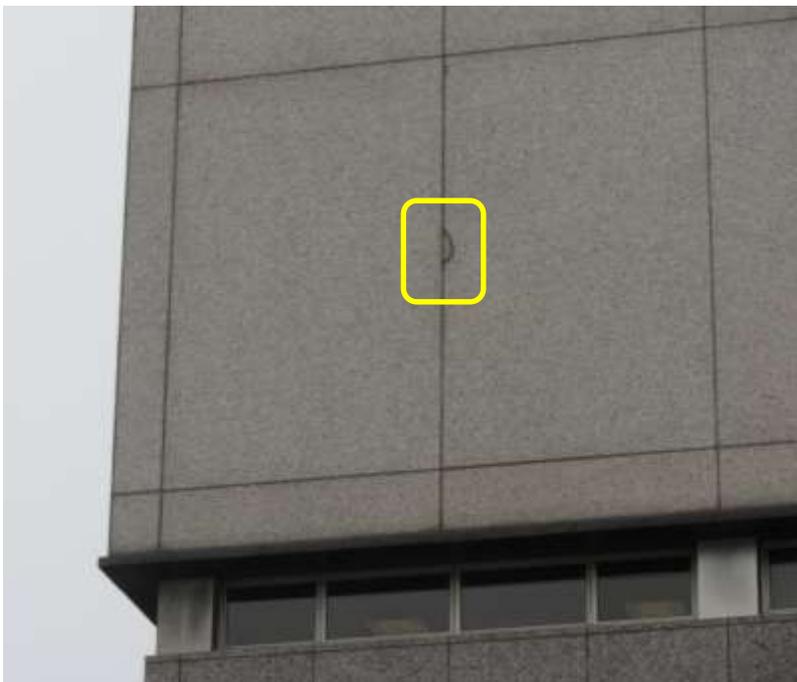
Figure 18. A crack in a second floor level granite panel at the south elevation was previously filled with sealant (yellow box).

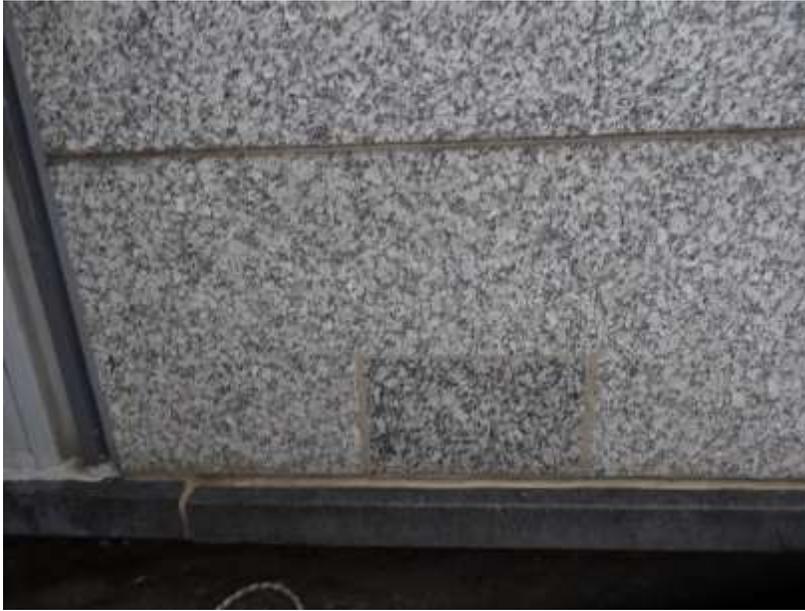
Figure 19. A previous patch of polished granite panel at the base of the north wall did not match the finish of the surrounding stone.

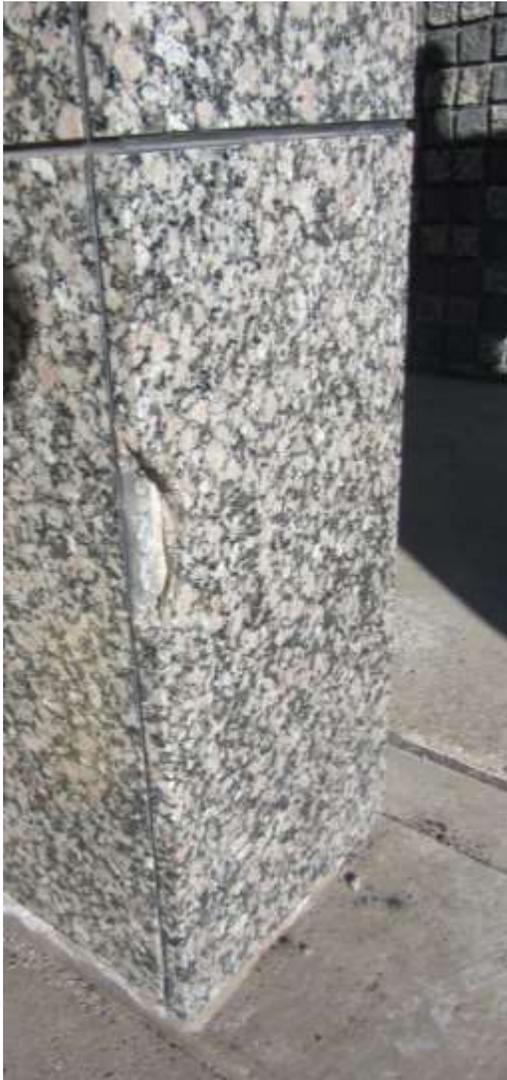
Figure 20. A missing spall in a granite panel at the south end of the building, near the loading dock.

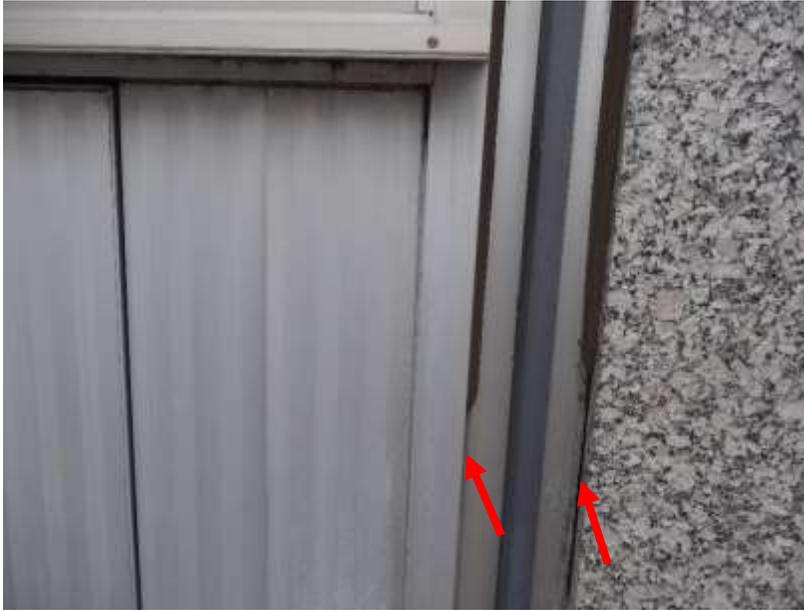
Figure 21. Missing sealant two parallel joints in aluminum transom panel above the north egress door extends to the concrete walk surface below.

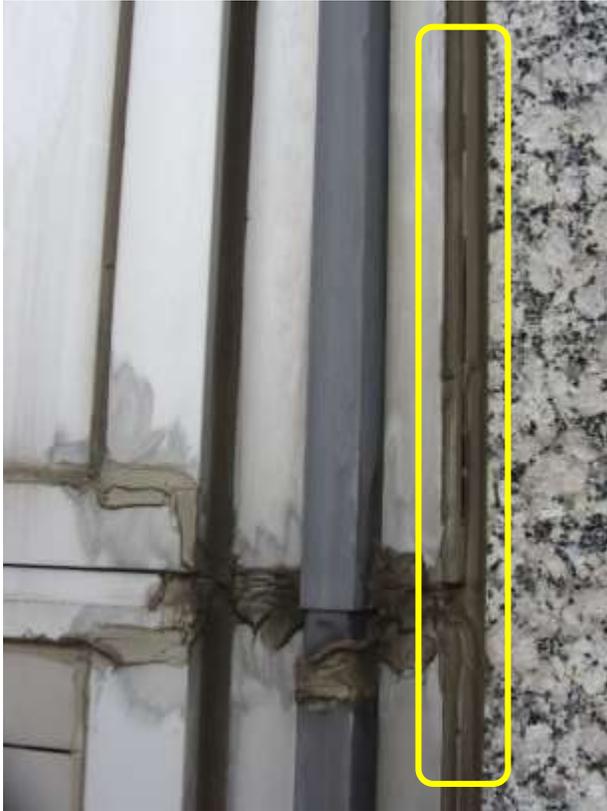
Figure 22. Adhesion failure at the primary seal between a fifth floor window and the granite wall panels along the west elevation (yellow box).

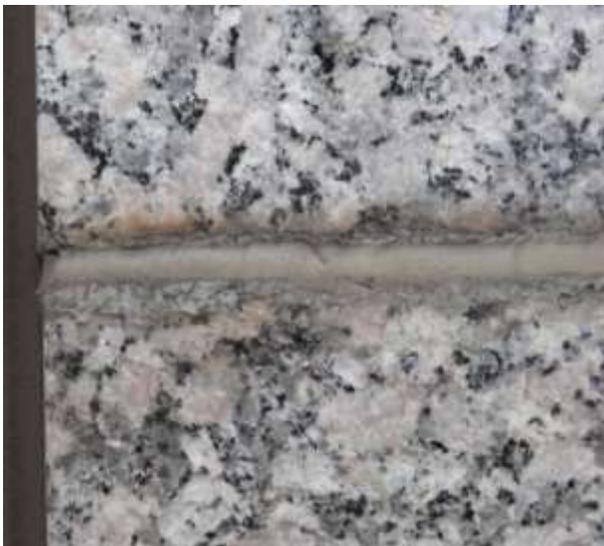
Figure 23. Oils and plasticizers from the sealant have migrated into the granite, discoloring the stone around the joints.

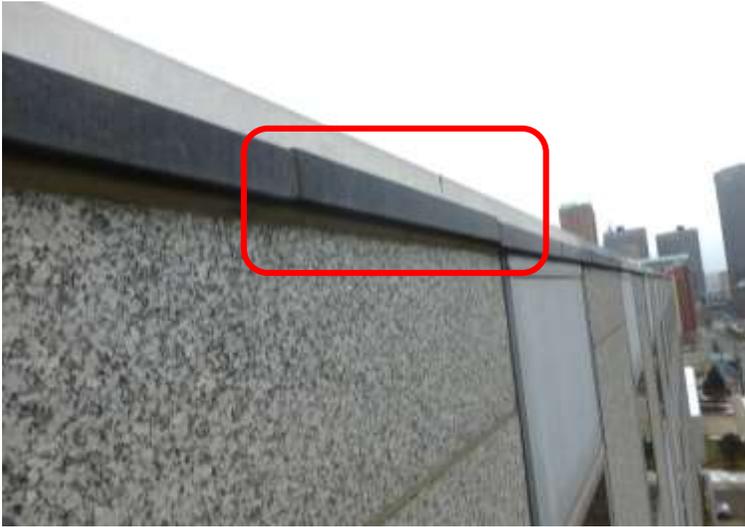
Figure 24. Displacement of the granite cap stones was noted along the tops of the walls (red box). None of the displaced units were noted to be loose.

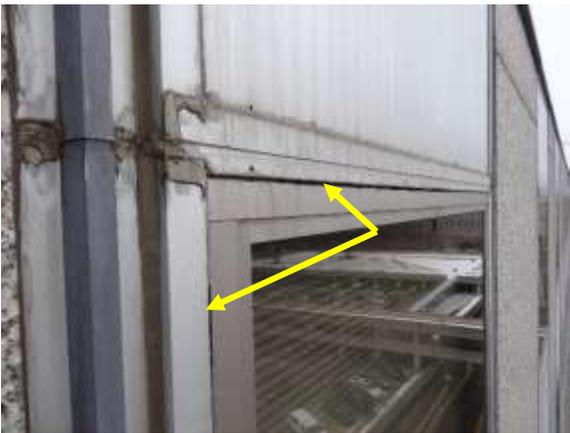
Figure 25. Sealant was missing at the head and jamb of this fifth floor window on the east elevation.

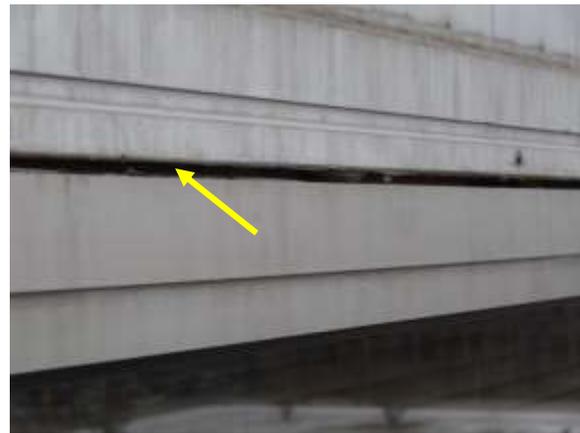
Figure 26. Detail view of the sealant missing from the window head shown in the previous detail, resulting in an open gap of about 1/4 inch width.

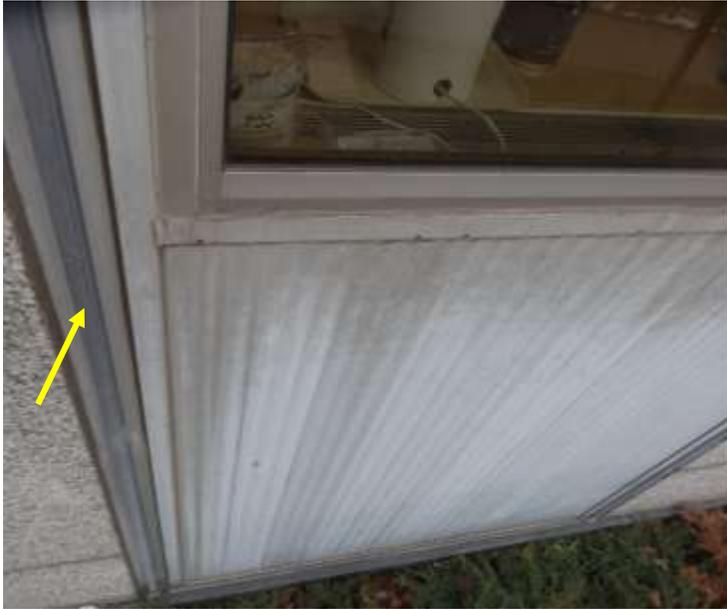
Figure 27. Oxidization of the aluminum spandrel panels has resulted in a deteriorated and irregular finish surface, and the original black color of the jamb accent has faded to gray (arrow).

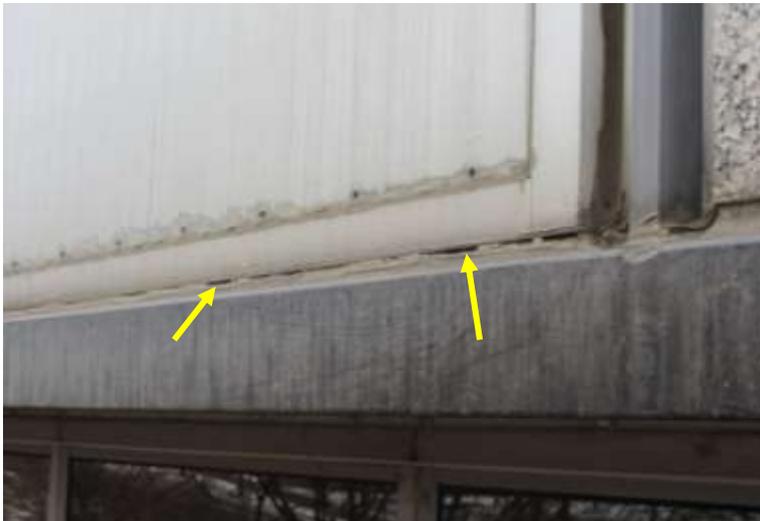
Figure 28. Adhesion failure was commonly noted at the base of the aluminum frames at the second floor level (arrows).

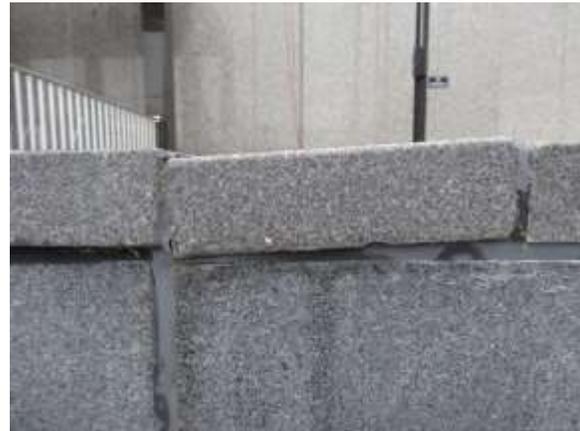
Figure 30. The existing condition at the terrace edge features sealant that impedes drainage and the flashing has been removed or covered. Trapped water underneath the pavers has caused displacement of some units as seen here.

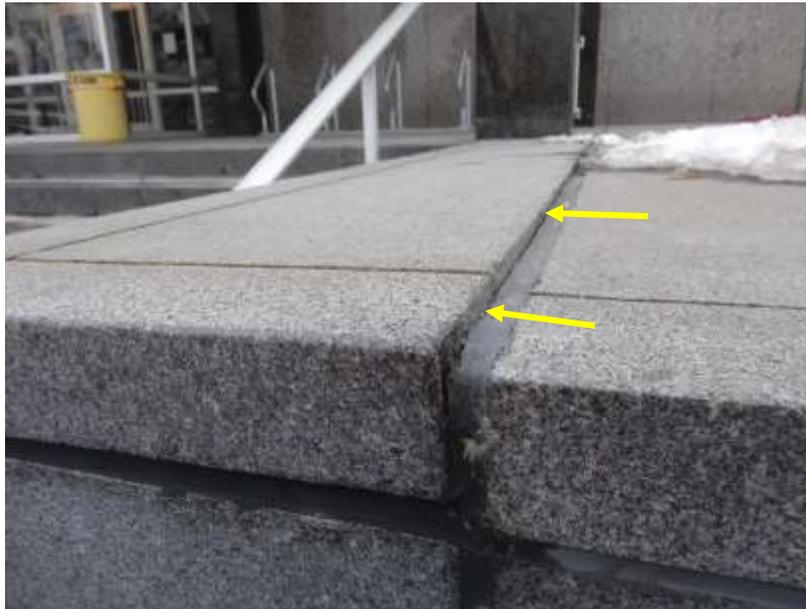
Figure 31. This paver at the west entry terrace has become displaced by freeze-thaw expansion of trapped water that leaked through the failed sealant joints (arrows).

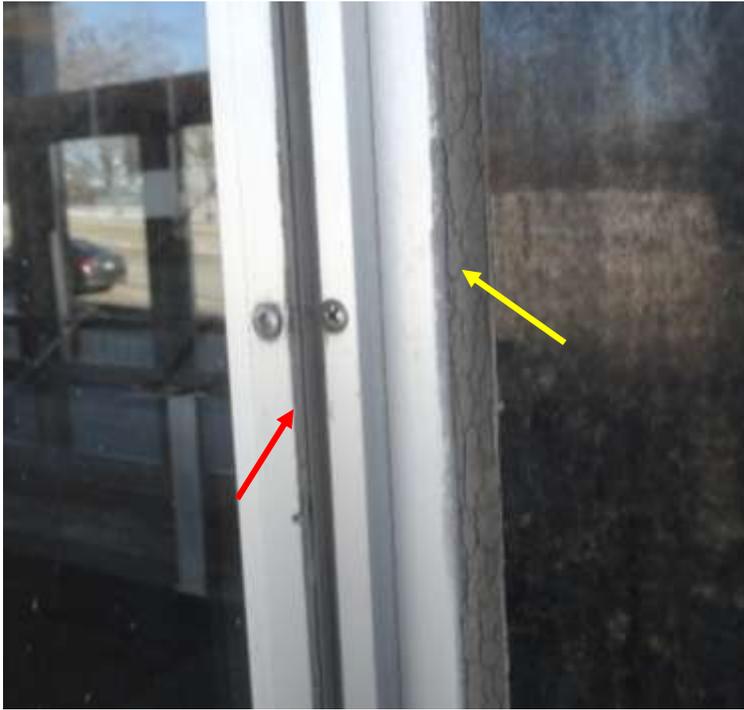
Figure 32. Detail view of the west entry vestibule showing single pane glazing (red arrow) and alligatored urethane sealant (yellow arrow).

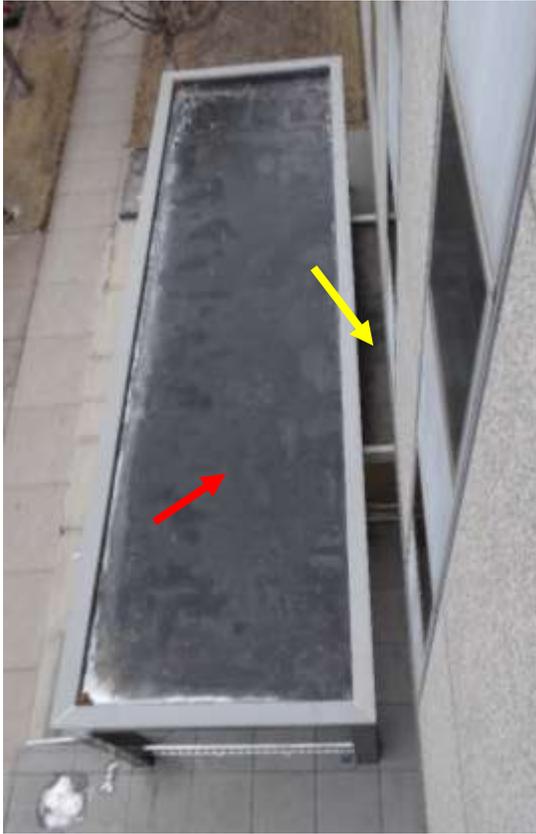
Figure 33. The west entry is covered by a two-tiered roof featuring an upper canopy (red arrow) above the vestibule roof (yellow arrow). The canopy roof was covered with a 1 inch thick layer of ice during our condition assessment.

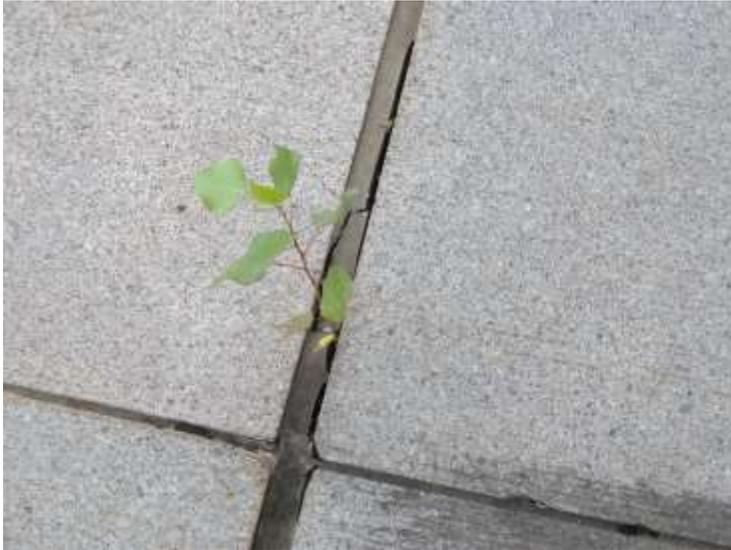
Figure 34. Plant growth in a failed sealant joint at the east terrace indicates long-term water leakage.

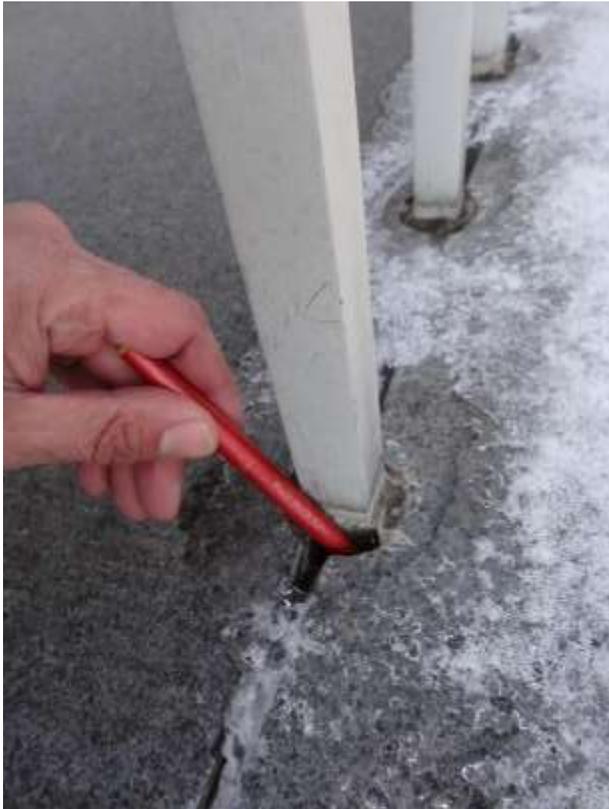
Figure 35. Missing sealant at the joint surrounding the guard rail pickets of the east terrace allows water penetration.

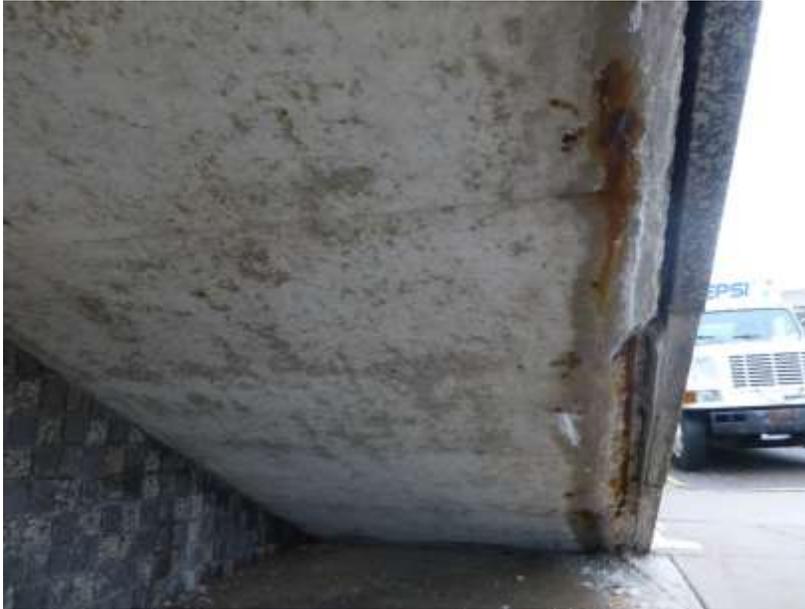
Figure 36. Spalling and delaminated concrete has exposed the corroded reinforcing steel along the east edge of the stair structure.

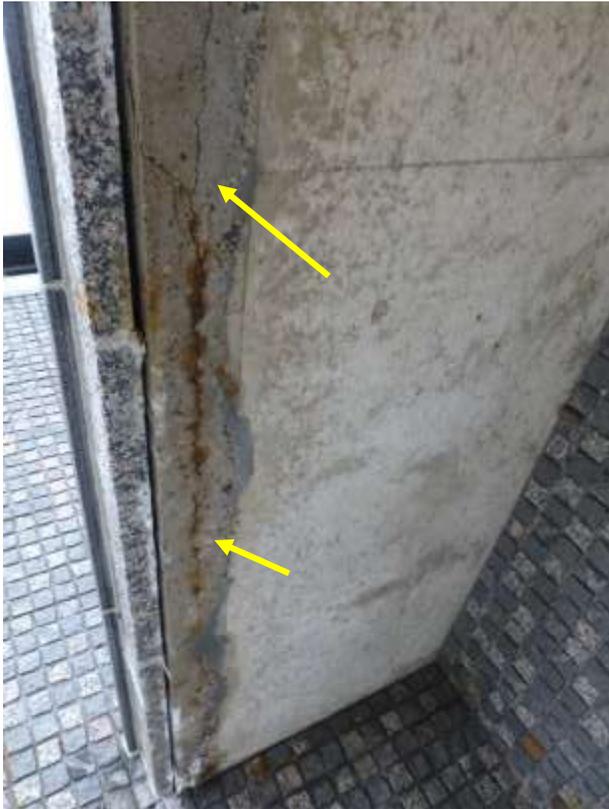
Figure 37. Previous repairs at the south end of the stair landing have begun to deteriorate (yellow arrows).

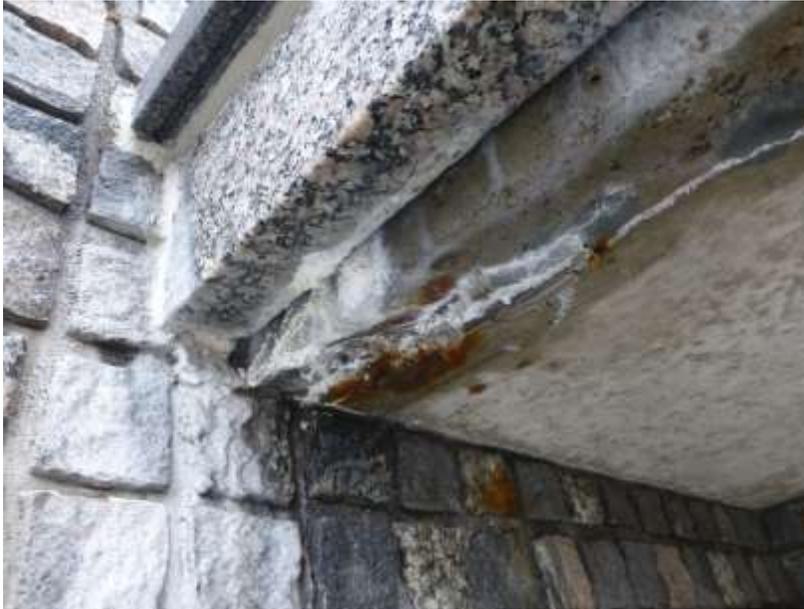
Figure 38. Calcification at the interface between the stair landing and the precast (Type E) wall panels at the south end of the stair.

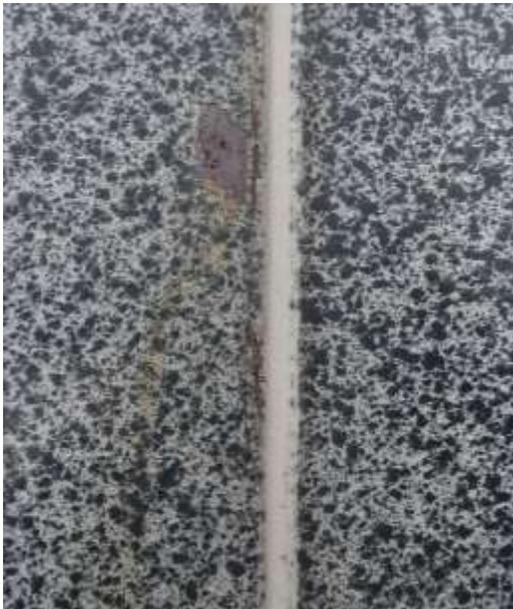
Figure 39. Rust staining at a surface spall and along the edges of a sealant joint in the enamel finish of the rooftop penthouse cladding.

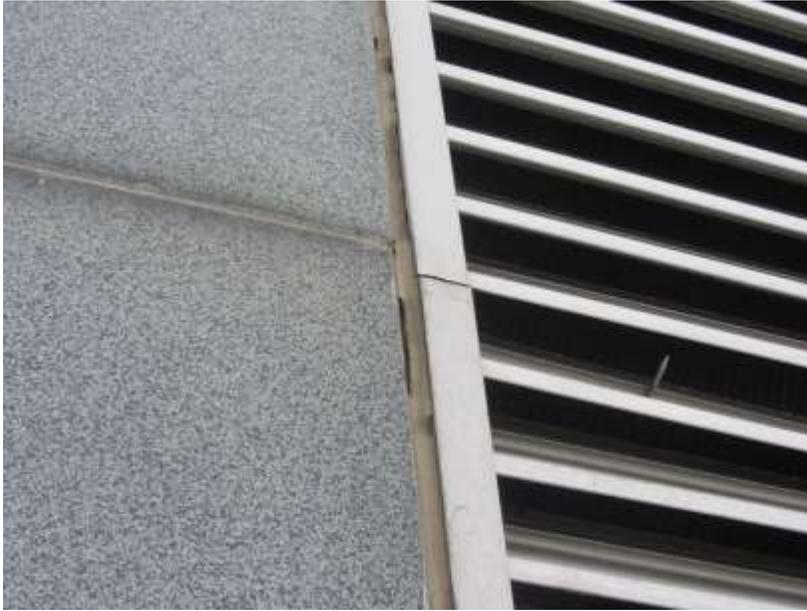
Figure 40. Adhesion failures were common in the primary sealant joint between the rooftop penthouse louvers and the adjacent metal panels.

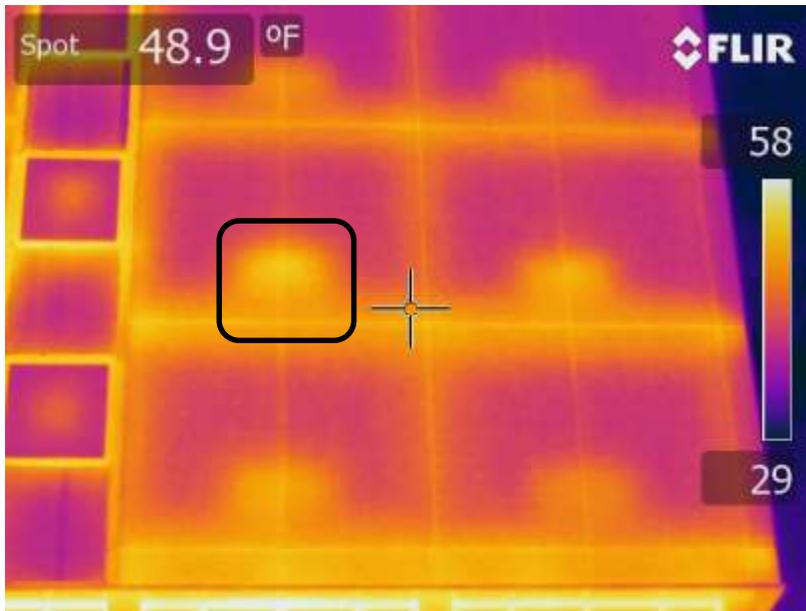
Figure 41. Warm spots in this IR scan indicate heat loss from cabinet heaters that interrupt the wall insulation (box).
