**Section 2.2.4
Second Floor Conditions Assessment
Historic Structures Report**

MINNESOTA STATE CAPITOL
HISTORIC STRUCTURES REPORT
VOLUME 2.2.5

THIRD FLOOR SPACE INVENTORY AND CONDITIONS

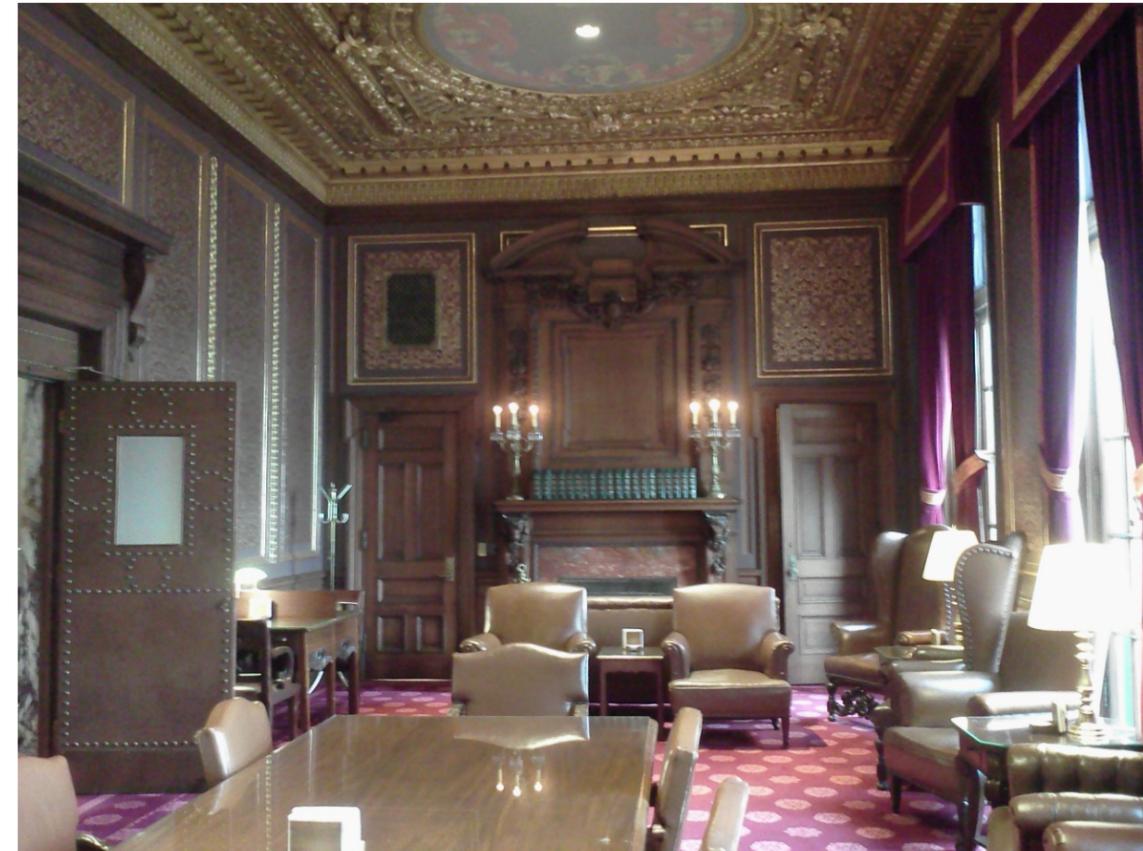
Same as above with the exception of new lighting fixtures, carpet and the removal of some of the original furnishings. See significant alterations.

Building Element:	Description	Condition of Original Material
Floor	Wood/carpet	Wood floor original, Carpet replicated
Walls	Wood Wainscot, fabric panels	Intact
Ceiling/Cornice	Painted and gilded plaster	Replicated, see below
Doors/Frame:	Wood with leather cover	Intact, Type
Hardware	Brass Lever	Removed
Light Fixtures	Chandeliers	Chandeliers replicated, Type
Artwork	None	None
Mechanical	Bronze decorative Grilles	Intact
Trim	Oak	Intact

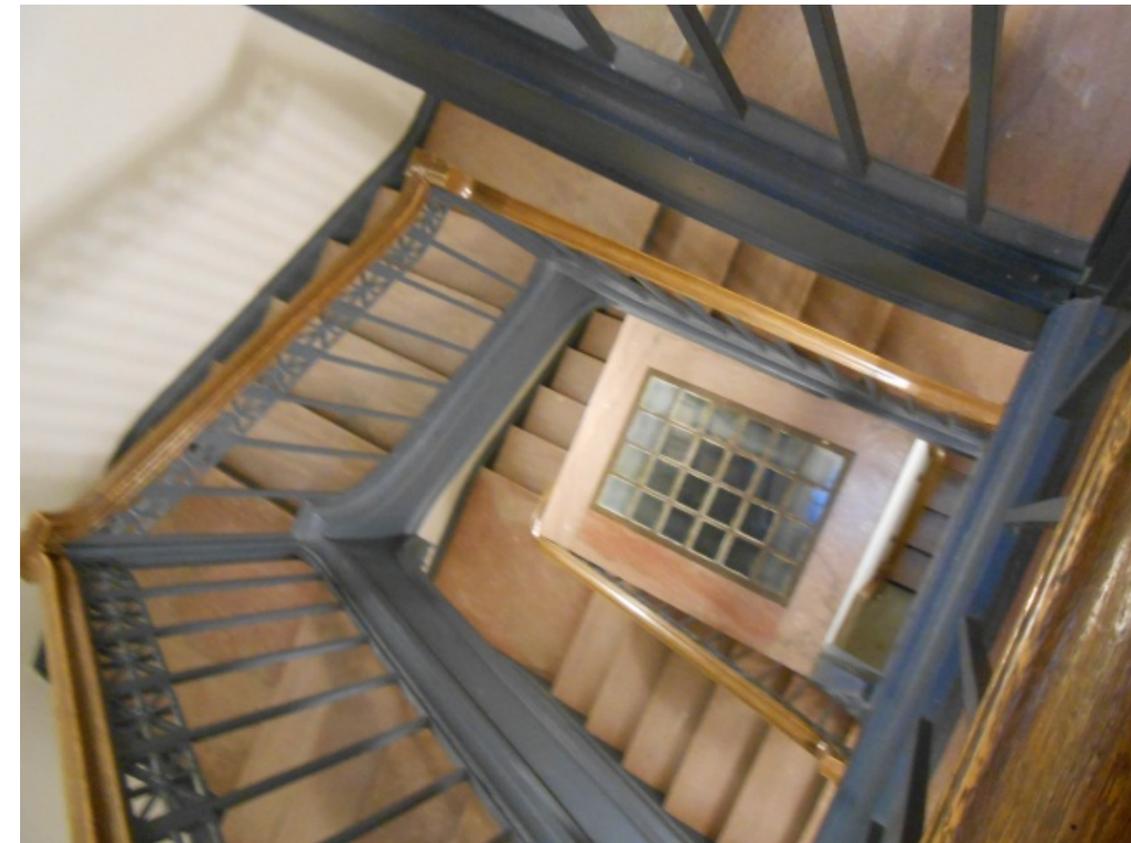
The Senate Stairs give access to the Senate Gallery. There are two of them on either side of the Senate Chamber and are identical. The stair structure is iron, with wooden handrails. Each one has a laylight. The treads are Pink Tennessee Marble. A notable feature is a small kiosk in the center of each one at the Second Floor Level. Each Kiosk has a glass block ceiling that admits light.

Building Element:	Description	Condition of Original Material
Floor	Tennessee marble	Intact
Walls	Plaster	Damaged
Ceiling/Cornice	Plaster with laylight	Some damage
Doors/Frame:	Original wood	Intact, Type
Hardware	Brass Lever/knobs	Not original/original
Light Fixtures	Ceiling mounted fixtures	Not original
Artwork	None	None
Mechanical	None	None
Trim	Wood/iron	Intact

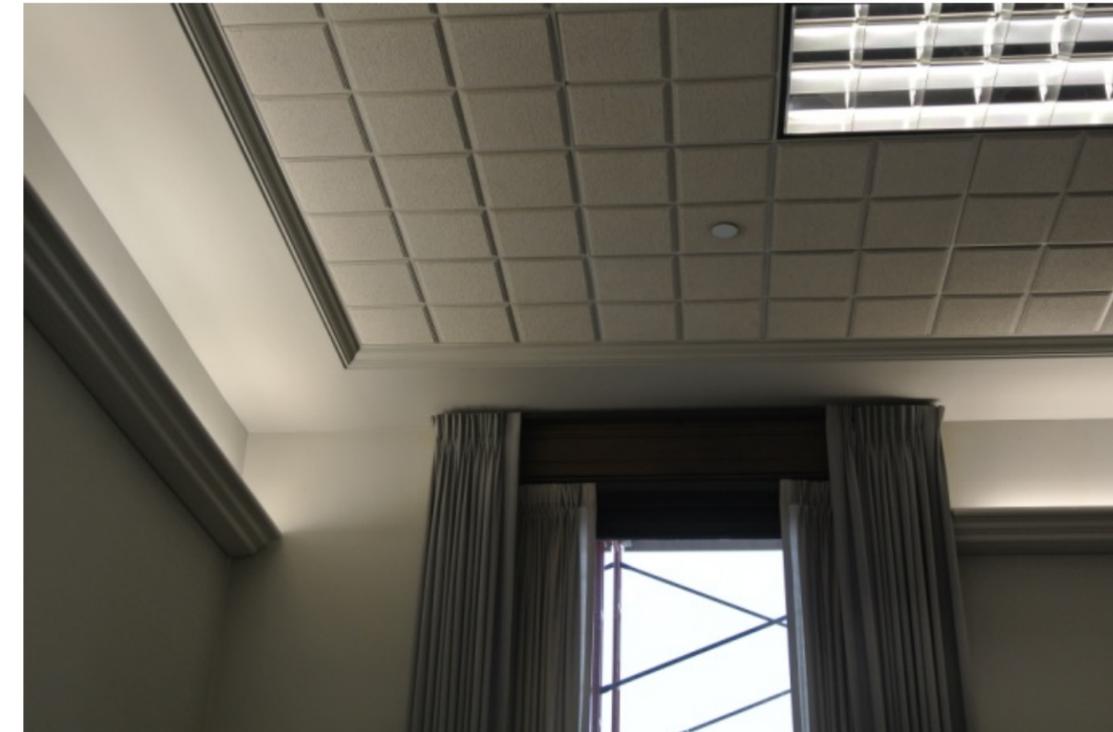
Adjacent to the House Chamber was the former Post Office. Decommissioned as a Post Office in the seventies, it was used as a Coffee Bar before being converted into offices. The Post Office originally had a tile floor which may still be present beneath the carpetting.

Building Element:	Description	Condition of Original Material
Floor	Concrete, tile/carpet	Unknown
Walls	Plaster/paint	Modified
Ceiling/Cornice	ACT over plaster/none	Some damage
Doors/Frame:	Original wood	Intact, Type
Hardware	Brass Lever/knobs	Not original/original
Light Fixtures	Wall mounted uplights, lay in lights	Not original
Artwork	None	None
Mechanical	Stamped louver	Not historic
Trim	Plaster/oak	Intact

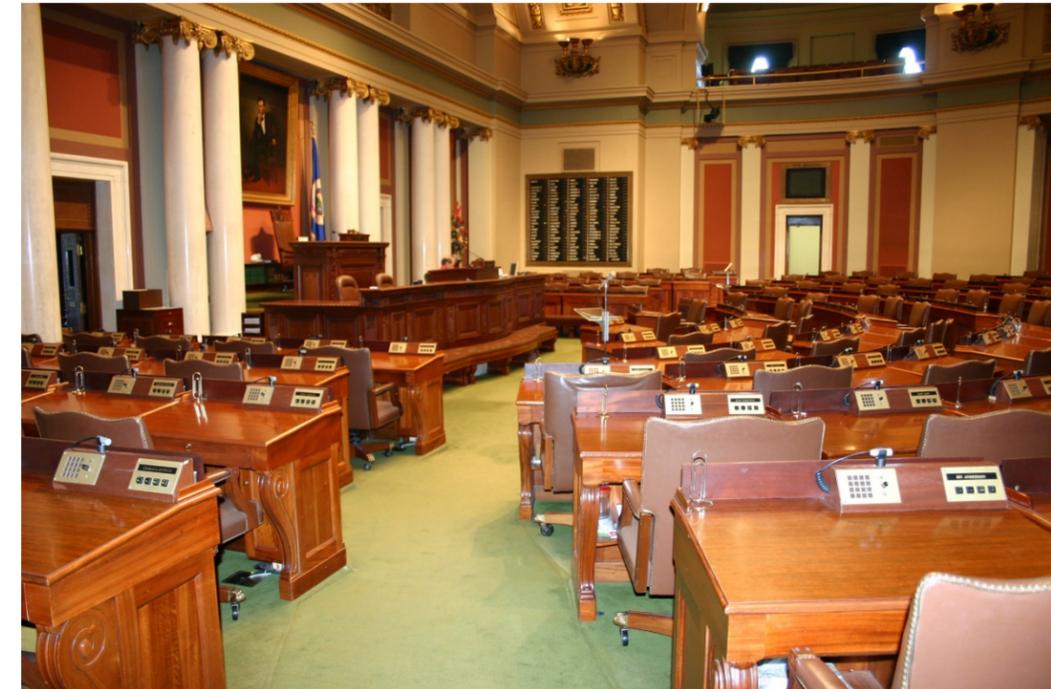
In 1989 The House Chamber was restored to its original appearance, with the following exceptions; the north gallery has been converted into office space. In the archway above the speakers desk is a plaster relief sculpture depicting Minnesota the Spirit of Government. In the center a classically dressed woman stands on a podium above the great seal of the state. She holds in her hands a mace and a book with the dates 1849 and 1858. She is

supported on her right side by two Native American figures and on her left two French Voyageurs. Behind the sculpture is a ground of gold fleur-de-lis and the words Vox Populurium est Vox Dei. At either end of the great archway, above the supporting piers is found an eagle clasping in its talons a scroll with the dates 1949 and 1958, respectively. Voting boards are found on the east and west walls. Above the east and west doorways are video display monitors.

Building Element:	Description	Condition of Original Material
Floor	Concrete, replica carpet	Original wood destroyed
Walls	Plaster	Intact
Ceiling/Cornice	Decorative plaster	Intact
Doors/Frame:	Original wood, leather covered	Intact, with light wear
Hardware	Brass push plate/pull handles	Intact
Light Fixtures	Wall sconces, non original can lights	Intact/not original
Artwork	Statues, decorative plaster painting	Intact
Mechanical	Bronze decorative grilles	Intact
Trim	Plaster/oak	Intact

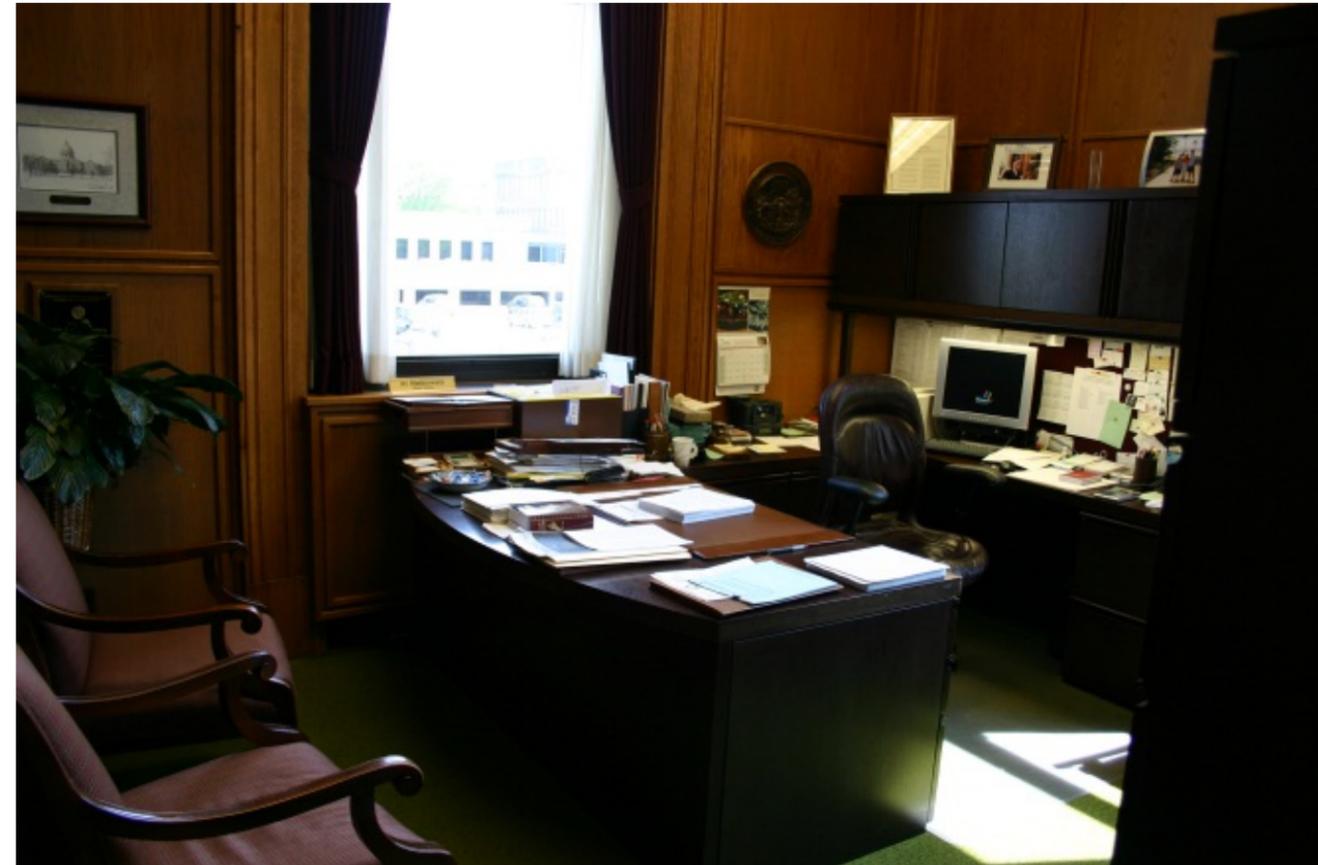
This office was subdivided in the second renovation, and was lined with paneling. Originally, there was no pass-through hallway.

Building Element:	Description	Condition of Original Material
Floor	Concrete/carpet	Destroyed
Walls	Wood paneling/plaster	Not original/unknown
Ceiling/Cornice	ACT over plaster	Unknown
Doors/Frame:	Original wood	Intact
Hardware	Brass push plate/pull handles	Intact
Light Fixtures	Lay in	Not original
Artwork	None	None
Mechanical	Stamped Louver	Not original
Trim	Plaster/Oak	Intact.

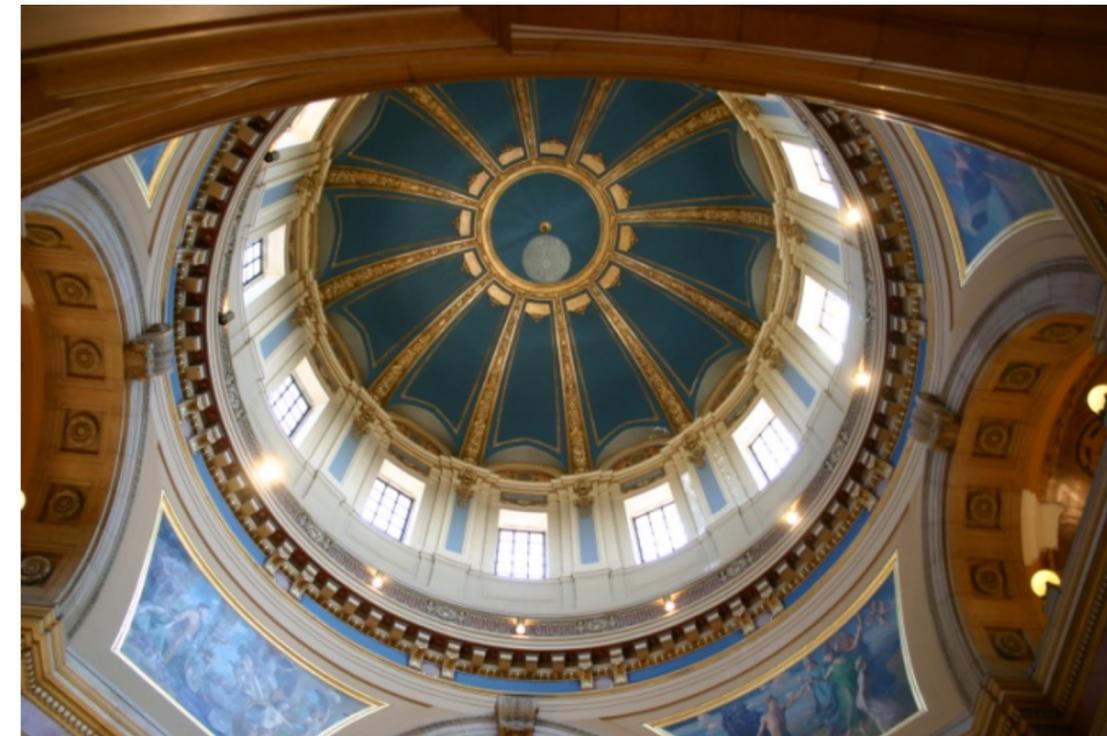
The plaster column capitals are within hands reach on this level, and many of them are damaged. The Corridor ceilings, with their decorative painting, have all been extensively restored in 2008.

Building Element:	Description:	Condition of Material:
Floor	Limestone and Marble	Intact
Walls	Kasota Stone/Plaster	Intact/water damaged
Ceiling/Cornice	Plaster/paint	Heavy water damage
Doors/Frame:	Wood	Intact
Hardware	ADA levers	Not original
Light Fixtures	Chandeliers and wall mounted fixtures	Intact/Restored
Artwork	12 small and 4 large murals, column capitals, decorative painting	Water damage
Mechanical	Bronze decorative Grilles	Intact
Trim	Plaster/stone	Intact

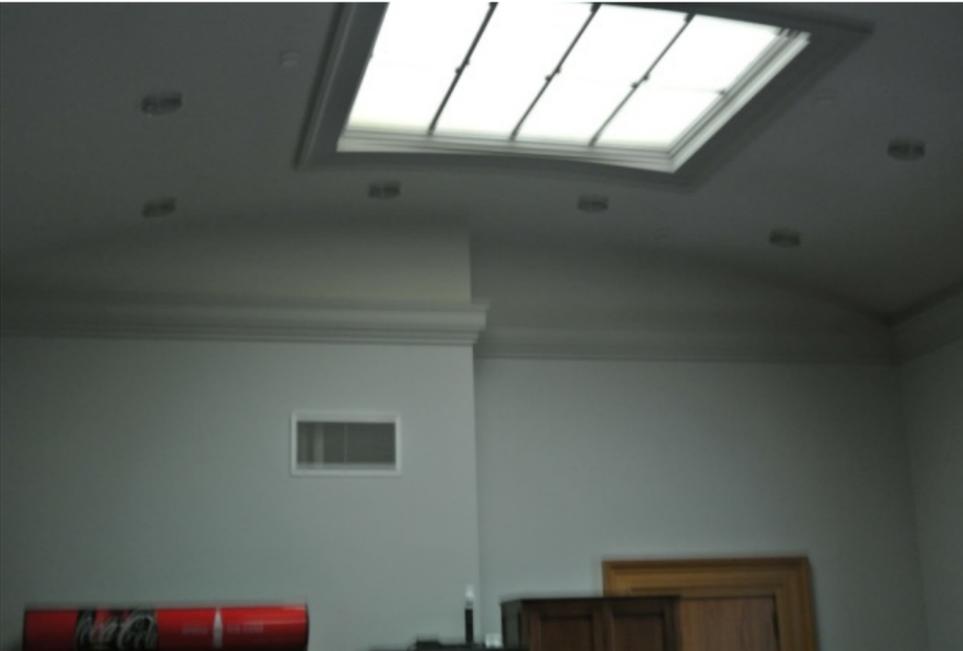
This area was once the North East Minor Corridor and offices belonging to clerks of the Supreme Court and law library. It is unclear whether tile floor for the minor corridor remain under carpeting.

Building Element:	Description:	Condition of Material:
Floor	Carpeted	Unknown
Walls	Plaster	Modified
Ceiling/Cornice	Plaster	Modified
Doors/Frame:	Wood	Not original
Hardware	ADA Lever	Not original
Light Fixtures	Can lights	Not original
Artwork	None	None
Mechanical	Aluminum louver	Not original
Trim	Wood	Not original

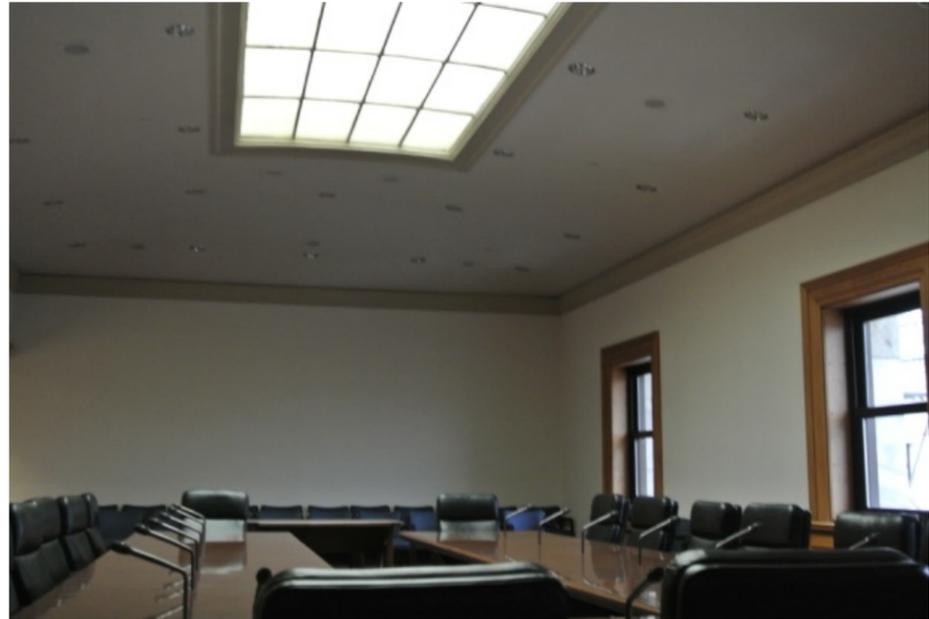
Conference room 316
 Formerly Law Library
 316
 Treatment Level: 2

This is a Large Conference Room with a skylight. It was formely a Law Library. There is no wall between it and the minor corridor and there was none originally.

Building Element:	Description:	Condition of Material:
Floor	Carpeted	Unknown
Walls	Plaster	Modified
Ceiling/Cornice	Plaster	Modified
Doors/Frame:	Wood	Not original
Hardware	ADA Lever	Not original
Light Fixtures	Can lights	Not original
Artwork	Hung painting	Intact
Mechanical	Aluminum louver	Not original
Trim	Wood	Not original

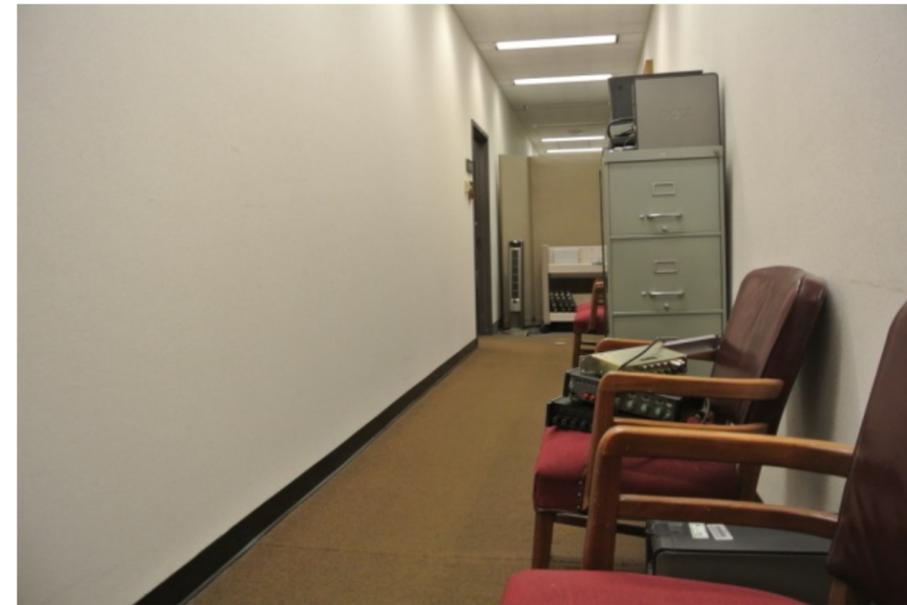
Offices
 Formerly Law library
 317, 317A-H
 Treatment Level: 3

This Office Suite was created from the Supreme Court's Law Library. The two East Minor Corridors end in this area presumably with their tile floors.

There was a skylight above Offices 317D, 317E but it has been covered.

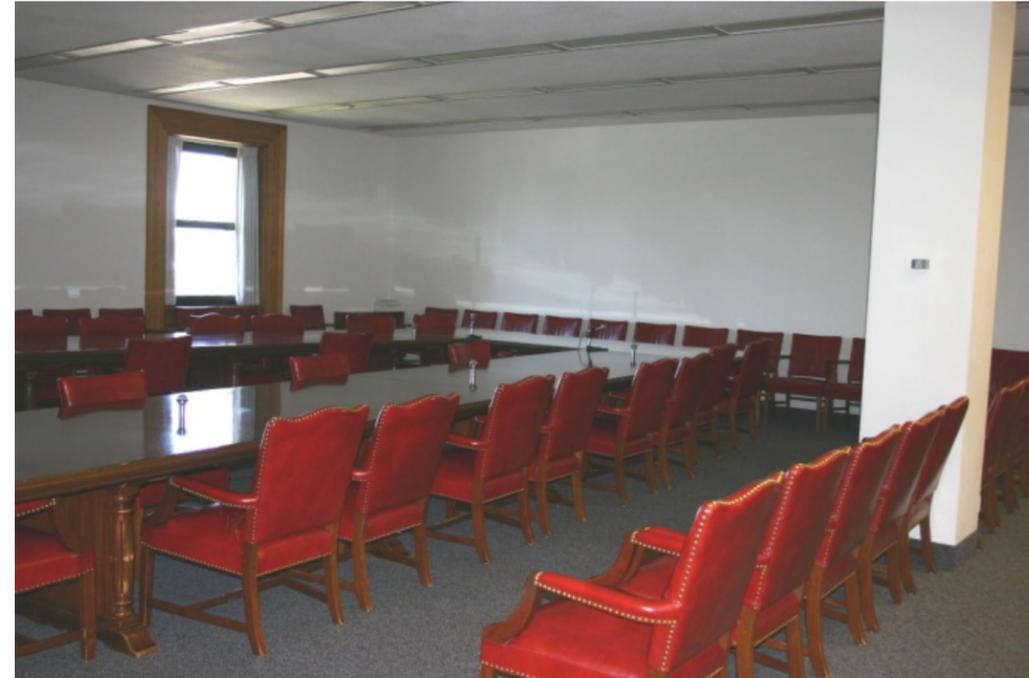
Conference Room.

There was a skylight above Conference Room 318 and adjacent offices but it has been covered. Skylights were replaced in 1994, so the skylight above should be functional

Building Element:	Description:	Condition of Material:
Floor	Carpeted	Unknown
Walls	Plaster/gyp	Modified
Ceiling/Cornice	ACT	Unknown
Doors/Frame:	Wood/Hollow metal	Not original
Hardware	ADA Lever	Not original
Light Fixtures	Lay in	Not original
Artwork	None	None
Mechanical	Ceiling distribution	Not original
Trim	Wood/vinyl	Not original

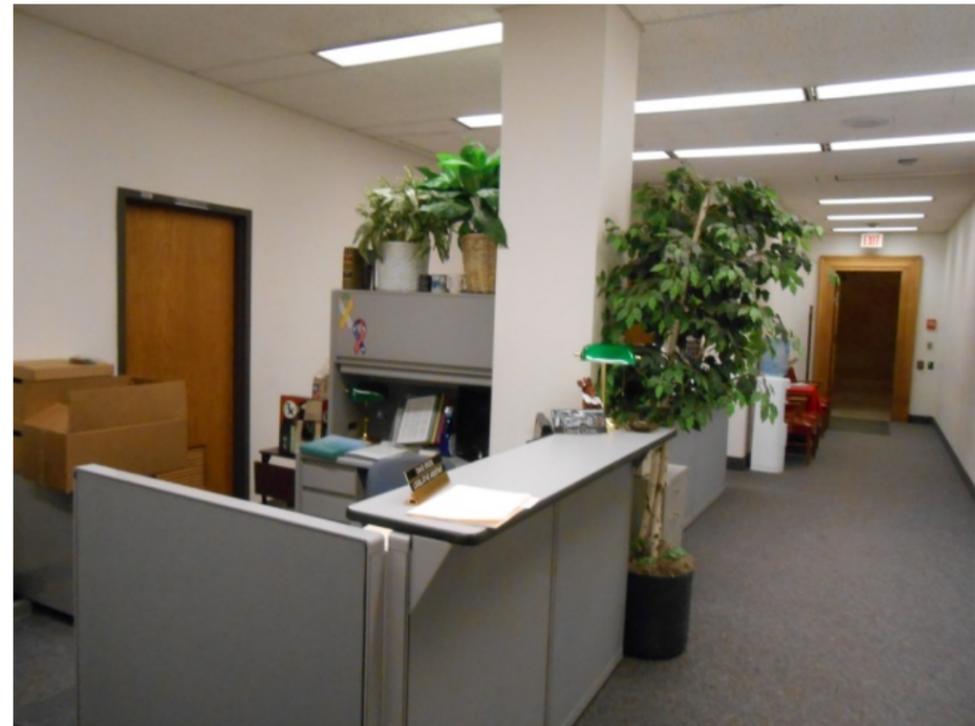
There were two skylights above Training Room 320 but they have been covered.

Building Element:	Description:	Condition of Material:
Floor	Carpeted	Unknown
Walls	Plaster/gyp	Modified
Ceiling/Cornice	ACT	Unknown
Doors/Frame:	Wood/Hollow metal	Not original
Hardware	ADA Lever	Not original
Light Fixtures	Lay in	Not original
Artwork	None	None
Mechanical	Ceiling distribution	Not original
Trim	Wood/vinyl	Not original
