3.1.1 General Description of the Capitol.

Section 3.1.1
General Description
Historic Structures Report

Minnesota State Capitol Restoration

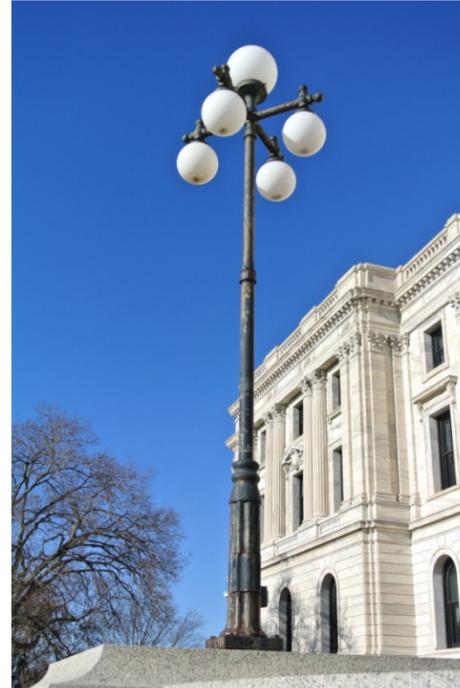
These exterior posts are either the original exterior light fixtures alluded to in the final report from the Board of Capitol Commissioners, or replaced them long ago. They are in very poor condition, with visibly rusting iron parts and dirty globes.

There are two of them for each entrance.

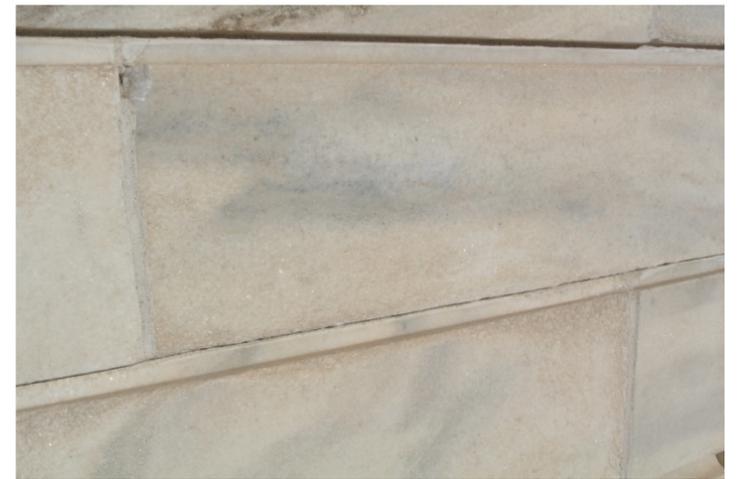
White Georgia Marble-Amicalola, Georgia: on the upper floors and dome. Much controversy took place when this stone was chosen for the Capitol. See Section 1.2.3 History of the Capitol Construction. The original stone is badly deteriorated from weathering, and is undergoing a comprehensive restoration project.

The exterior stone has gone through numerous studies, remediation campaigns and is currently undergoing a major restoration effort that involves removal of loose material, grinding of sugared material, crack repair work, Dutchman patching and some replacement.

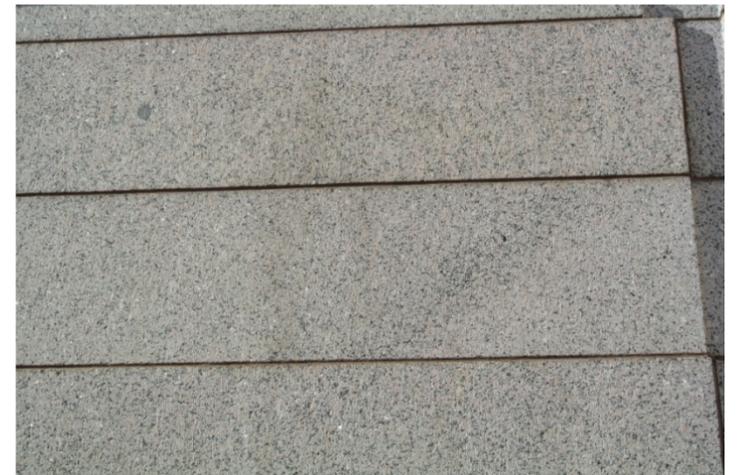
By contrast, the original Granite is in excellent condition. The occasional tuckpointing project has taken place, otherwise most exterior granite is just as it was when installed.

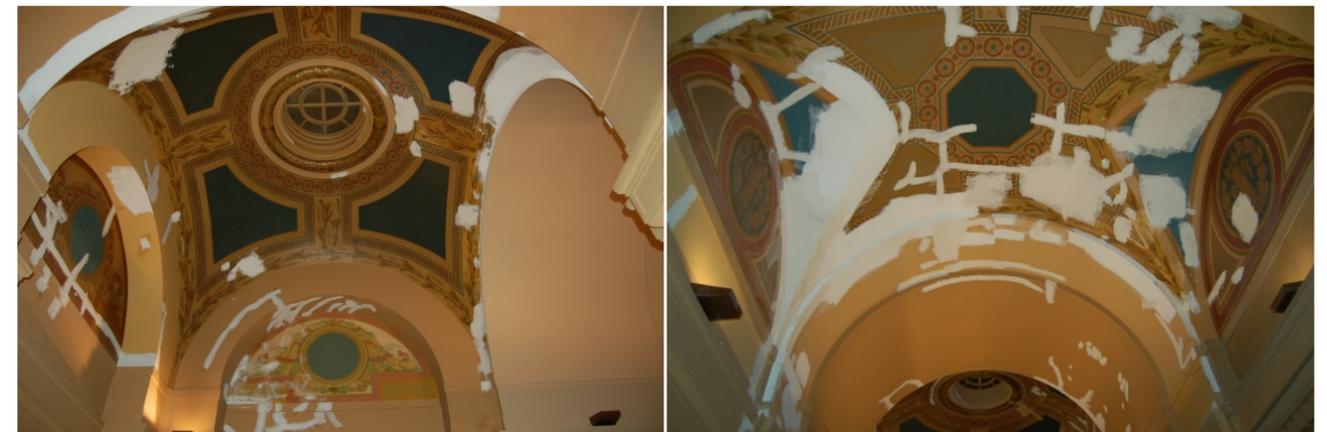
Dome Corridors: Plaster in the Dome Corridors was also recently restored. Widespread cracking and delamination had threatened this area, but enough of the existing material remained in good condition for the decorative painting to be studied and replicated in restored areas. Photo Credits: Conrad Schmitt Studios, inc. Photos show ceiling during restoration.

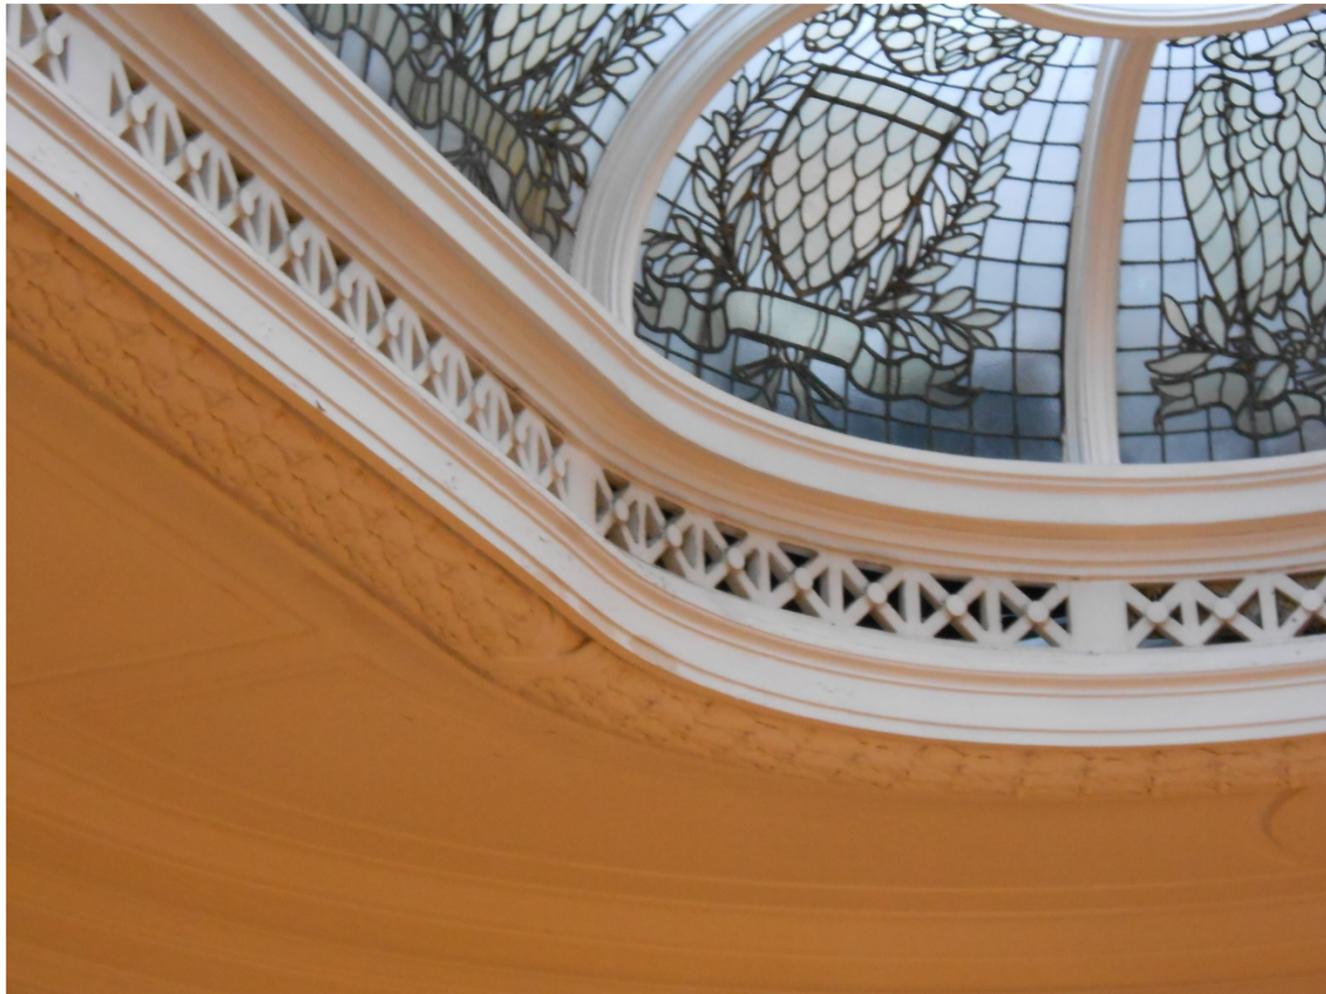
The Oval staircase also shows some signs of cracking on the decorative plaster surrounding its skylight. Further investigation is required to determine whether this is a problem with the plaster, perhaps caused by water infiltration through the skylight, or if it is merely paint cracking. It is also important to note that this was detected only because a person can get close enough to the skylight to see it at the Oval Stair. An examination of the plaster surrounding the other major skylights is recommended.
