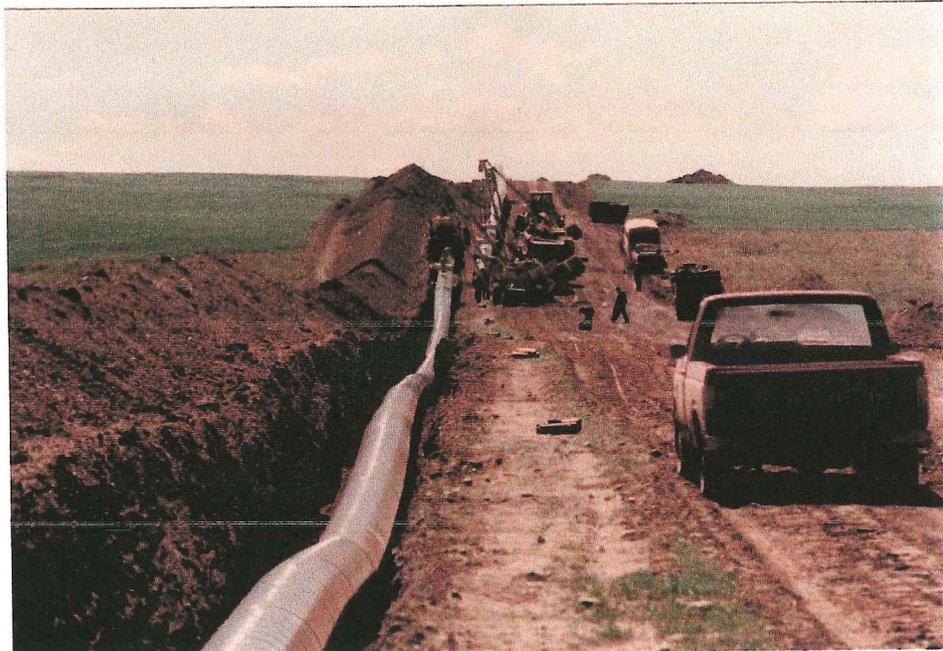
#17 Taped pipe after lowering-in, ready to be covered.
Photo taken June 26 on state parcel PH012.

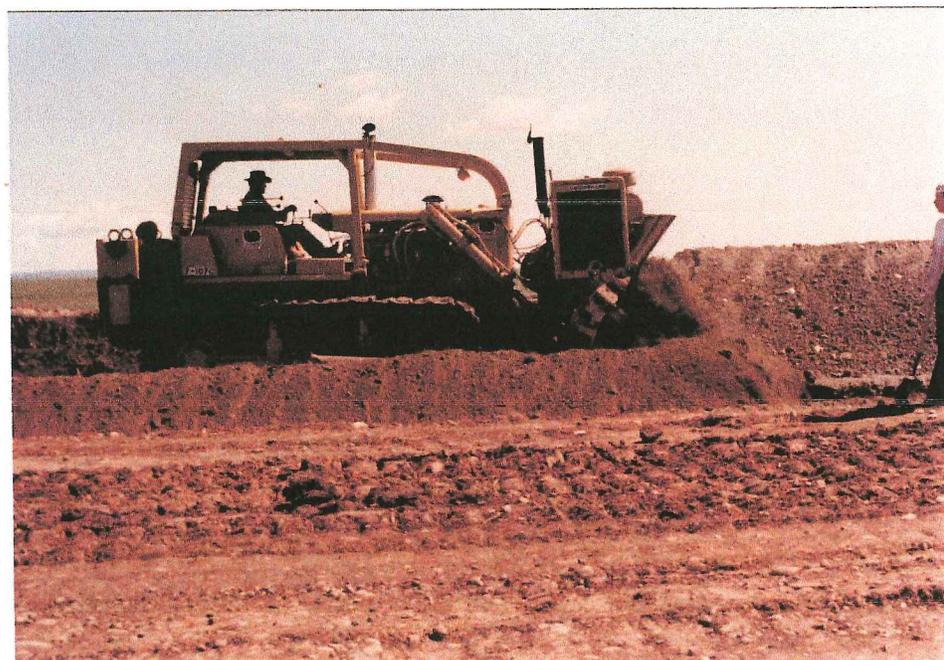
#18 Ditch spoil being replaced by auger mounted on front of tractor.

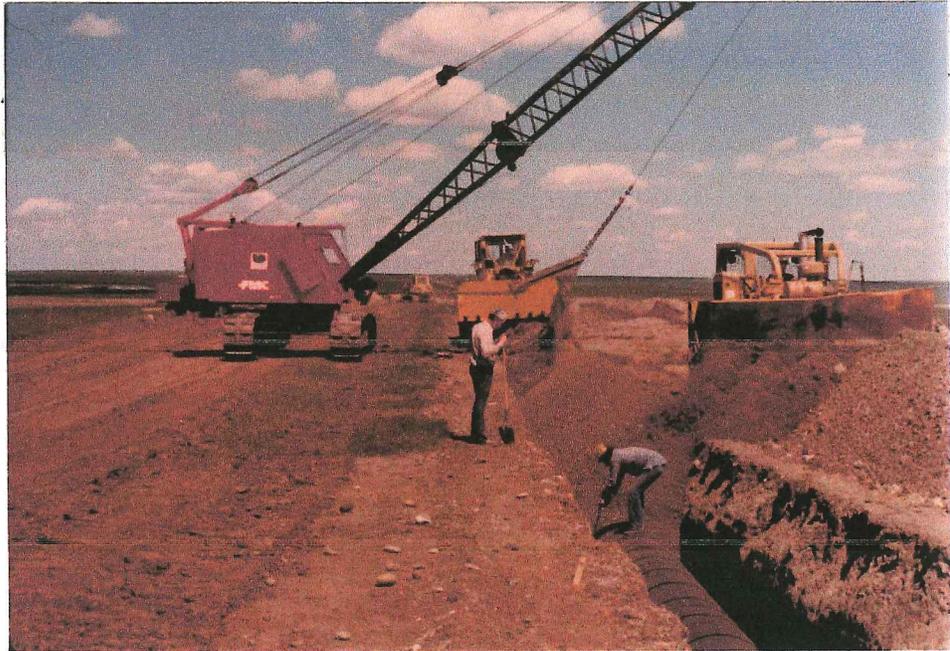
#19 Backfill operation consists of: augering, a dragline pulling in the rest of the ditch spoil, and a front-loader bringing up the rear acting as a packer. The man on the pipe in front of the auger is responsible for flipping rocks off the pipe to prevent damage to the wrap. Photo taken June 26 on state parcel PH012.

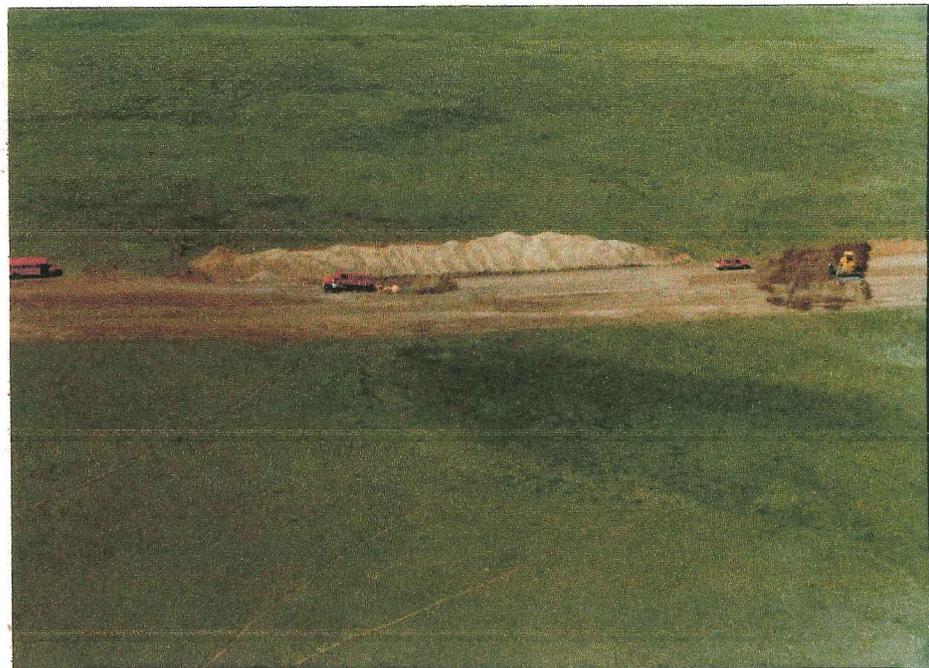
#20 Aerial view of clean-up operation in Phillips County as it begins on June 26. The dump truck is burying rock, dug up during trenching and clearing, in a side-hill cut.

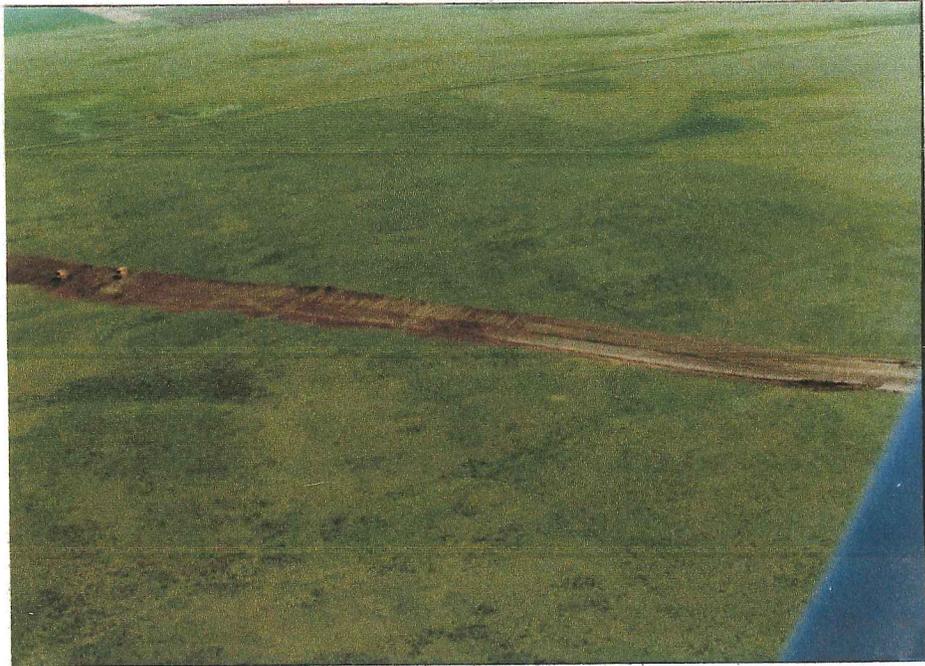
#21 Clean-up, Phillips County, looking northwest on June 26. Note the subsoil showing through. The ditch is on the north side of the r-o-w. (See also photo #78)

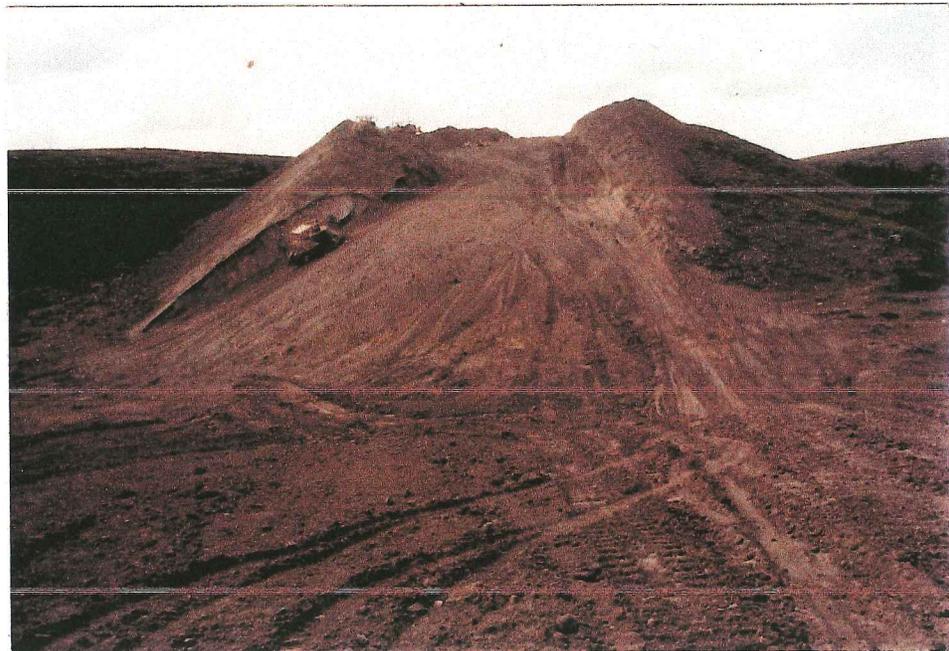
#22 West bluff of Frenchman Creek Valley being re-contoured on July 22. See photos #40 to #43 for a more detailed description of restoration on rough terrain.

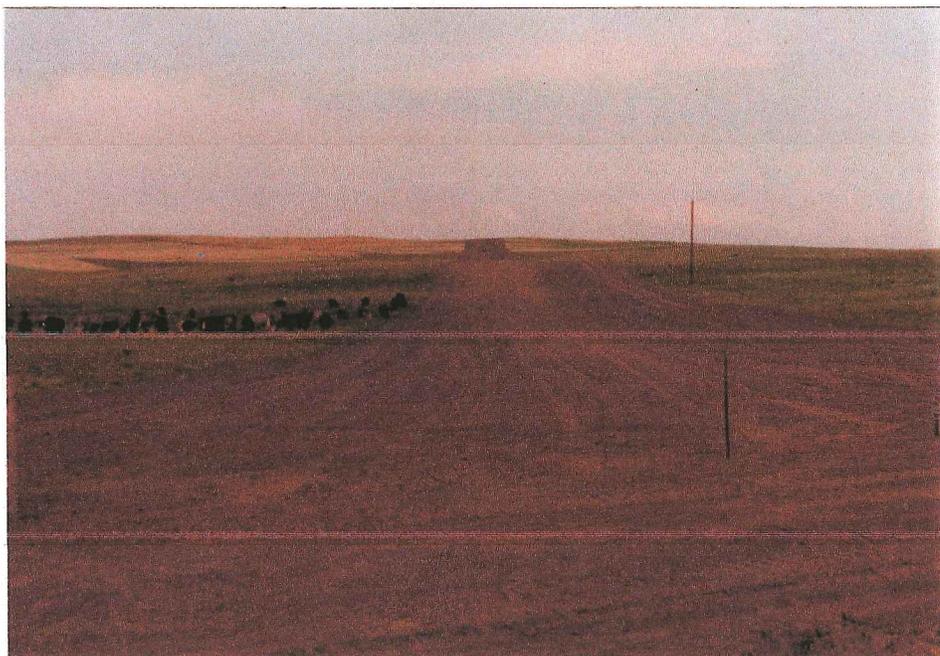
#23 Clean-up completed by July 24th at the beginning of Spread #2, about 3 miles east of Big Muddy Creek in Roosevelt County.

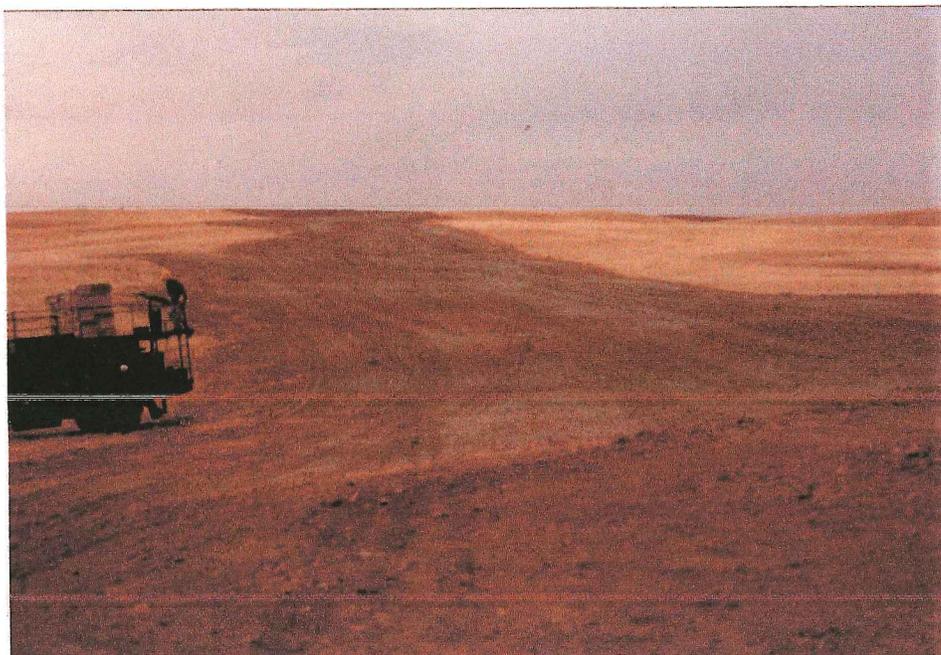
#24 Reclamation, November, 1981, in Phillips County. Mulch has been applied (photos#24 through #27 courtesy of Office of the Federal Inspector.)

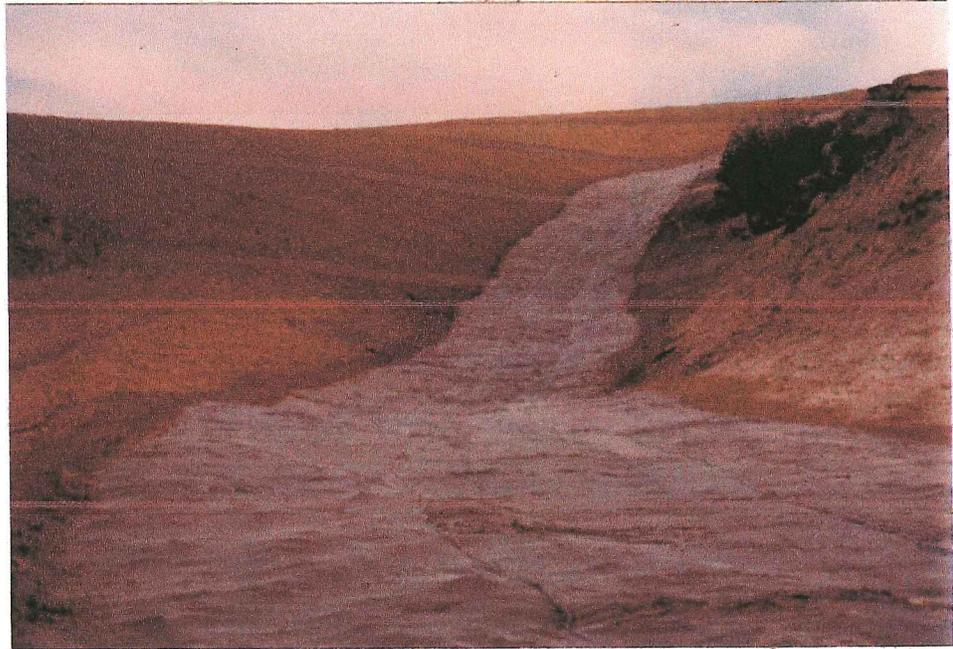
#25 Erosion prevention in drainageway, November 1981. The exposed soil surface is covered with a biodegradable mesh after seeding has been completed.

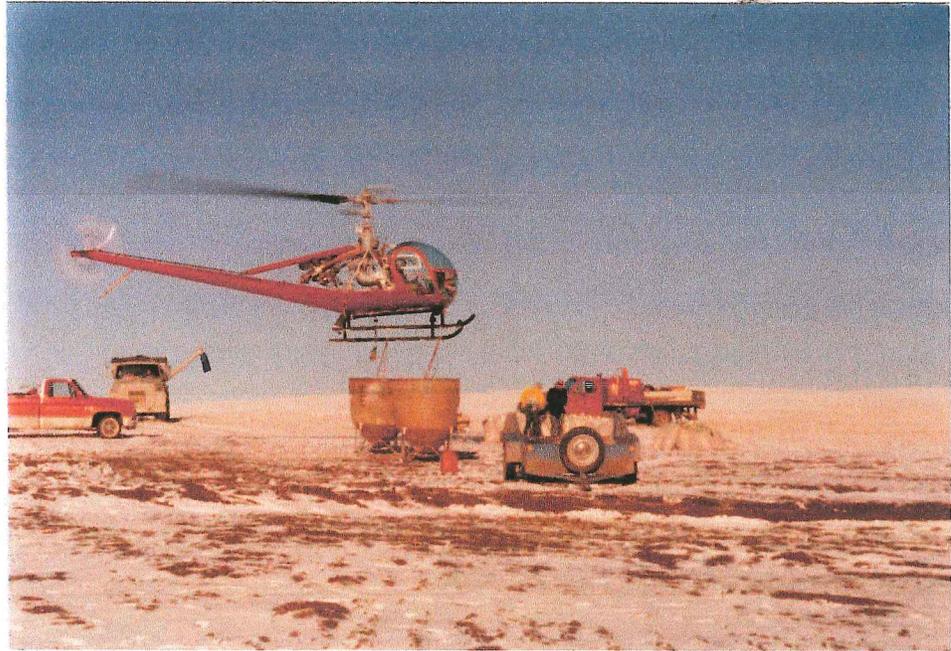
#26 Helicopter seeding crew. The helicopter carries a bucket that spreads native grass seeds on the r-o-w.

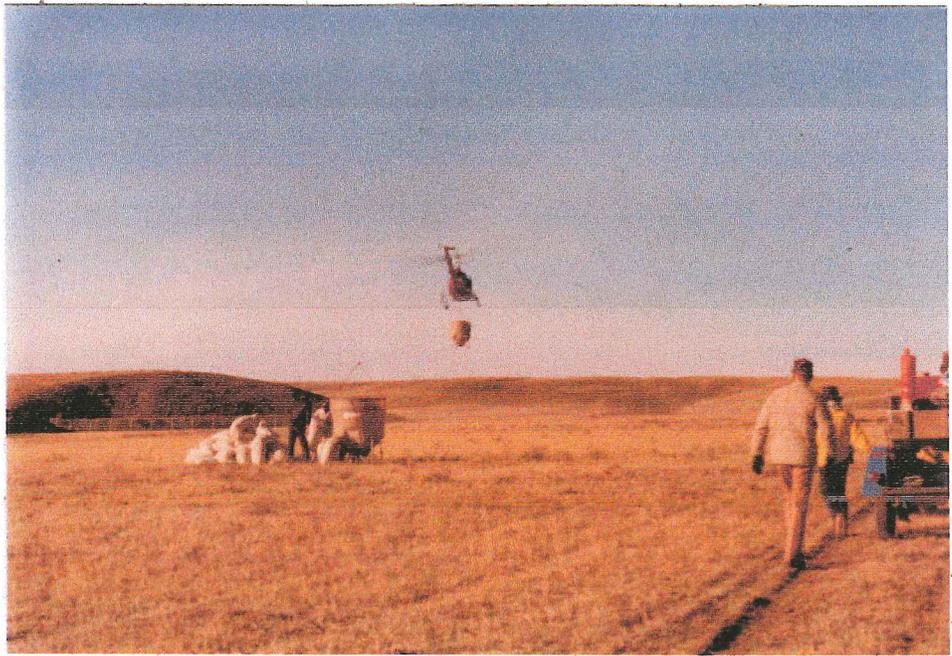
#27 Helicopter seeding crew.

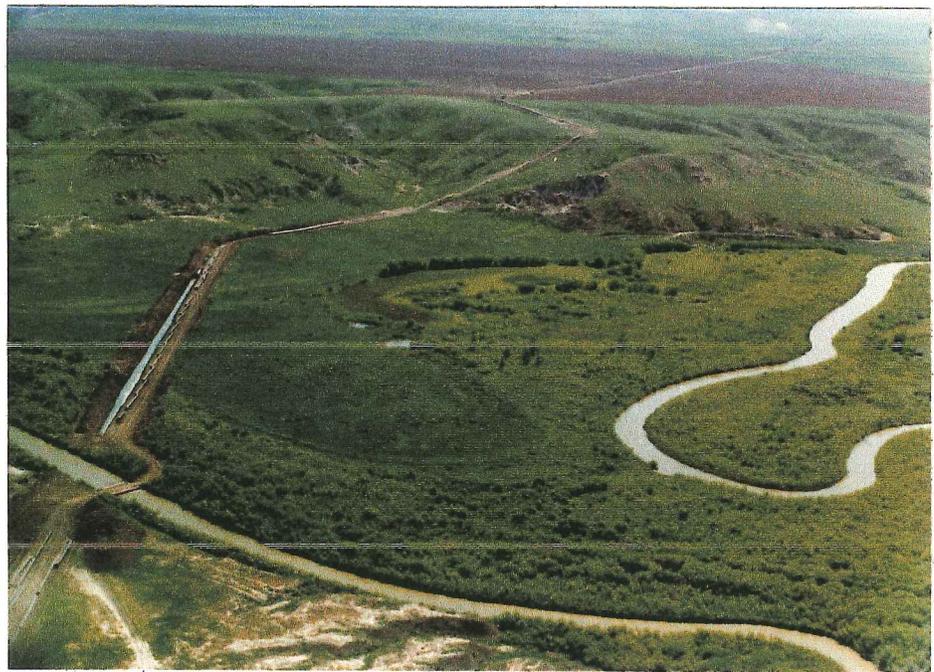
#28 Crossing of Frenchman Creek Valley looking east on June 26. The Frenchman Reservoir is just downstream, and a proposal to raise the reservoir level would result in this area being flooded. Note: 1) the east bluff had not been cleared at the time of the photo because no final agreement had been reached with the landowner, even though construction had been nearly 7 weeks before, 2) the DNRC owns 40 acres of floodplain just west of the base of the bluff which is crossed by the pipeline (VA001), 3) a floating bridge which remained until completion of construction.

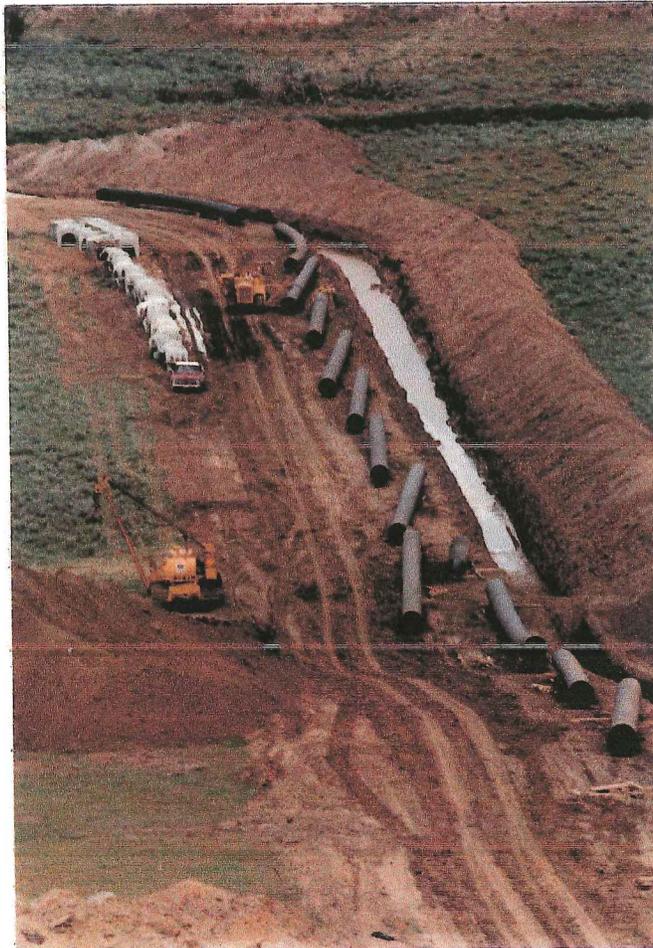
#29 East side of Frenchman Creek floodplain on July 14, pipe ready for welding. The eastern side of state parcel VA001 is just beyond the pipe bend. Note: 1) Trench filled with water across most of floodplain seen in #28, 2) Concrete weights to prevent pipe rising out of saturated floodplain, ready to be placed on pipe. Two kinds can be seen; rectangular "set-ons", and rounded "bolt-ons" are placed both above and below the pipe, 3) Trench side-wall slump, requiring additional backhoe excavation.

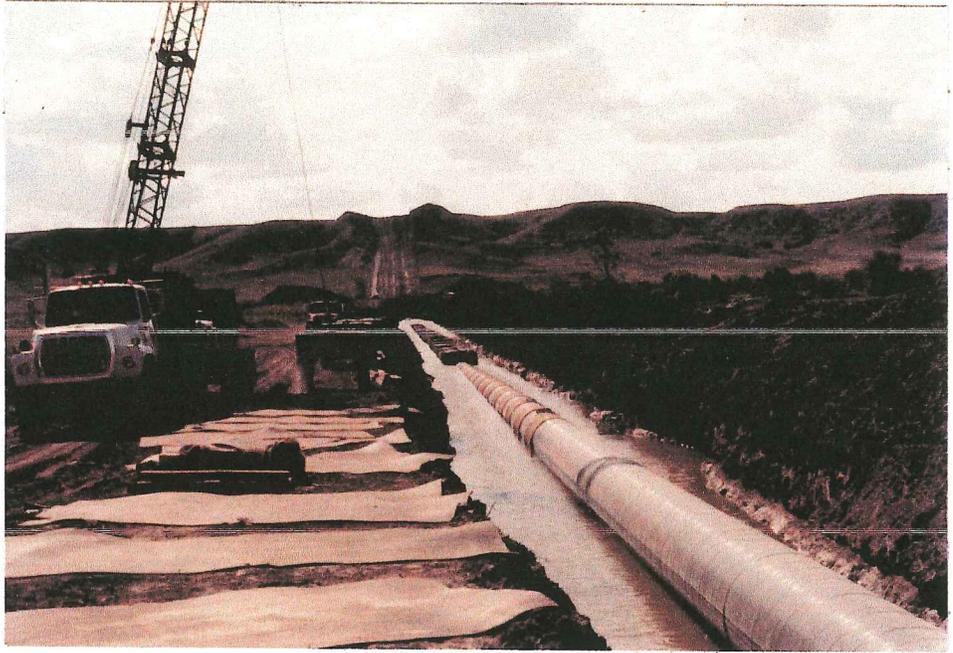
#30 Set-on weights being placed on pipe after it is in trench. Note the thick felt pads placed around the pipe to protect it. Photo taken July 14 on state parcel VA001.

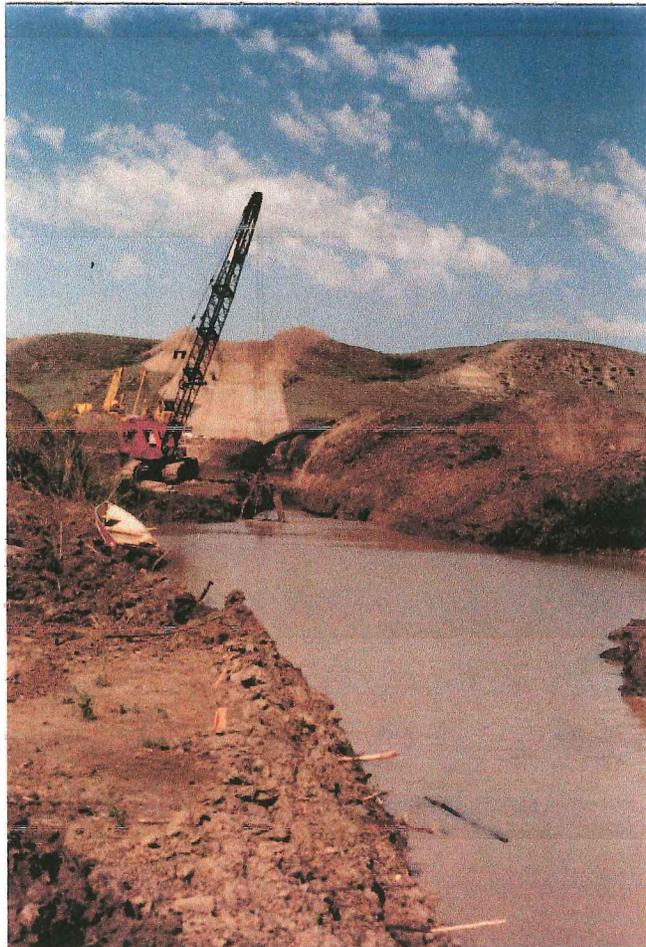
#31 Dragline opening ditch across Frenchman Creek, the last step before placing the pipe. Taken looking west from the east bank on July 14.

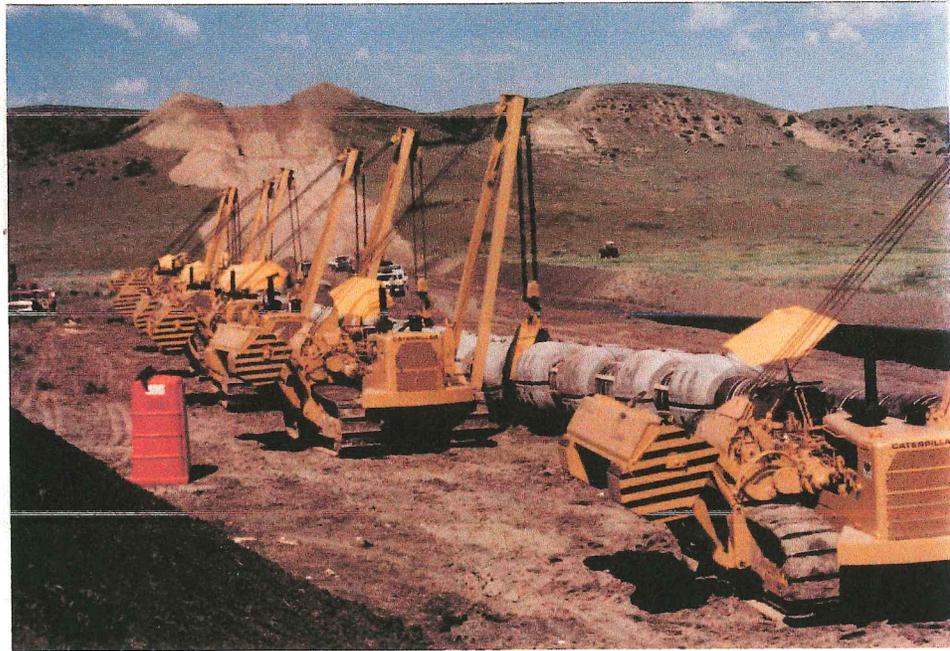
#32 Side-boom tractors lifting the creek section to pull it across. Concrete weights in place. The lead tractor, which winches the section across the creek with a cable, is in the foreground.

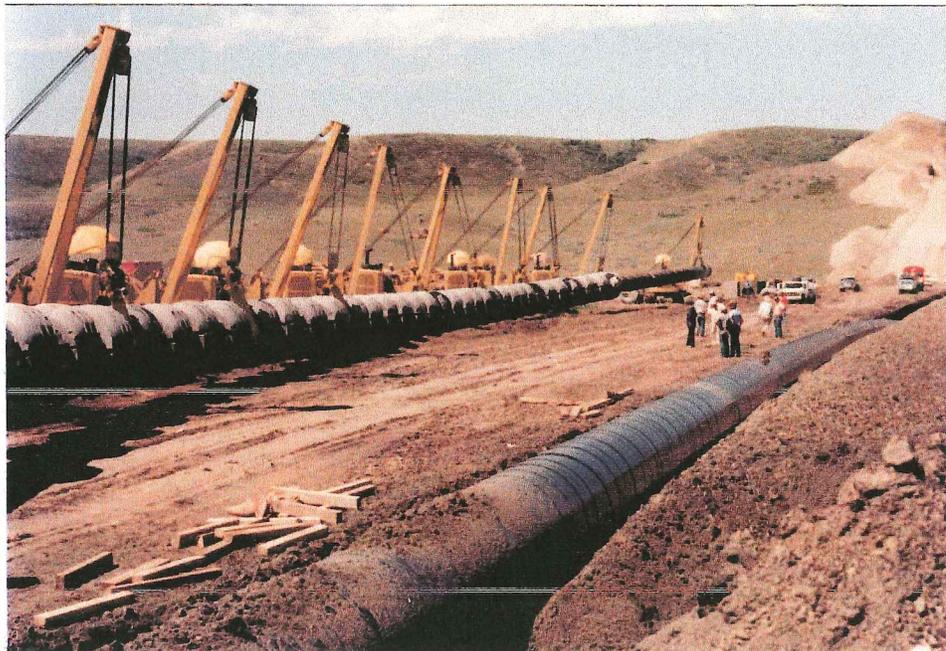
#33 Another view of the river section ready for pulling. View is looking west on July 14.

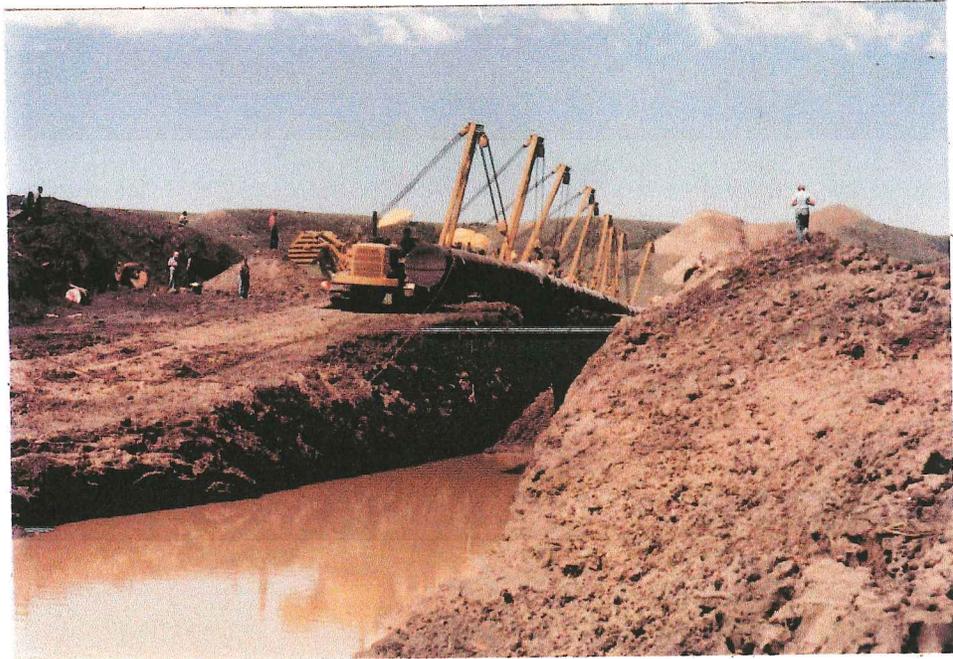
#34 Approaching the creek from the west. The lead tractor, not in the photo, has started to run out cable for pulling pipe. The foreman across the stream stands on the spoil bank to the right and orchestrates the movement of the tractors.

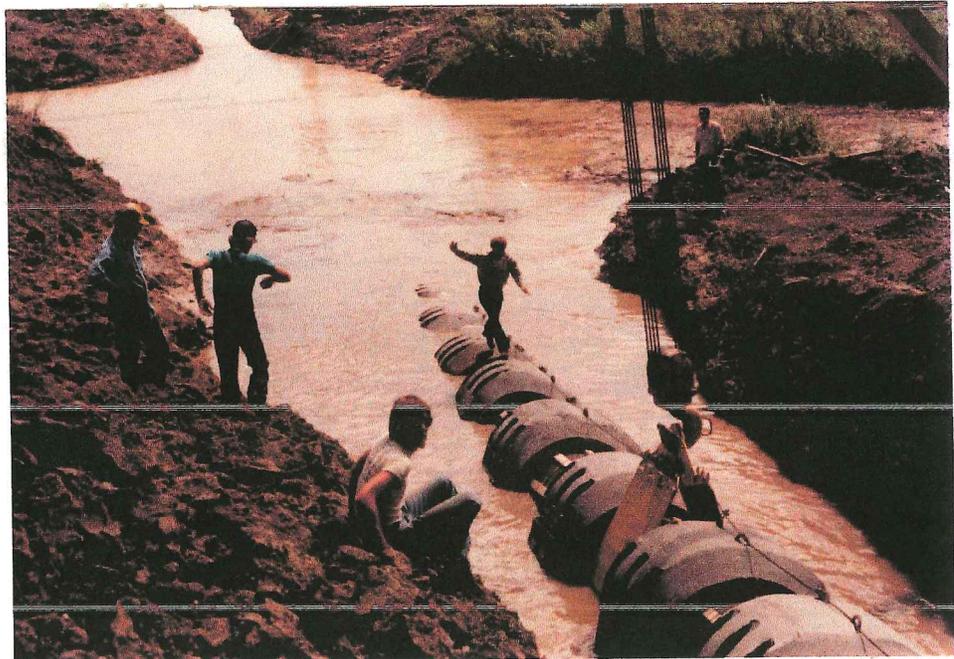
#35 Frenchman Creek section being pulled, looking east. A tractor, out of the picture, is winching it across the stream.

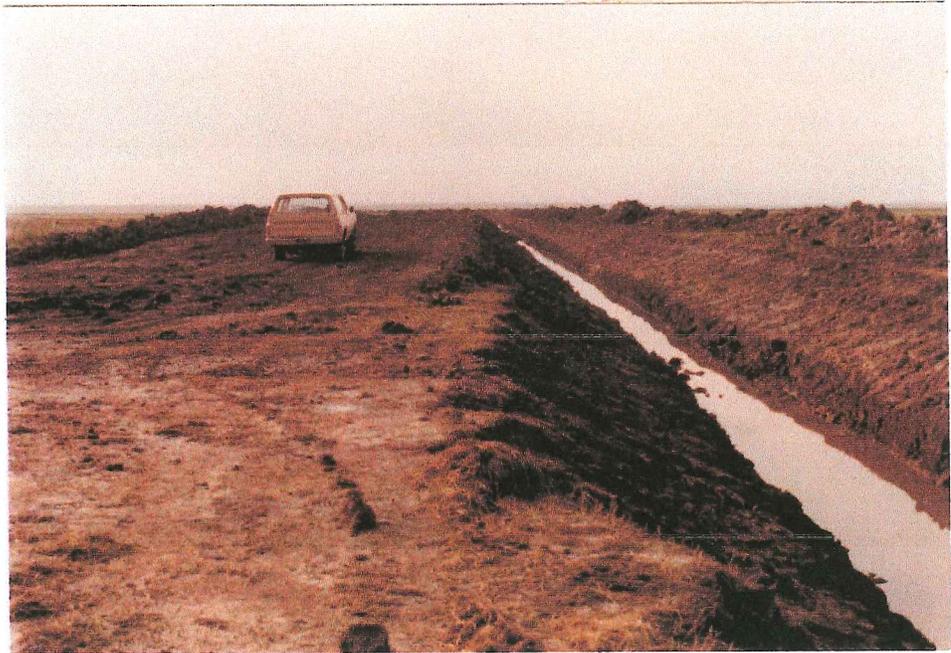
#36 Ditched floodplain of Big Muddy Creek, Roosevelt County, looking west from creek edge on July 24.

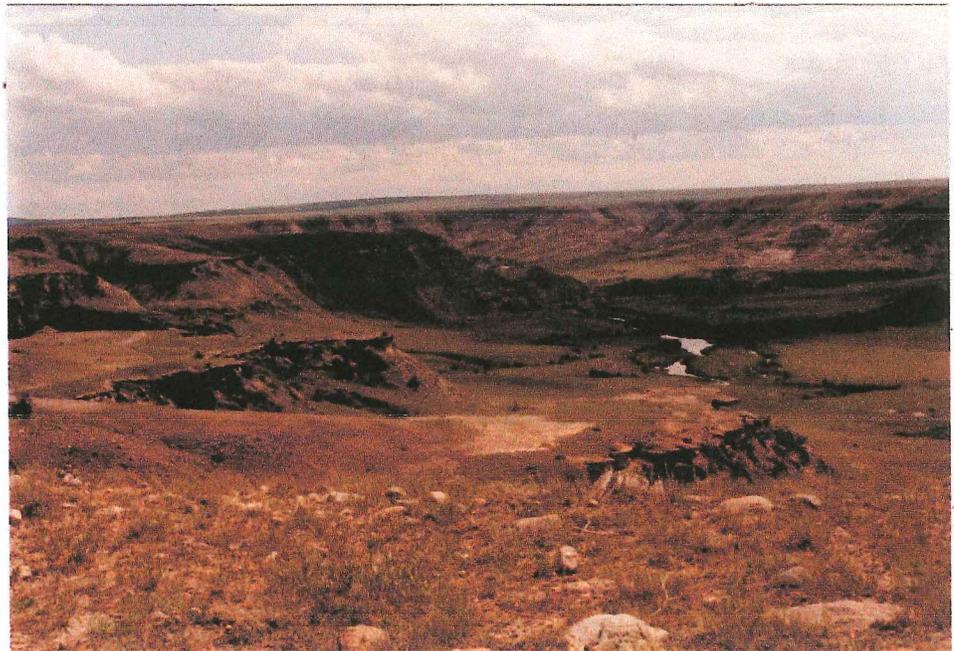
#37 Rock Creek Canyon, Valley County, looking south from the pipeline right-of-way on the east bluff on July 14.

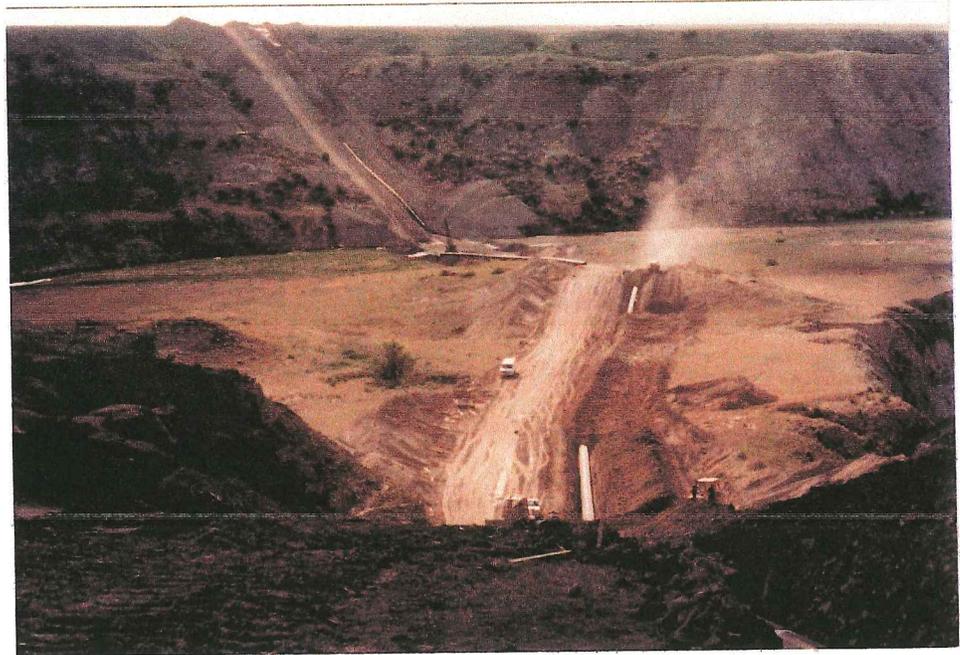
#38 Rock Creek Canyon, looking west on July 22, construction in progress. Note: 1) Dozer covering pipeline, 2) River section lying next to creek on the base of the west bluff. This was the roughest terrain encountered in Montana.

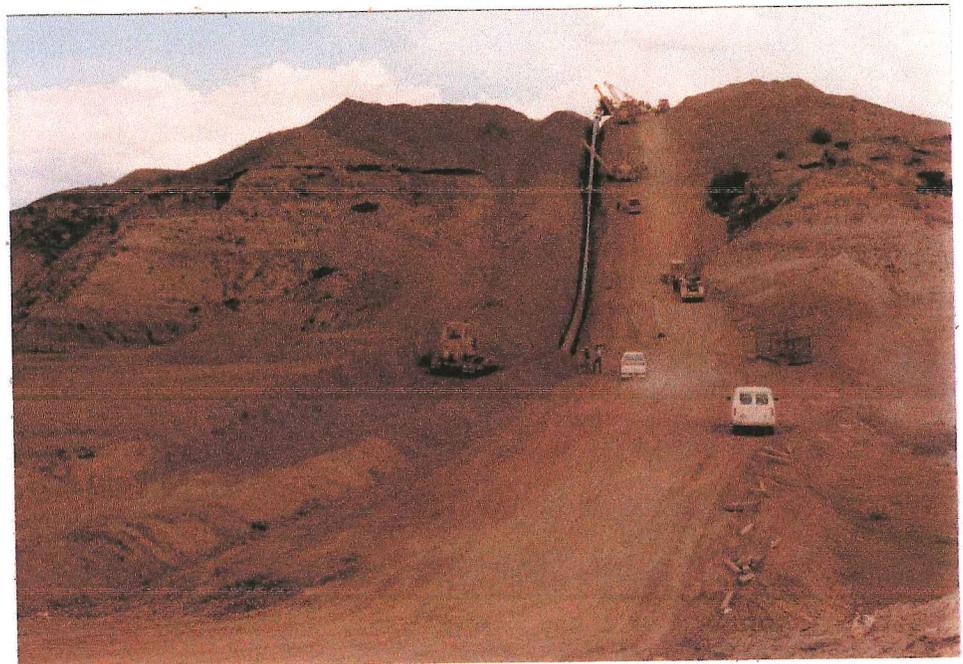
#39 East bluff of Rock Creek, pipe being laid on July 22. Note: 1) Sandstone ledge which required blasting, 2) tractor pulling truck up slope, 3) dozer blading spoil back into ditch.

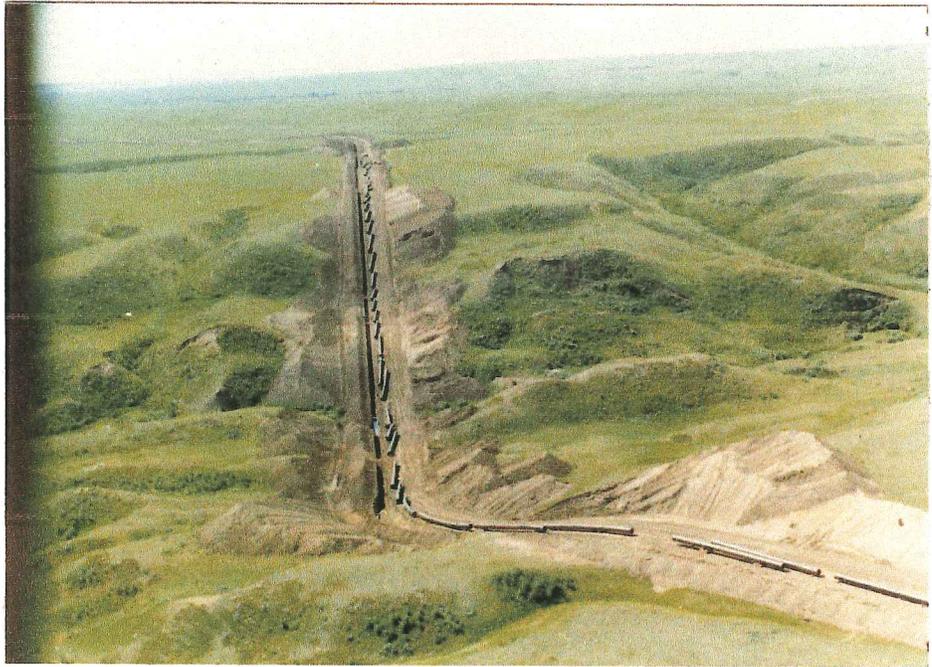
#40 Aerial view of Coyote Coulee area, Phillips County, looking east on June 26 toward Frenchman Creek on the horizon. (This is partially BLM land, parcels PH028 and PH029.) Compare this with next three photos and see "Right-of-way requirements" section.

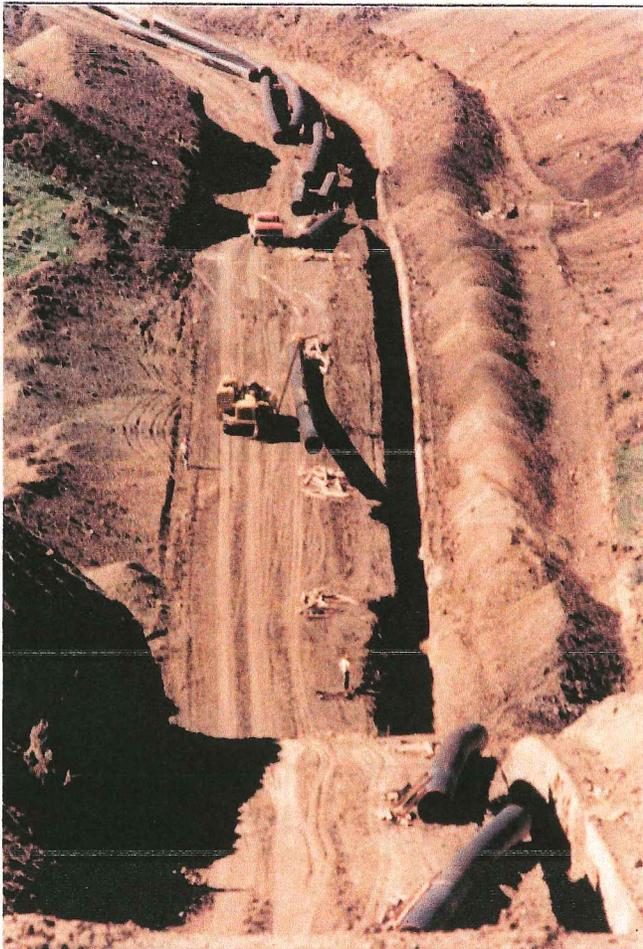
#41 Same coulee as above, looking west on June 25. Note: 1) the side-boom tractor negotiating the 80-foot pipe section, 2) depth of burial of the pipe in some cuts (see photos #69-#73 below).

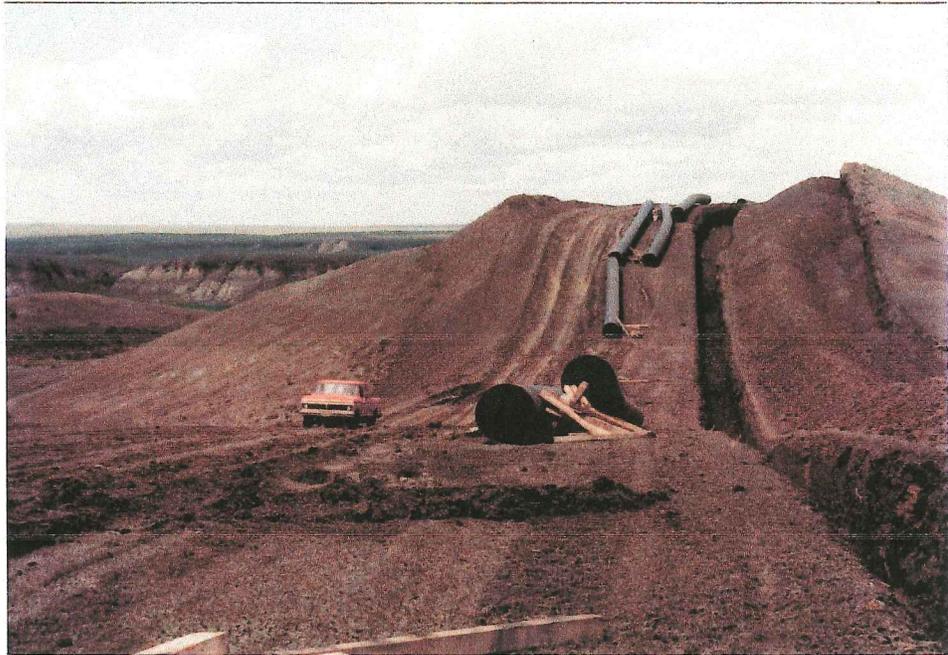
#44 Construction across badlands. The r-o-w crosses an unvegetated shale knob on the east side of the Bitter Creek Valley. The top of the knob was crossed rather than a drainageway because less erosion would occur on top. Note the depth of cut into the knob on the right side of the picture. Photo taken looking west on July 22.

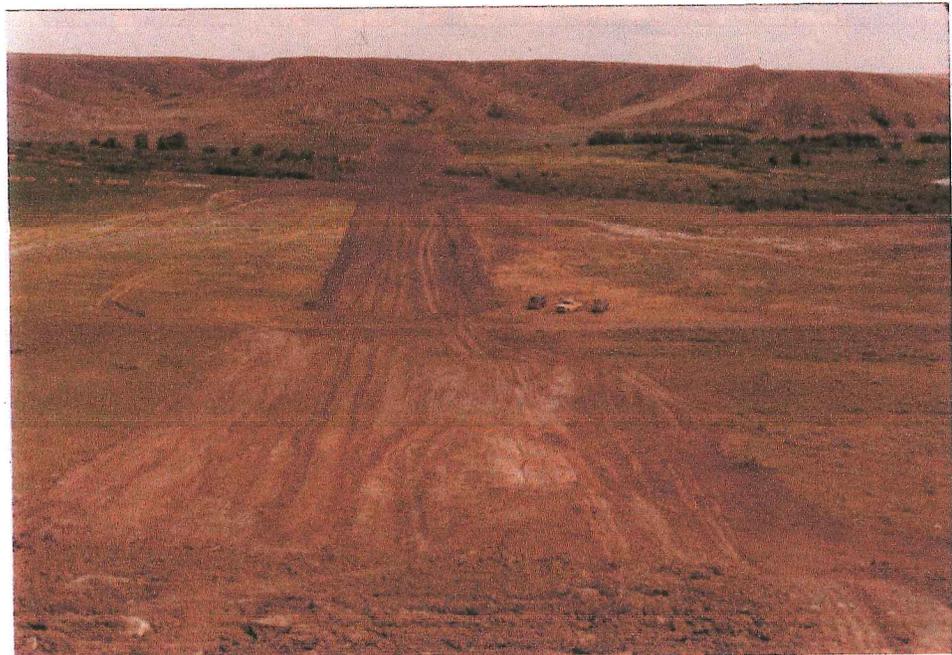
#45 Frenchman Creek crossing after re-contouring, looking east from the base of the west bluff on July 22.

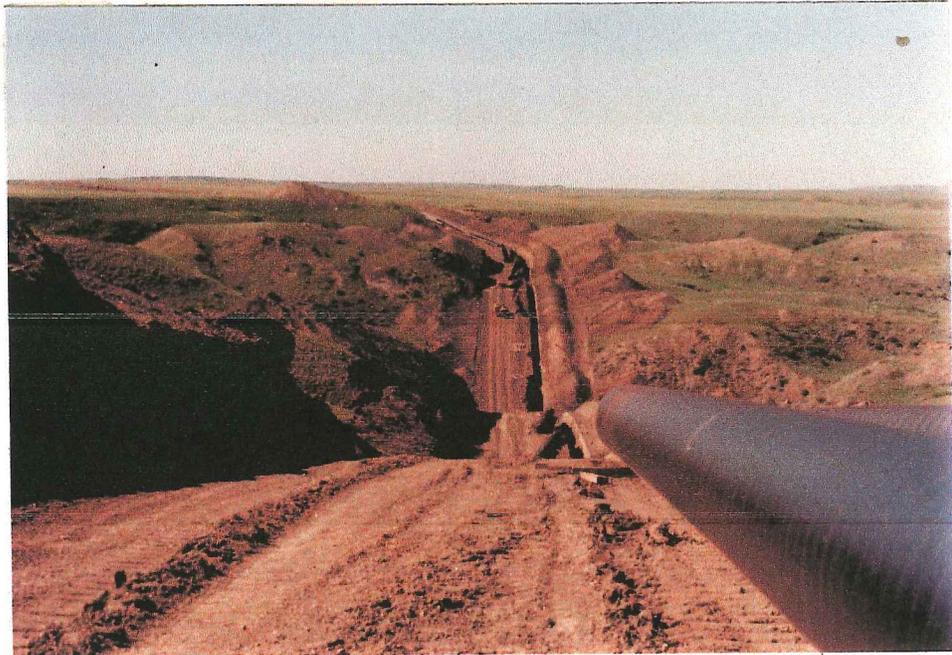
#42 Same coulee looking west from east side on June 25.

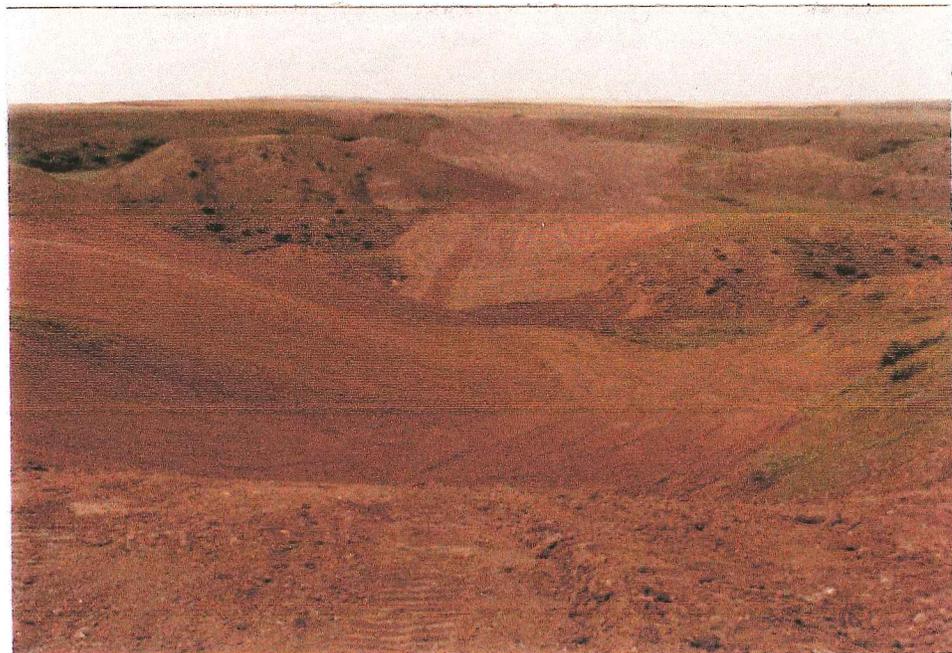
#43 Same coulee on July 22, from approximately the same spot as #42, after re-contouring. Waterbars, small dikes built across slopes to slow water erosion, are present but not visible.

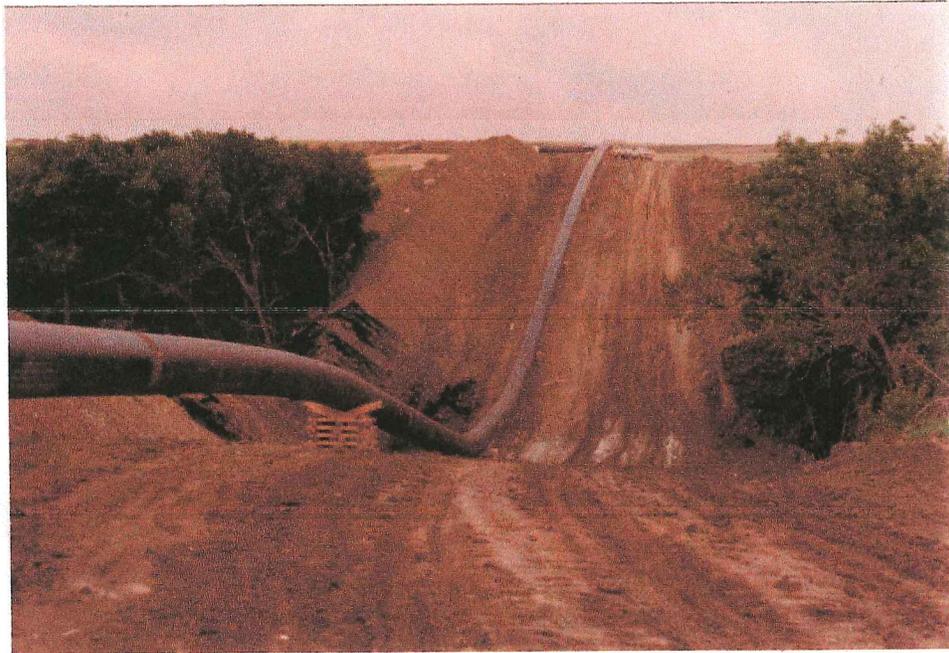
#46 Deciduous shrub/tree coulee about six miles east of Big Muddy Creek, Roosevelt County. American elm and green ash are the main tree species. The black material on the spoil bank is lignite. Photo taken July 24.

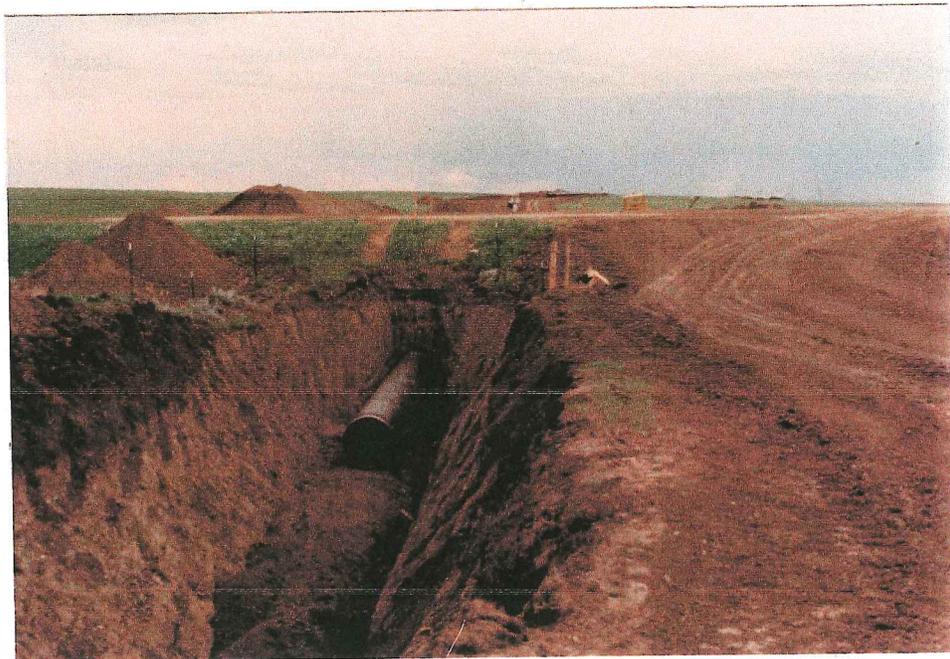
#47 Bored road crossing, Valley County. Boring was done, even on small roads, to prevent road maintenance problems. Photo taken June 23.
