RIGHT-OF-WAY REQUIREMENTS AND STRIPPING OF TOPSOIL

Construction on flat terrain, hillsides, and across drainages.

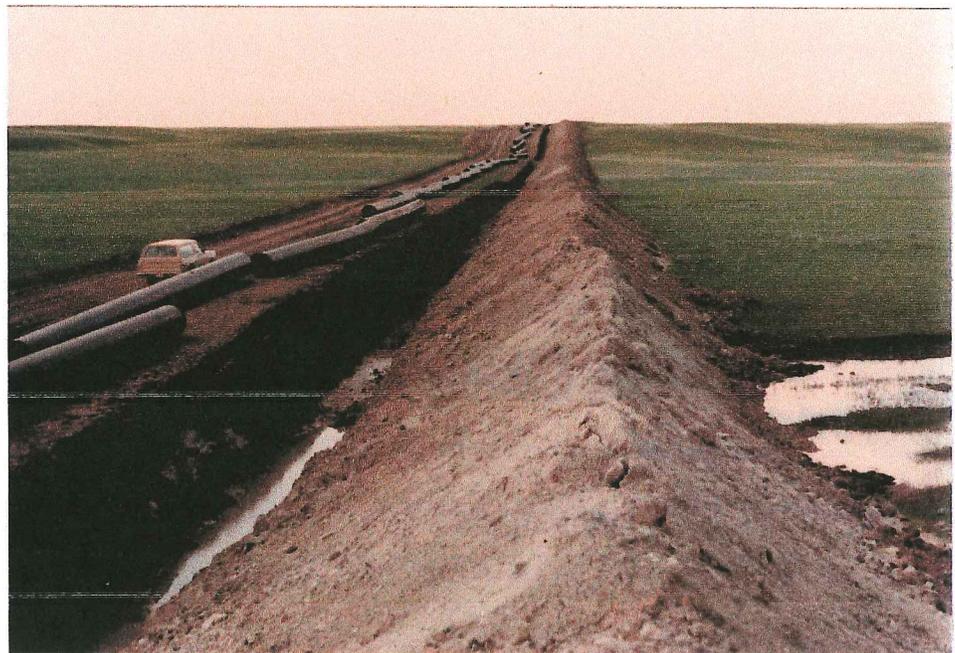
#51 Same view as #50, about 300 yards farther west and from atop the trench spoil bank on July 23. Note that in the distance a trencher was used and in the foreground a backhoe was used. An 85-foot right-of-way was cleared in this area, and it became slightly wider after ditching, especially where the backhoe was used.

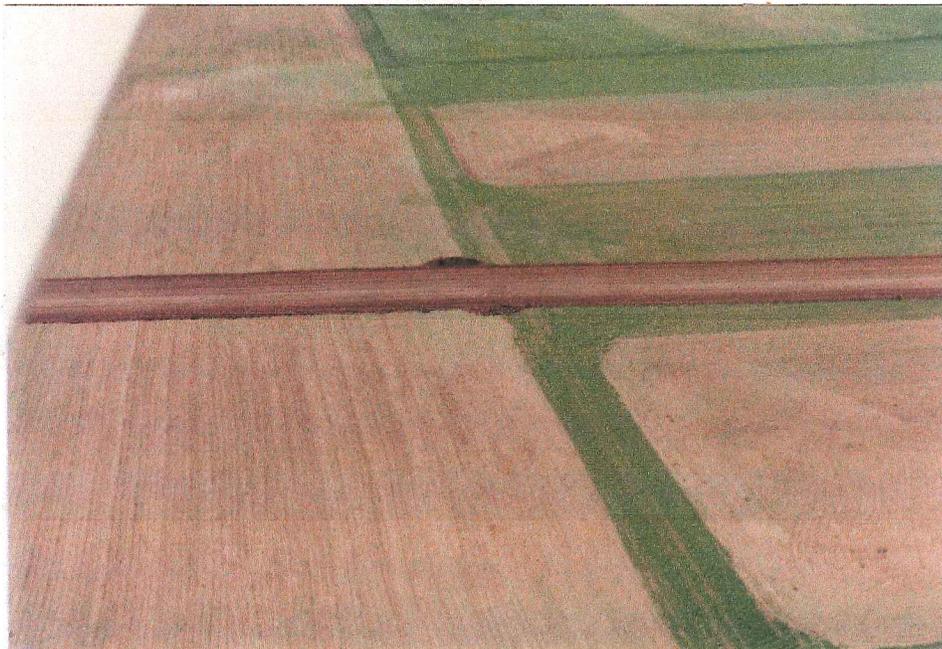
#52 An 85-foot cleared right-of-way on cropland in Roosevelt County on June 26. The r-o-w width increased slightly as the pipeline was constructed, but the width was well within 100 feet in most cases on this flat terrain.

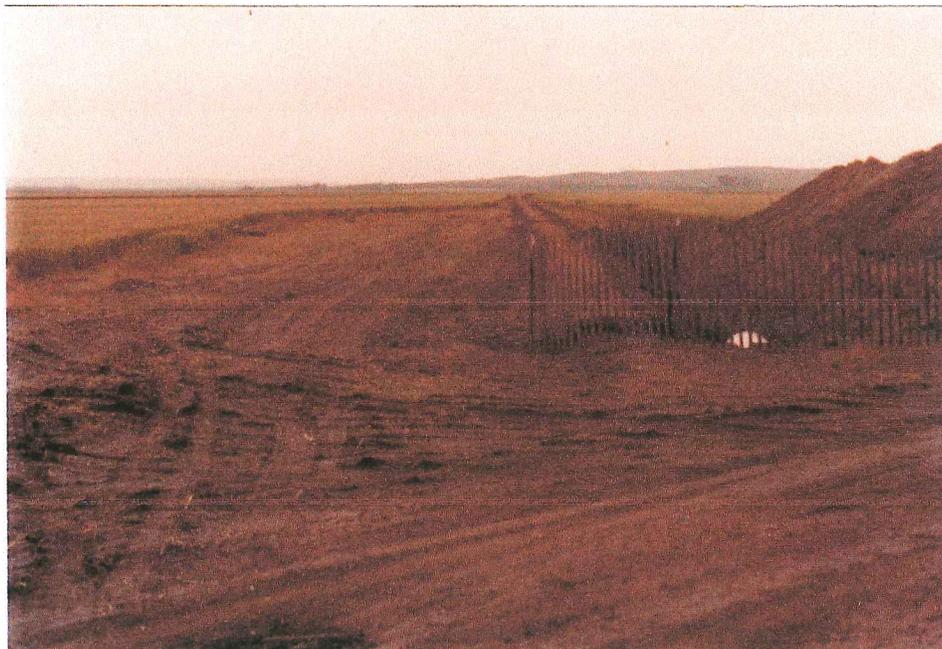
#54 Same view as #53 on July 24. This was the only state parcel that was cropped. The r-o-w was generally about 85 feet wide on this parcel although it was wider in the foreground because the field road was bored under rather than ditched through.

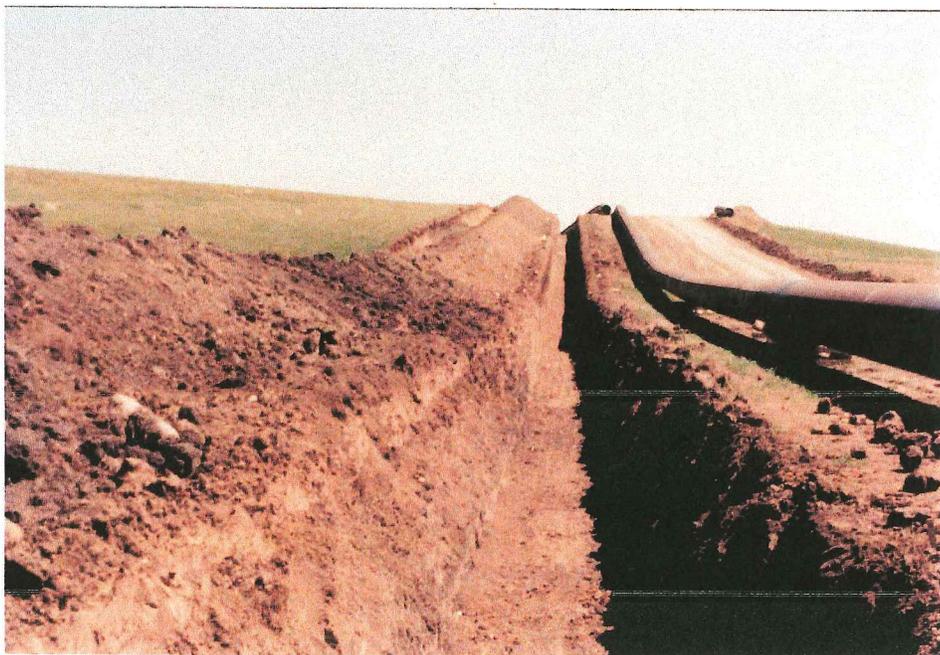
#55 Compare this view with that at cross-section "B" in Figures 1-3 (this view is to the east, however). Note the cut on the left providing fill for the work space on the right. This is taken about 1.5 miles west of state parcel PH018 near Turkey Track Road. Photo taken June 25.

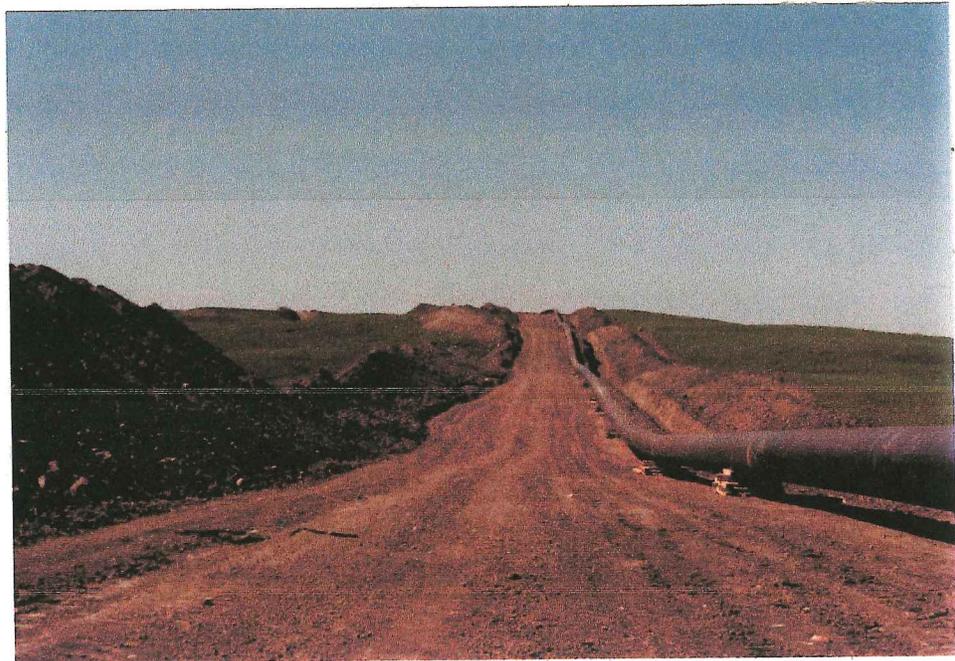
#57 Same view as #56 on June 25 about 150 yards farther to the southeast. Note similarities to cross section "B" on Figures 1-3.

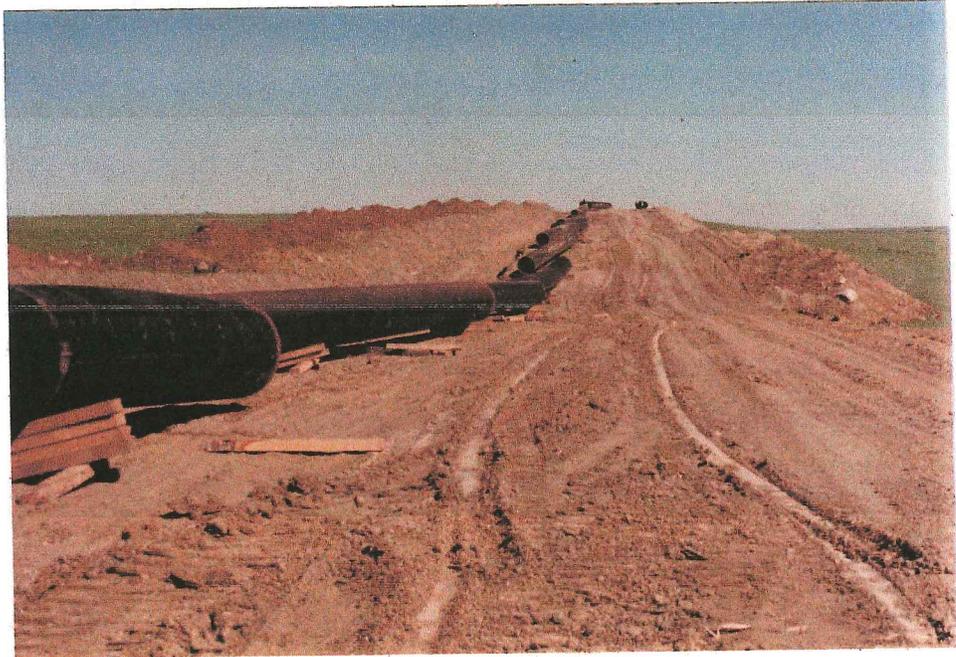
#58 Looking east on June 25 at a long stretch of south-facing slope on state parcel PH026. Note that on this parcel topsoil has been stored uphill to the left.

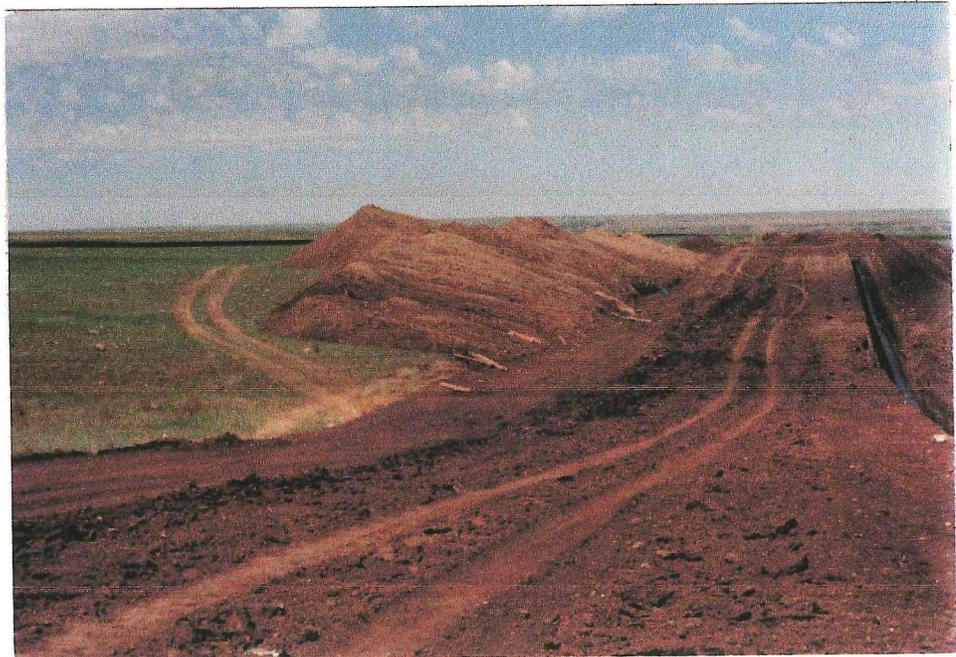
#59 Compare this view to views of cross section "A" on Figures 1-3. This photo, taken July 15, looks west on state parcel VA006. Note that there is poor topsoil separation in this area, although a small pile can be seen behind the large pile of subsoil.

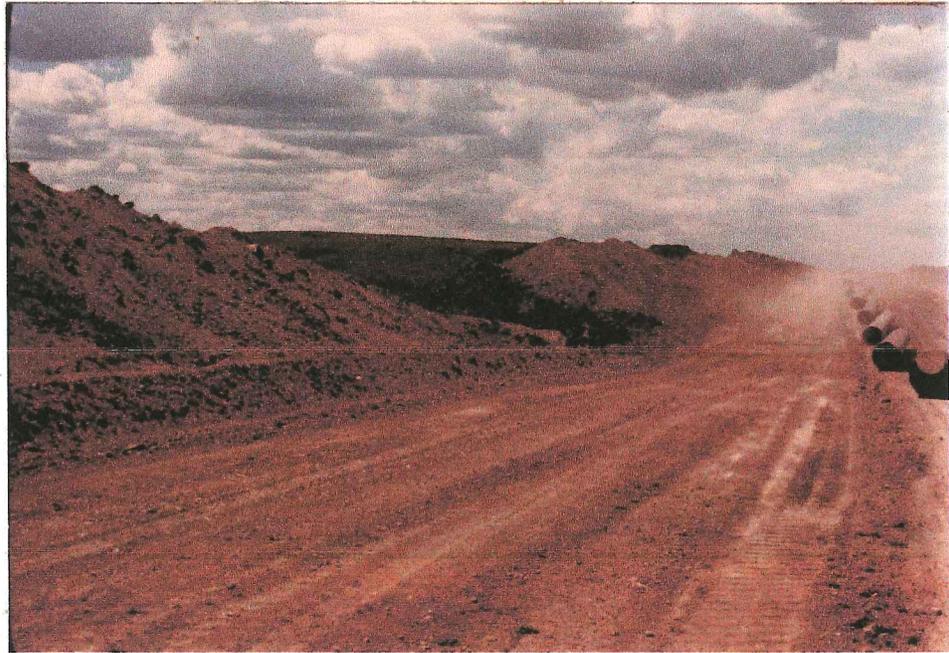
#60 Compare this view to cross section "A" (on Figures 1-3) and to #59. This view looks west on private land several miles west of the parcel shown in #59. Note the pile of topsoil on the outside of the pile of material from the cut.

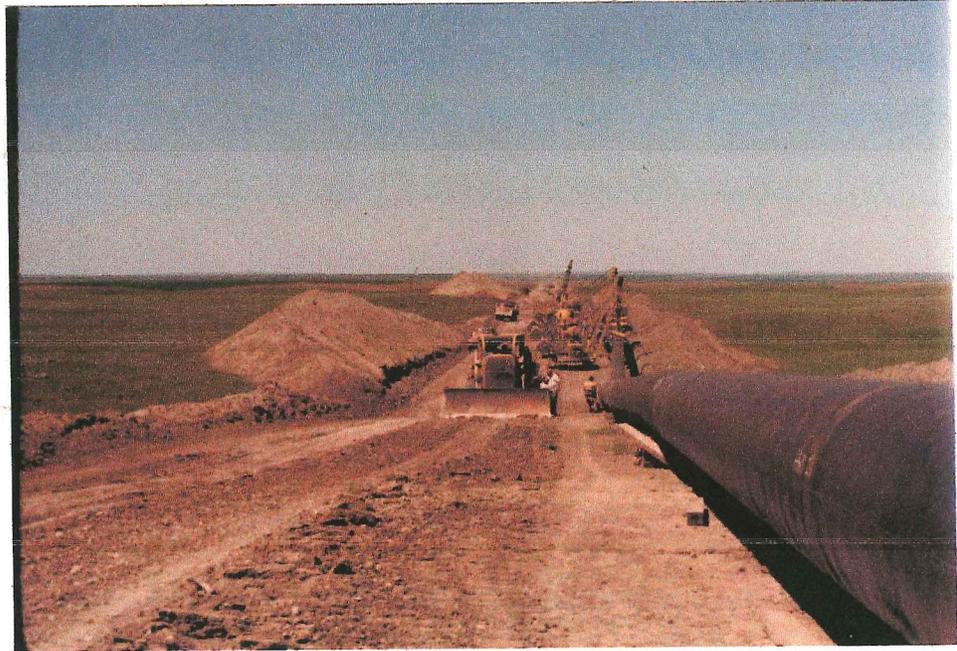
#62 Same view as #61 on June 26, and see view "A" on Figures 1-3. Note the lack of topsoil storage piles. This section was cleared in the first few days after construction began, and little topsoil was saved even though saving 12 inches of "topsoil" was stipulated on the Department of Lands lease. (See conclusions section.)

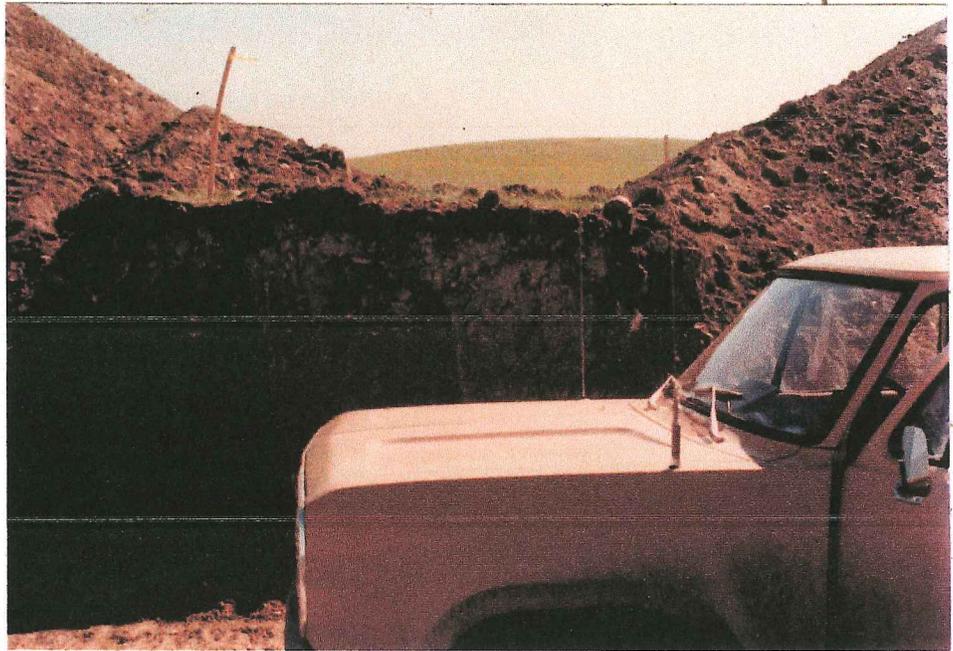
#64 Side-hill cut on work pad (as in cross section "A" on Figure 2) on state parcel PH026. This was the cut made in the hill on the other side of the drainage way shown in #63. Note the shallow depth of the A horizon (compare to #74 below.) Slope is about 7 degrees on this hill. Photo taken June 25.

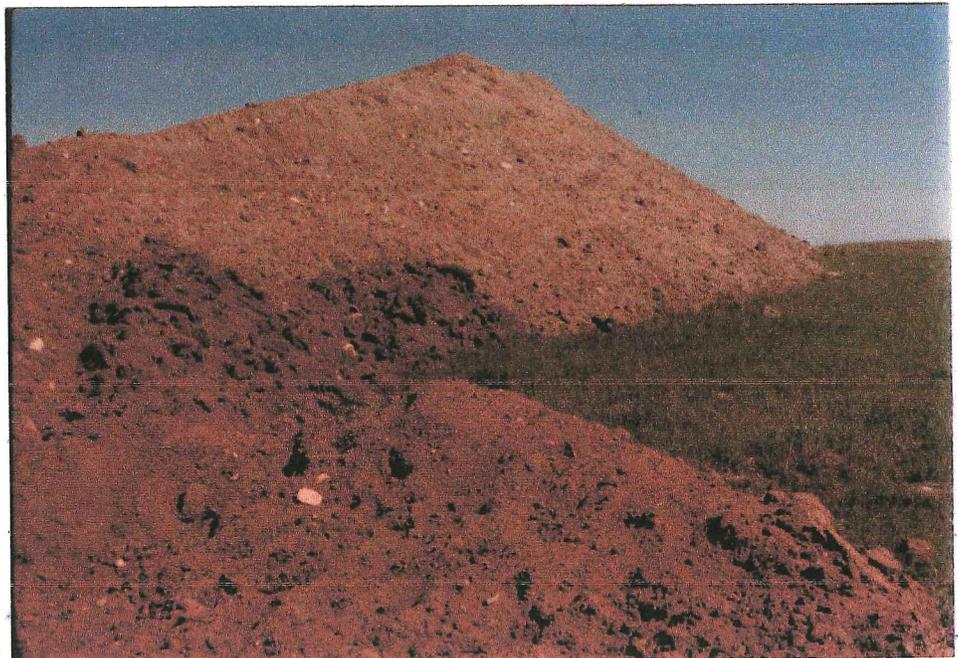
#65 Topsoil storage pile covered by spoil from cut close to spot where #64 was taken. Photo taken June 25.

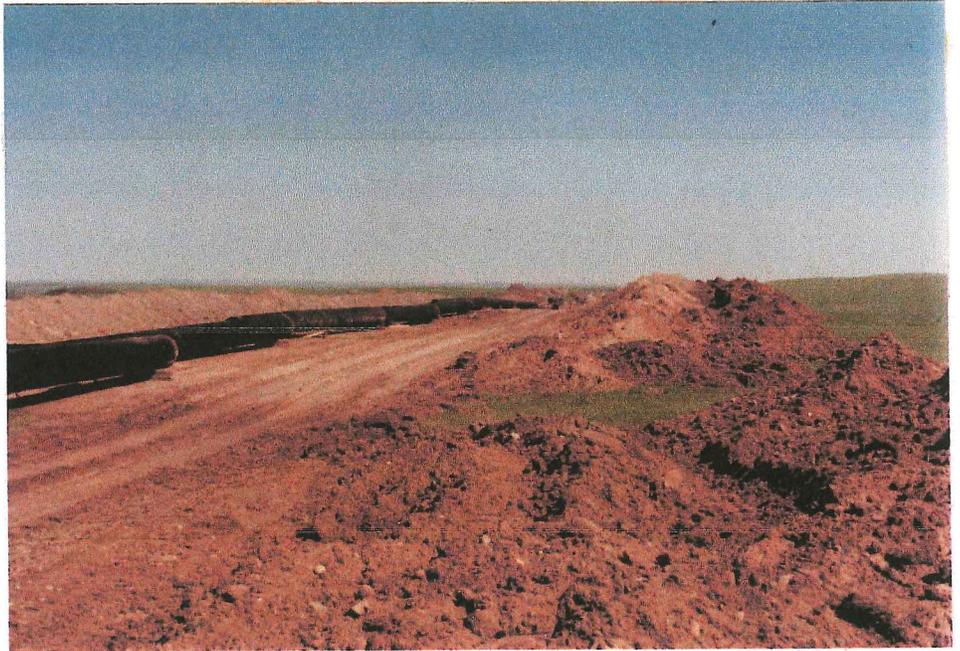
#66 Topsoil storage on PH026. View is to the southeast on June 25.

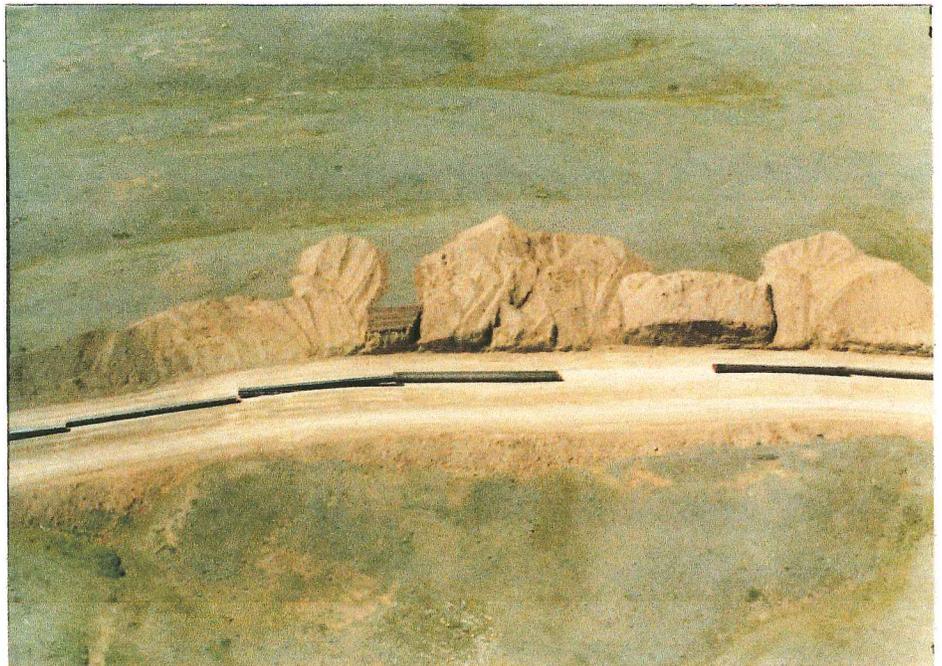
#67 Side-hill cutting similar to cross-section "B" on Figures 1-3. The ditch will be dug next to the cut and the work space is on the near side. This side hill is along a drainage. Photo taken June 26.

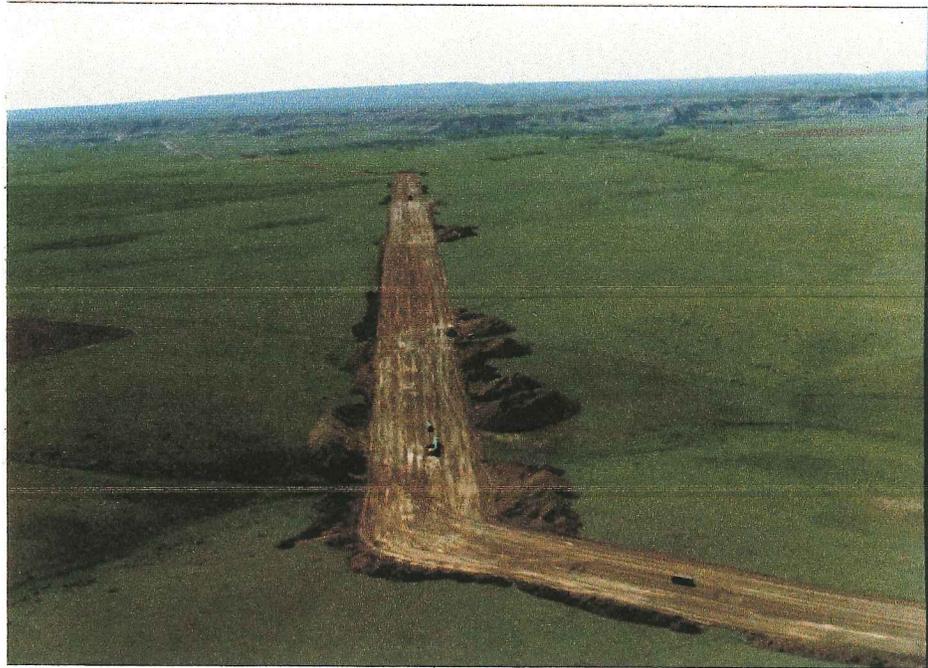
#68 View of state parcel VA27.5 looking southeast toward the Willow Creek valley before pipe-stringing began. Note: 1) soil/spoil storage is on alternate sides of the r-o-w, depending on the direction of slope, 2) the cleared r-o-w is about 85 feet wide on the flat areas shown in the photo, and 3) r-o-w requirements rapidly expand when soil/spoil storage areas are needed. VA27.5 begins on the other side of the fence beyond the sharp bend. This bend is the beginning of the "Bitter Creek Re-route" which follows an old road through the Bitter Wilderness Study area. Photo taken on June 26.

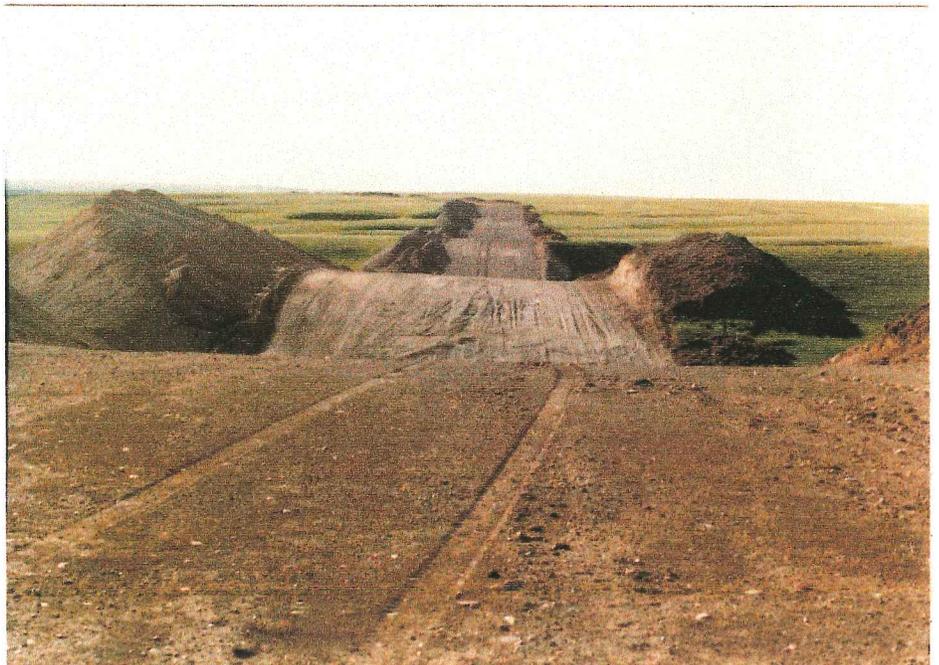
#70 Same view as #69, same spot, taken June 26, before ditching and pipe stringing began. Note that each ridge is cut extensively, resulting in more gradual bends on top of the hills. This result cannot be obtained at the bottom of drainageways, however, because the pipe cannot be placed in unconsolidated fill.

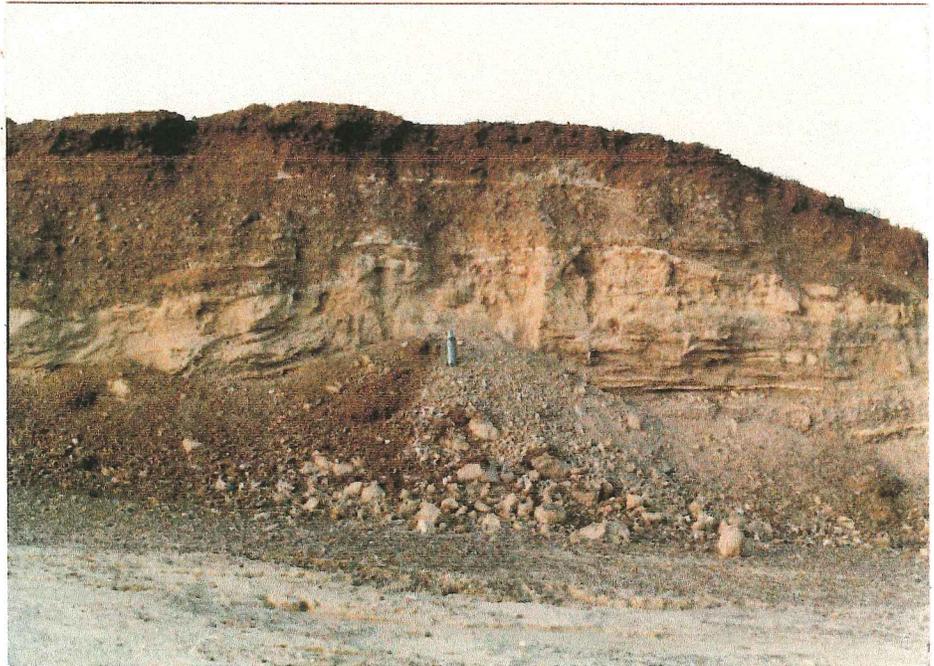
#71 Close-up view of the first cut on the right side of #70. Note the 1 quart thermos for scale. This area was very gravelly and sandy. The bottom of the pipe will be 7 feet below the level surface at the bottom of the photo. This means pipe burial of about 13 feet deep from the top of this ridge. The cut shown is about 10 feet deep.

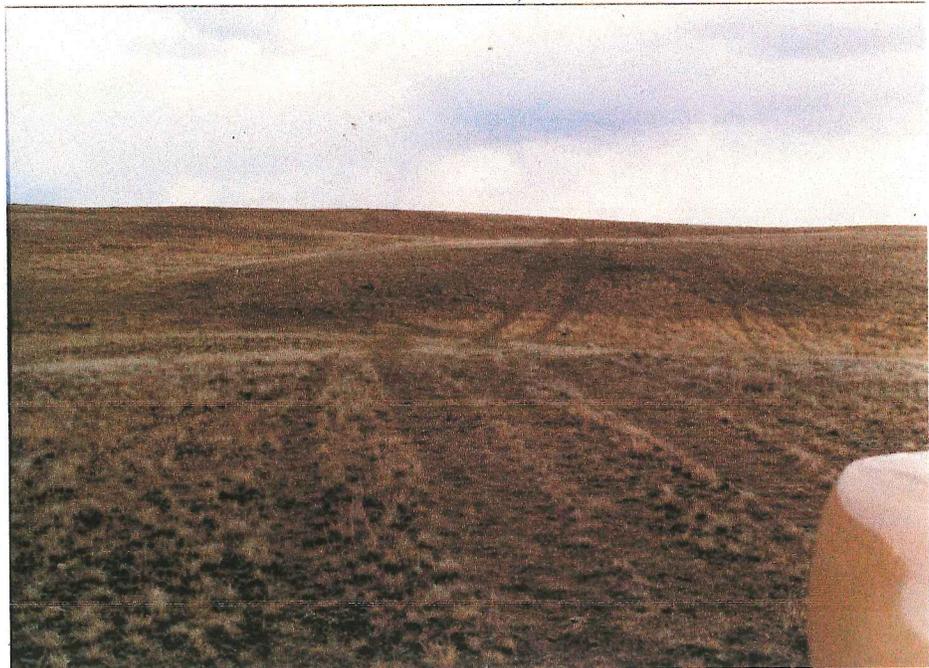
#72 State parcel PH012 looking southeast on April 21 down the staked centerline before construction began. NBPC personnel estimated a r-o-w width of 100 feet here on this date. Compare with #73.

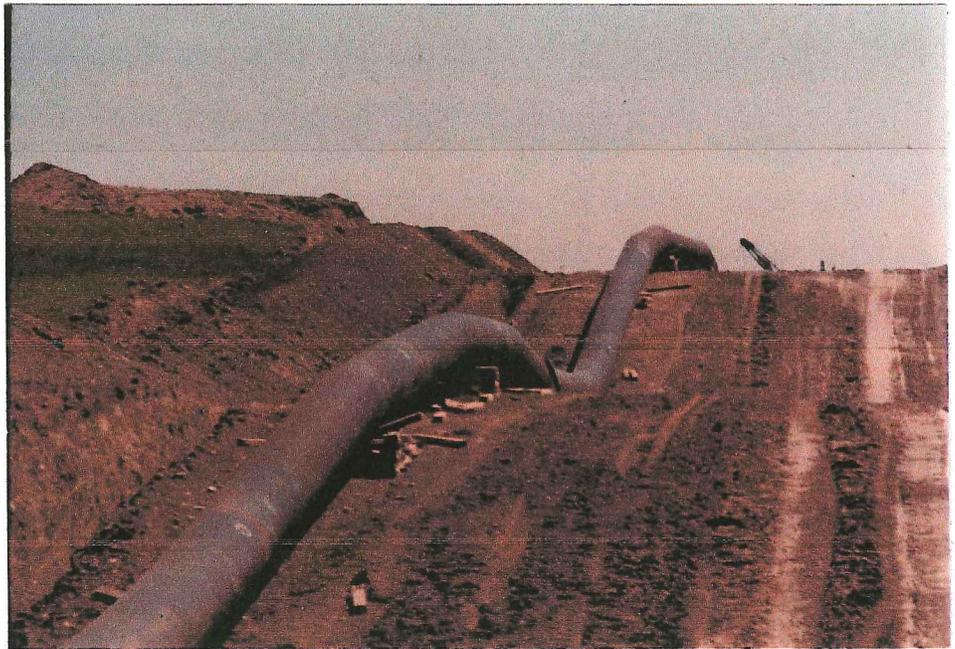
#73 Looking southeast at approximately the same spot as #72 on June 25. The r-o-w was about 230 feet wide here as a result of this side-hill cutting, which occurred within a few days of construction start-up (May 4).
