# DNRC

## Northern Border Pipeline

#### CONSTRUCTION ON MONTANA STATE LANDS

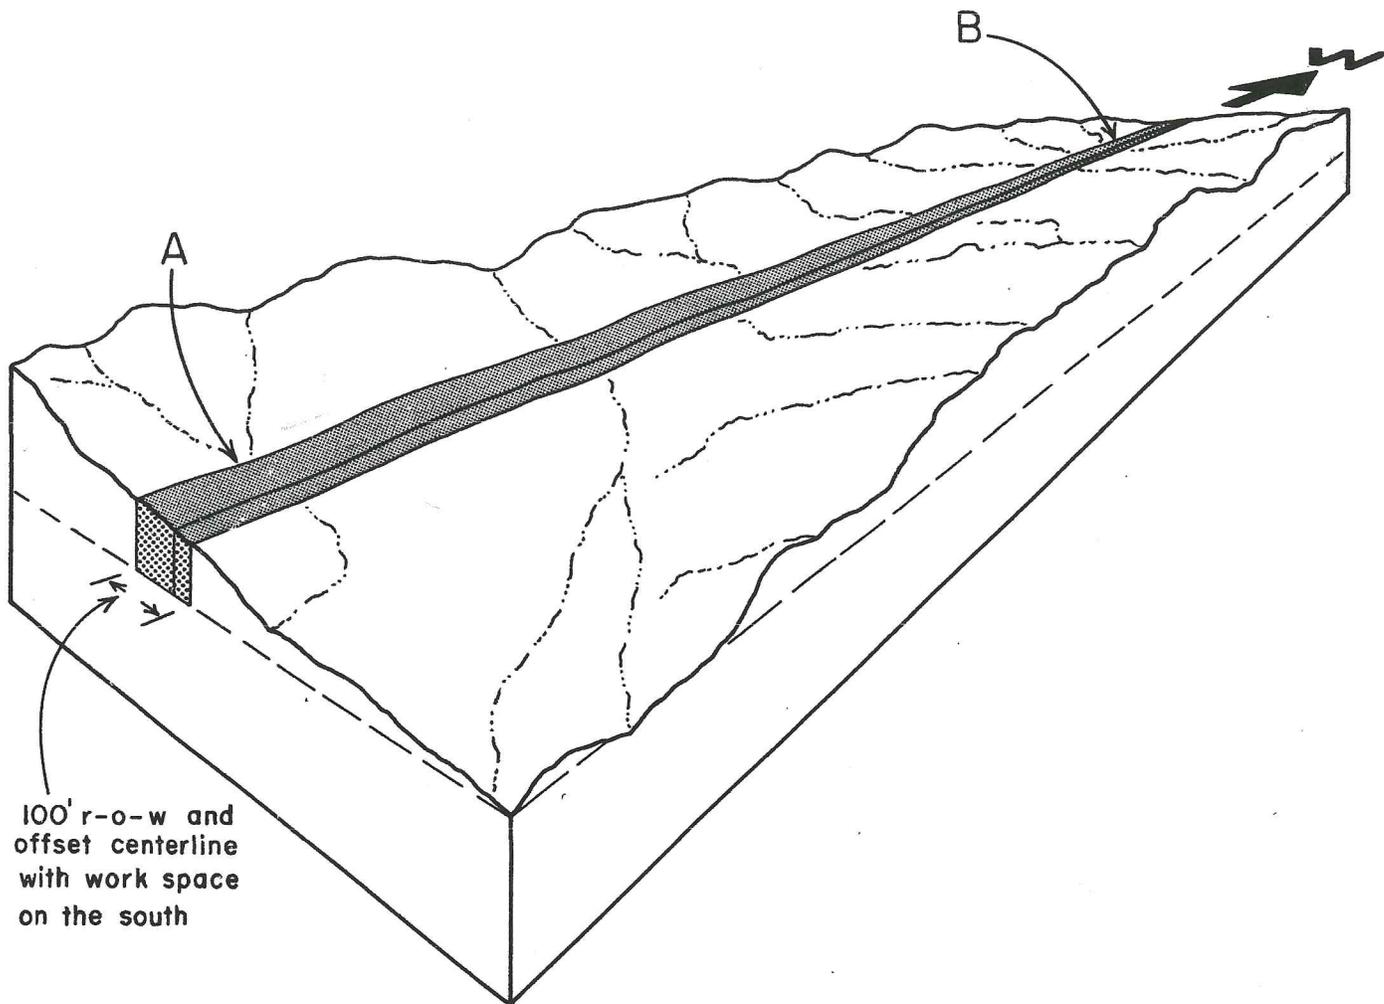
**FIGURE I**

Generalized view of an east-west 100' pipeline Construction right-of-way as foreseen in Northern Border Pipeline Company's applications to cross Montana state lands. The terrain is typical of Montana state lands crossed in Phillips and Valley counties, where, aside from drainages, the steepest slopes are on the order of 5-7°, and rangeland is the primary land use.

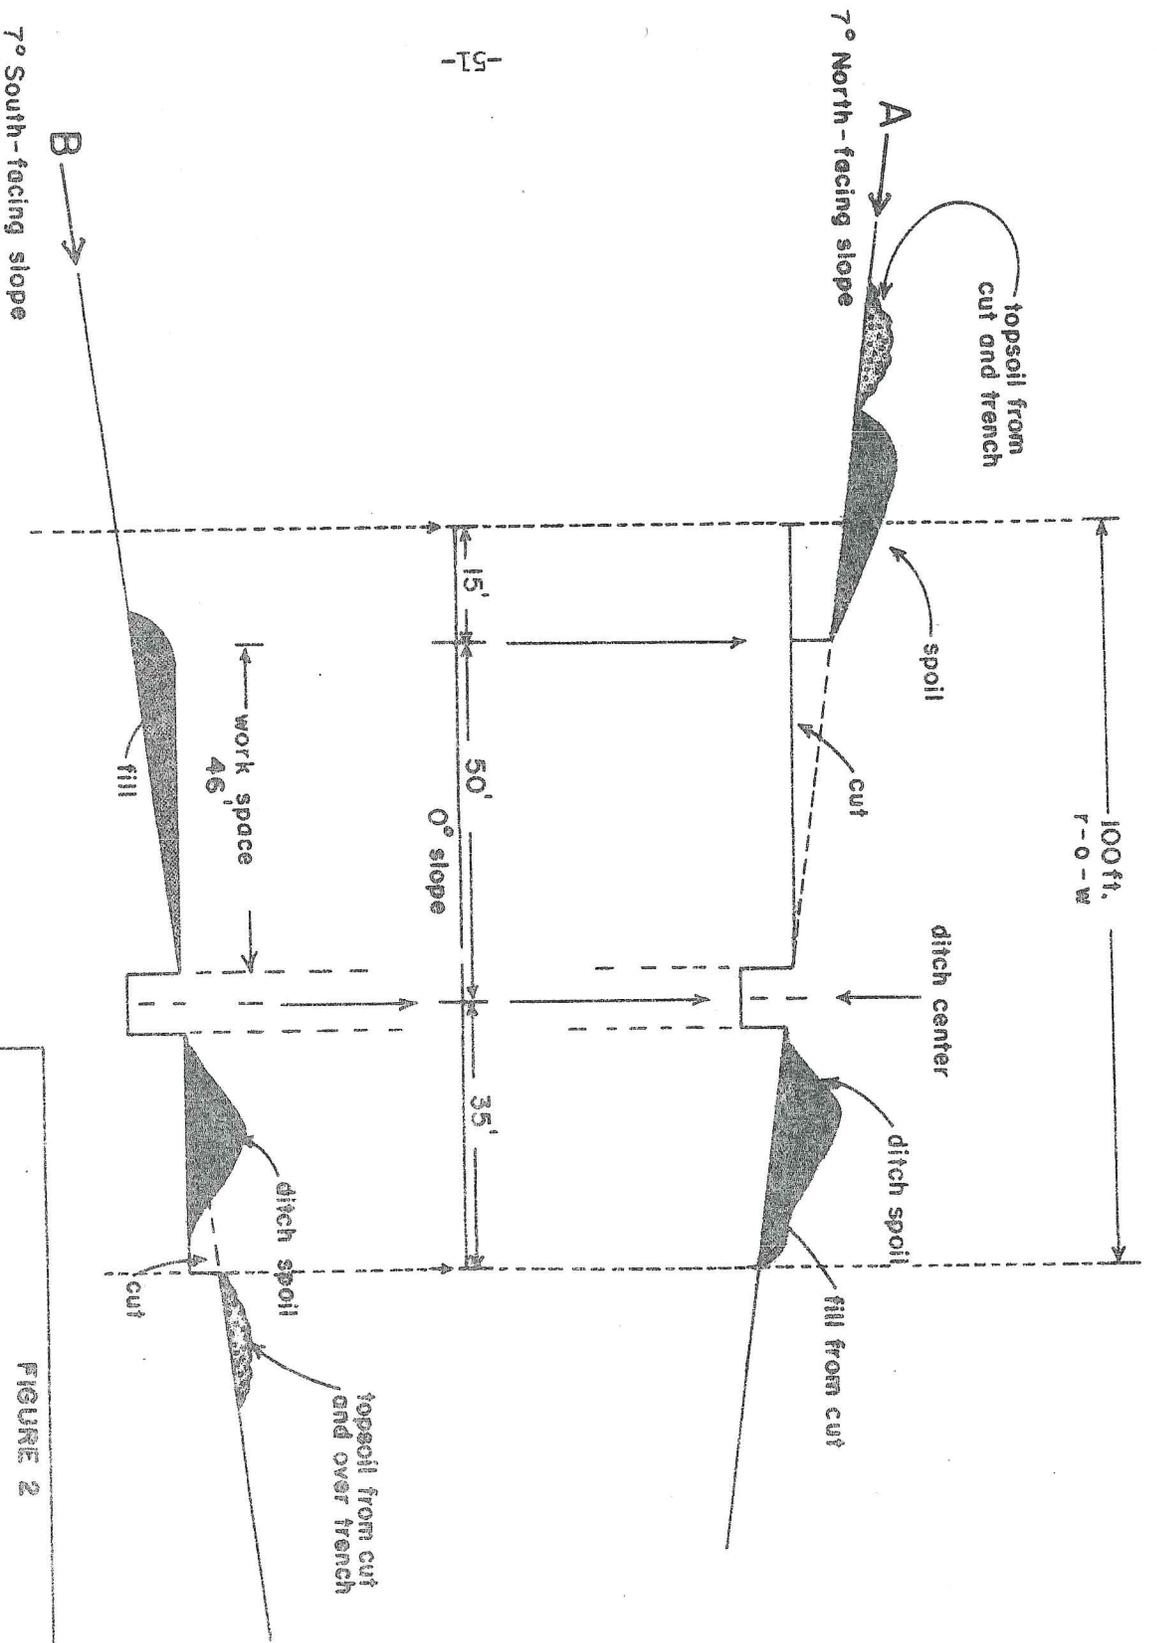
FIGURE 2

Note that the south facing slope, "B", has a narrower r-o-w because spoil can be used as fill and thus less space is needed for soil and spoil storage. As shown in the pictures in the previous section, there is considerable variation from site-to-site, especially with spoil and soil storage.

Cross sections of the cleared right-of-way at points A and B in Figure 1, as seen looking west. Trench dimensions are depicted at 7' deep and 8' wide.

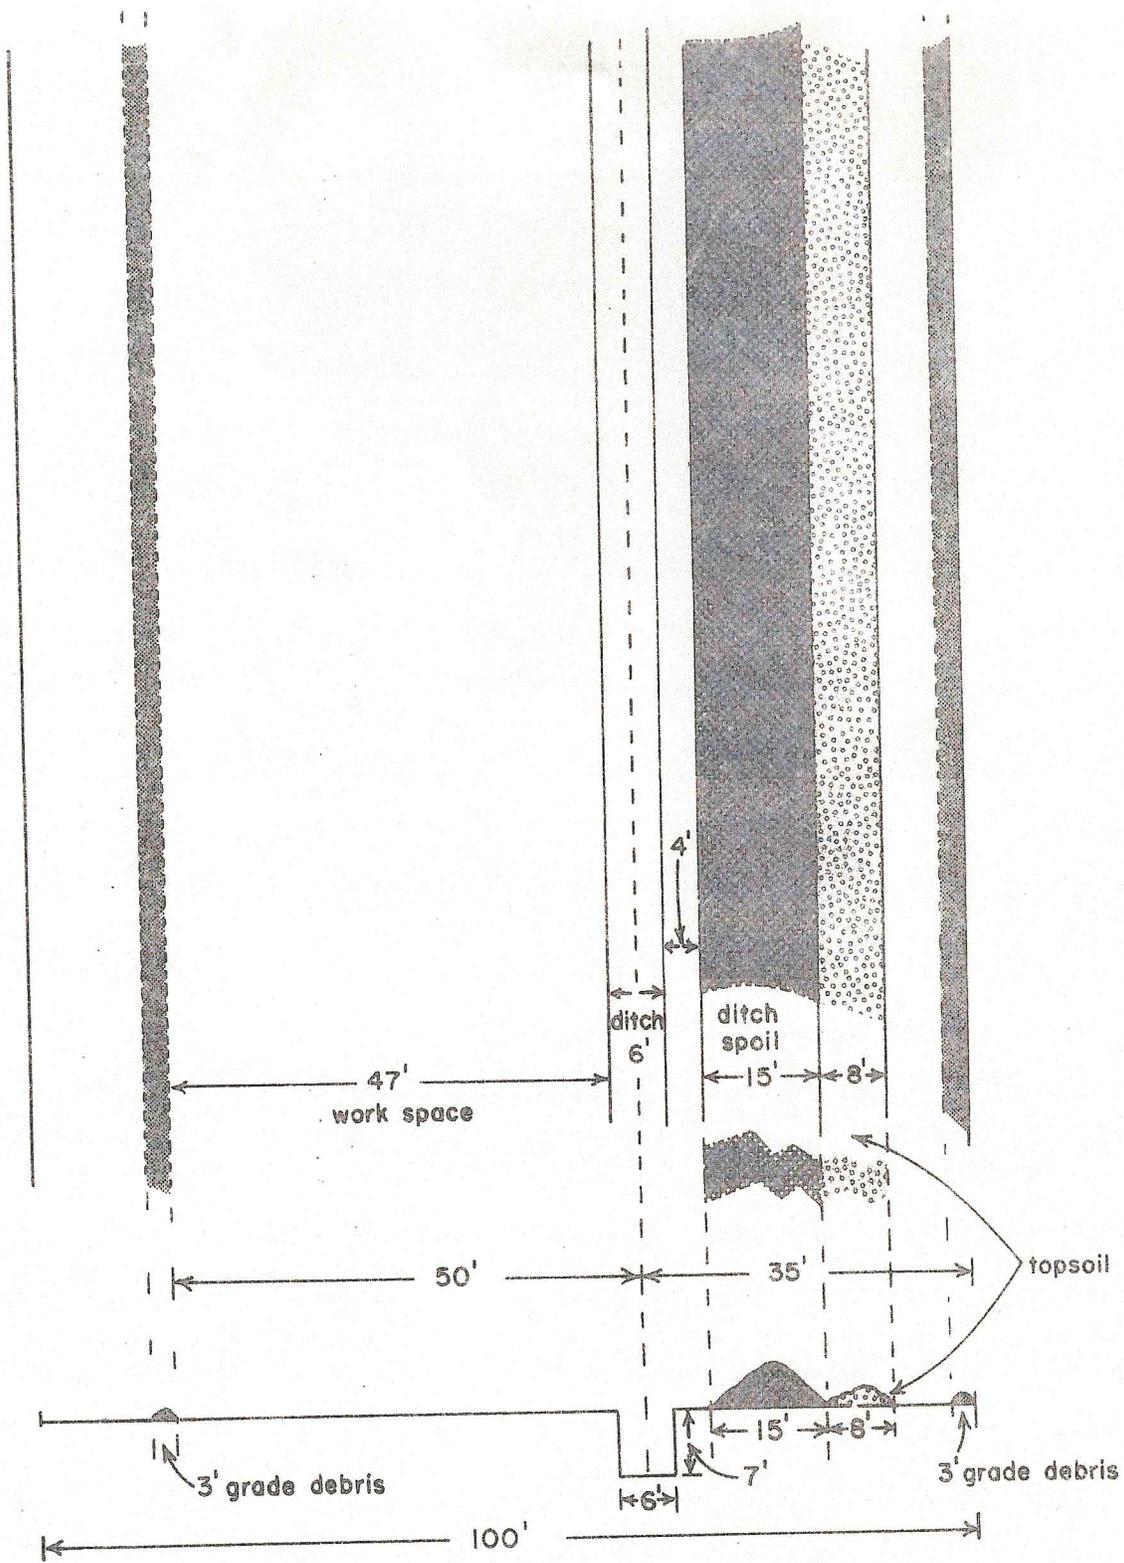
FIGURE 4

Construction across flat terrain. In this case a six-foot-wide ditch is depicted, which occurs when a trenching machine is used, and no backhoe work was necessary.

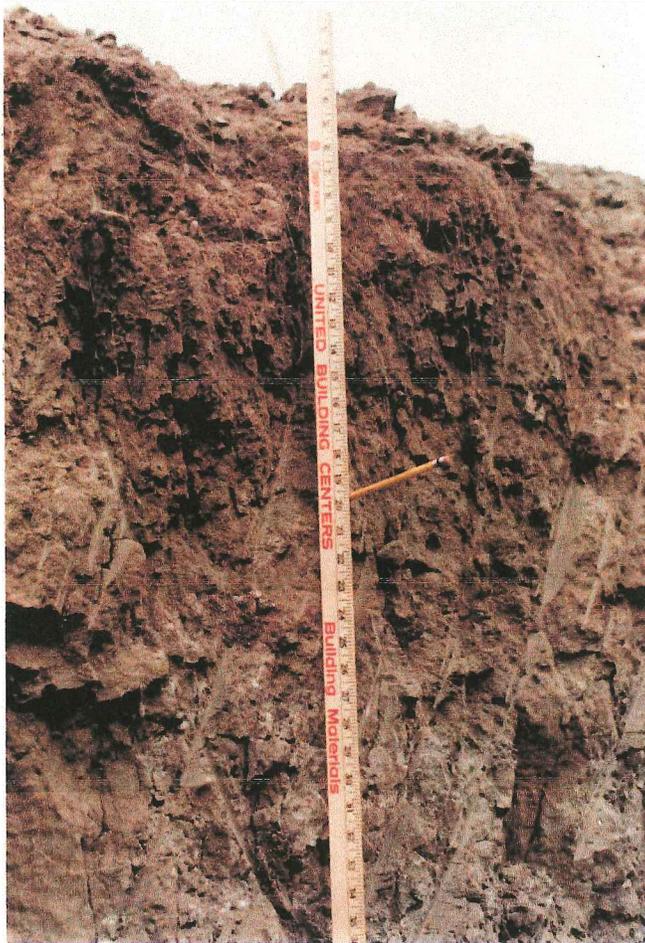
Soil samples were taken in several locations to determine the extent to which topsoil was mixed with parent material. The results of a soil analysis on these samples are given in Appendix A, and it confirms the photographic evidence that there was inconsistent and insufficient topsoil removal and handling during r-o-w clearing and grading. Tests with 7 percent acid solution (HCL) on state parcels VA051, VA052, VA053.5, and VA057 indicated that the calcium carbonate layer on the trench sidewall ranged from 6 inches to 23 inches from the surface after blading and trenching (see photo #74). IPTF observers also saw substantial amounts of gypsum on the soil surface after clean-up on parcels PH018 and Ph019. These crystals were evidence that ditch spoil from several feet below the surface were mixed with top soil.

- #74 Lack of sufficient topsoil removal as indicated on trench side wall on state parcel VA052. The top of the yard stick is at the surface after removal of 3-4 inches of topsoil. The pencil is at the level where an acid reaction began (see text). Note the dark and deep A & B horizon.

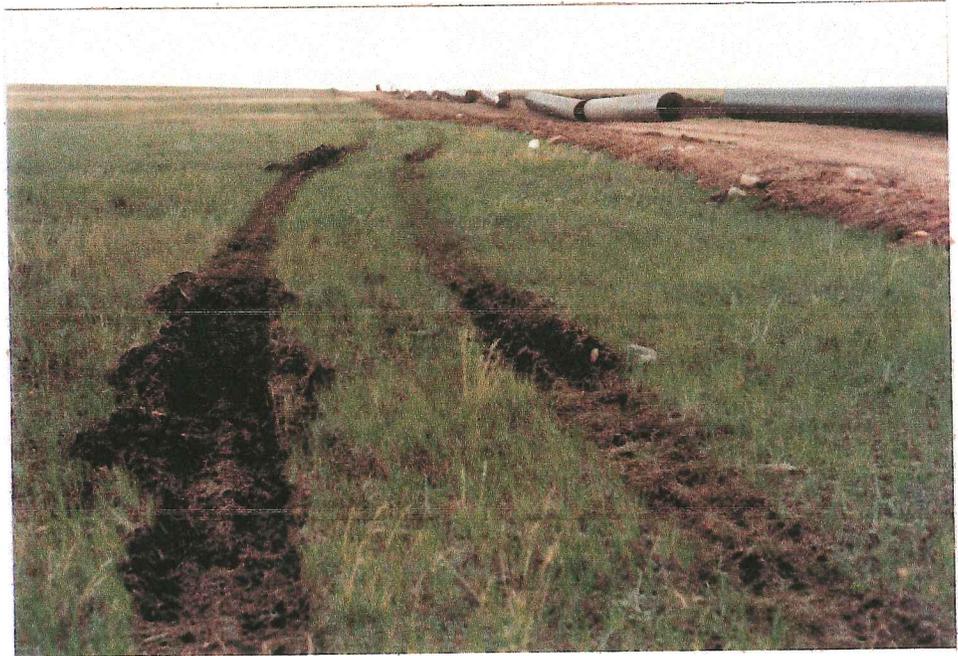
#75 Traffic off the r-o-w under muddy conditions on state parcel VA57. Photo taken July 15.

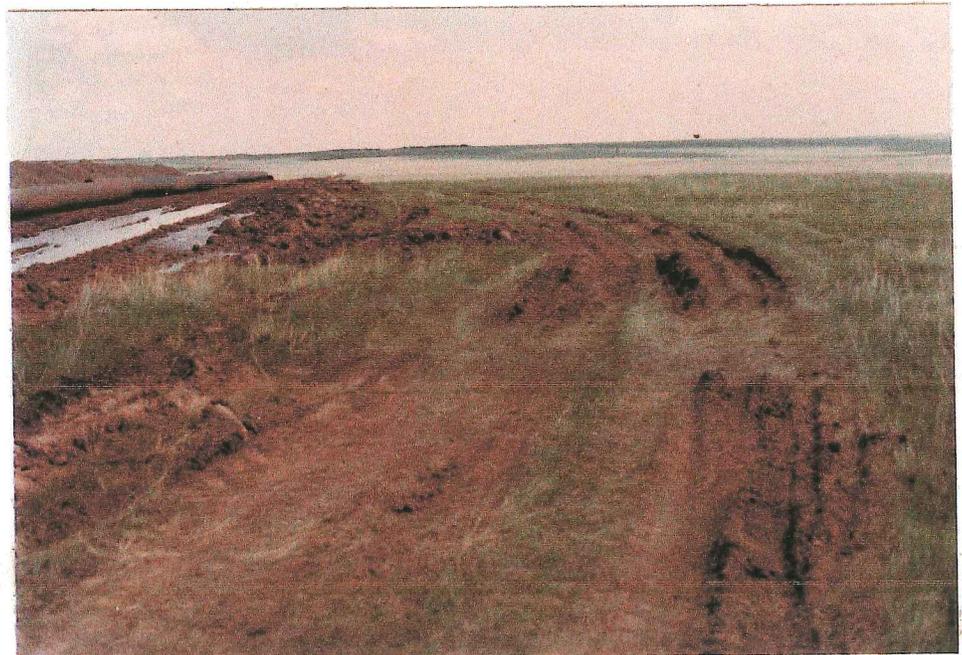
#76 Traffic off the r-o-w to avoid a mudhole on state parcel VA56. The prairie in this area was poorly drained. Photo taken July 23.

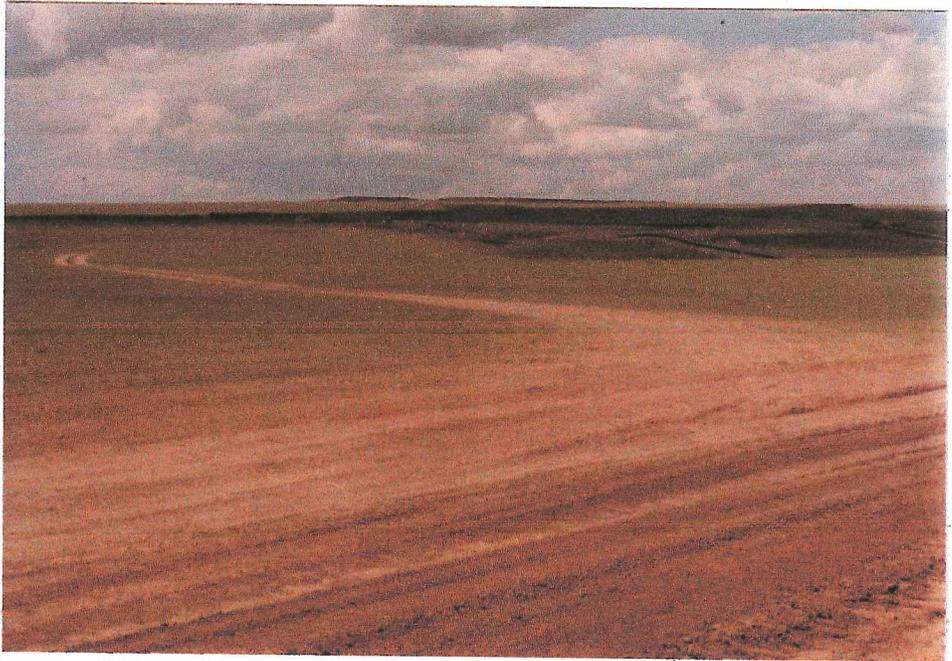
#77 Traffic off the r-o-w on state parcel VA027.5 to avoid two gates near the northern part of parcel. Photo taken July 15.

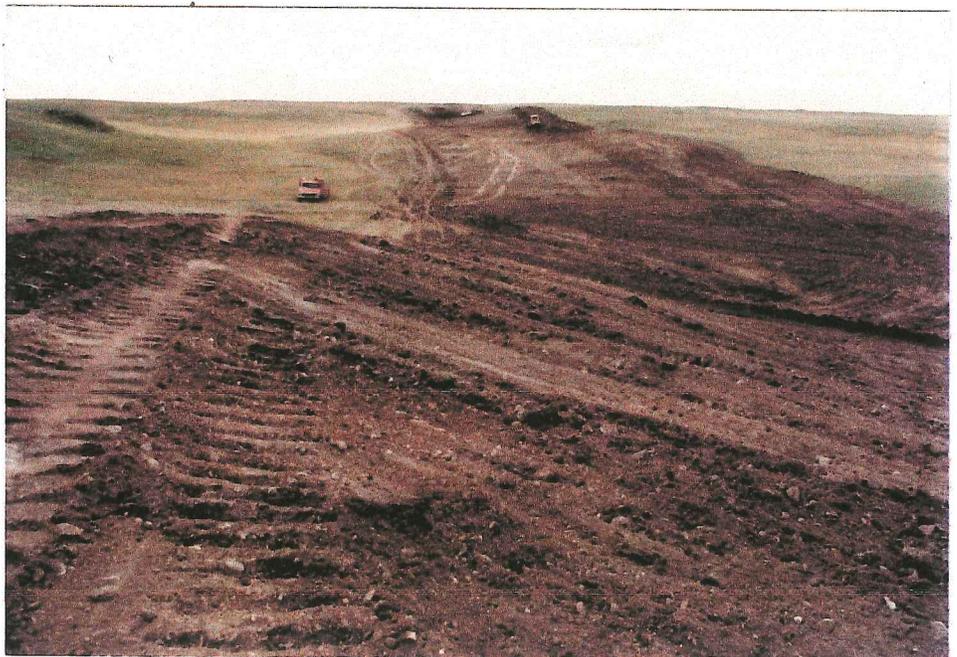
#78 Typical clean-up in progress in wide r-o-w area in Phillips County. Dozers first push the soil back roughly to the original contour, then a road grader with chisels reduces soil compaction and finishes contouring. Note that there has been extensive traffic outside soil/spoil storage areas. This adds to r-o-w width requirements as noted earlier. Photo taken July 22.

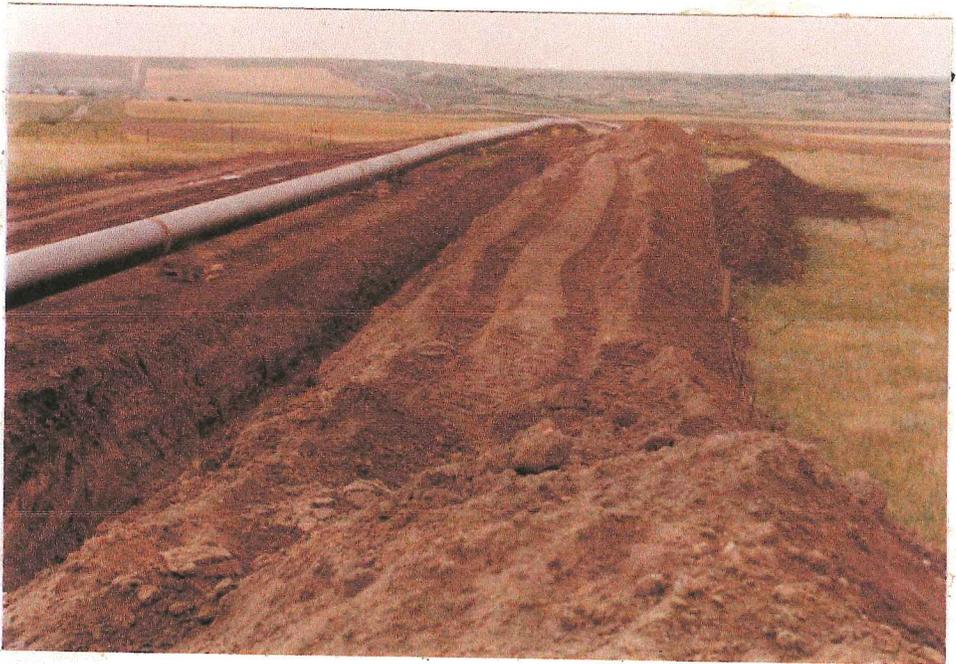
#79 State parcel R0142. Only the area shown in the photo is crossed by the pipeline. Note that the r-o-w was fenced but backhoe widening of the trench added material to the spoil pile, covering the fence and topsoil. The view looks northwest on July 24 from the southern edge of the parcel.

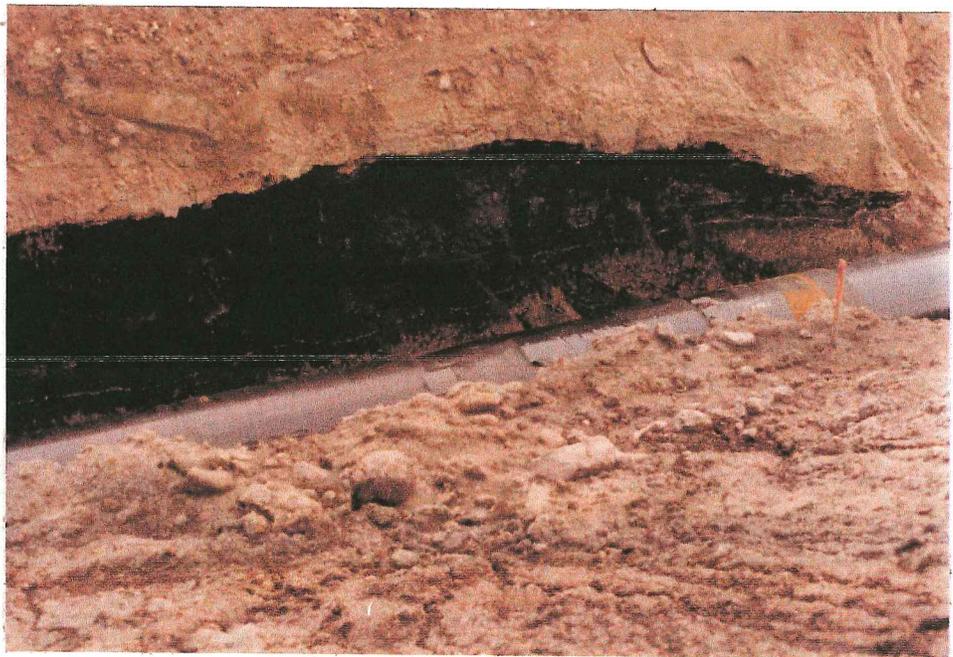
#80 Lignite seam cut by trench on R0142. The seam is directly below the vantage point in #79.

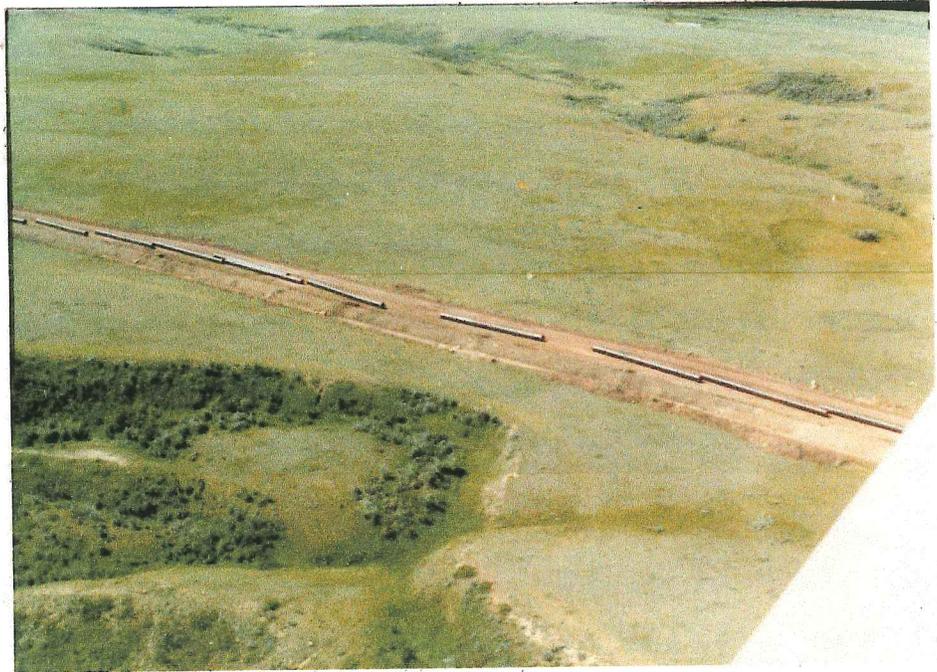
#81 State parcel PH033, looking south on June 26. The route passes closely to a known buffalo jump at the lower left and crossed several archaeological sites.
