February 14, 2024

**CONDITION REPORT:  
USS WARD #3 GUN**

The purpose of this project is to document the current condition of the USS Ward #3 gun that is currently installed as a memorial on the Minnesota State Capitol Mall prior to the move of the gun to a permanent indoor location. This report will also compile and summarize the history of preservation and conservation efforts to date in order to inform the proposed restoration of the gun.

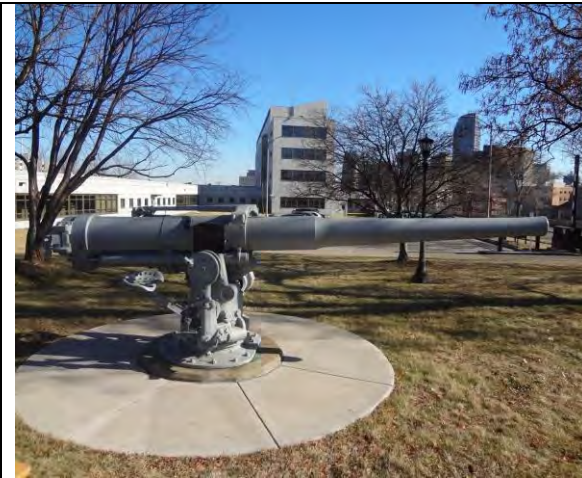
The paint is approximately 95% intact on the PR (West facing) side of the barrel. There is some paint breakdown with peeling/flaking and rust staining beginning under the front of the top sight mount.

Proper right-side overview

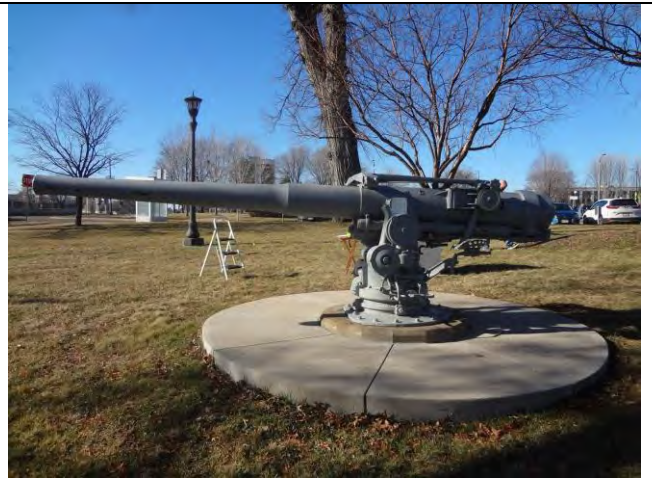
Proper left side overview

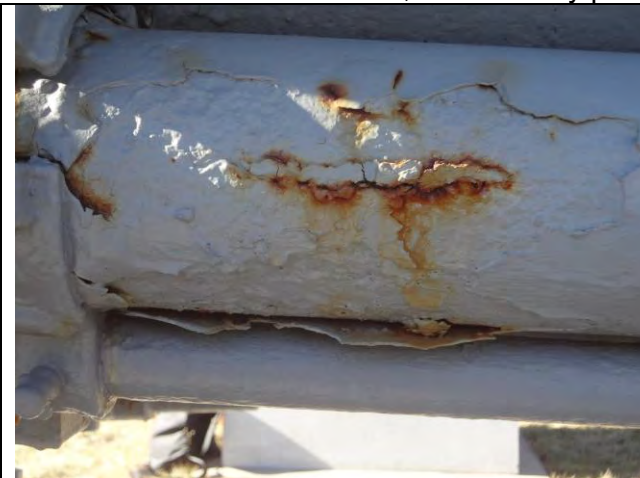
There is paint loss and rust staining breakthrough along the lower part of the PR and PL recoil tubes. The metal of the recoil tube is heavily corroded underneath the paint layers. That has been an on-going condition of the gun and indicates probable water infiltration into the recoil tubes, but the entry point(s) are not apparent.

Corrosion breakthrough and paint failure, staining on PL recoil tube.

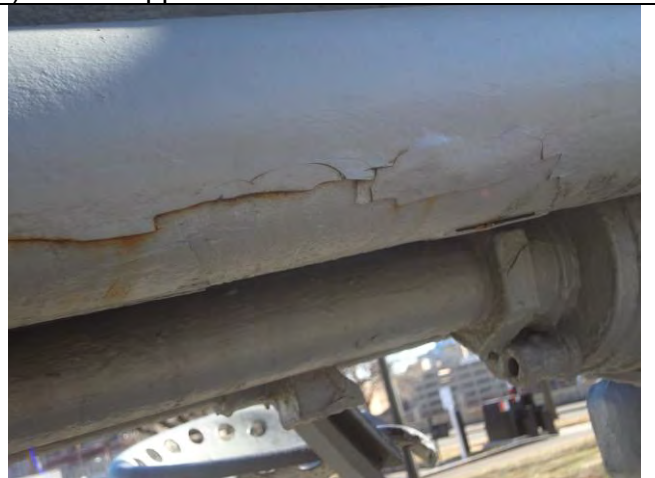
Painting flaking and rust staining on PR recoil tube.

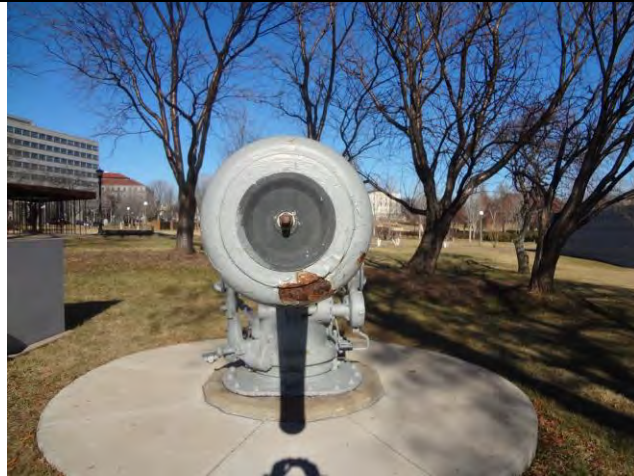
Overview of muzzle showing modified plumbing plug, installed in 2006.

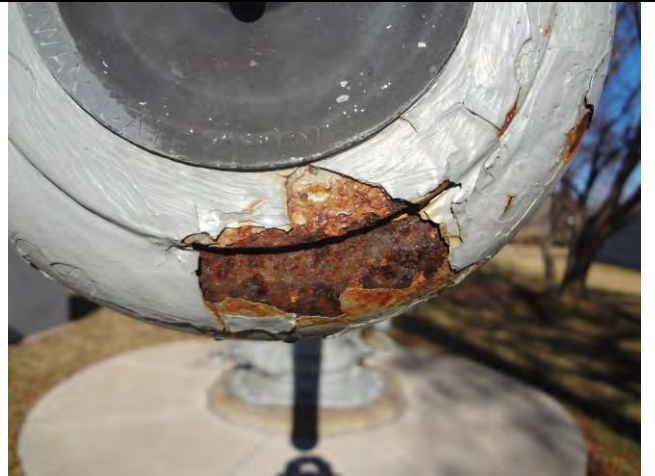
A modified plumbing pipe plug was installed in the muzzle to prevent debris and water from getting inside the barrel in 2006 and is still intact. There is an approximately 4" long area of paint and metal loss on the lower margin of the muzzle rim. Some of the paint layers are revealed in the gap area.

Detail of corrosion breakthrough and paint loss on lower margin of the muzzle rim.

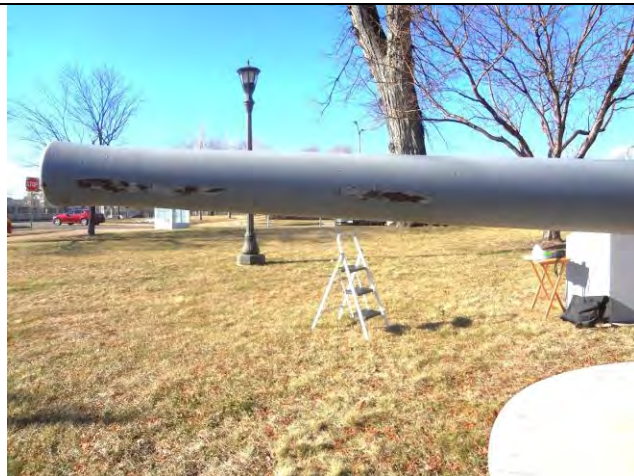
While the PR (West facing) side of the barrel has intact paint layers, there is an approximately 16" long by 2" wide loss area that exposes the corroded metal towards the muzzle end, and a smaller approximately 11" long by 2" wide area behind that towards the breech end on the PL (East facing) side.

Overview of PL side of barrel showing the two areas of paint loss and underlying layers.

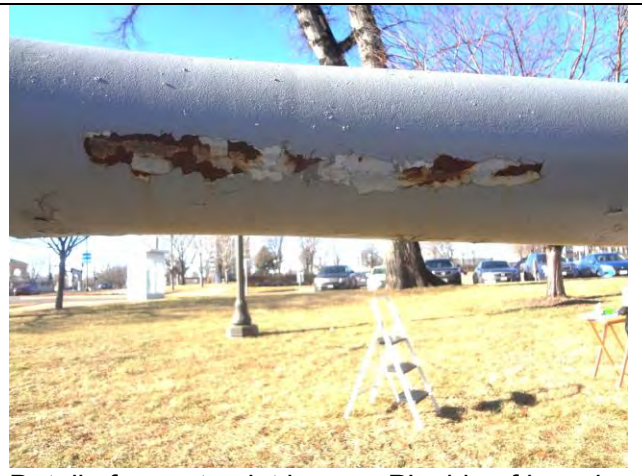
Detail of recent paint loss on PL side of barrel towards muzzle end.

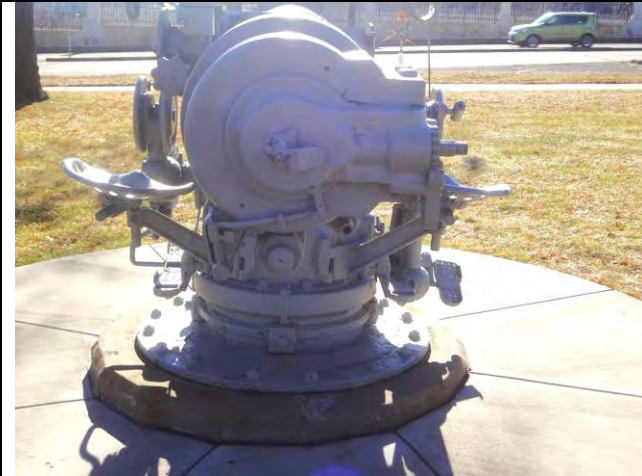
The North facing breech area and loading door assembly appears to be intact and the paint layers area in good condition.

View of the breech end

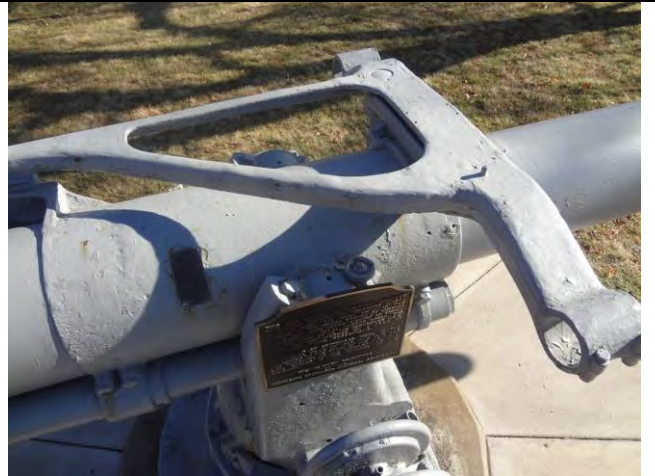
The sight support frame on top of the barrel also has intact paint layers over most of the metal with some paint loss and rust staining at the breech end.

View of the sight support frame

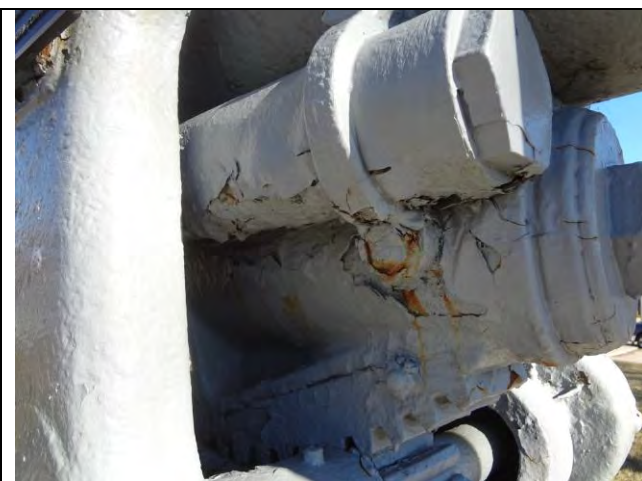
The recoil tube assemblies on both sides appear to have the most corrosion breakthrough, underlying corrosion expansion, and paint flaking/losses of all components on the gun. This may be due to a combination of factors- incomplete paint preparation, lack of consistent conservation treatment since 2009, possible hydraulic fluid corrosion from the interior, and water infiltration. The placement of the tubes above spaces in the swivel support that can hold water and debris can also be a contributing factor as this might create a 'microenvironment' with a higher level of humidity.

Detail of PR muzzle end facing recoil tubes

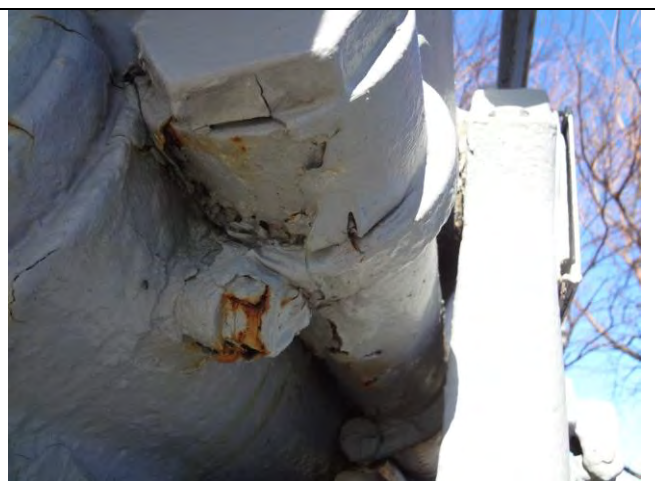
Detail of PL muzzle end facing recoil tubes

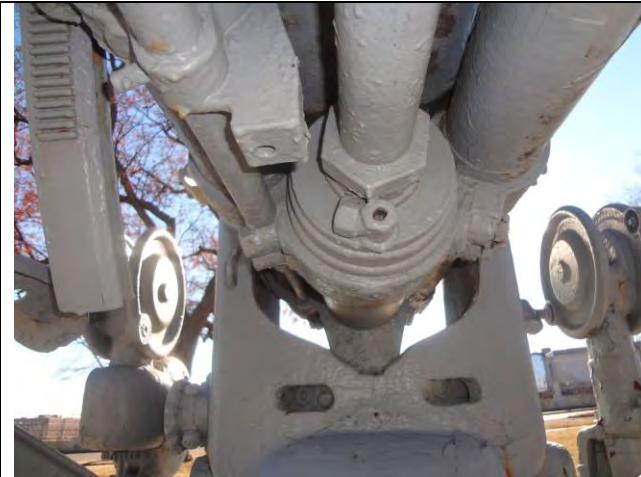
View towards breech end of the underside of the barrel assembly.

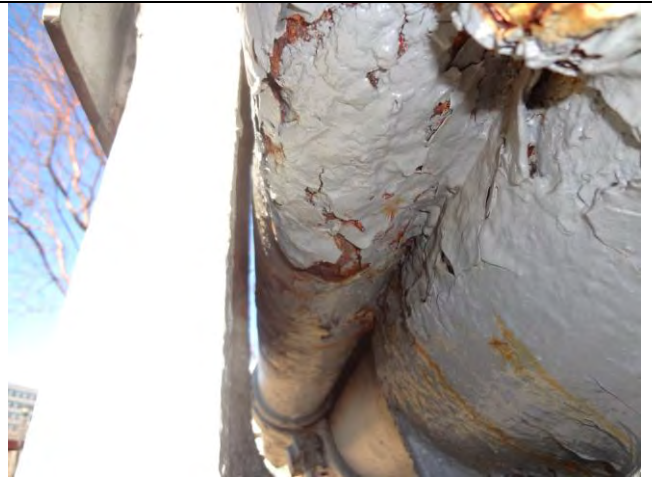
Detail of underside of the PR recoil tube showing condition of metal and paint layers.

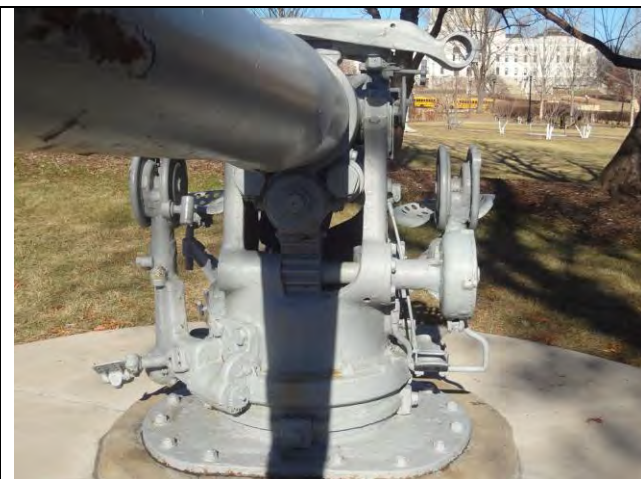
The overall condition of the swivel support base is stable in terms of the overall paint layers and state of visible metal corrosion. The least stable areas are in the recessed spaces directly under the barrel and recoil tube assemblies where rust and paint flakes have accumulated. Those spaces are the most difficult to prepare for repainting and the extent of the last completed painting included removing the previous accumulations and properly prepping the surfaces. As mentioned in the previous section, the debris layer can absorb and hold moisture that in turn can be released and affect the overhanging surfaces.

Front view of swivel support assembly showing overall condition.

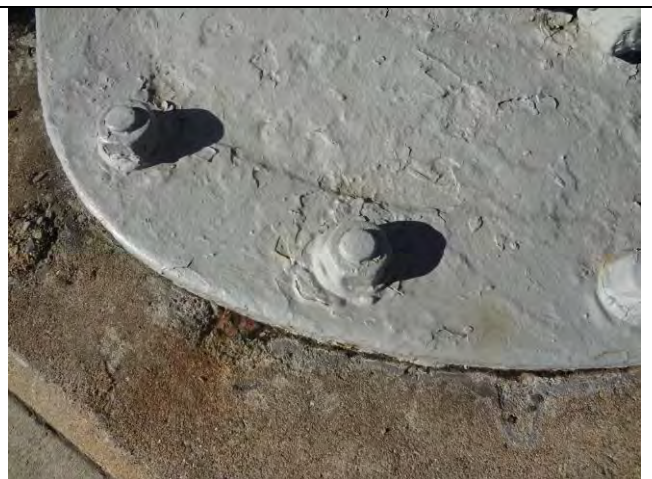
The bolts appear to have been welded to the base rim upon installation in 1958.

Detail of bolts in base and concrete interface

- Remove the gun from the base. That may involve intrusive methods to remove the welding around the bolts, if possible. All means of removal should be explored that avoid cutting the bolts off in order to lift the gun off the concrete pad.

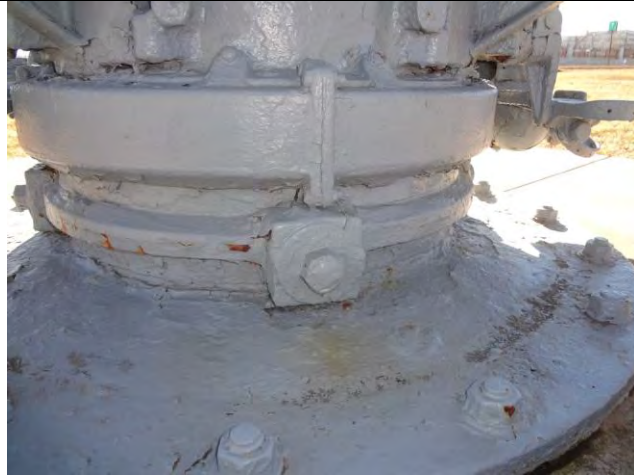
Detail of lower swivel support assembly condition.

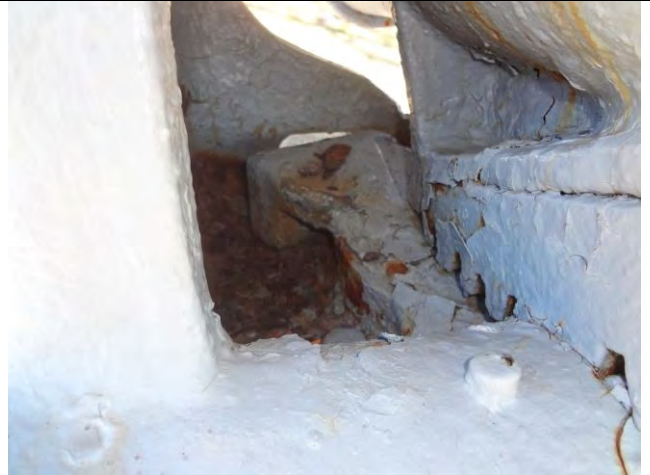
Overview of debris and rust accumulation 'inside' swivel support mount assembly below the recoil tubes and barrel

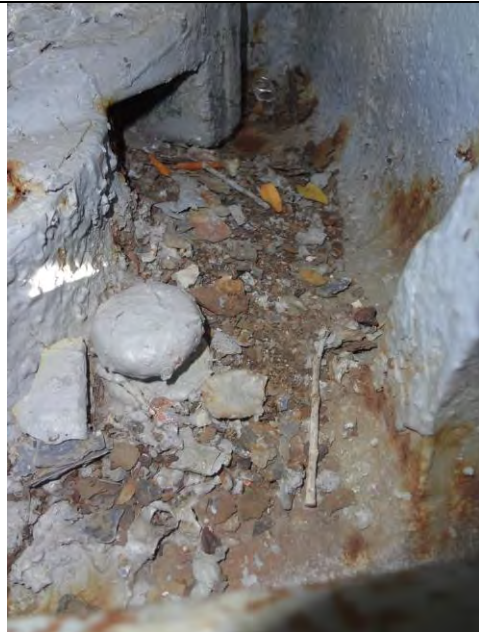
Detail of paint and rusted metal flakes on bottom of 'interior' of the swivel mount, PR side.

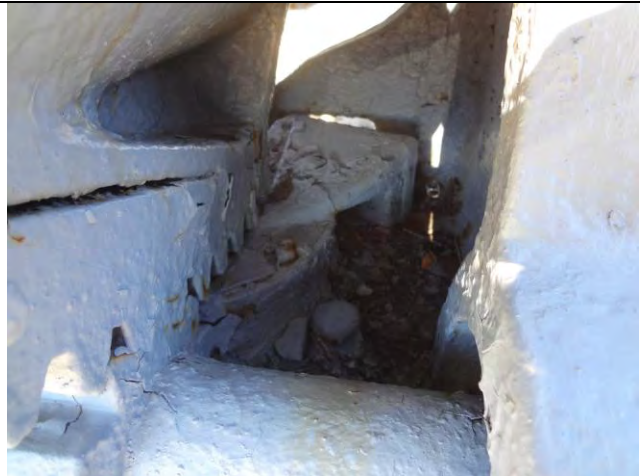
Detail of PL side swivel area showing rust staining.

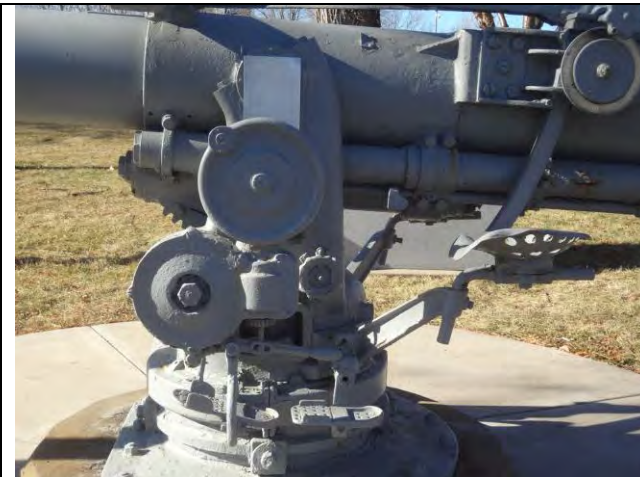
Overall, the painted peripheral components have retained their paint coatings from the last painting campaign with minimal losses and rust staining. There is some dripping of rust on the sides and curved surfaces, and some on the flat upper surfaces of both seats.

PL side showing trainer's seat, elevation wheels and other components.

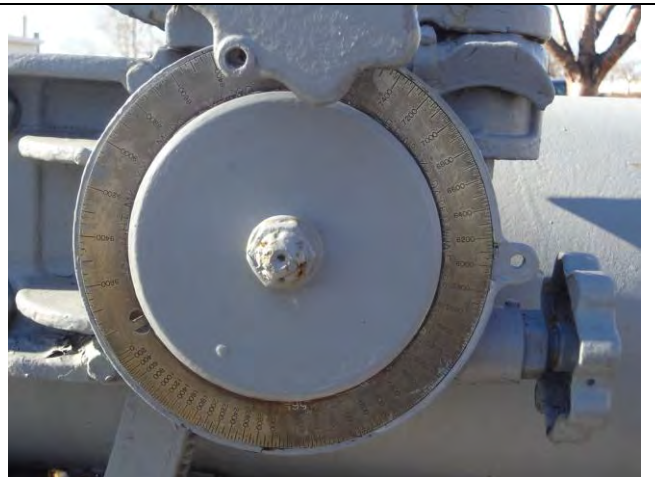
The vernier scale was last treated in 2009 to remove corrosion and coated with an acrylic resin. The same treatment was done to the cast brass 1958 dedication plaque on the PR side of the gun. That plaque is still in overall good condition with some mild corrosion breakthrough and tarnishing on the lower part of the face of the plaque.

The vernier elevation scale, PL side of the gun. The brass was cleaned and coated in 2006 and remains legible.

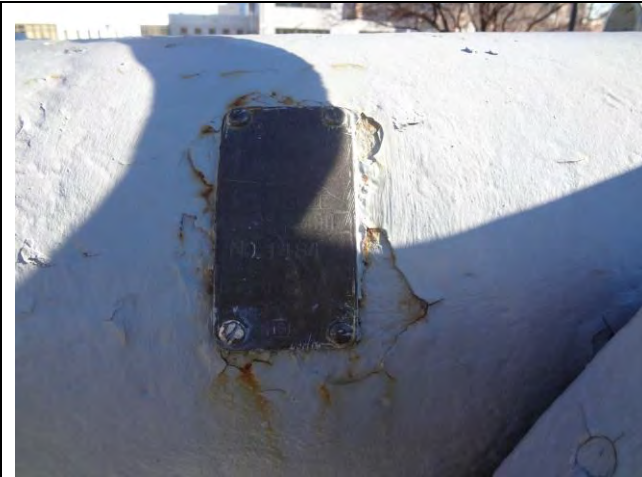
Both bronze maker's plates have oxidized to a dark brown with some corrosion staining from weathering.

Maker's bronze plate on the PR side of the barrel towards the breech end.

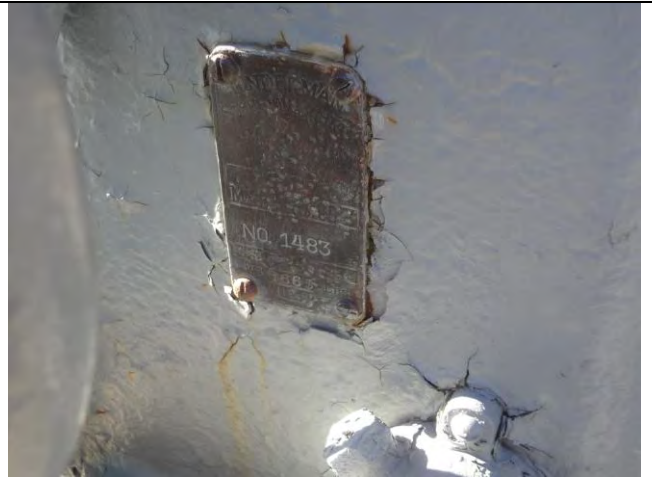
Maker's bronze plate on the PL left side just forward of the trainer's seat.

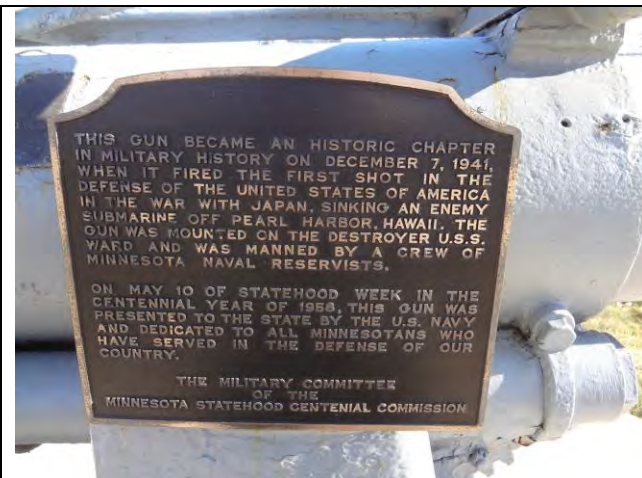
Cast brass 1958 dedication plaque on the PR side of the barrel. Cleaned and coated between 2006-2009.

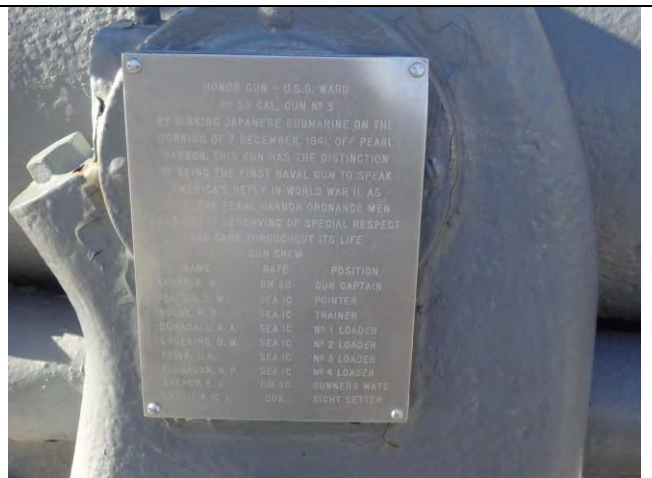
The "Honor Gun" plaque installed in 1958 was recently replaced with what appears to be an aluminum plaque in excellent condition. The fasteners were burnished so the plaque cannot be unscrewed from the gun.

Recent replacement of 1958 plated "Honor Gun" dedication plaque, prob. Aluminum.

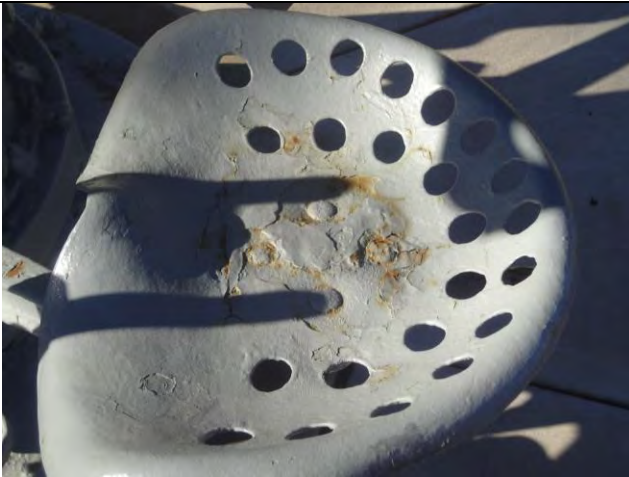
PL side trainer's seat

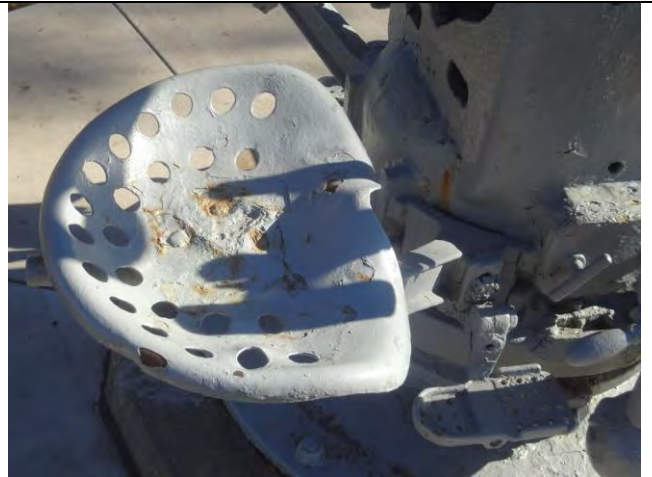
PR side fire control operator's seat

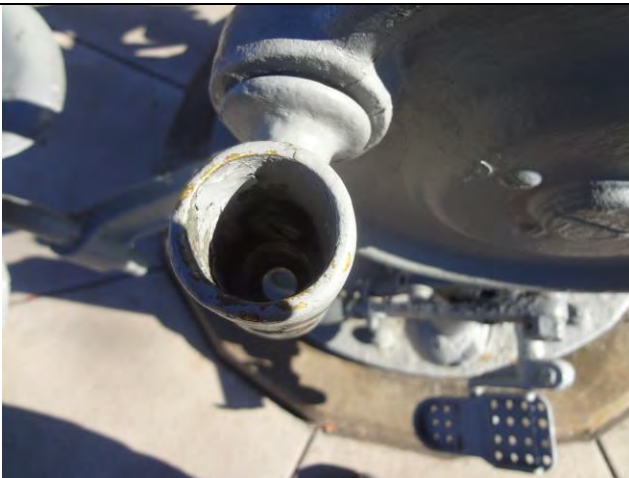
The painted brass components have retained their paint coatings with minor chipped areas exposing shiny brass below.

PR side mount for elevation wheel handle.  
Painted brass.

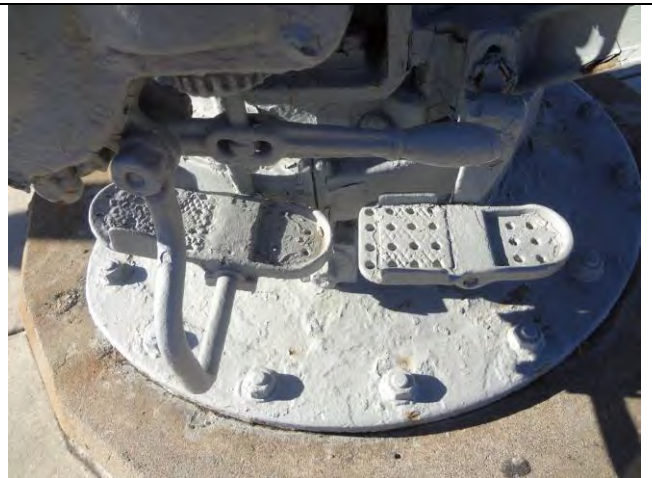
PL side foot rests. Painted brass. The foot  
rests on the PR side are also painted brass.
