Administration

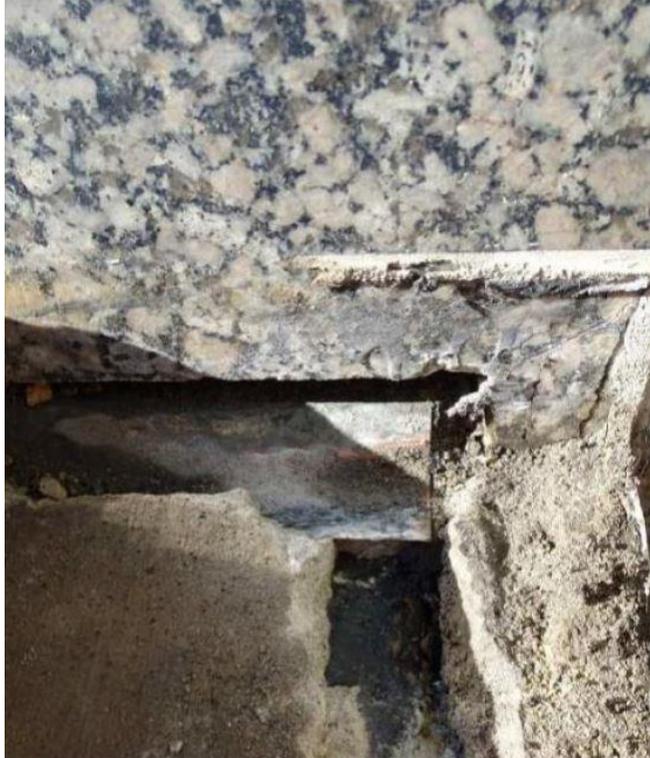
5. Centennial Office Building: exterior stone joint failure

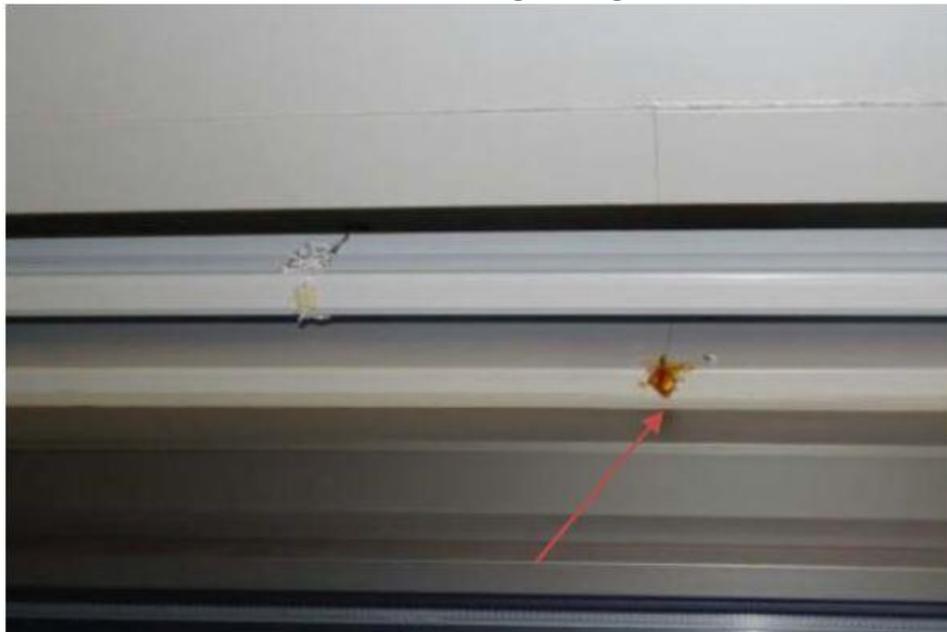
5. Centennial Office Building: ceiling and window leaks

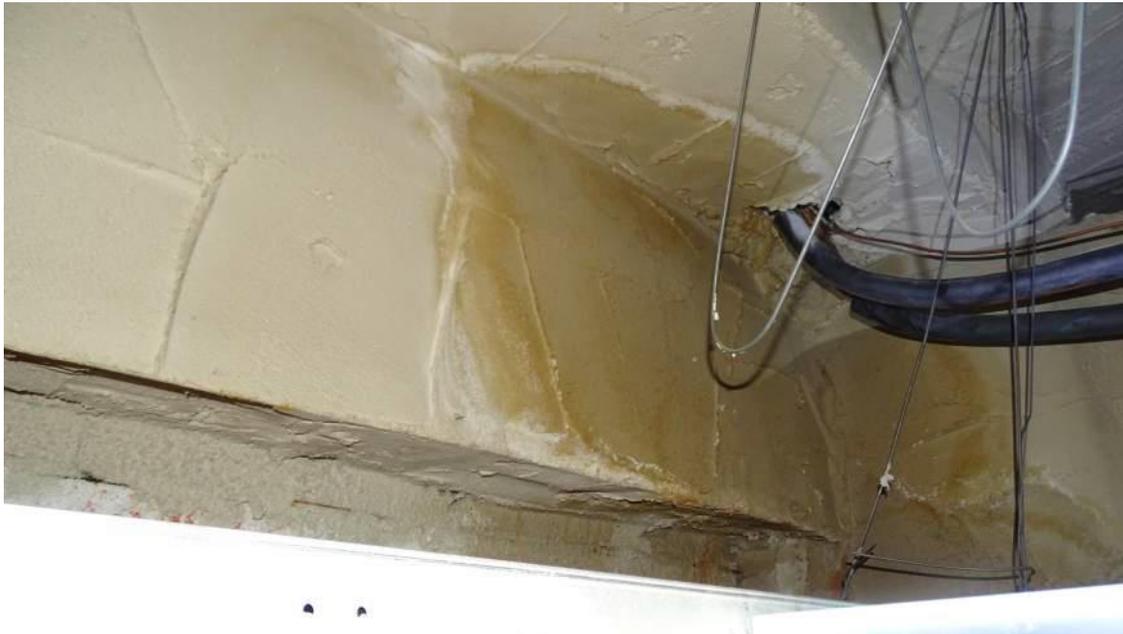
5. Centennial Office Building: exterior wall leak

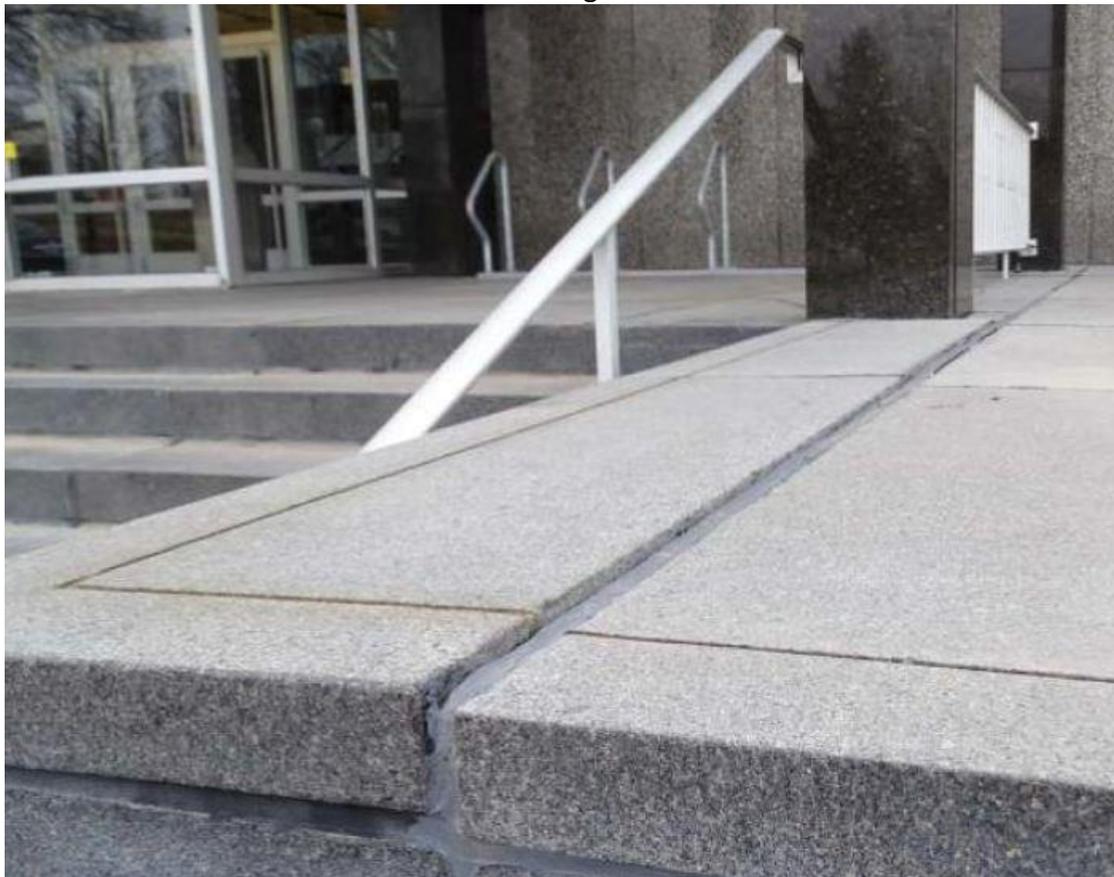
5. Centennial Office Building: external sealant failure

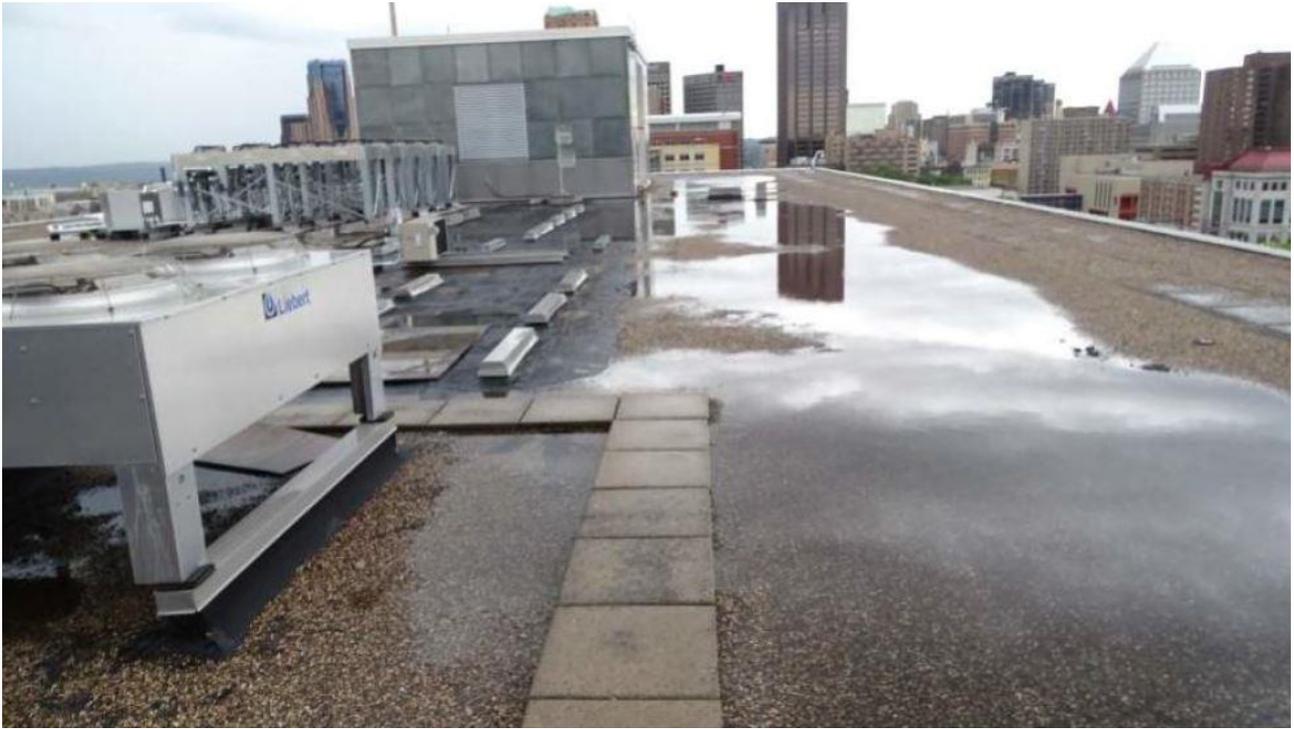
5. Centennial Office Building: roof not draining correctly

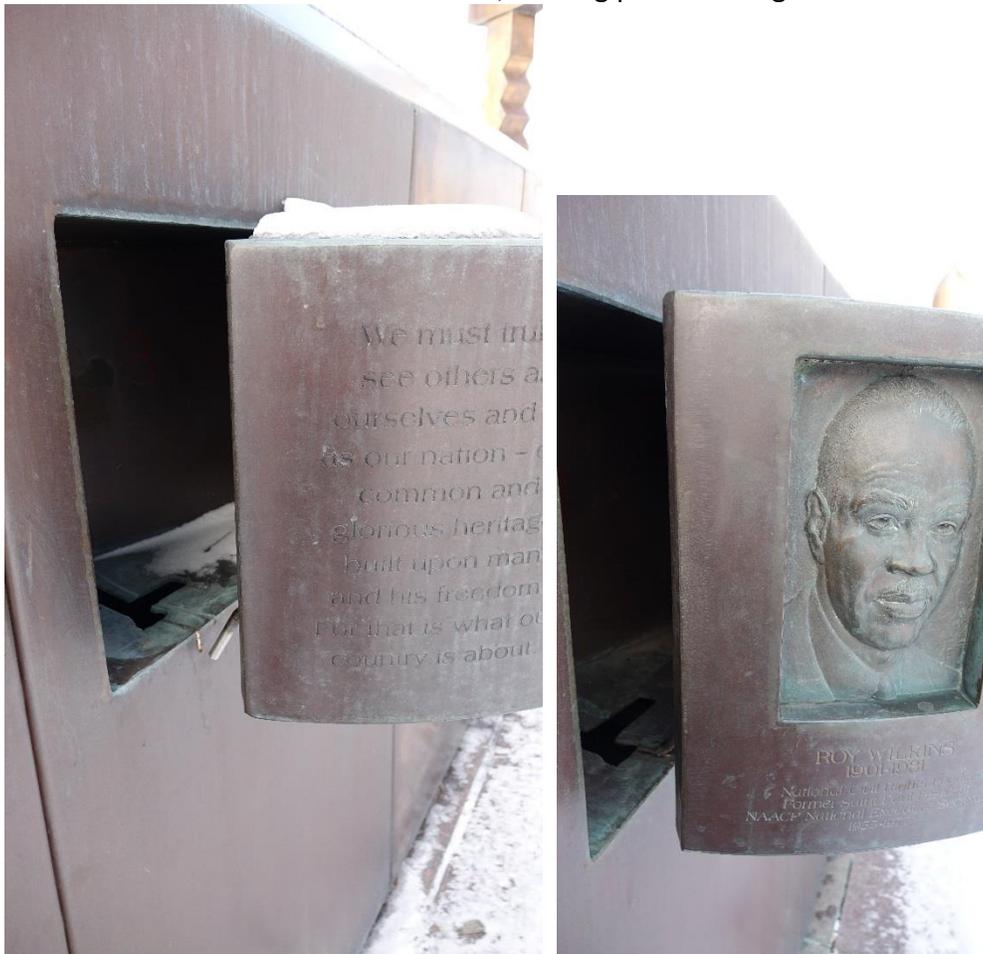
6. Capital Monuments and Memorials: Roy Wilkins (Intended to be an interactive memorial, moving parts no longer function correctly)

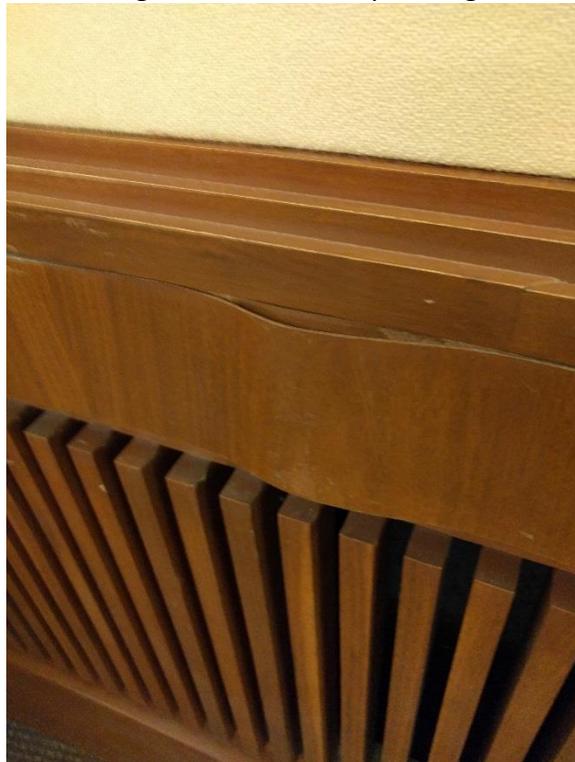
11. State Office Building: wood veneer separating in hearing chambers

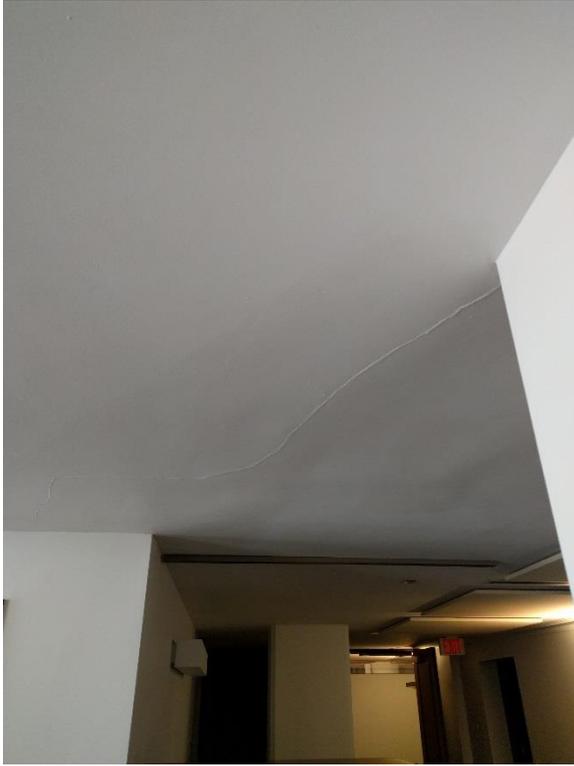
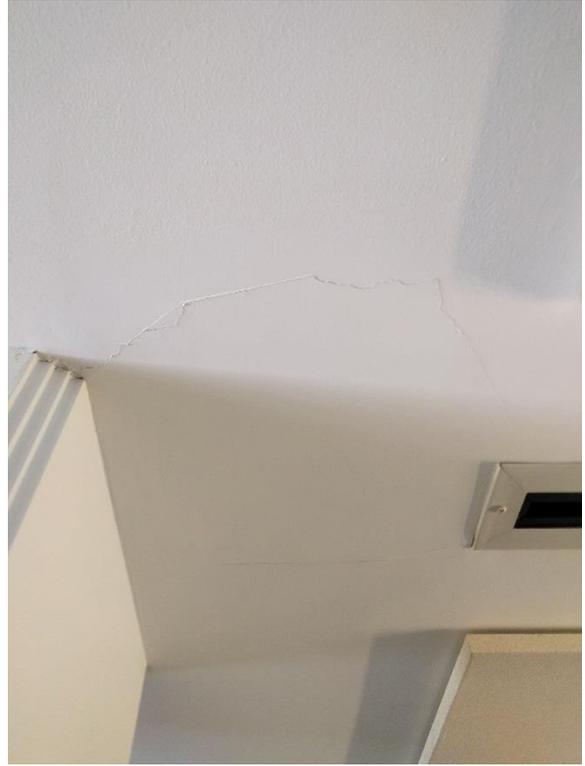
11. State Office Building: ceiling settlement cracking (same area, multiple floors)

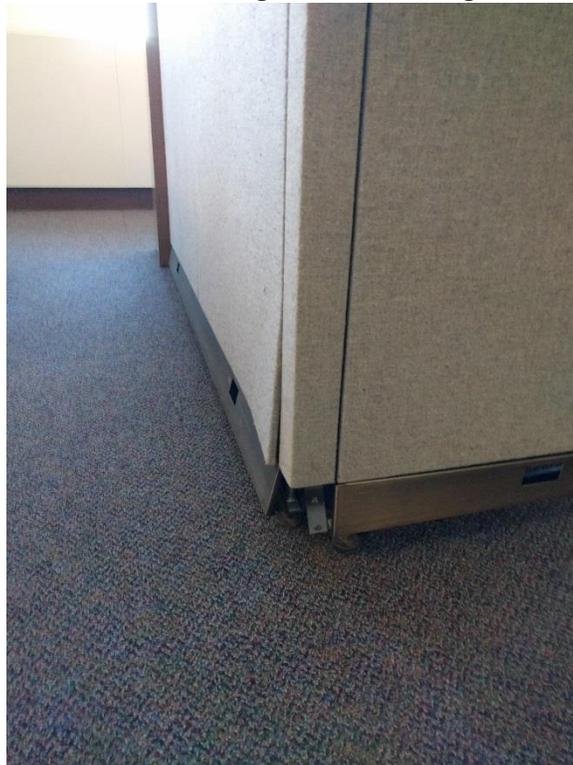
11. State Office Building: old and damaged workstations

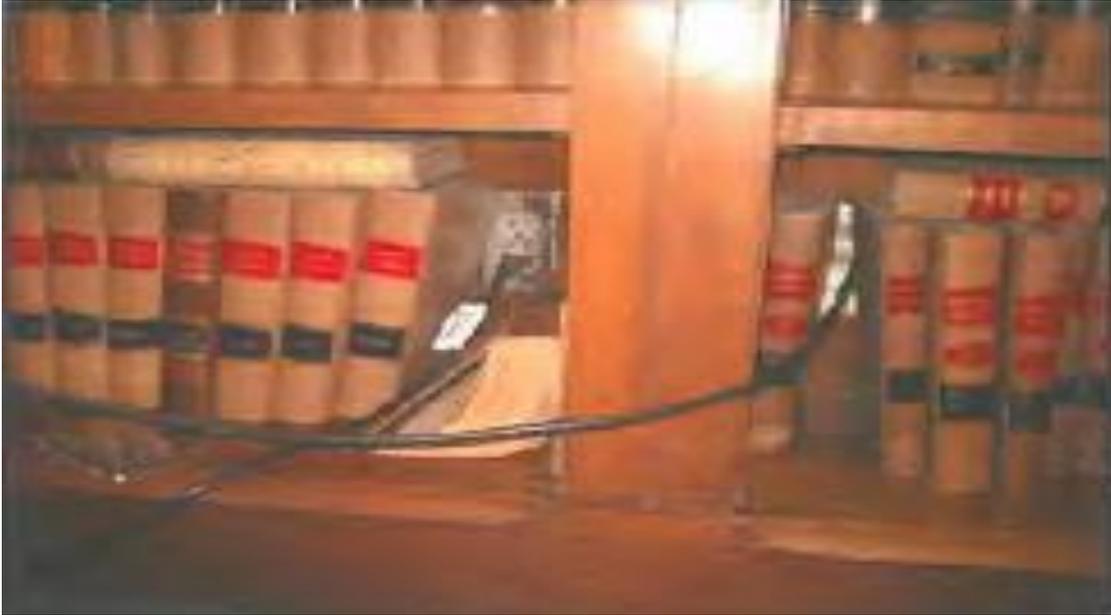
11. State Office Building: outdated electrical systems

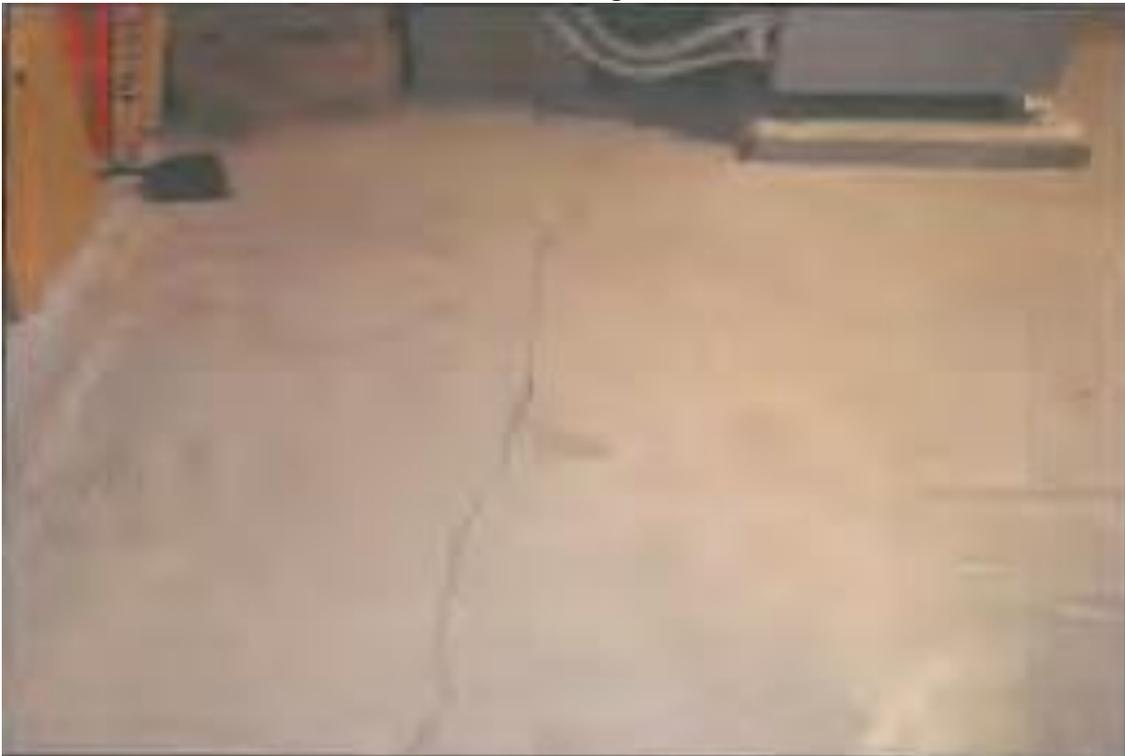
11. State Office Building: cracked floor slab
