# Minnesota State Capitol Window Restoration Project

## Preliminary Planning Phase Conclusions

Second Revision, September 11<sup>th</sup>, 2012

Hammel, Green and Abrahamson + Schooley Caldwell Associates

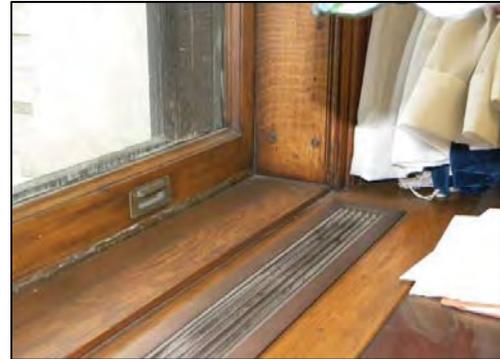
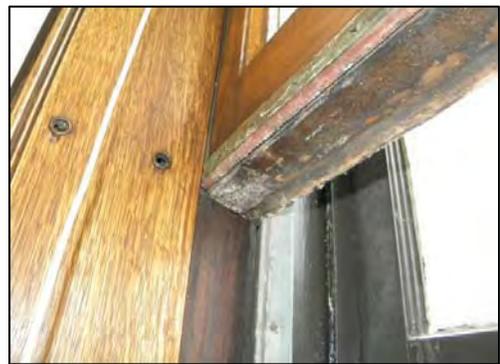
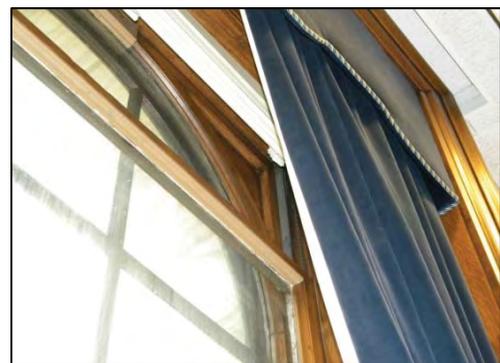
The two windows in the Attorney General’s office and the two windows in the Governor’s office have not been replaced with aluminum windows. The two windows in the Attorney General’s office are original sash and frame and are in good condition. The historic hardware is intact and operating effectively, including the weights, chains, and pulleys. Figures 5, 6, and 7 are photos of the original wood windows in the Attorney General’s office. Refer to Appendix B Exhibit 2 (page 97) for additional photos. The two windows in the Governor’s office are original frame and a replacement wood clad steel sash for incorporating ballistic laminated glass (see figures 8 and 9). Refer to Appendix B Exhibit 3 (page 101) for additional photos.

**Figures 5, 6, & 7: Original wood window sashes and frames at the Attorney General’s office**

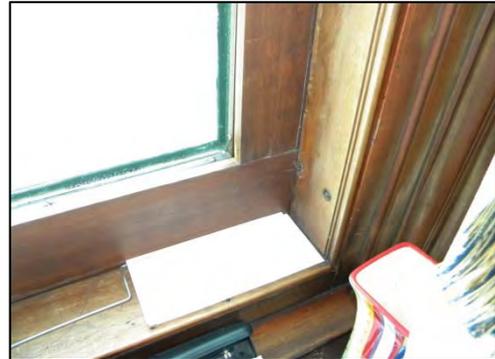
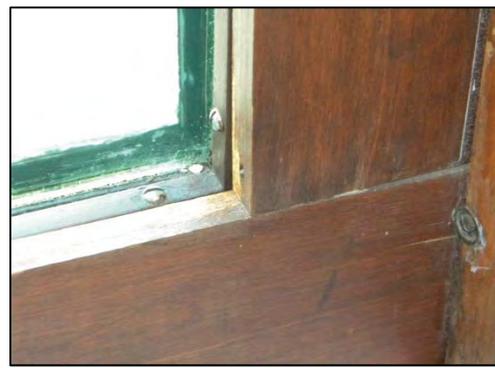
Figures 8 & 9: Ballistic glazing in a steel frame clad with wood at the Governor’s Original Office

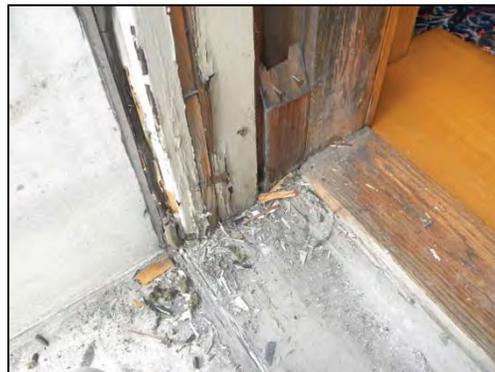
Figure 10: Original wood frame revealed after removing the current aluminum frame and panning. The existing frames are in relatively good condition and are capable of being repaired. See Appendix B for additional photos.

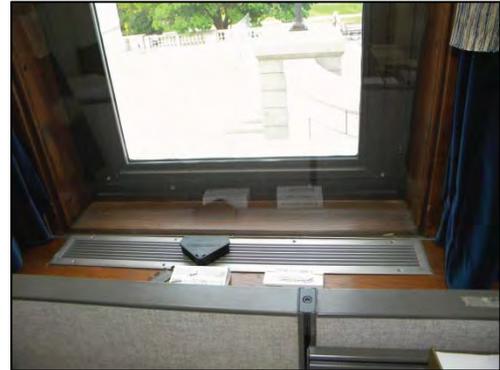
The aluminum windows have not been maintenance free. In 1989, windows throughout the entire building were repaired and weather-stripped, but the scope of these repairs was not found in existing documentation.<sup>10</sup> Some aluminum windows have been retrofitted with plexiglass barriers on the interior side of the window, presumably for preventing drafts (see figure 11).

**Figure 11: Plexiglass barrier installed on interior side existing aluminum window, likely for preventing drafts**

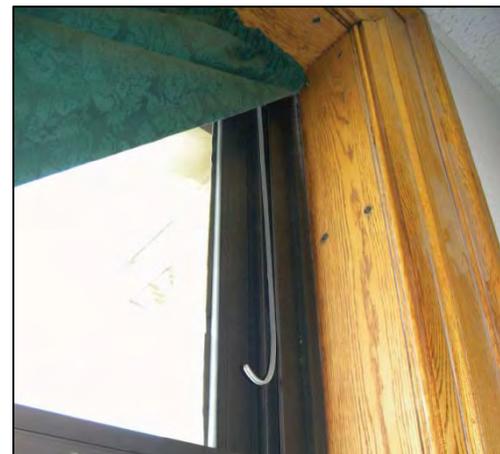
Although a majority of the current aluminum windows are in fair condition, there is strong evidence for incremental failure. The aluminum windows are showing considerable weathering and wear, including frame/sash corrosion, chalking, fading anodized finishes, migrating glazing unit seals, weather stripping failure, and damaged frame/sash components. Figure 12 illustrates the failure of weather stripping occurring at some locations. Total failure of the insulated glazing unit is evident in rare instances as illustrated in figure 13, and is characterized by the presence of moisture, fogging, and rust inside the glazing unit. During the field investigation, the maintenance staff indicated that

**Figure 12: Failure of weather stripping at existing aluminum window**

they received complaints that the windows are performing poorly thermally, allowing excessive air infiltration and drafts. The aluminum windows are thirty eight years old and at the end of their expected lifespan.

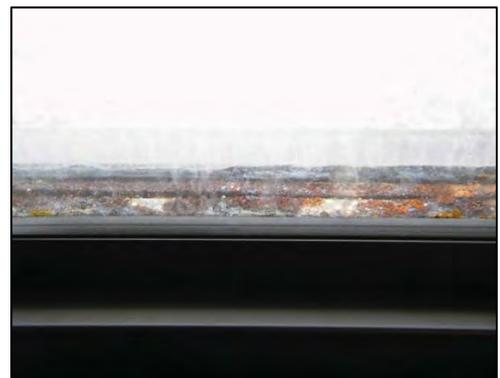
**Figure 13: Failure of insulated glazing unit at existing aluminum window**

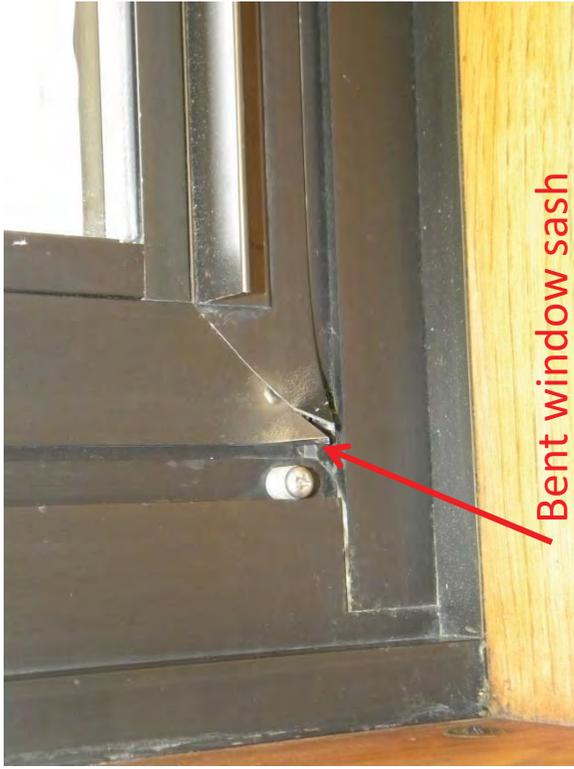
Loose weather stripping
