CORRECTIONS

Asset Preservation:

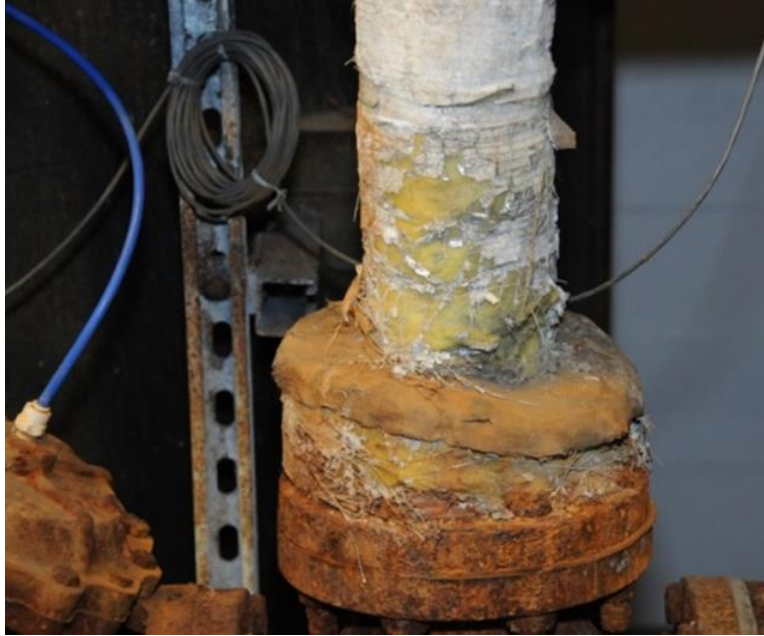
1. MCF-Stillwater pipe

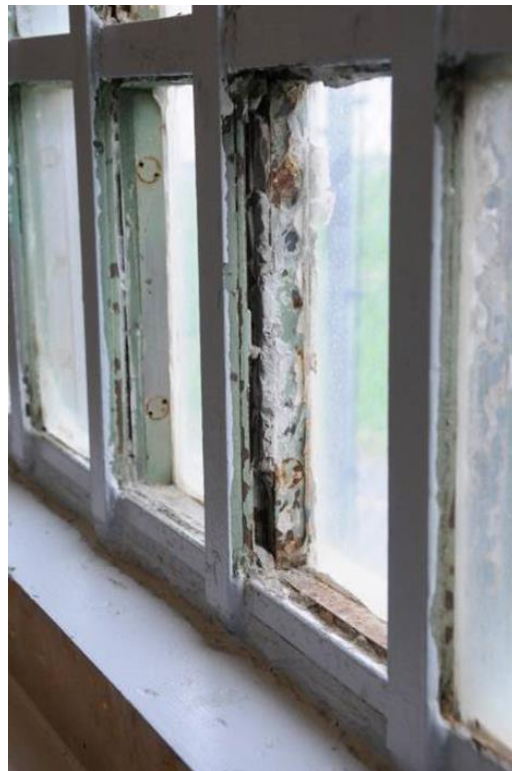
1. MCF-Stillwater Window

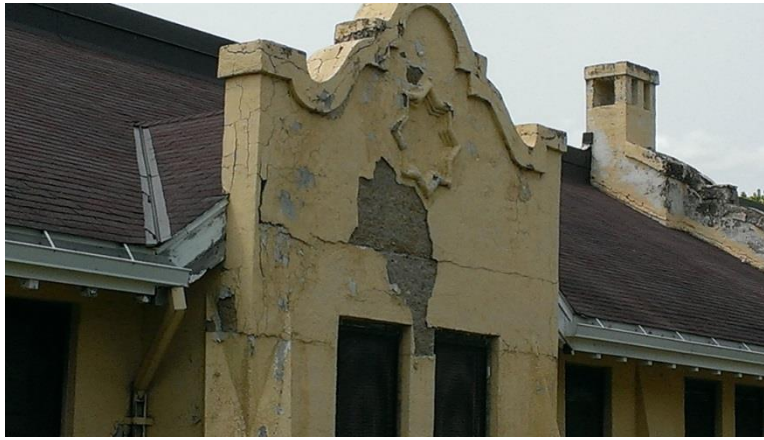
1. MCF-Faribault Deterioration

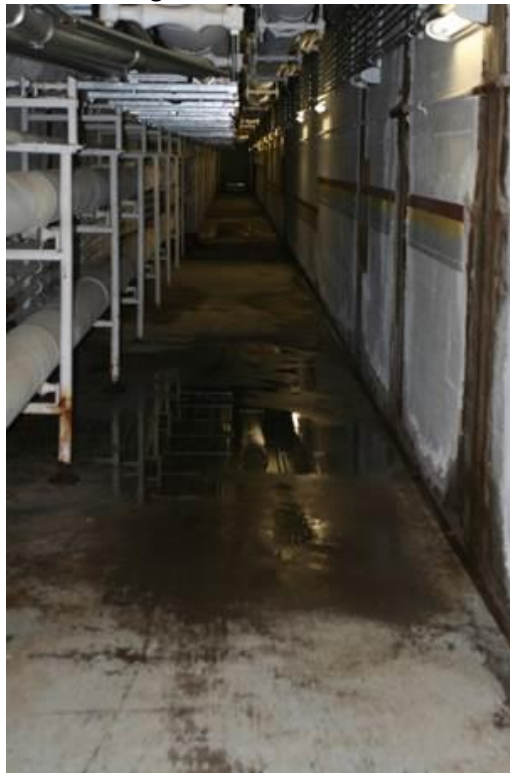
1. MCF-Moose Lake water running in due to roof and run-off from outside parking lot.

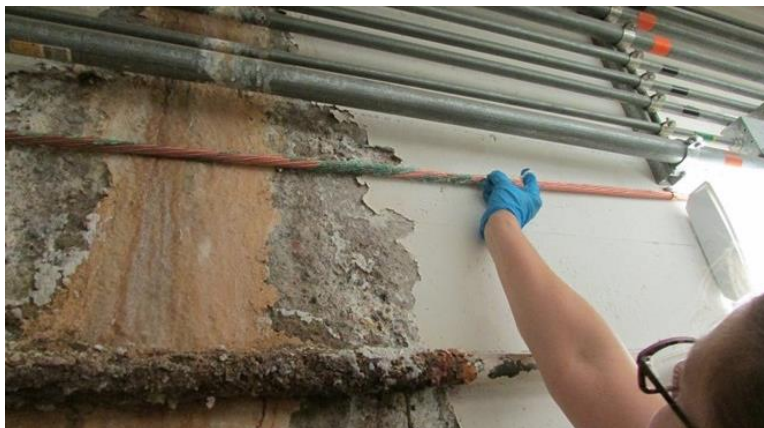
1. MCF-Moose Lake tunnel corrosion

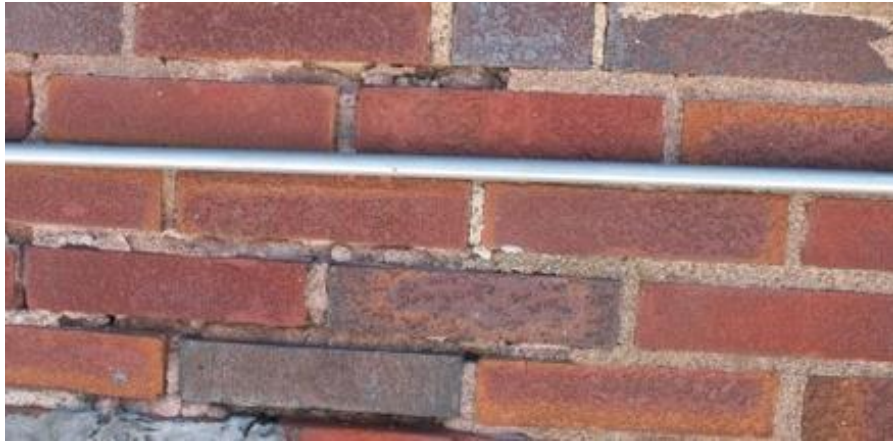
1. MCF-Lino Lakes Tuckpointing

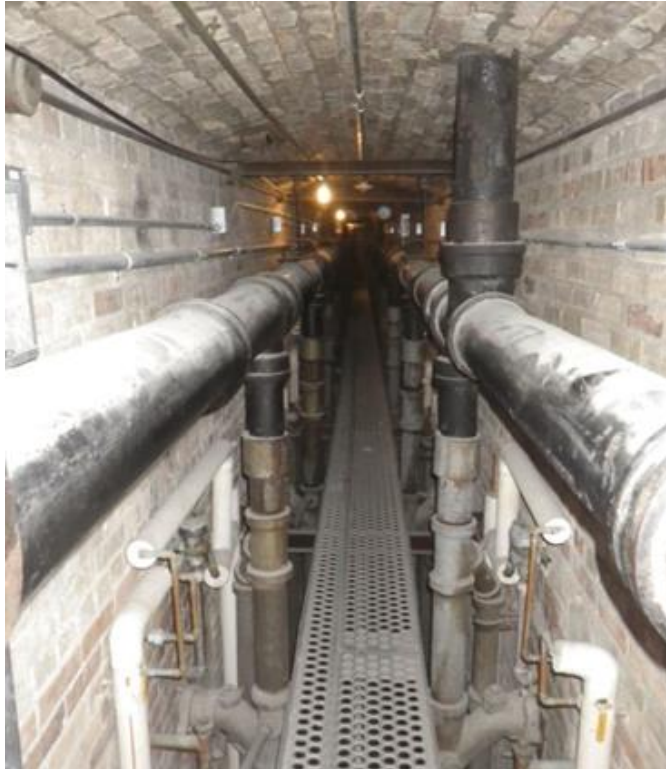
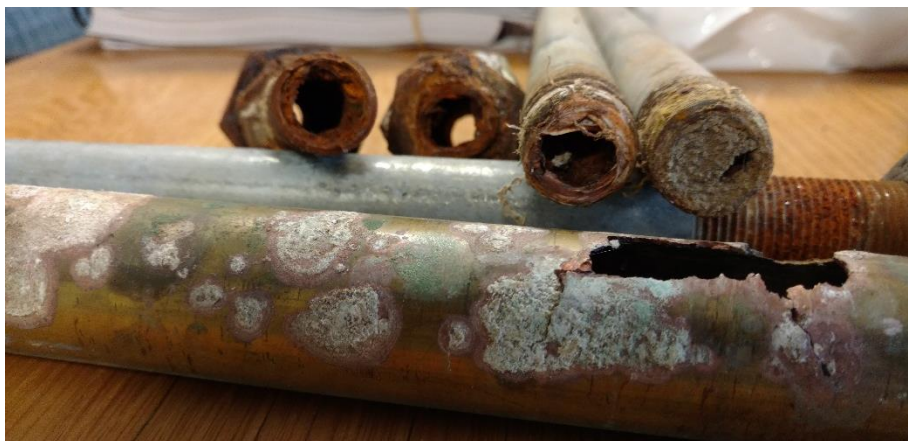
4. MCF-St. Cloud Plumbing and Ventilation:

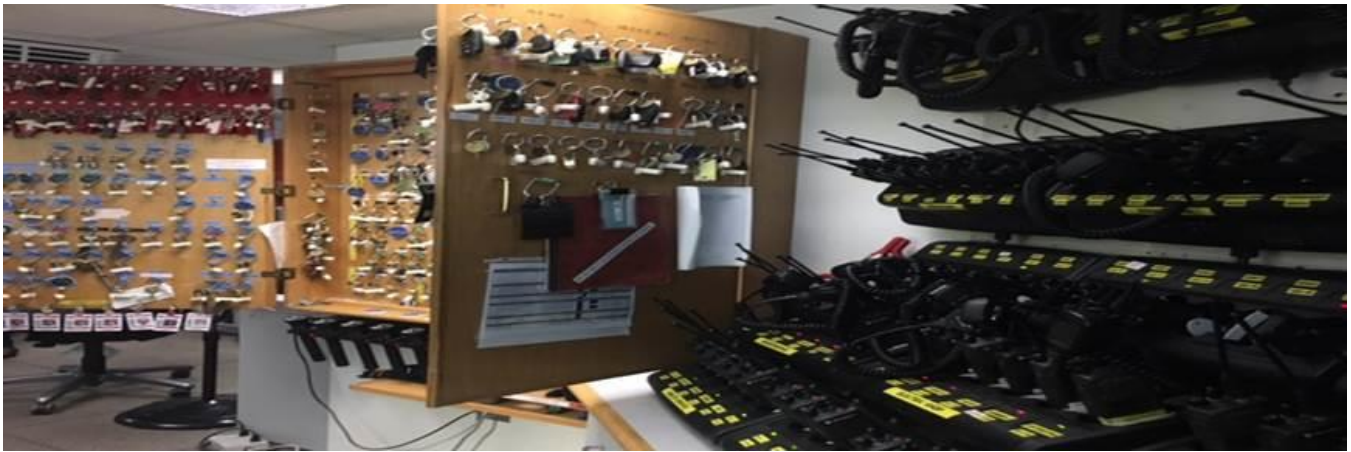
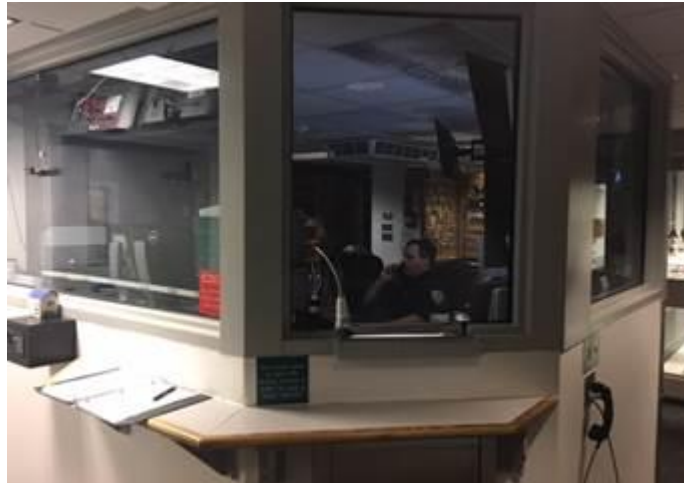
6. MCF-Moose Lake Master Control Renovation:

Current control center lacks space, has inadequate air quality and distribution, and security equipment is open and seen from the window that offenders pass by.
