CONSTRUCTION OF THE NORTHERN BORDER PIPELINE IN MONTANA

Report to File

Paul Stolen, Assistant Coordinator

Montana Department of Natural Resources and Conservation

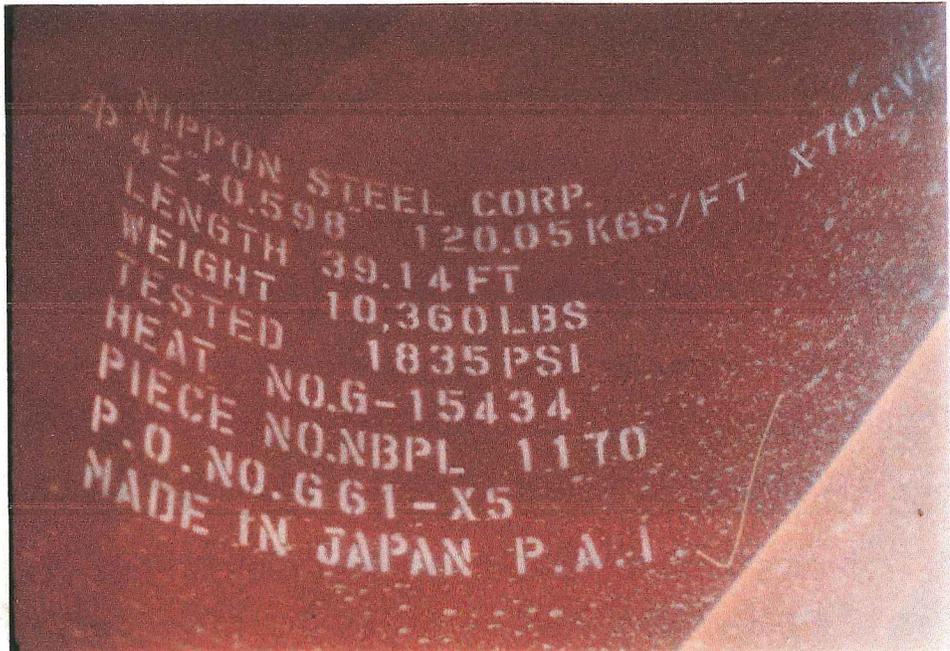
#1 Label inside a pipe section showing origin, strength, weight, thickness, and grade (X70). American-made pipe was used in other states along the Northern Border route. Forty-foot sections were transported by rail to the Valley Industrial Park near Glasgow.

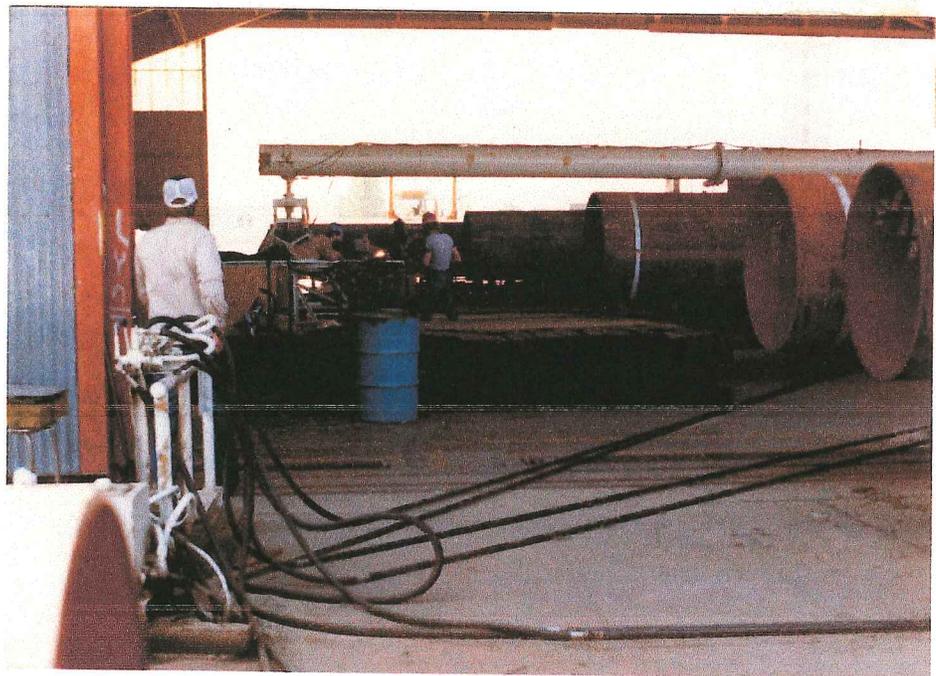
#2 Two forty-foot sections were machine welded together at Valley Industrial Park ("double-jointing").

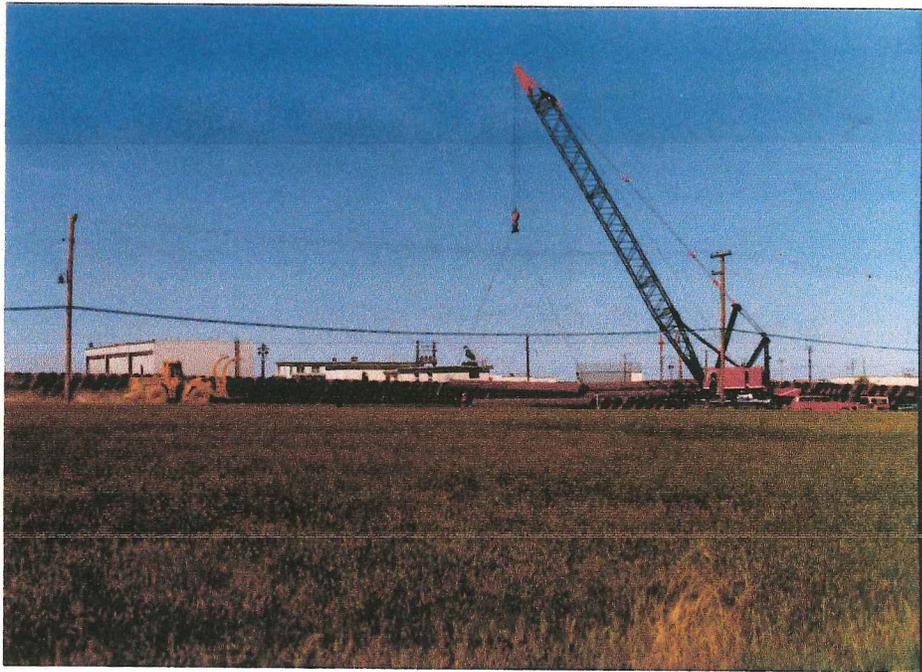
#3 Storage of 80-foot sections ("joints) at VIP.

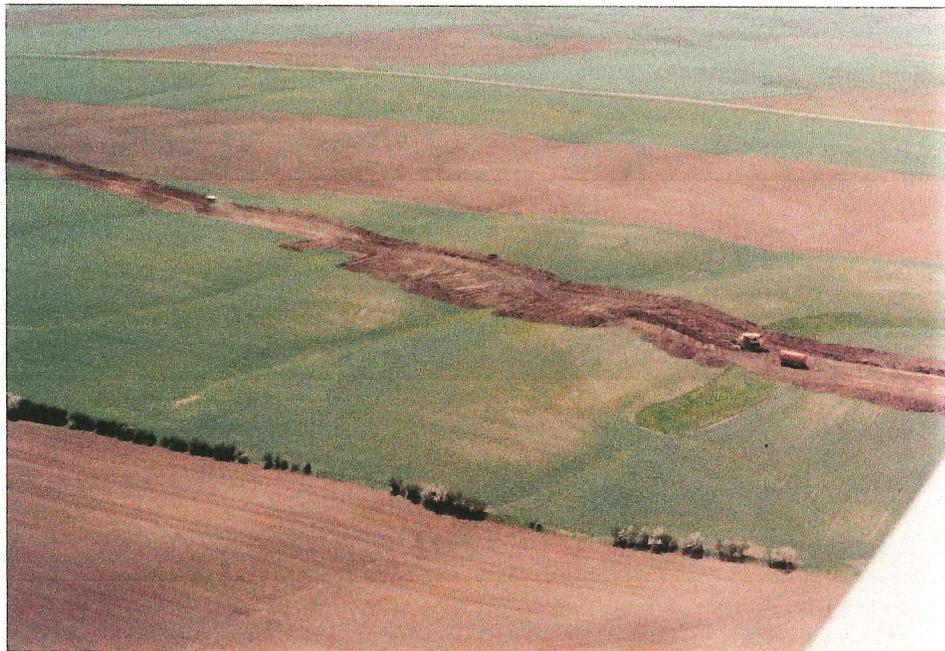
#4 Right-of-way clearing June 26. Soil and spoil is usually moved perpendicular to the centerline to simplify recontouring. All clearing was completed in Montana by July 15.

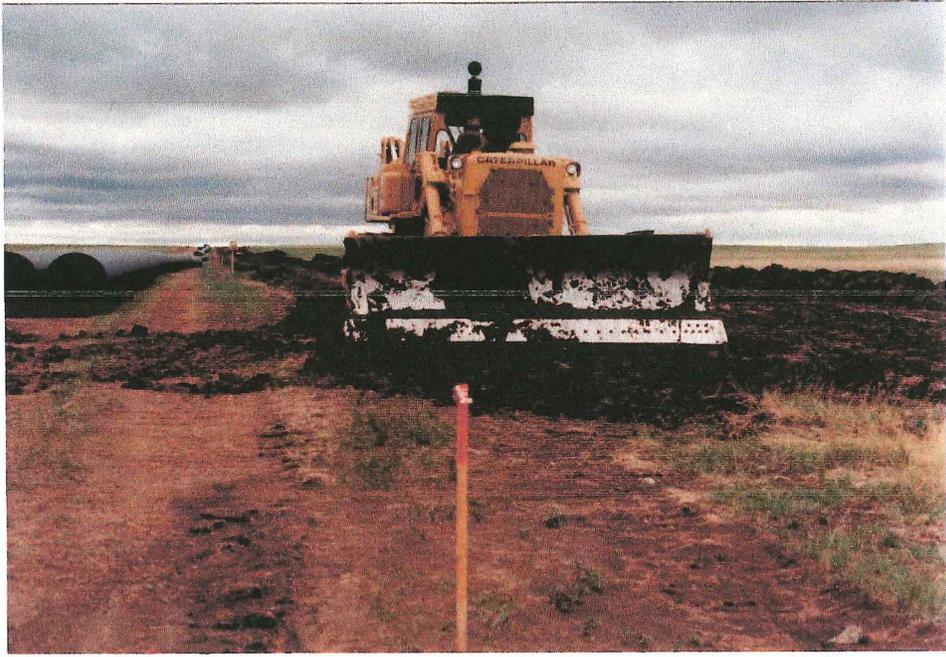
#5 Dozer blading 3-4 inches of topsoil from over trench area prior to ditching. This operation was combined with r-o-w clearing when the terrain was not as flat as shown in the photo, taken on July 16 on state land parcel VA057 west of the West Fork Procupine Creek.

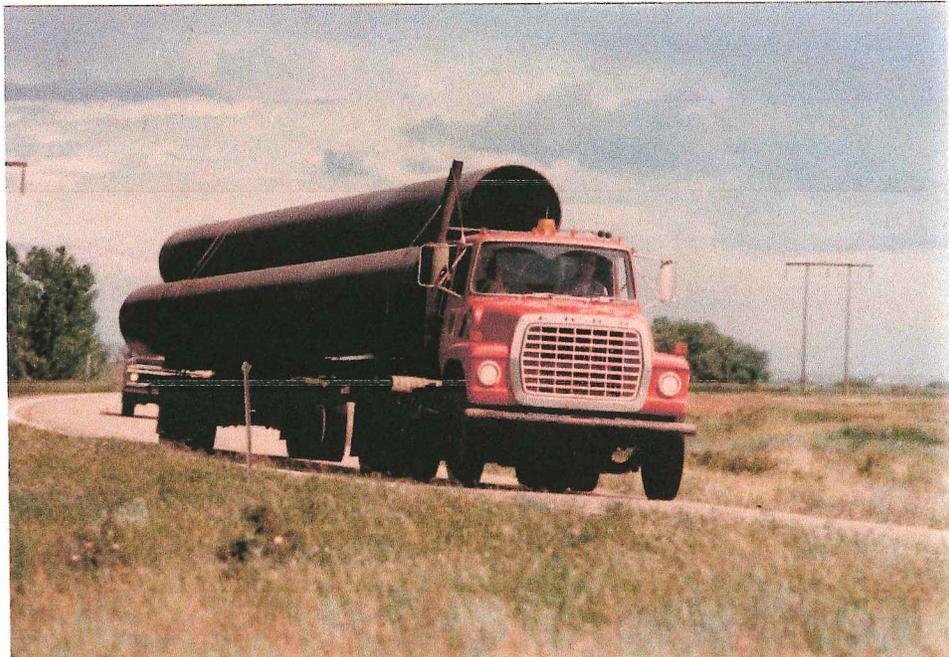
#6 Pipe truck hauling three 80-foot joints on U.S. Highway 2. Load is approximately 63,000 pounds.

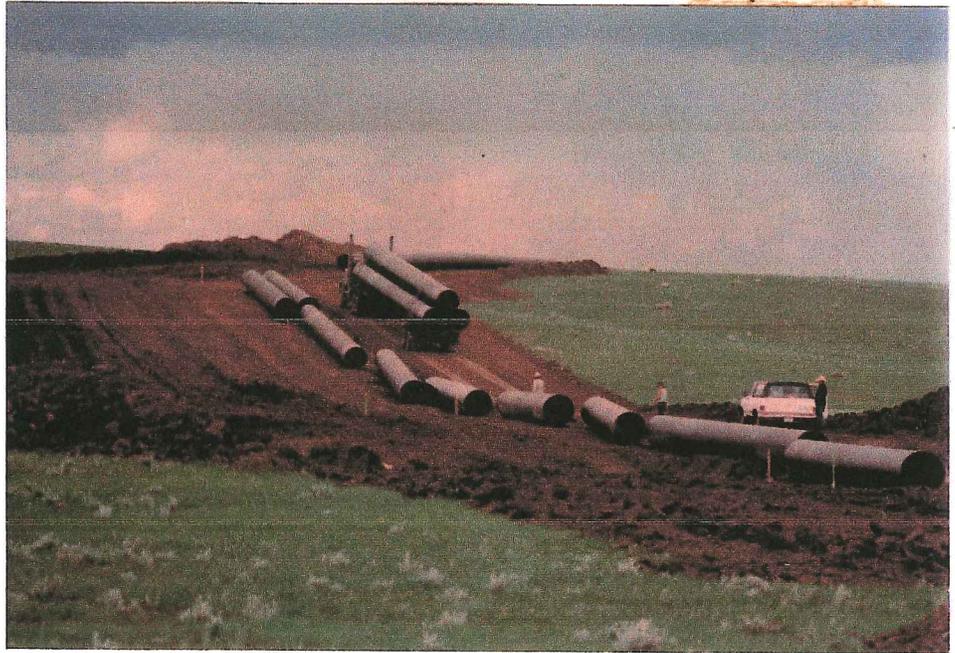
#7 Stringing pipe on r-o-w, which was used as road in many locations, after clearing was completed. Photo taken June 23.

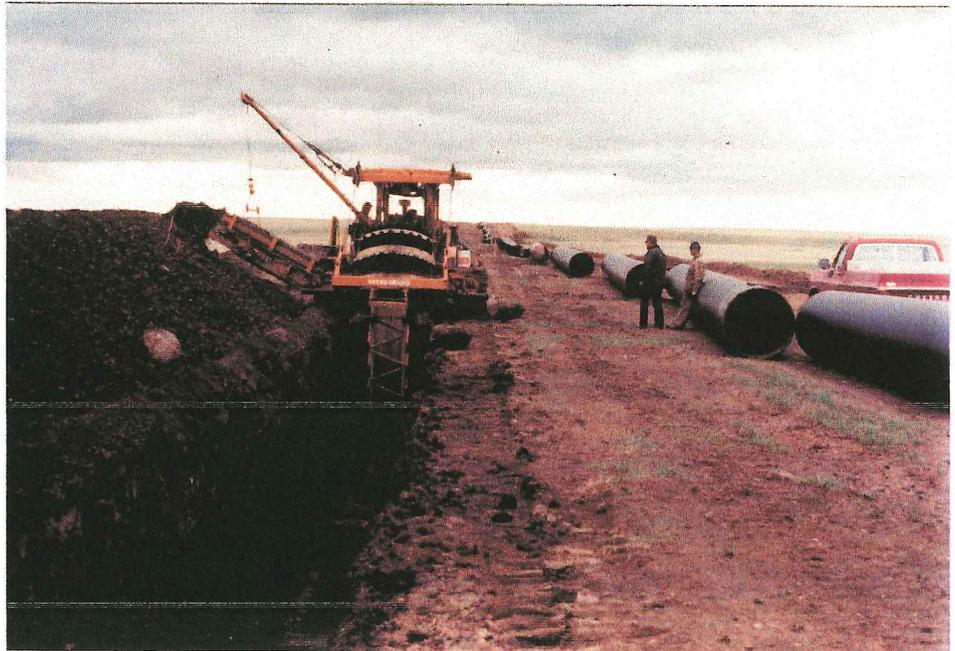
#8 Trenching on state parcel VA052 on July 16. Note the grass remaining on the work area. Terrain was flat and little side-hill cutting was required.

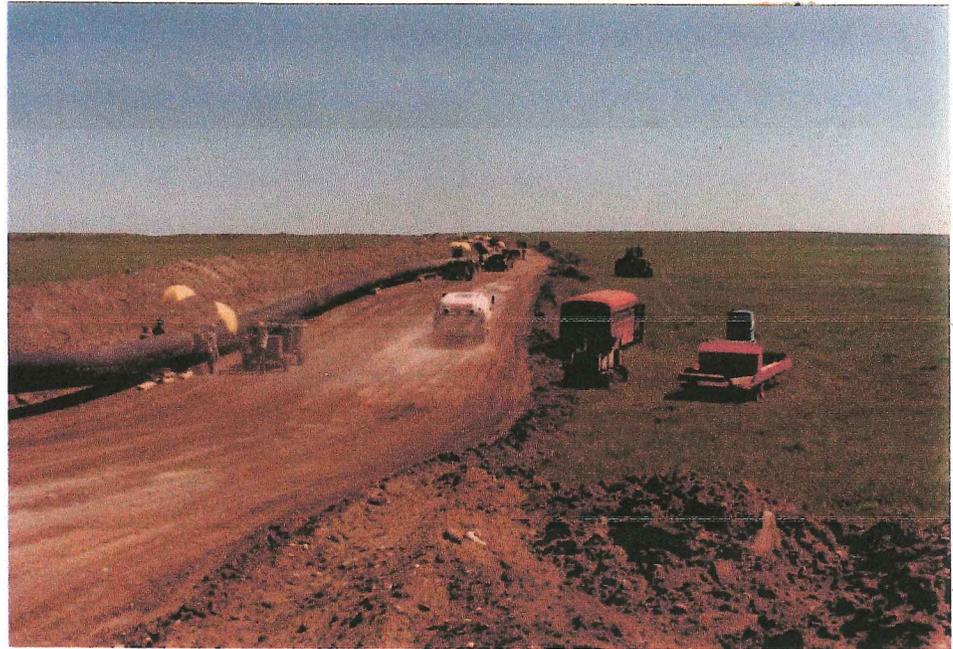
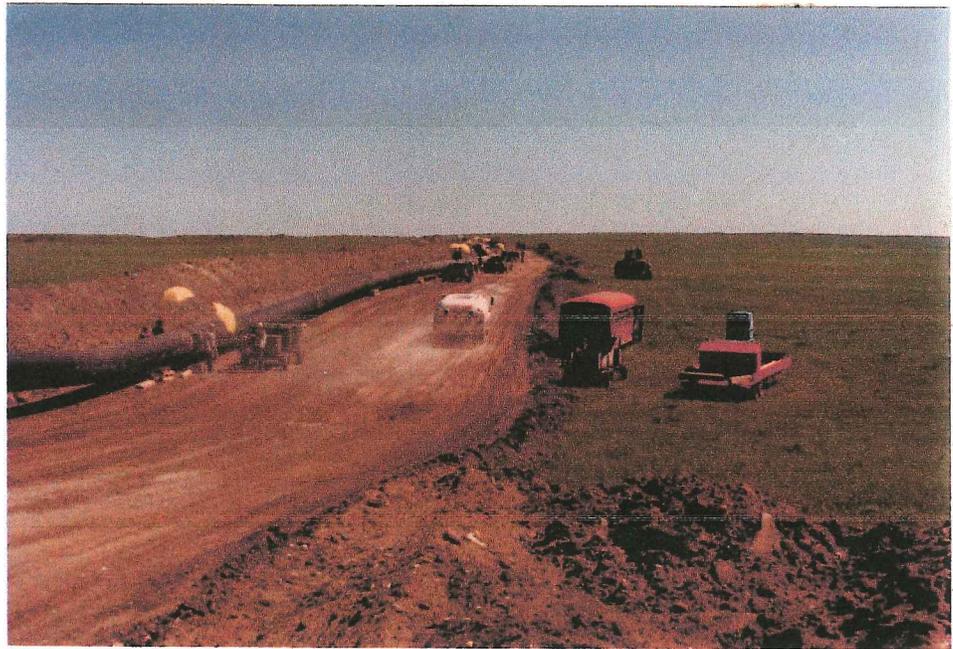
#11 Welding spread in Phillips County on state land parcel PH018 near Turkey Track Road. Photo taken June 25. Note the welding trailers at each weld. The farm tractor on the right side of the r-o-w was used to pull the trailer. The bus was used to bring pipeliners to work. It was about a 1.5 hour one-way trip to this work site from Glasgow.

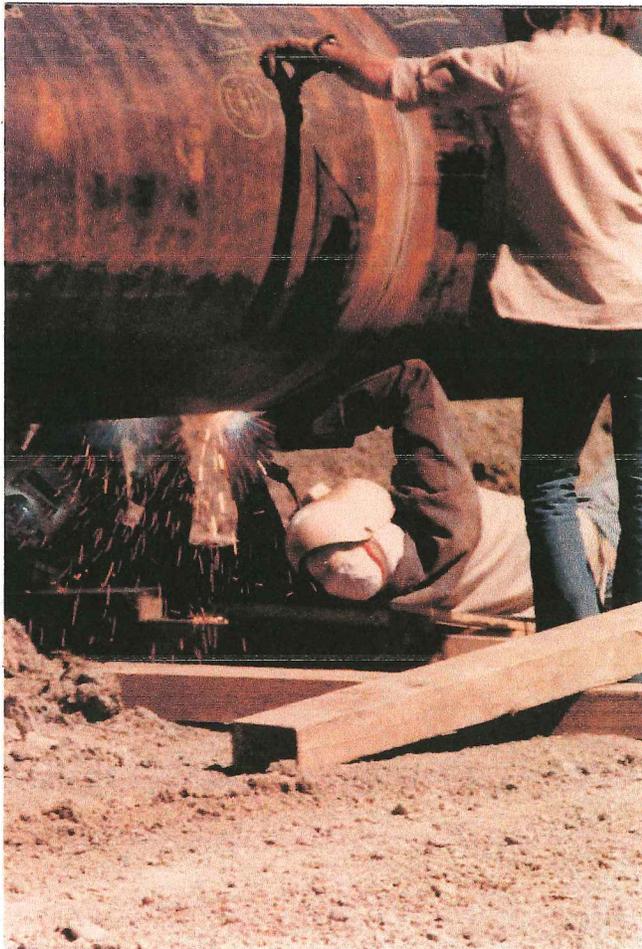
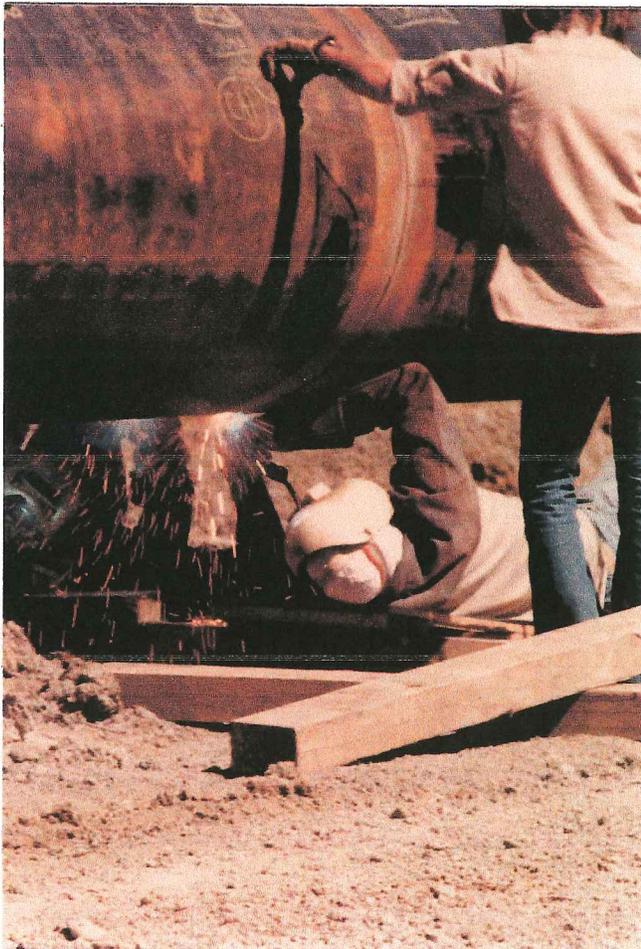
#12 Two welders joining 80-foot joints. Eleven welding passes were needed to join the .598 inch thickness pipe. Each weld was x-rayed for damage or faulty welds.

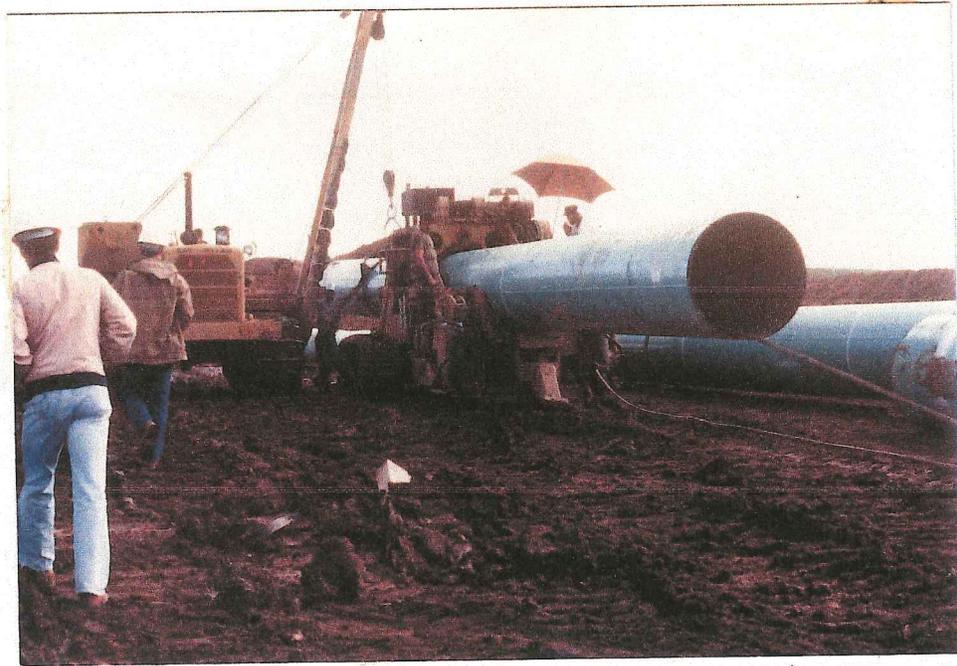
#9 Pipe joint in bending machine in Idaho on the Western Leg of the ANGTS. Similar machines were used in Montana. Pipe was coated with teflon, rather than tape, on the Western Leg. Pipe is bent to closely conform to terrain after it is strung out on the r-o-w.

#14 Taping machine. In operation, it is suspended by a side-boom tractor. Pipe was coated with Teflon on the Western Leg of ANGTS rather than being wrapped with tape (see photo #9).

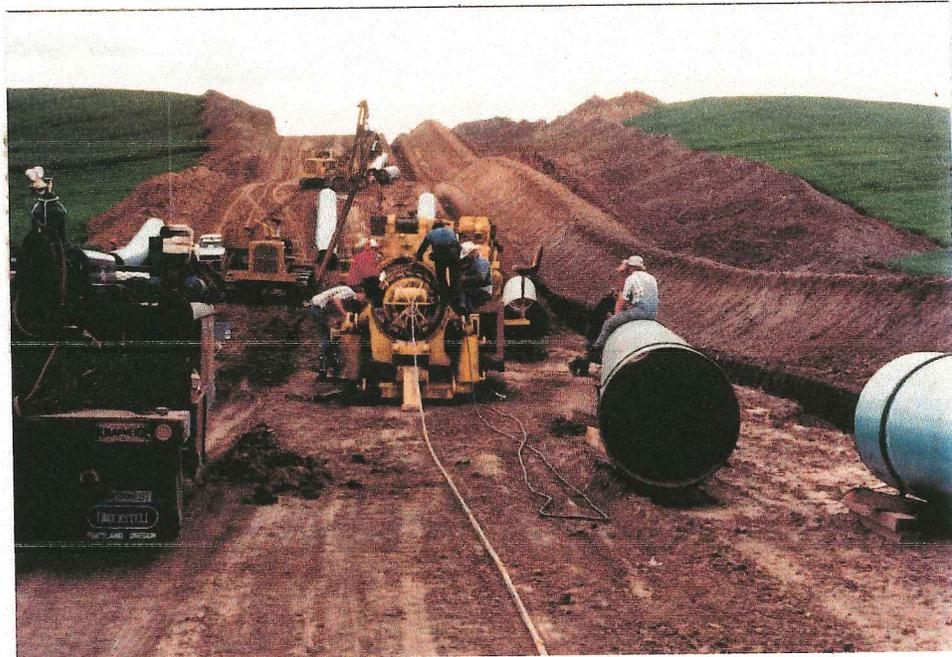
#10 Bending machine again in Idaho. Note the "pig" which is run into the pipe joint to prevent kinking during bending by applying hydraulic pressure against the inside of the pipe. Photo taken June 24, 1981.

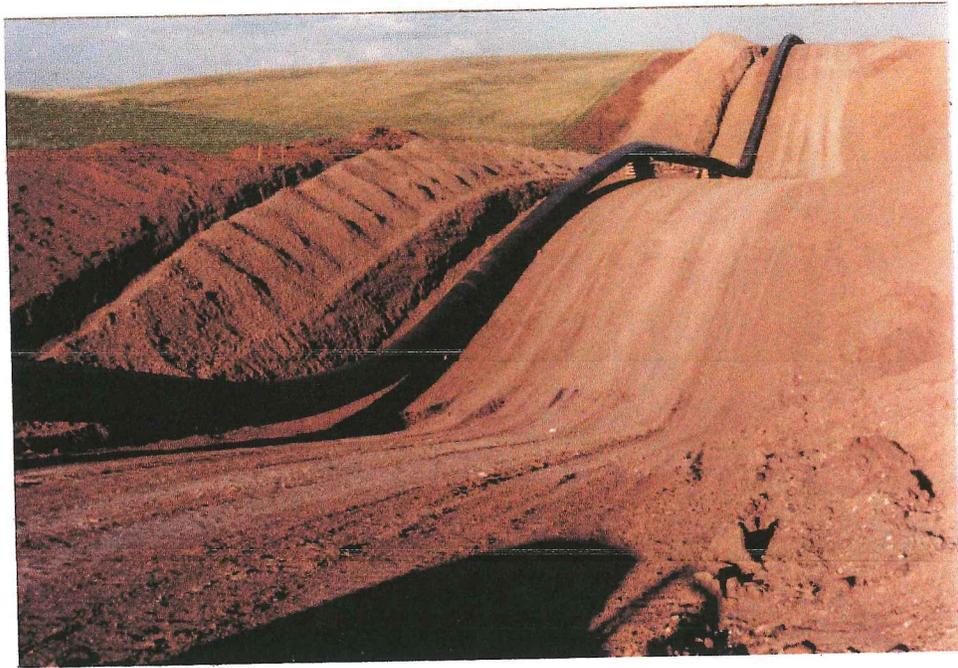
#13 Welding completed, and pipe ready for wrapping and lowering-in in Phillips County.

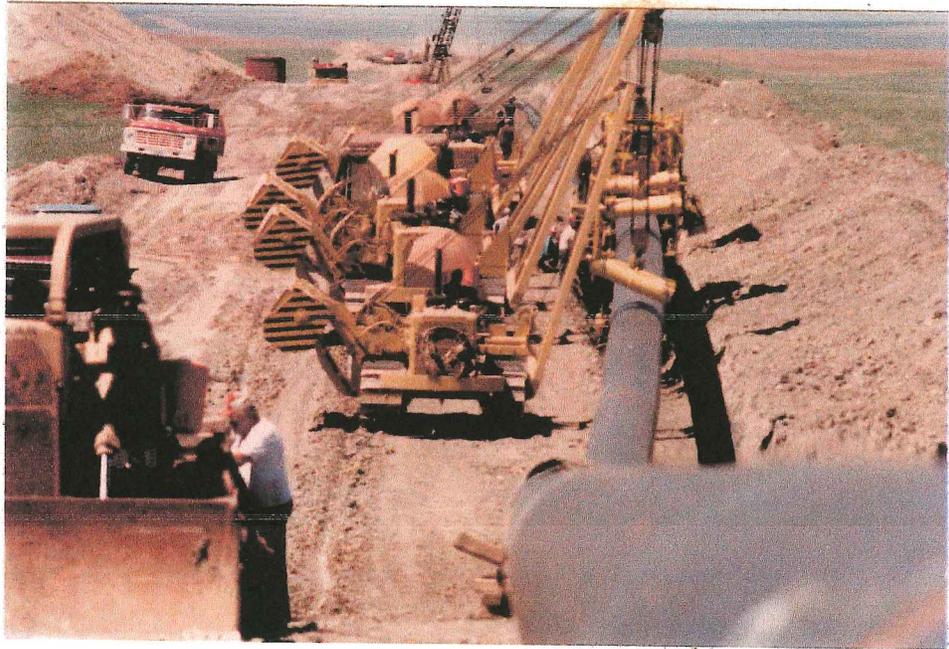
#15 Side-boom tractors lifting pipe and feeding it into the tape machine behind them. The tractors move slowly forward and the pipe is suspended on rollers. After wrapping, the pipe is lowered into the trench. The tractor in the foreground pulls a cart which carries hardwood blocks that prop up the welded pipe. This is state parcel PH012 on June 26.

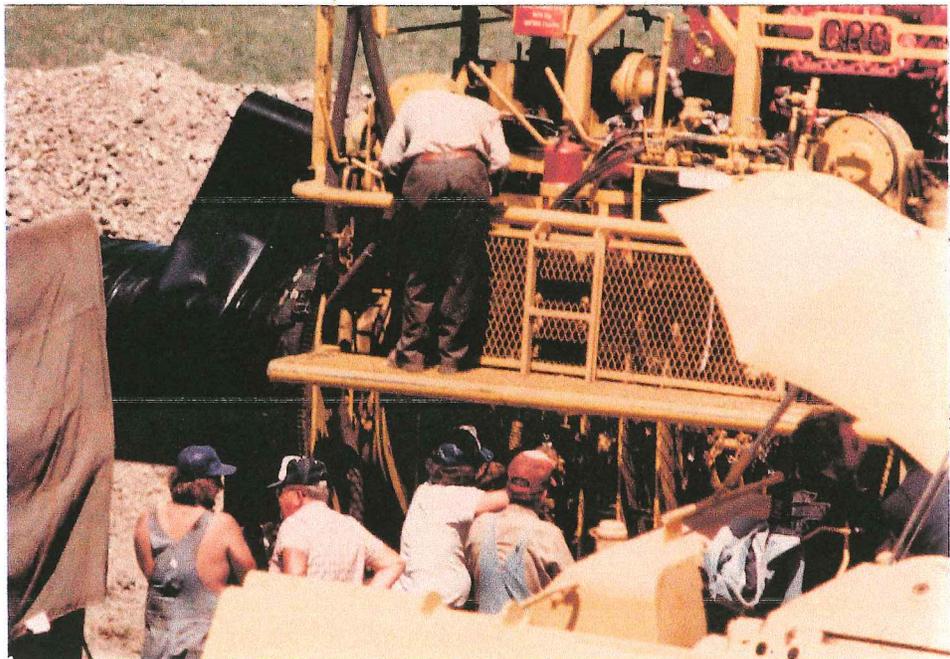
#16 Taping machine wrapping pipe with plastic tape to prevent corrosion. It was stalled at the time of the photograph.
