Natural Gas Pipeline and Partial Exemption Application

Faribault Energy Park, LLC
Minneapolis, MN

March 2004

Stanley Consultants INC.

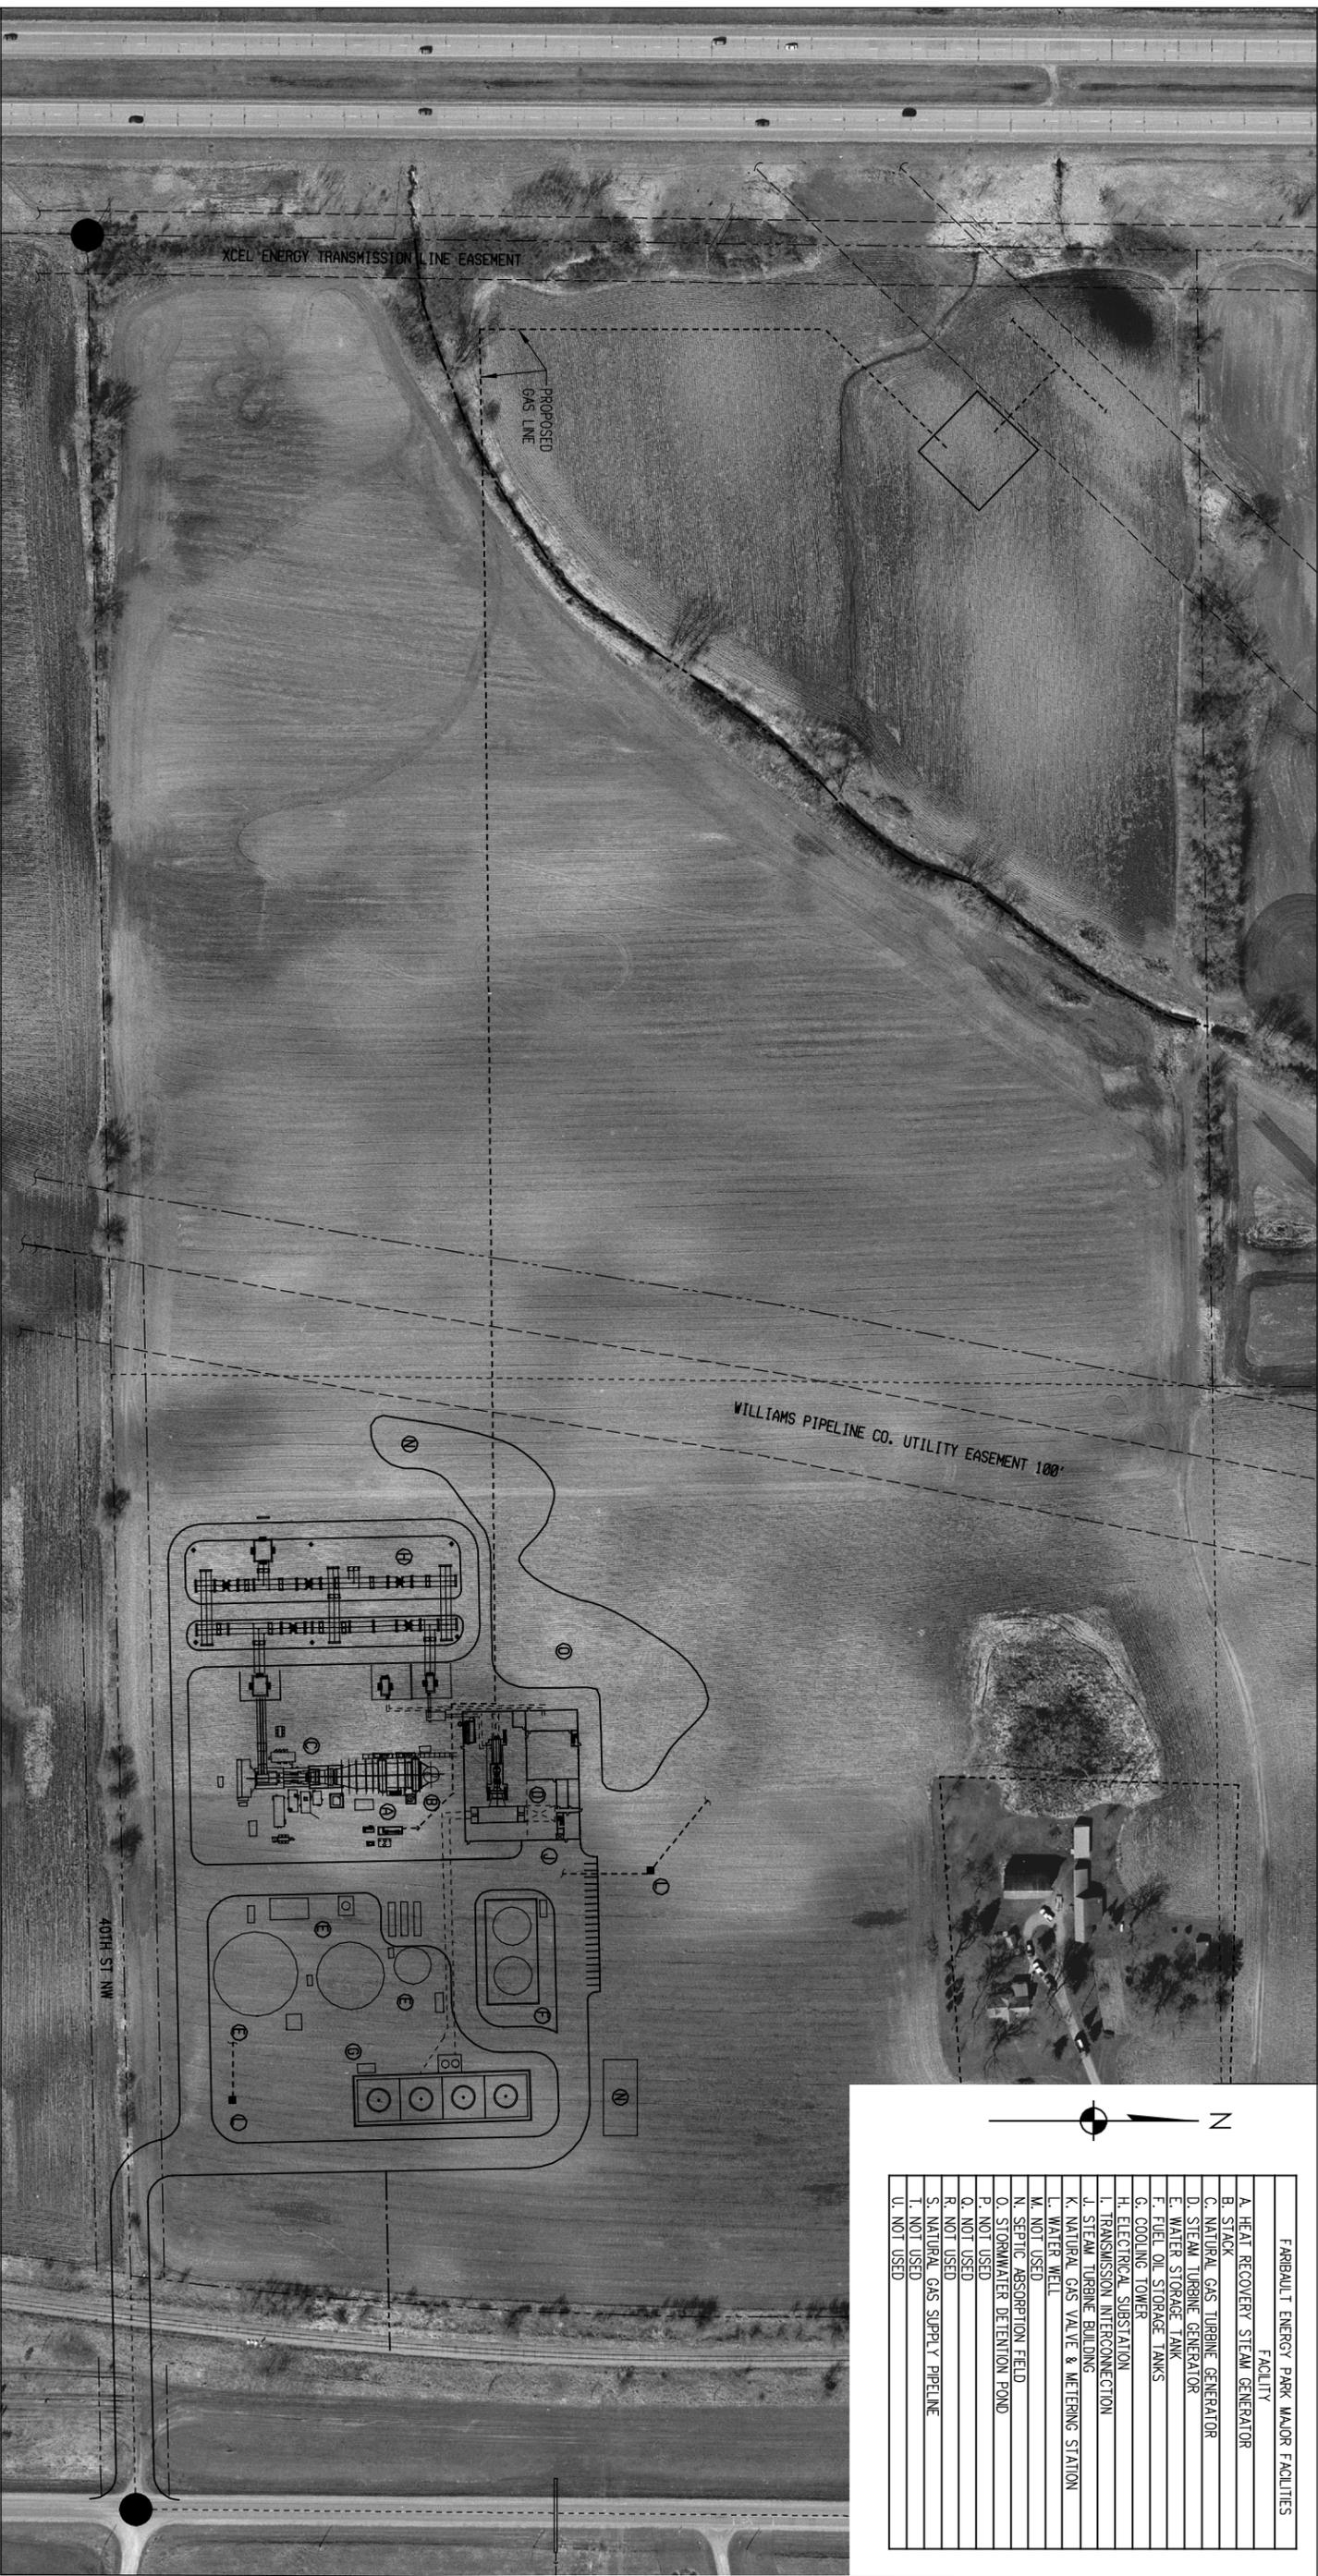
CONCEPT PLAN

FARBAULLT ENERGY PARK MAJOR FACILITIES FACILITY	
A.	HEAT RECOVERY STEAM GENERATOR
B.	STACK
C.	NATURAL GAS TURBINE GENERATOR
D.	STEAM TURBINE GENERATOR
E.	WATER STORAGE TANK
F.	FUEL OIL STORAGE TANKS
G.	COOLING TOWER
H.	ELECTRICAL SUBSTATION
I.	TRANSMISSION INTERCONNECTION
J.	STEAM TURBINE BUILDING
K.	NATURAL GAS VALVE & METERING STATION
L.	WATER WELL
M.	NOT USED
N.	SEPTIC ABSORPTION FIELD
O.	STORMWATER DETENTION POND
P.	NOT USED
Q.	NOT USED
R.	NOT USED
S.	NATURAL GAS SUPPLY PIPELINE
T.	NOT USED
U.	NOT USED

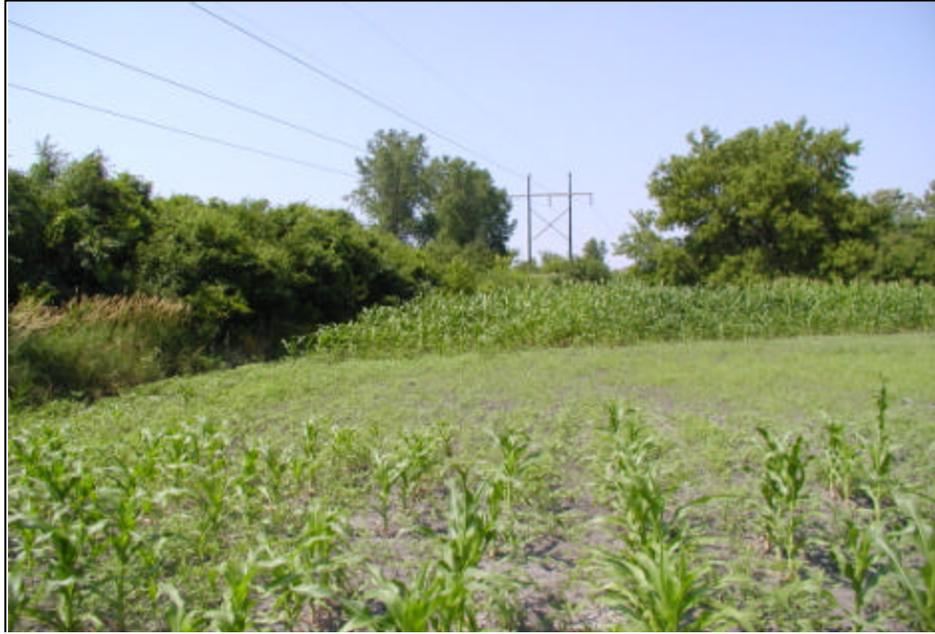
Photo 1: Looking north at Wetland A. I-35 right-of-way to left.

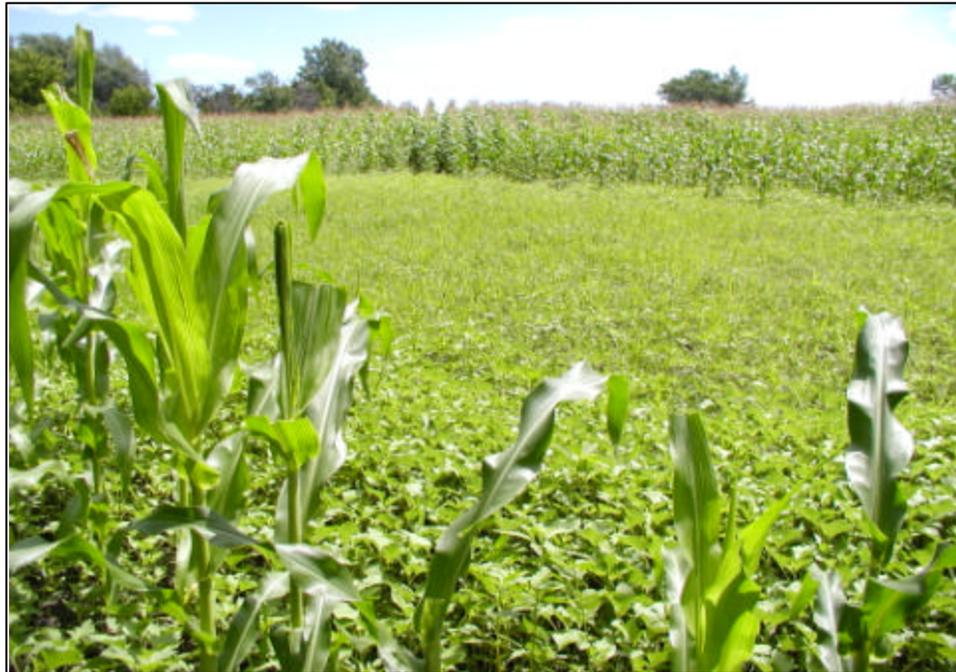
Photo 2: Looking east at Wetland A and location of Data Point Nos. A-1 and A-2.

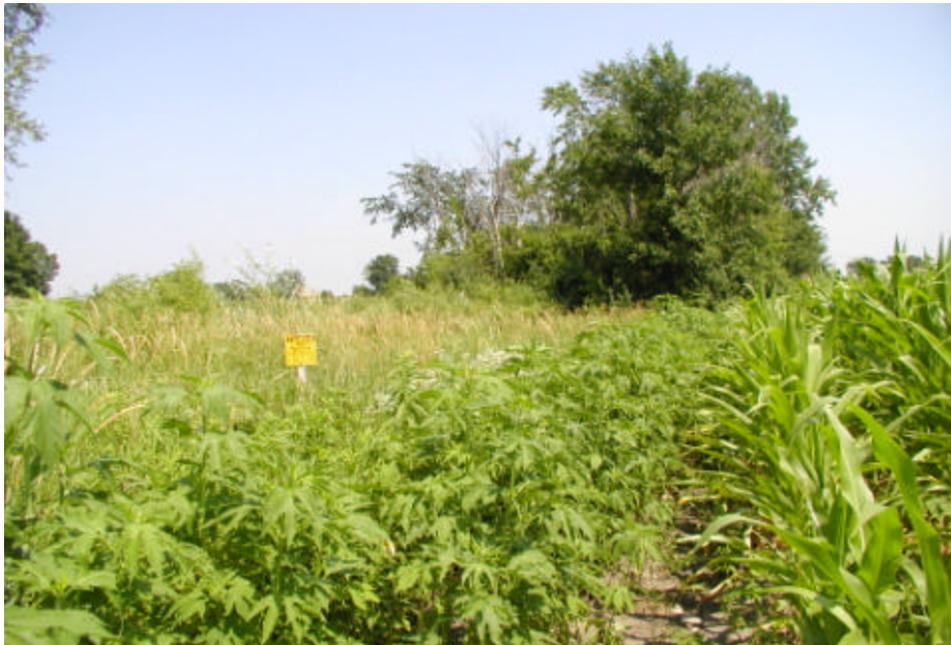
Photo 4: Looking northeast at Wetland B. Sign marks Enron gas pipeline crossing.

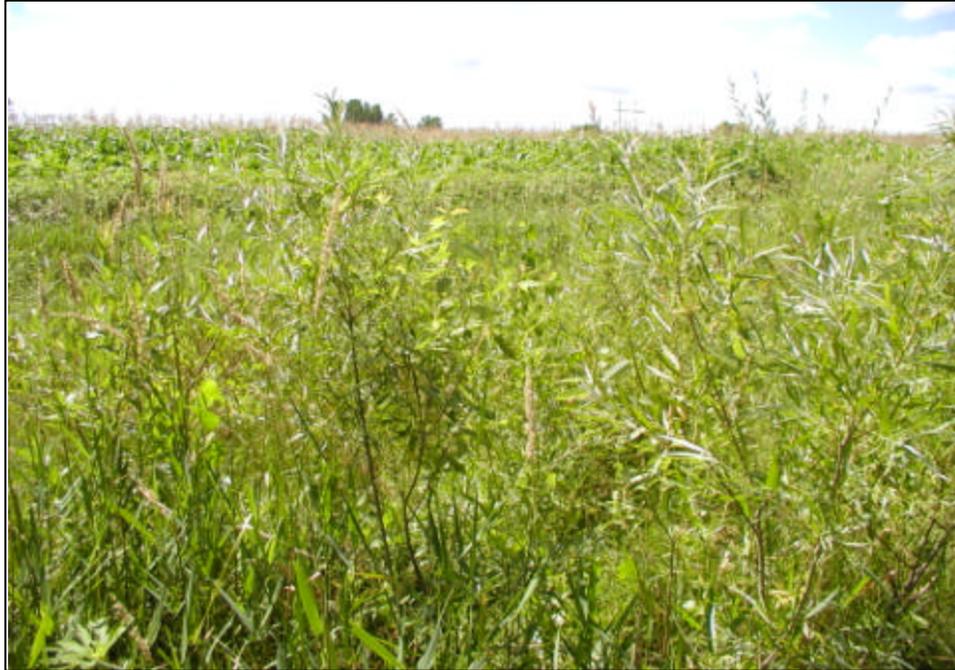
Photo 5: Looking south at Wetland B and at location of Data Point Nos. B-1 and B-2.

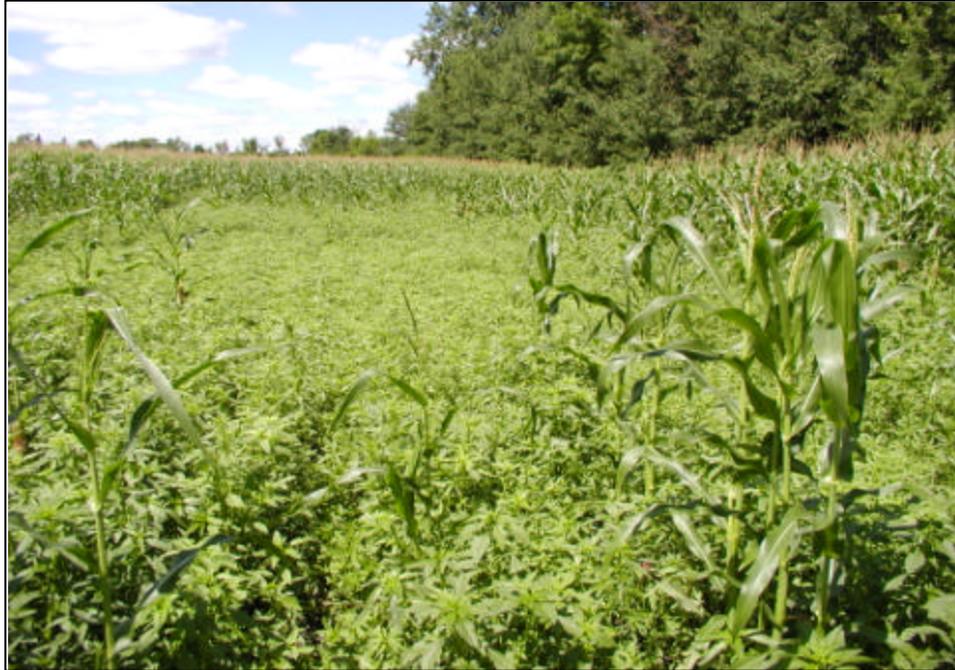
Photo 7: Looking west at Wetland C and at location of Data Point Nos. C-1 and C-2.

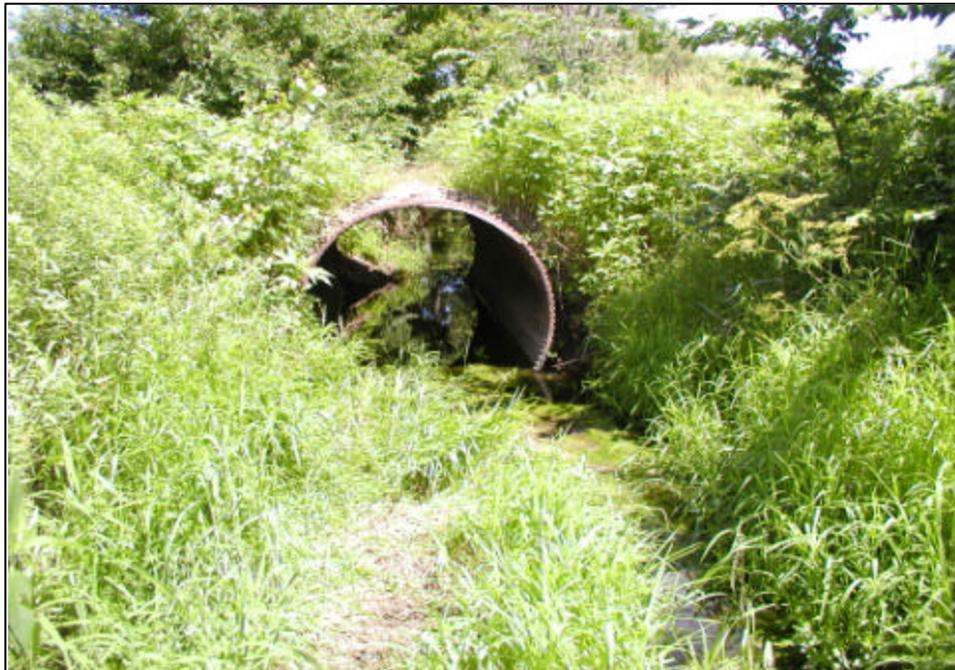
Photo 8: Looking north at culvert located on north end of Wetland D. Data Point No. D-1 taken at bottom of drainageway in foreground.

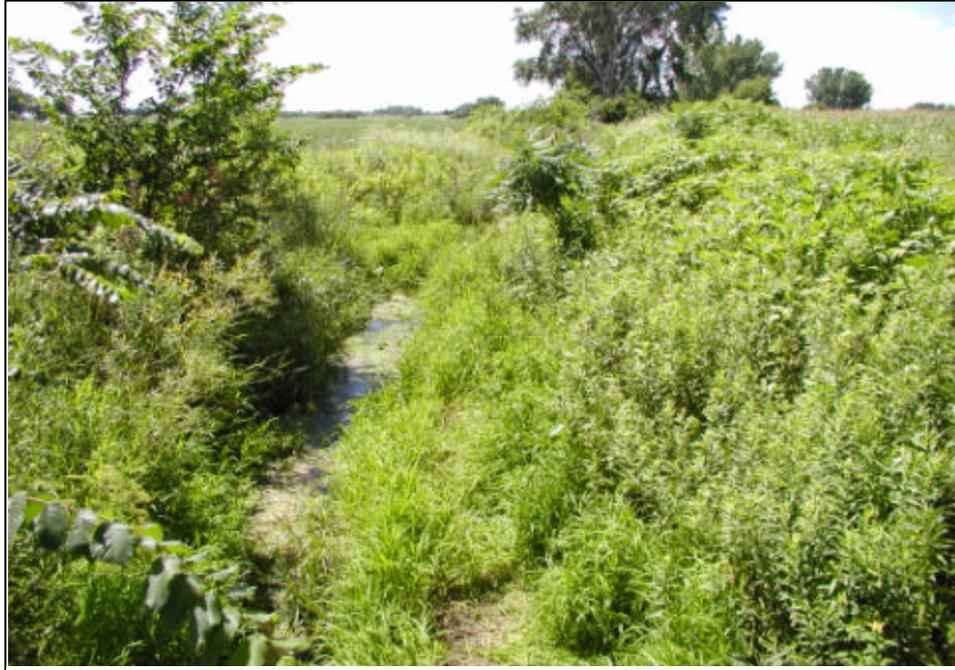
Photo 9: Looking south at Wetland D. Photo taken from south end of culvert. Note – soybean field to east and cornfield to west. Data Point No. D-2 taken at top of bank to west.
