Site-Level Guideline Monitoring

Timber Harvesting and Forest Management Guidelines on Public and Private Forest Land in Minnesota:

Monitoring for Implementation

2011 Monitoring Implementation Results
A report by the Minnesota Department of Natural Resources
Respectfully submitted to the Minnesota Forest Resources Council

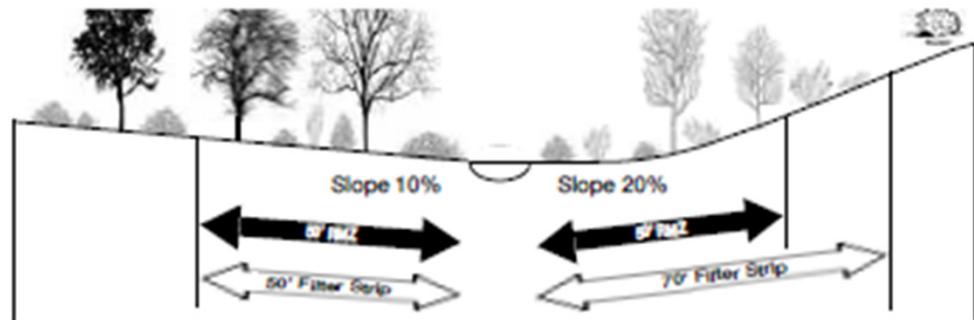
Schematic showing the distinction between RMZs and filter strips. The width of the filter strip and RMZ if present may be the same or different depending on slope and water feature type.

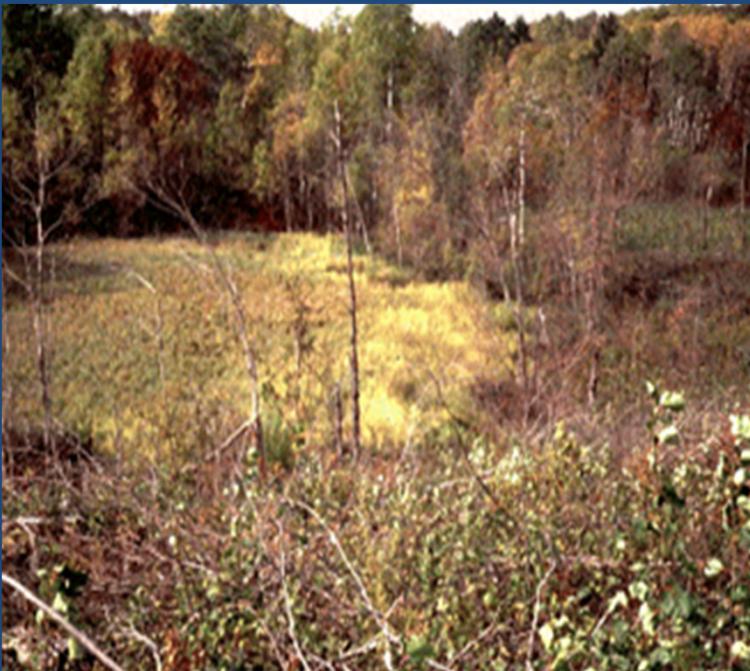
Apply filter strips to all perennial and intermittent streams, lakes, open water wetlands, non-open water wetlands, seasonal ponds, seeps, and springs.

- Minimum filter strip width is 50 feet for slopes less than 10%. Increase the width by 2 feet for each slope percent above 10%.
- Limit soil disturbance in the strip to less than 5% of the area and do not concentrate at any one location.
- Minimize compaction in all filter strips.
- Avoid placing roads, skid trails, and landings in filter strips.

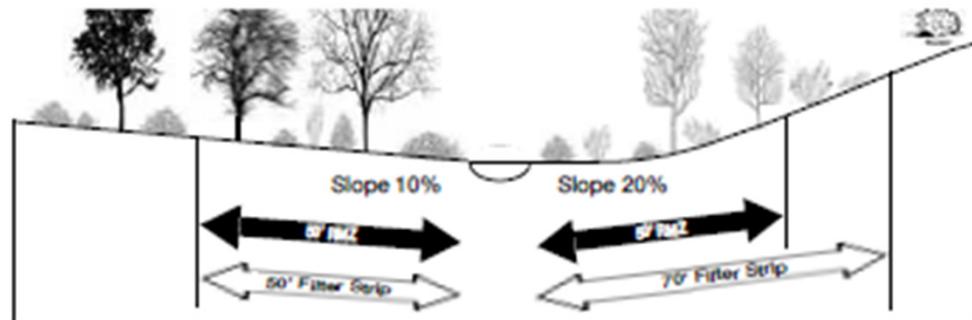
Schematic showing the distinction between RMZs and filter strips. The width of the filter strip and RMZ if present may be the same or different depending on slope and water feature type.

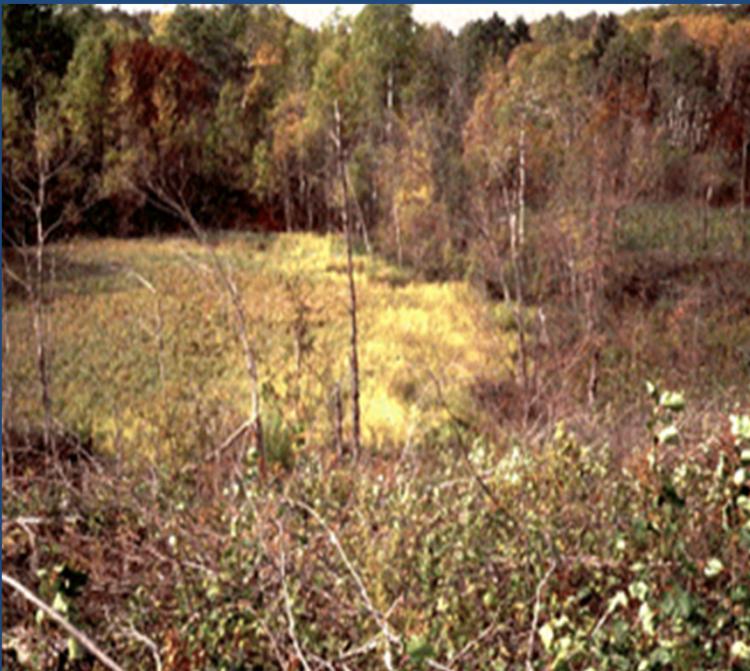
Apply filter strips to all perennial and intermittent streams, lakes, open water wetlands, non-open water wetlands, seasonal ponds, seeps, and springs.

- Minimum filter strip width is 50 feet for slopes less than 10%. Increase the width by 2 feet for each slope percent above 10%.
- Limit soil disturbance in the strip to less than 5% of the area and do not concentrate at any one location.
- Minimize compaction in all filter strips.
- Avoid placing roads, skid trails, and landings in filter strips.

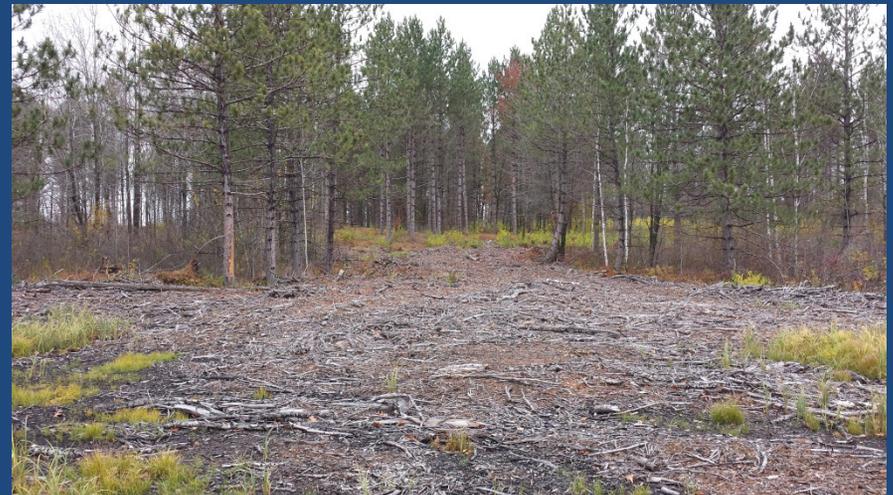
Non- Compliant Filter Strips

- Landing within filter strip (where alternative available) 21
 - 11 in MH
 - 7 in SUP N&S
 - 2 within RR
- Roads within filter strip (not crossings) 8
- Rutting within filter strip..... 8
- Skid trail with exposed soil..... 1

- Refers to only 8% of sites

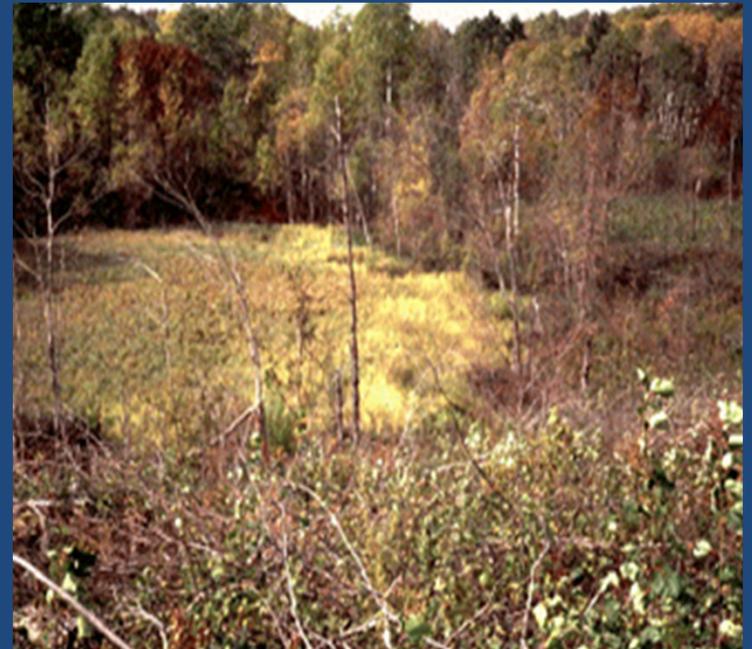
Filter Strip Effectiveness

- **100%** of filter strips showed no evidence of erosion (94% in 2011) 👍
- **100%** no evidence of sediment reaching a wetland or waterbody (98% in 2011) 👍

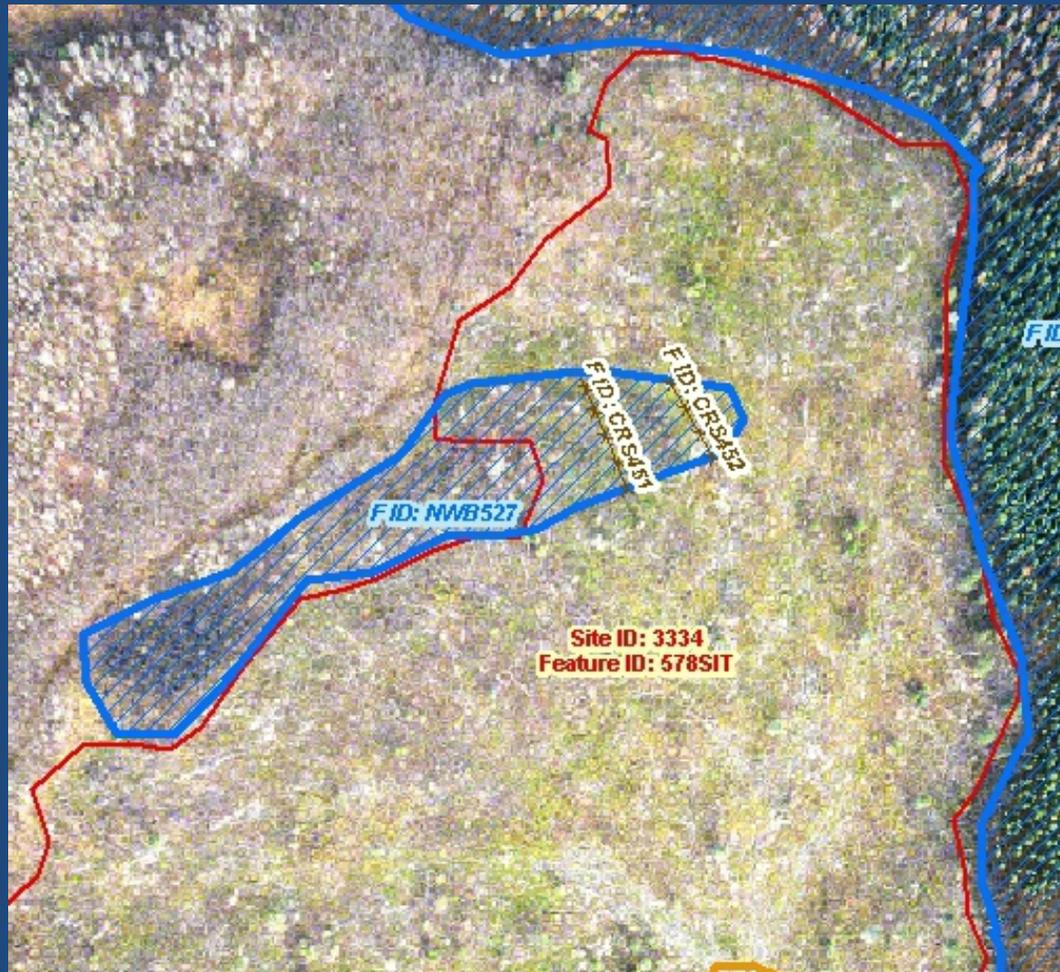
Example of “clipping the corner” of a wetland as well as “two crossings close together”

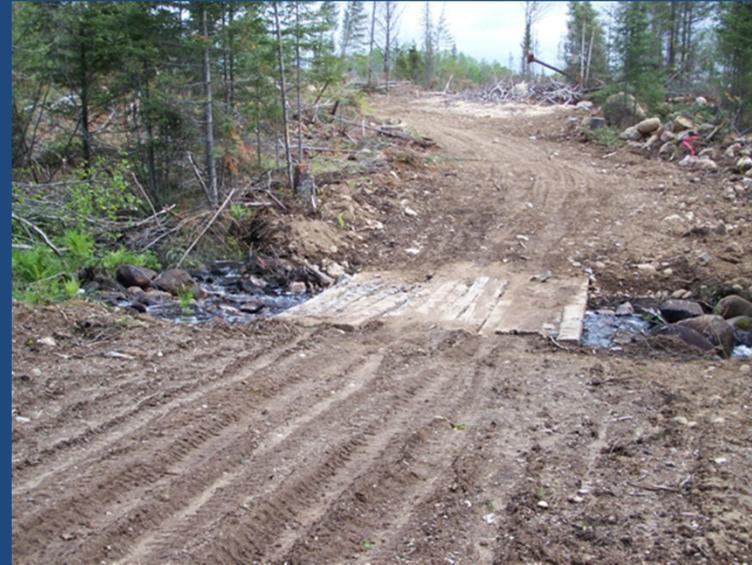
Approaches - Effectiveness

- Only 20 of 472 Approaches had erosion occurring

- **By watershed:**
 - **MH:** 8 Approaches sediment reaching wetland
 - **SUP N&S:** 5 had sediment reaching wetland
 - **RR:** No erosion visible on approaches

- Redistribute tops and finer slash to approaches as operation progresses
- Monitor presence of bare soil on approaches and segments
- Install water diversion on all approaches especially those with bare soils
- Ensure that erosion control is sufficient to sustain through spring runoff and heavy summer rains
