# Flute Reed River Watershed Restoration Projects

MINNESOTA FOREST RESOURCES COUNCIL

September 17, 2014

# Great Lakes Restoration Grant:

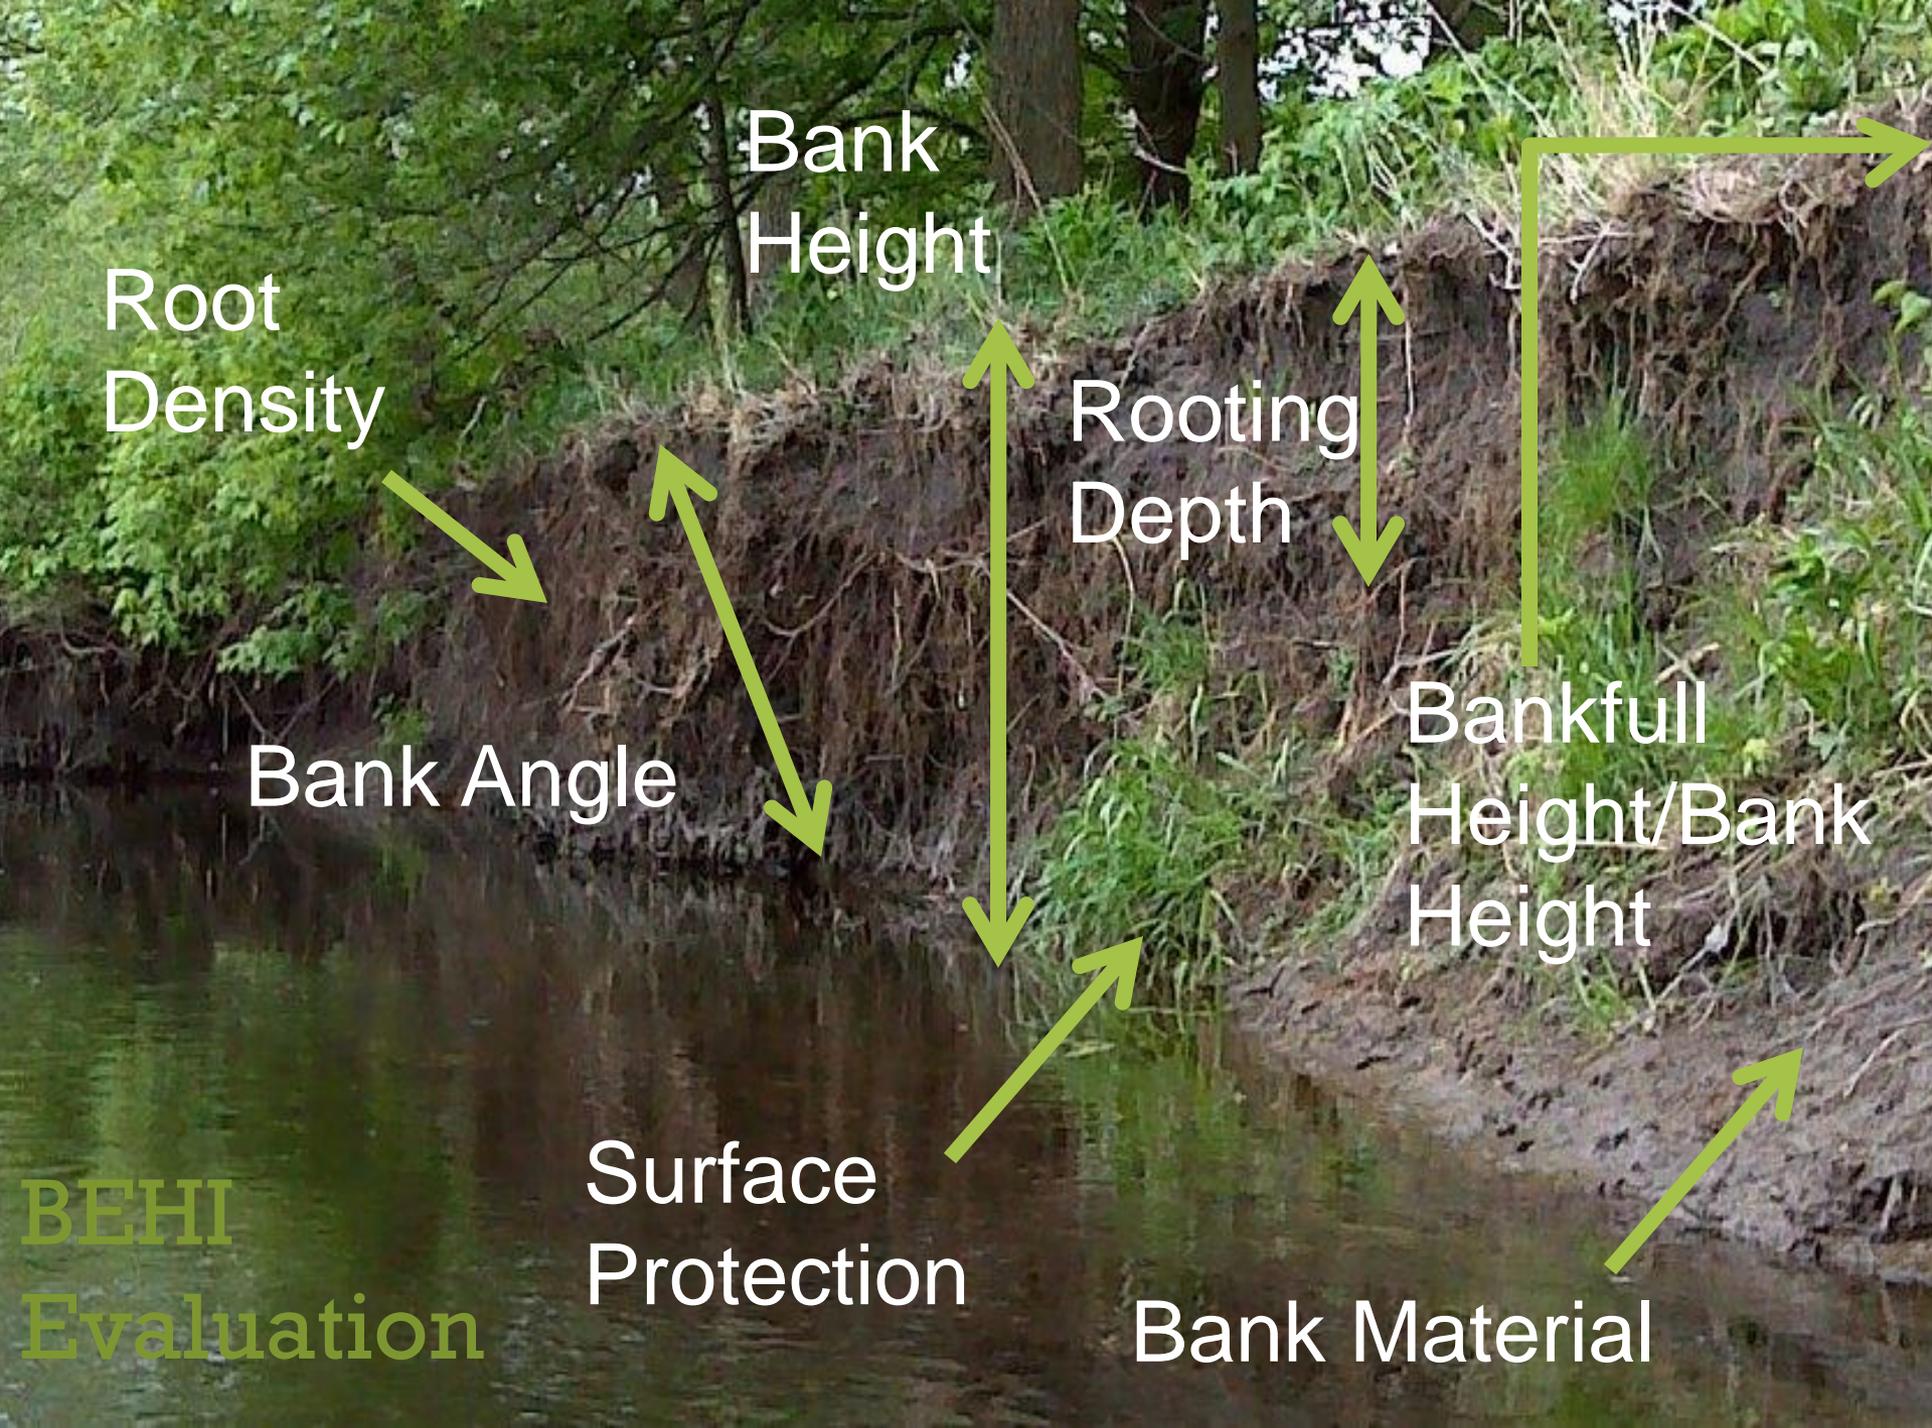
BEHI Evaluation

Bank Height

Root Density

Rooting Depth

Bank Angle

Bankfull Height/Bank Height

Surface Protection

Bank Material

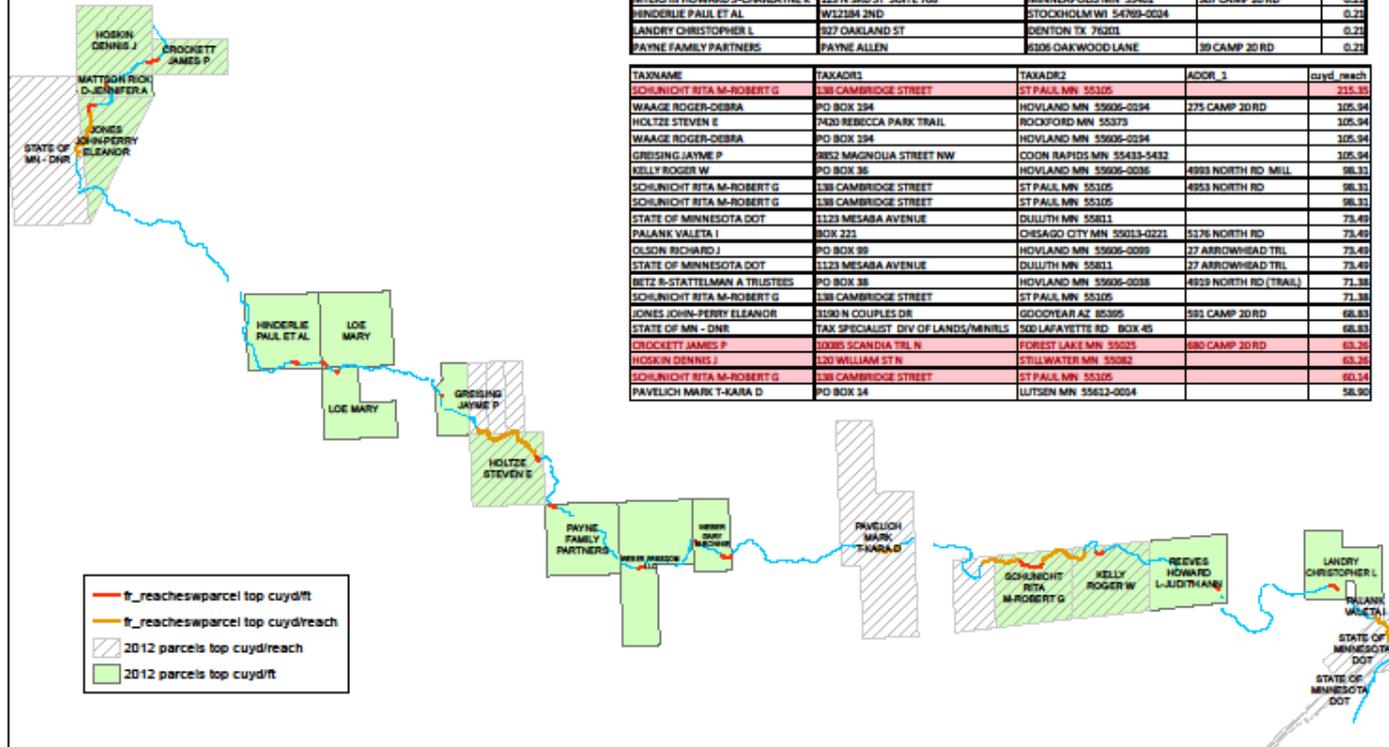
# Top Reaches With Parcels

## Flute Reed Project Ranking Top 20 Stream Reaches by cu yd/ reach and cu yd/ foot

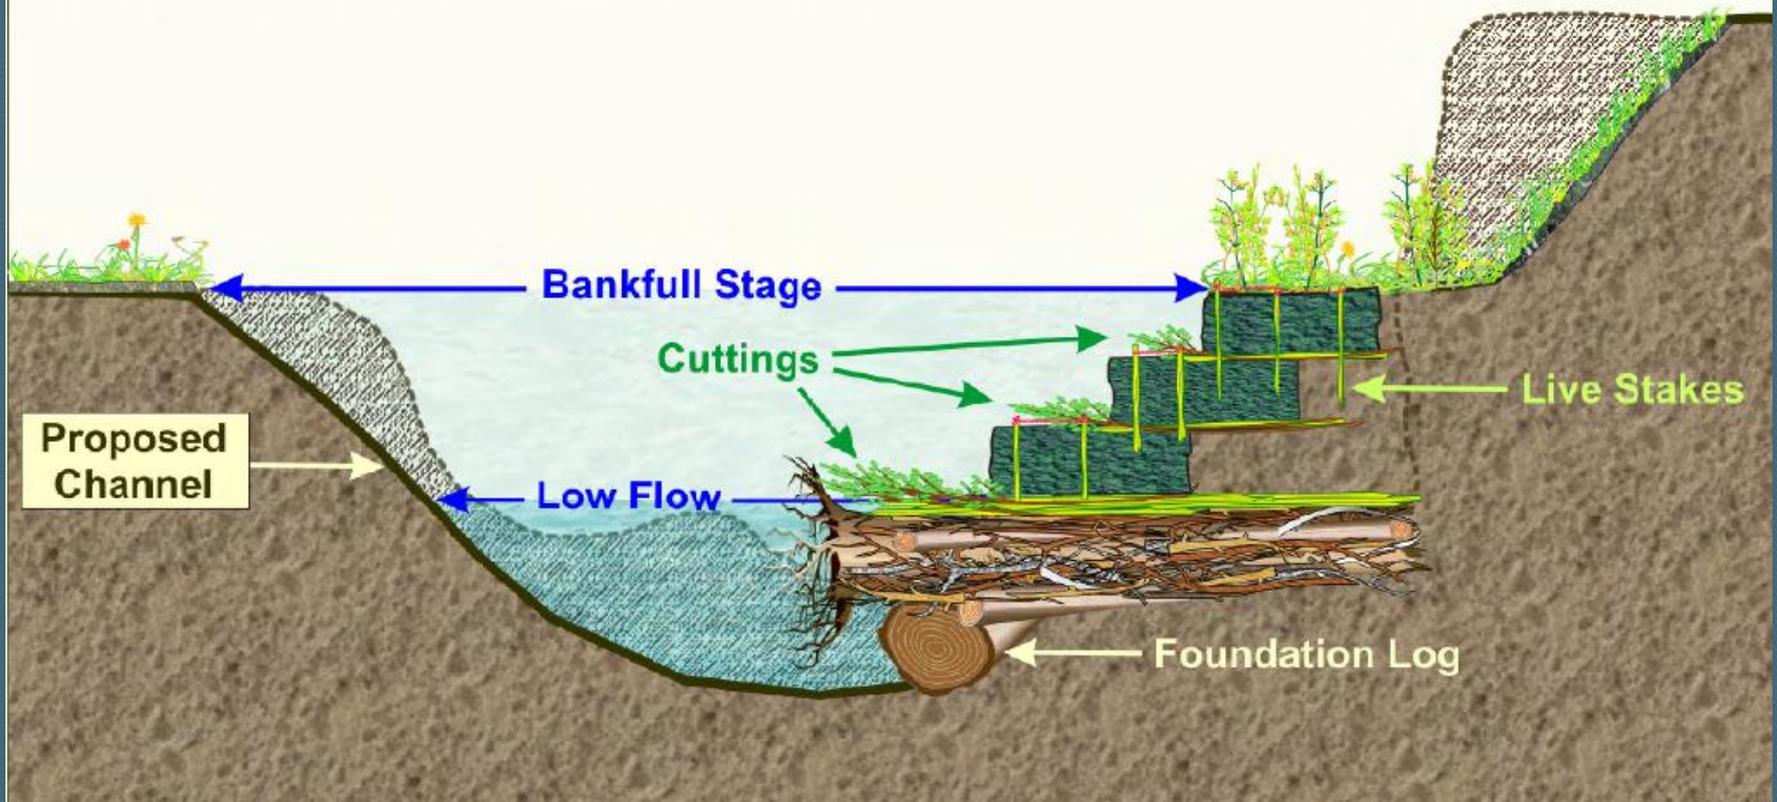
# Toe Wood Technique

## Sod Mats with Live Staking Option

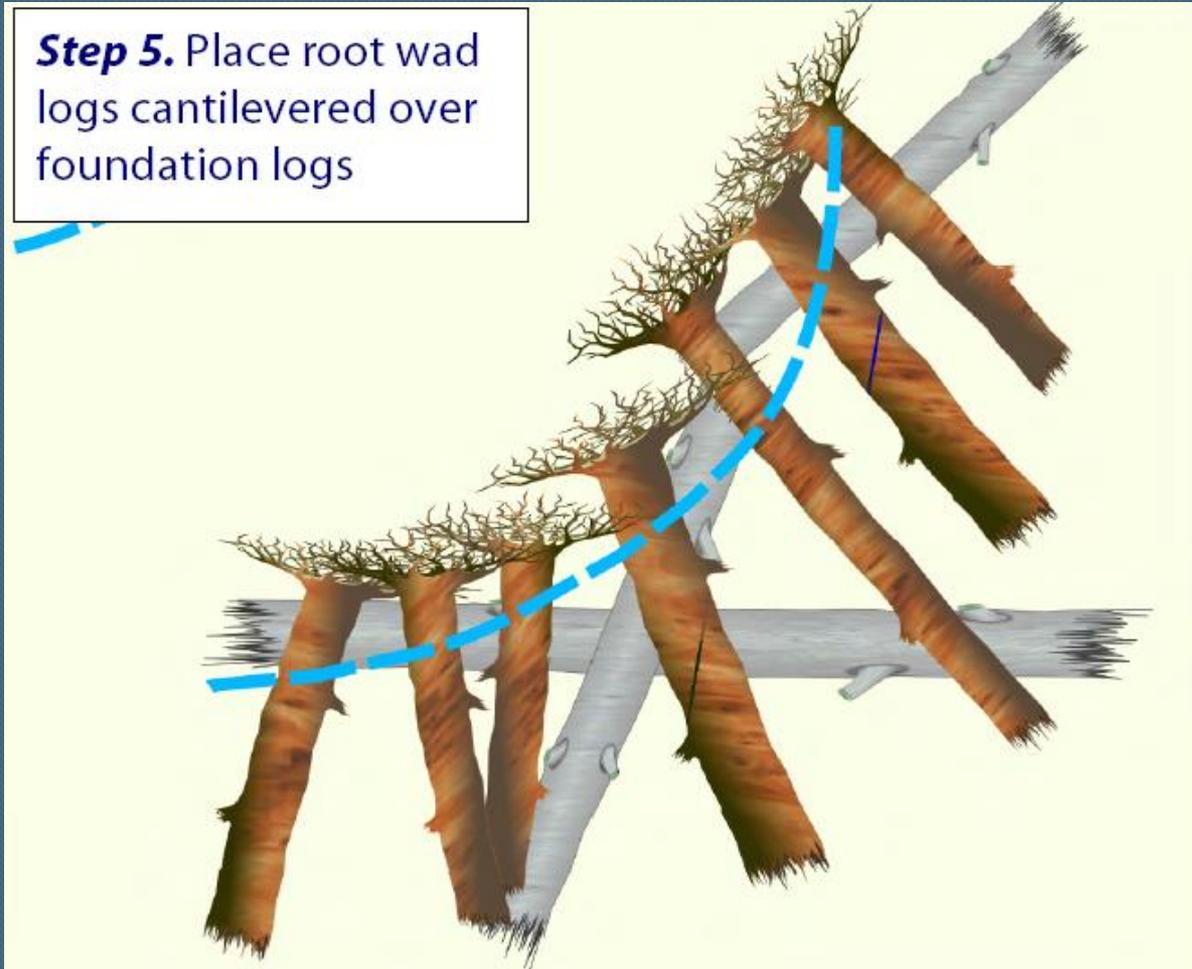
# Toe Wood Technique

**Step 5.** Place root wad logs cantilevered over foundation logs

Drawing courtesy Dave Rosgen

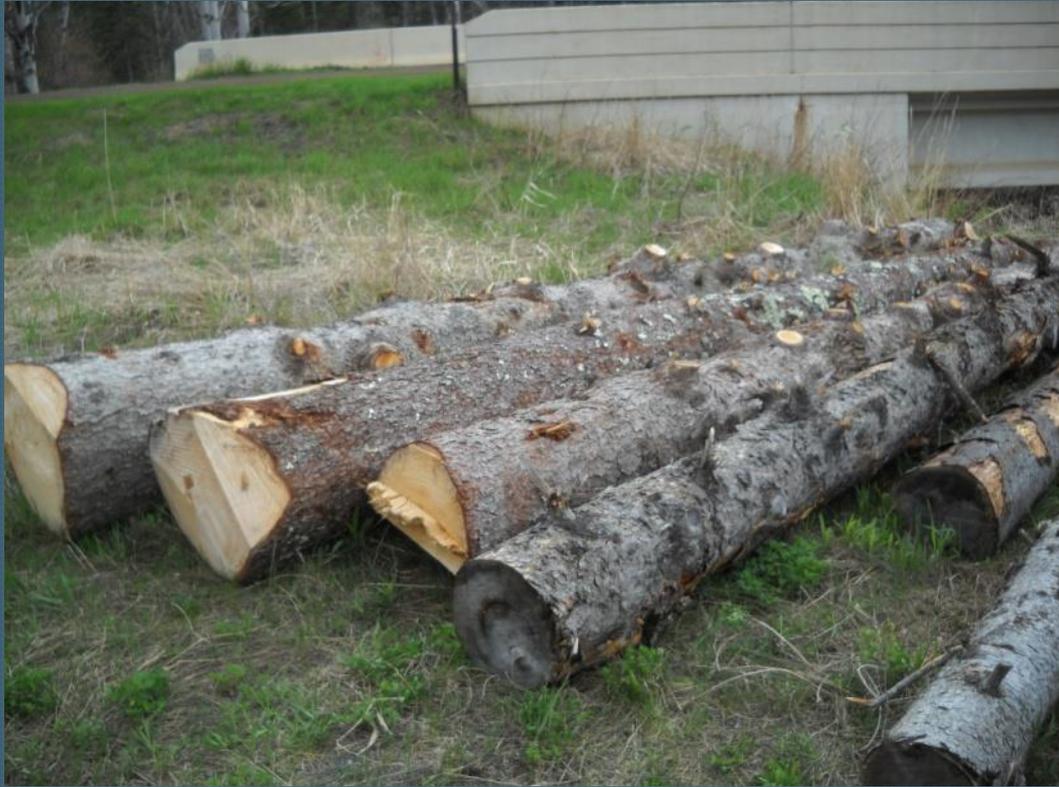
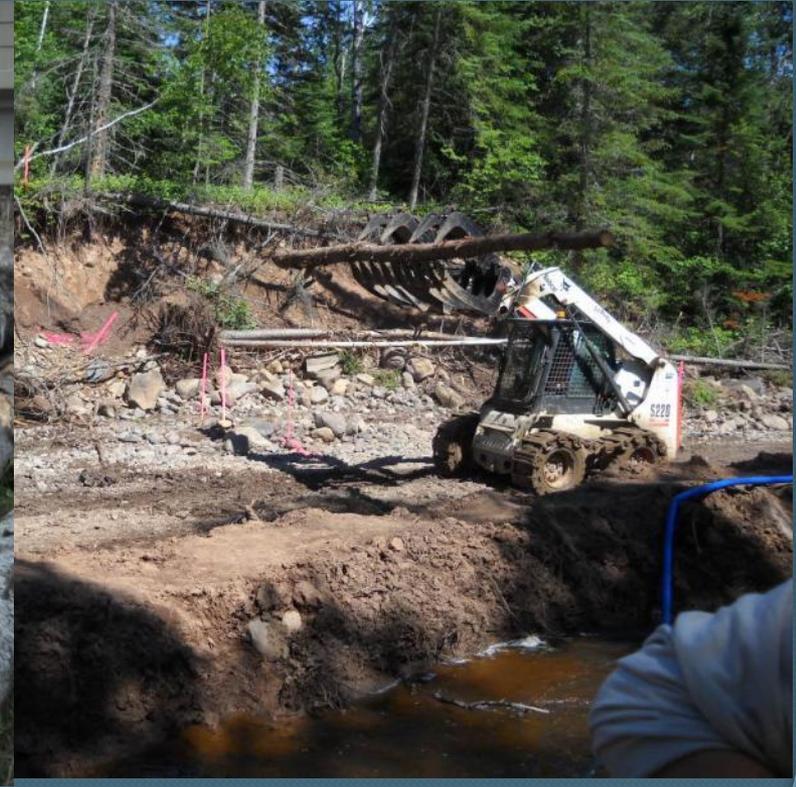
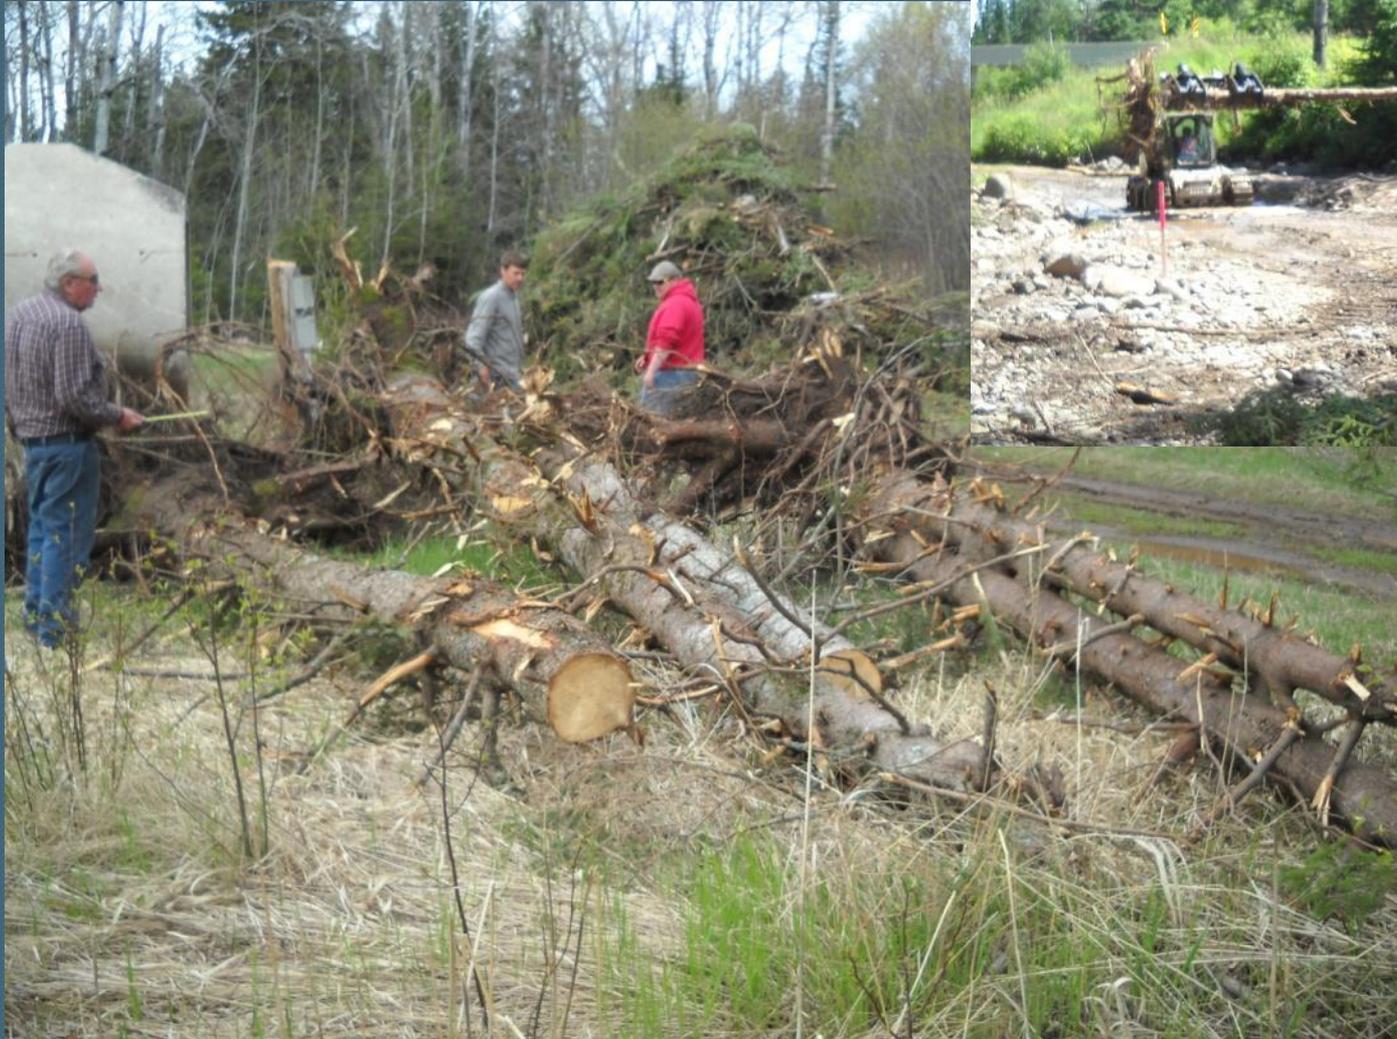
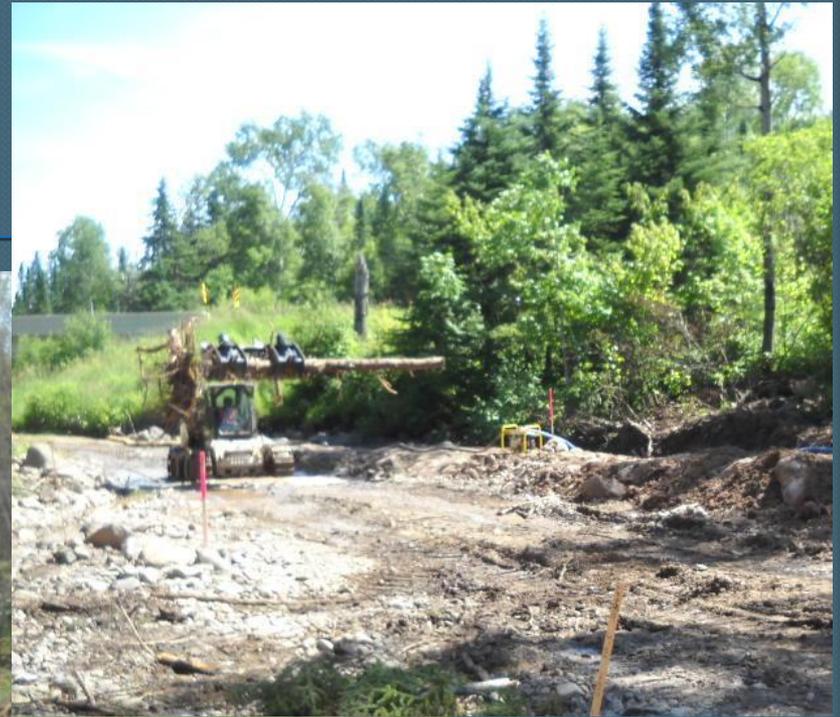
# Footer Logs

- Footer logs and root wads were pine, spruce, or other coniferous species.
- Footer Logs - 8' long and 12" diameter.
- Root Wad Logs - The root wads were harvested by carefully excavating around the roots of the tree and by pushing the tree over to expose the root wad. A minimum trunk diameter at breast height was 12" and the minimum height is 15'.

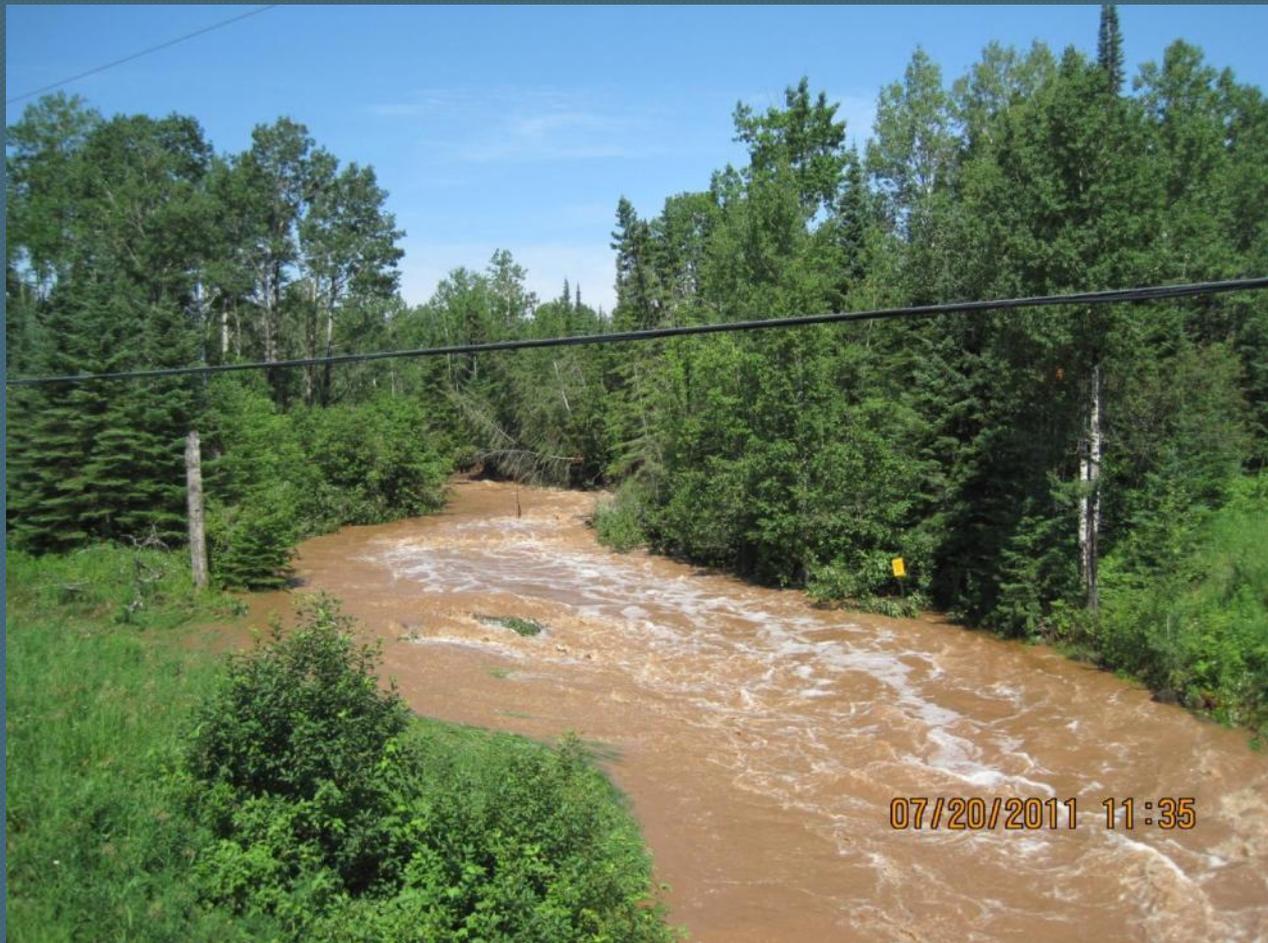
## North Road Bridge Site

Before

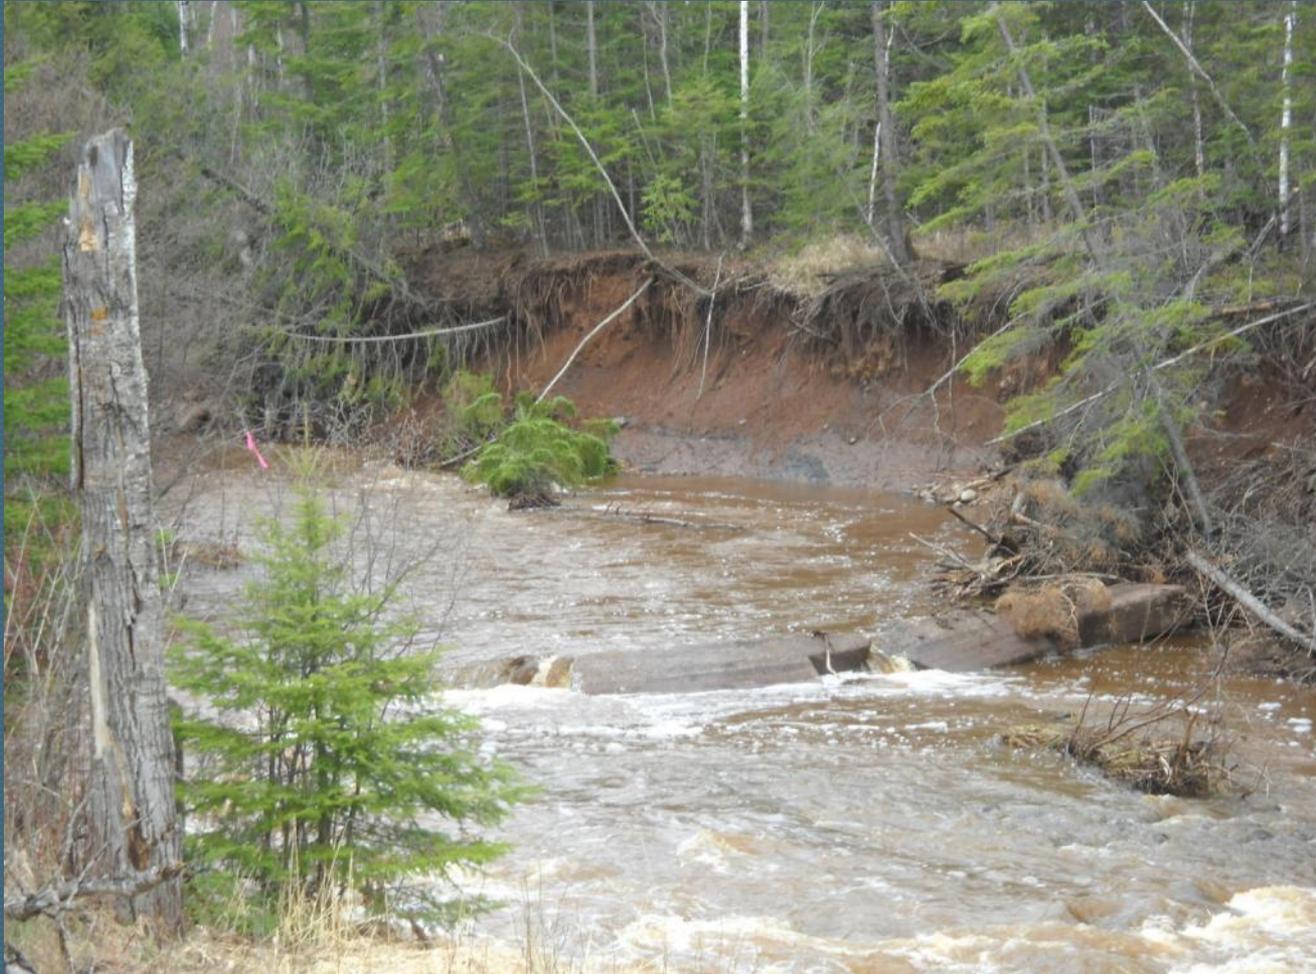
North Road Bridge Site

Before

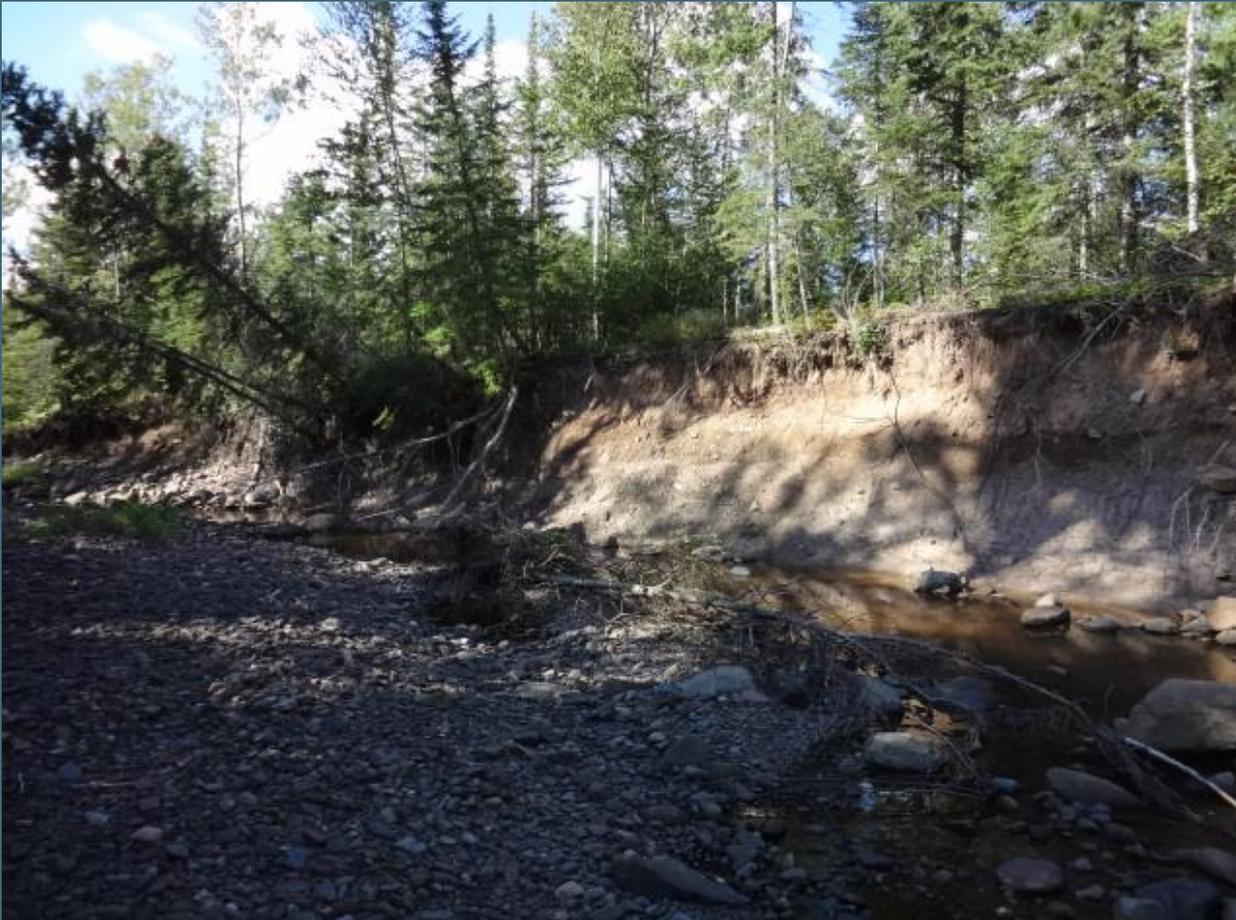
North Road Bridge Site

Before

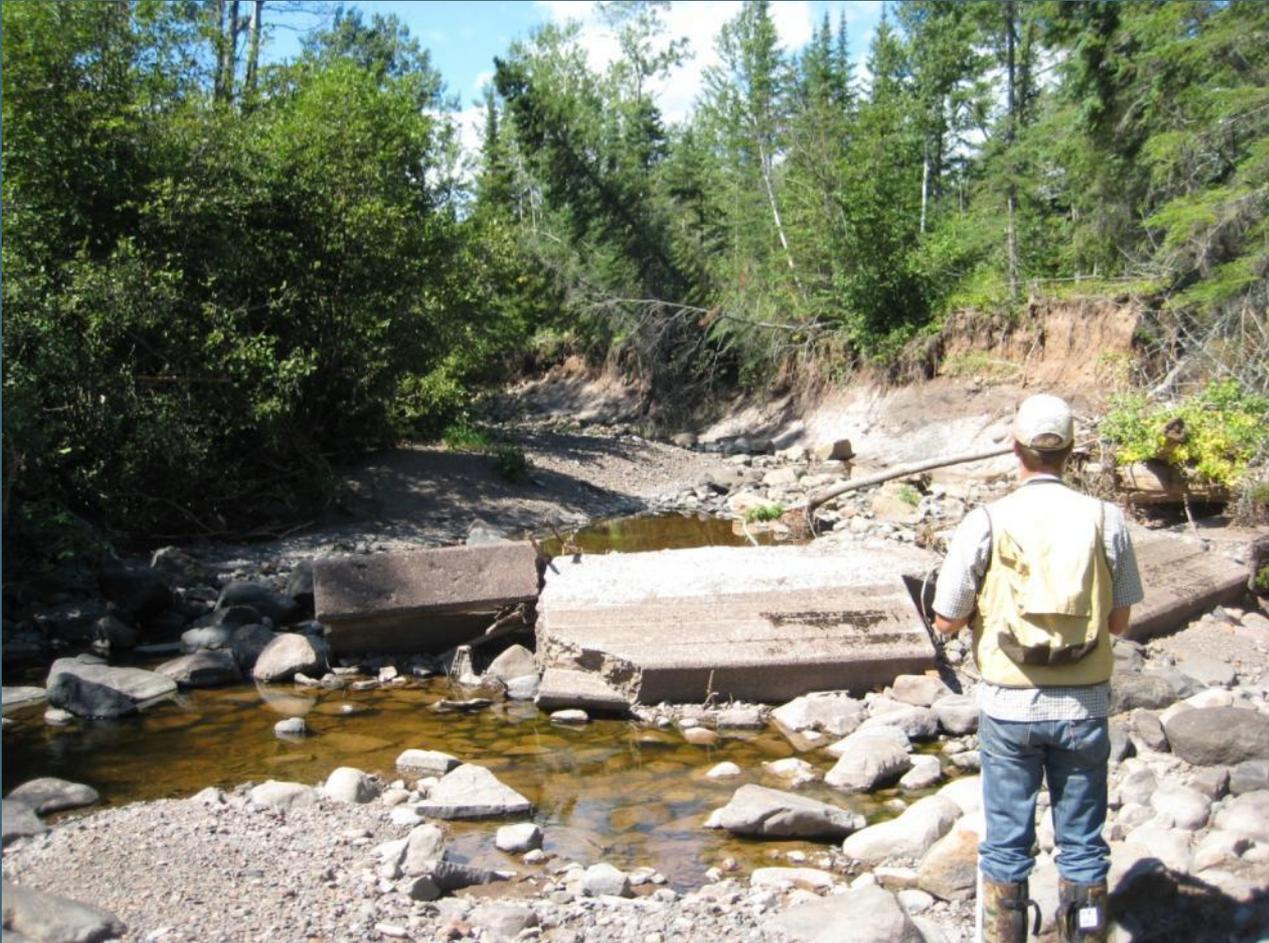
## North Road Bridge Site

Before

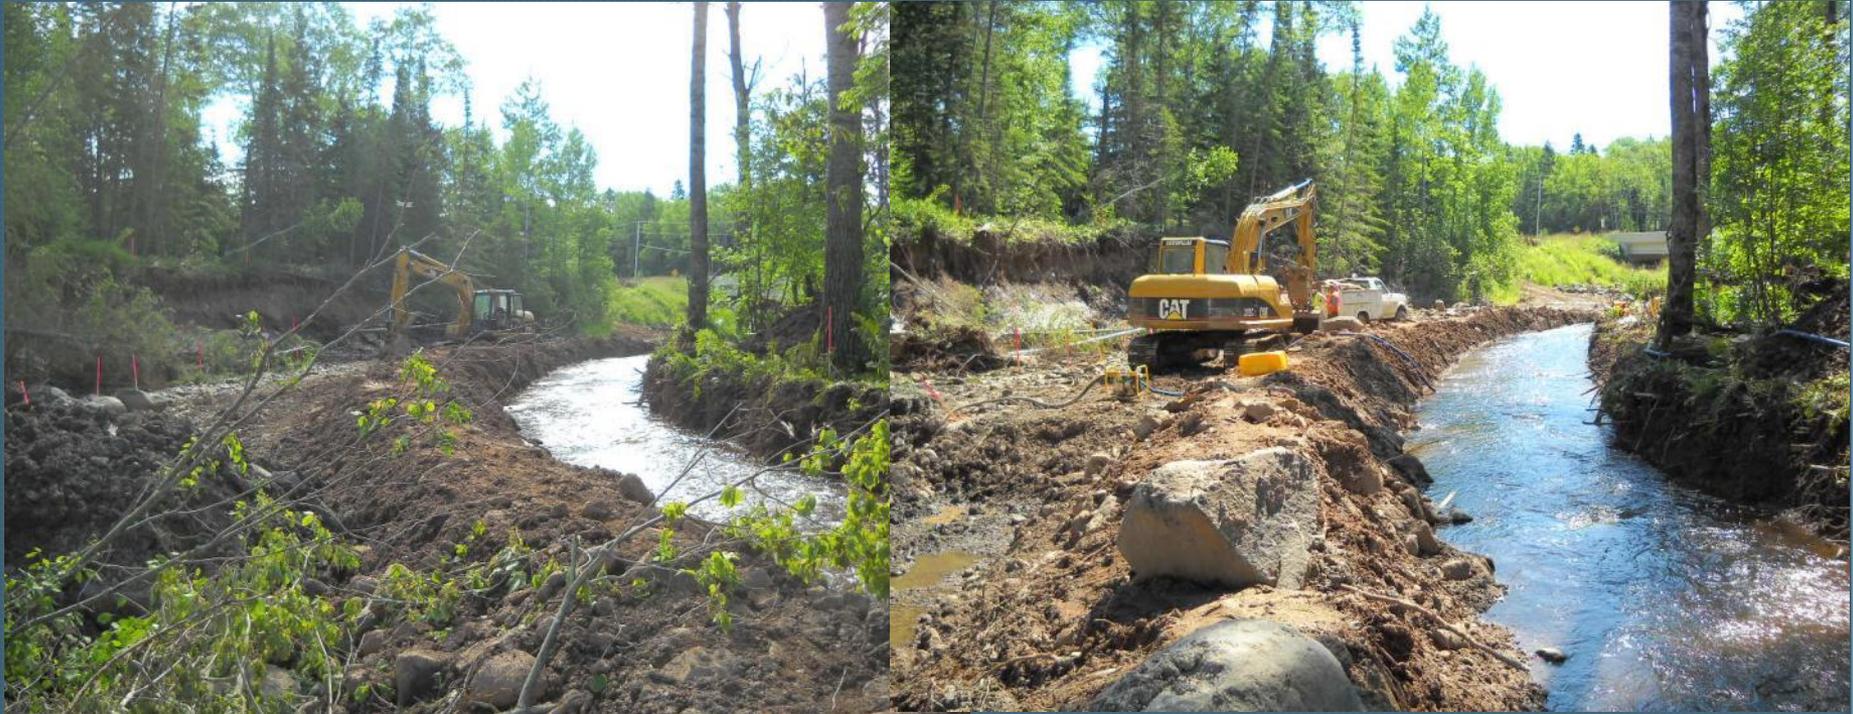
## North Road Bridge Site

During

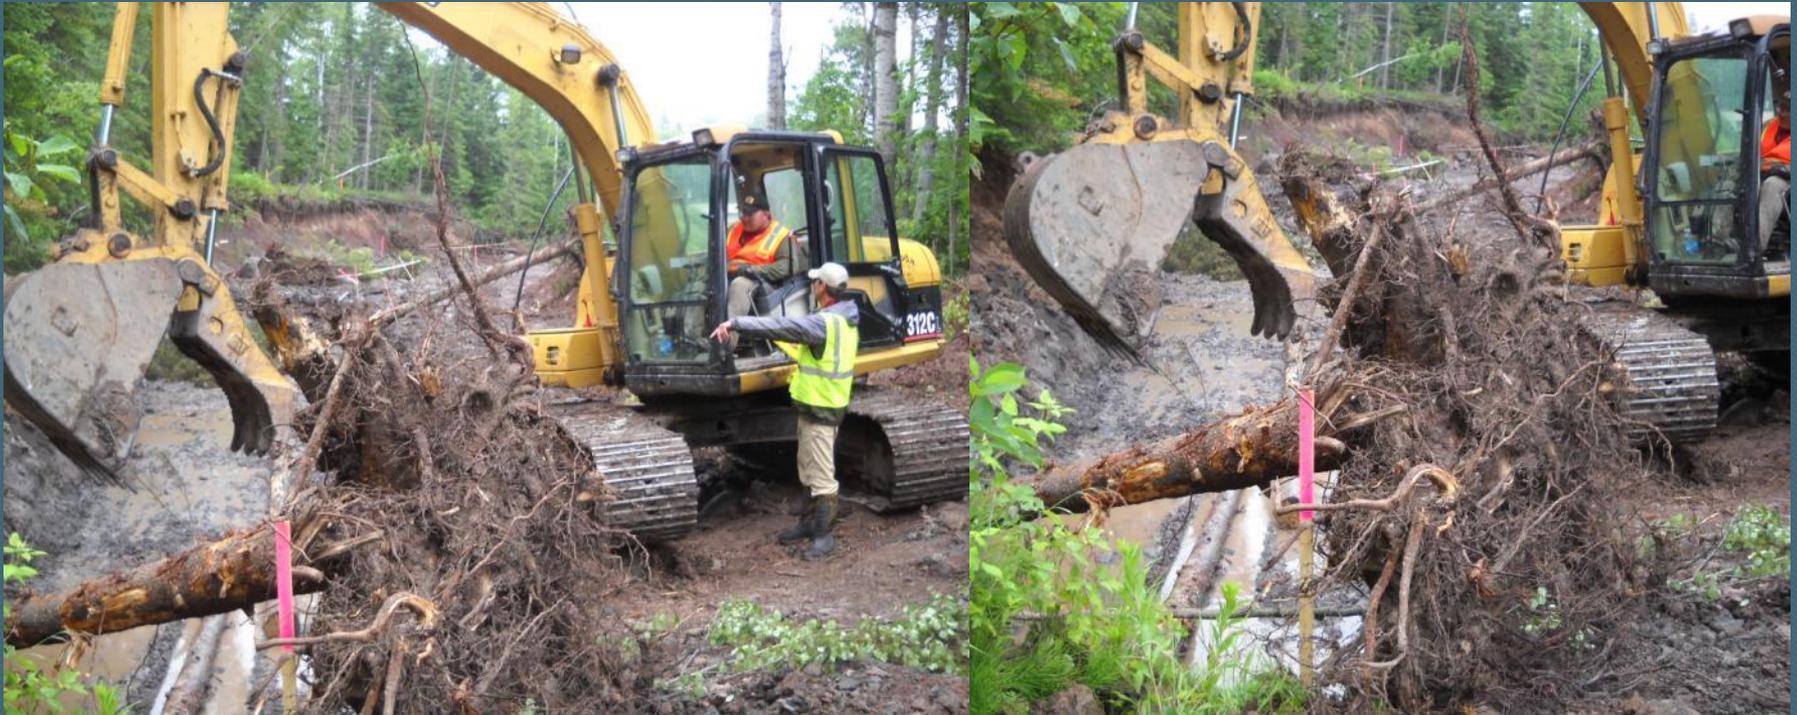
## North Road Bridge Site

During

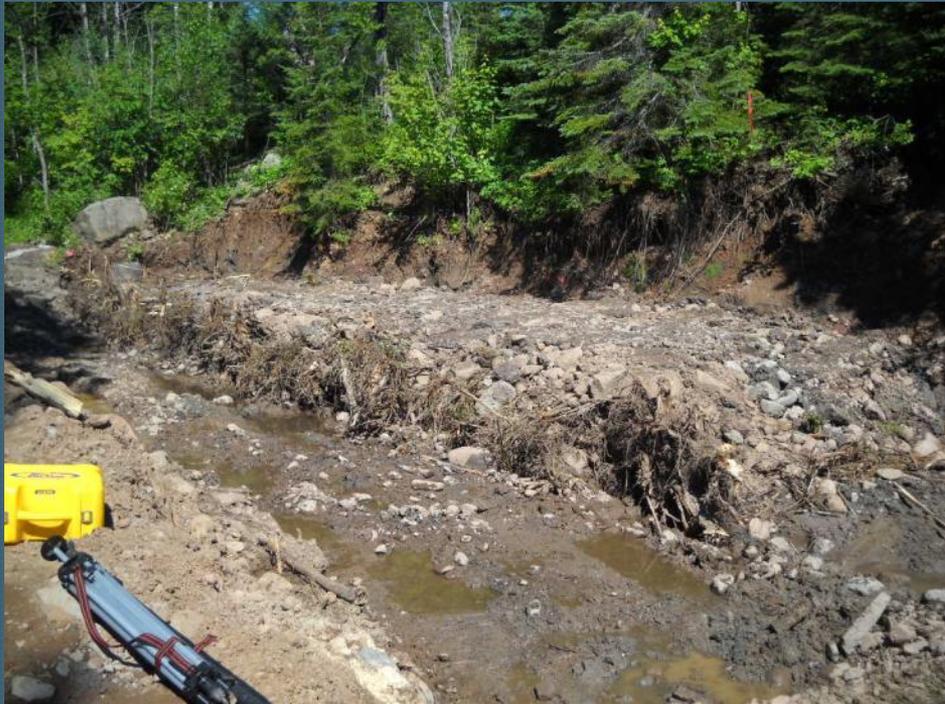
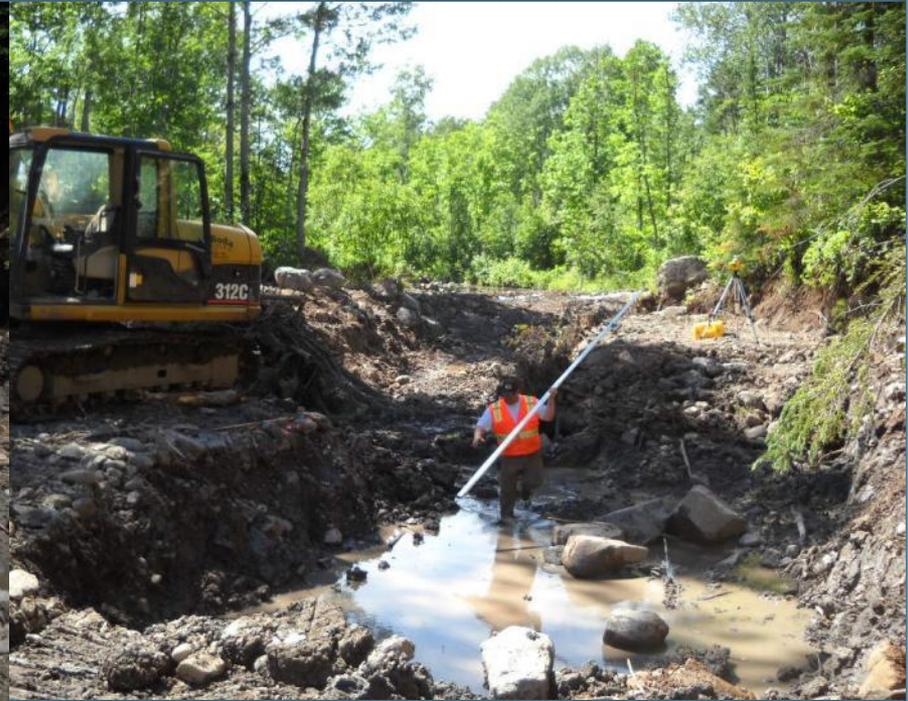
## North Road Bridge Site

During

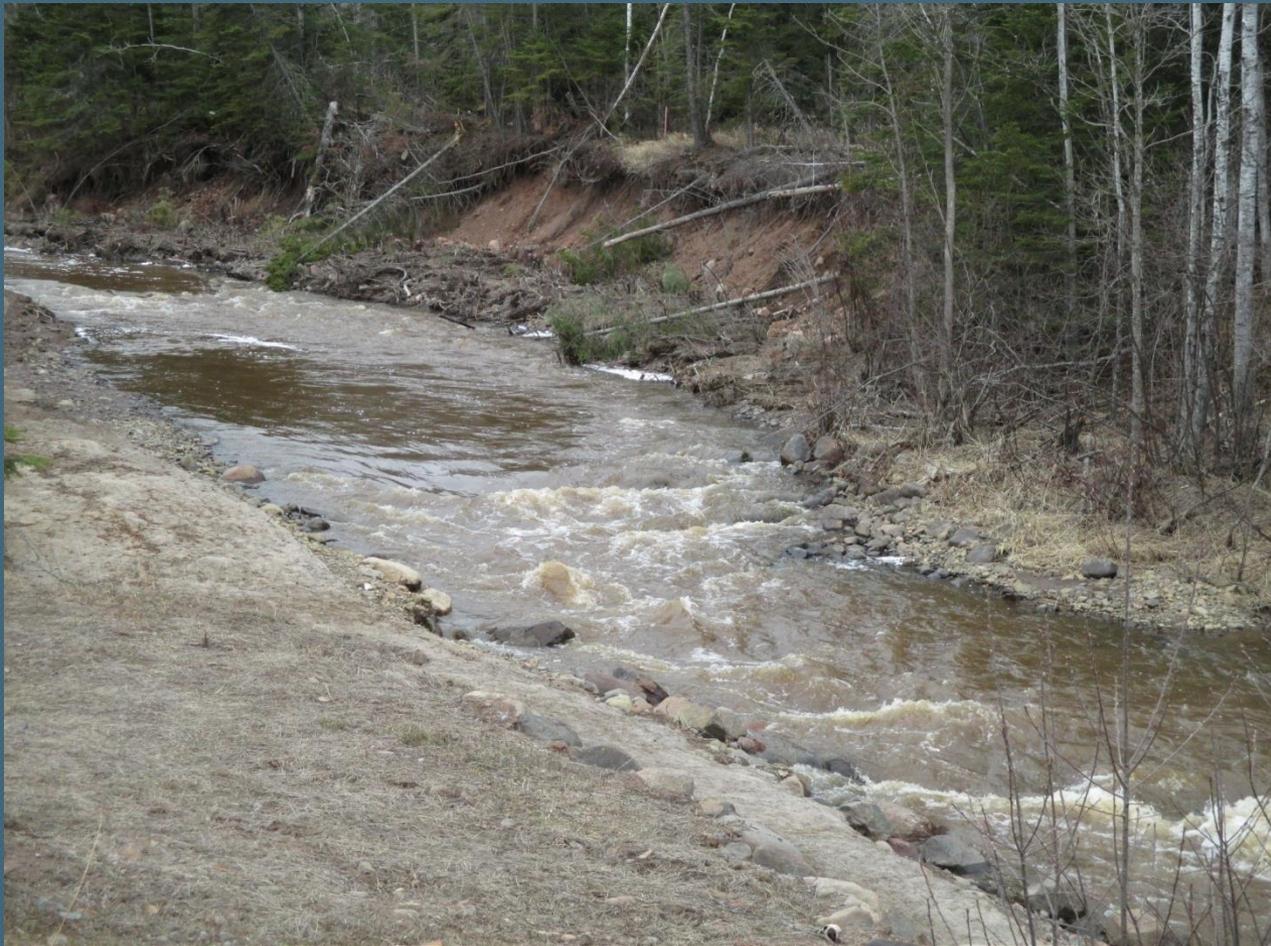
# North Road Bridge Site Complete

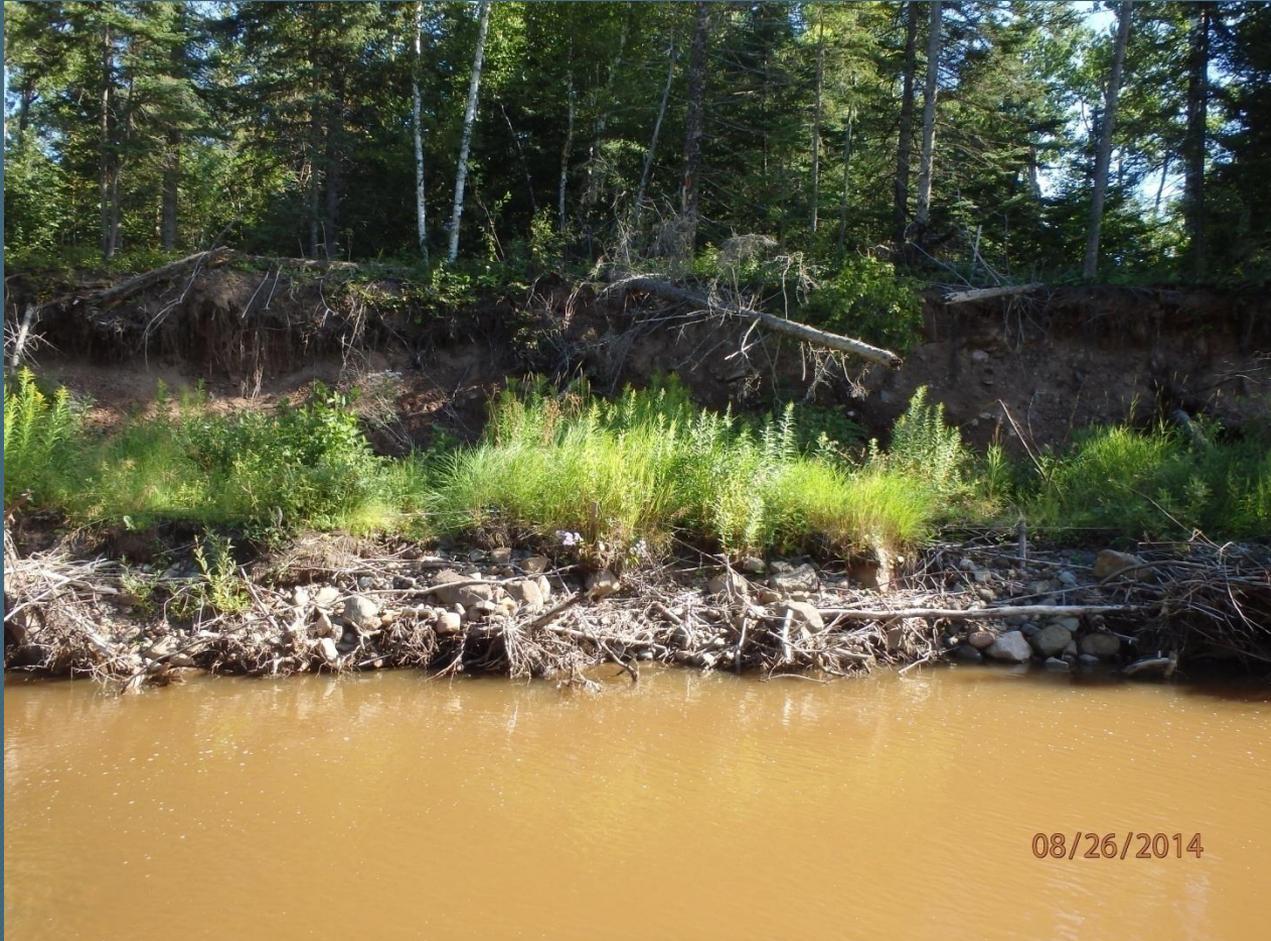
08/26/2014

# North Road Bridge Site Complete
