FINAL REPORT

Facility Condition Assessment

321 Grove Street #1

MN Department of Administration
Real Estate and Construction Services
Facility Condition Assessments – Property Management
Buildings

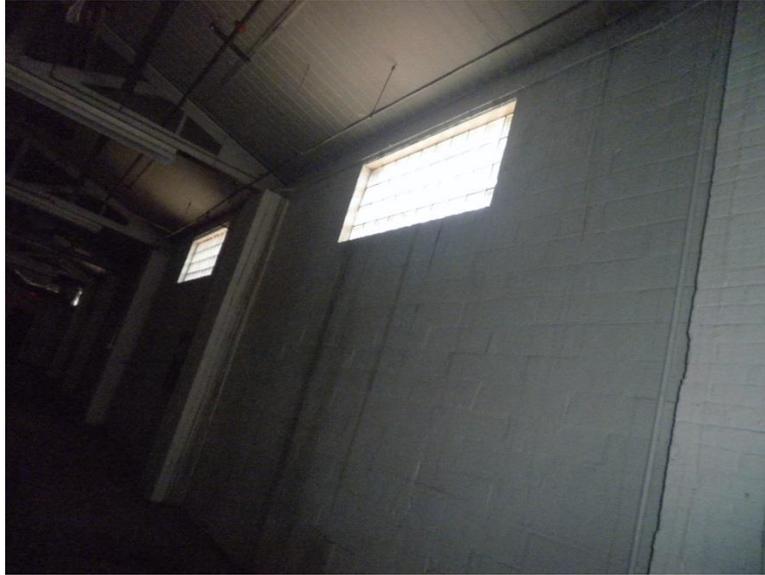
(Picture of deficiency A - B2210 Exterior Windows)

- A. **B2210 Exterior Windows: Major System:** Glass block windows appear to be original and is in poor condition.

Other Systems: Individual Aluminum Windows (punch). System was installed around 1980 and is in poor condition

Reason for Condition Rating: The seals are broken on approximately 20% of the windows. Some windows are leaking and broken. Age of system (Lifespan: 5 years remaining).

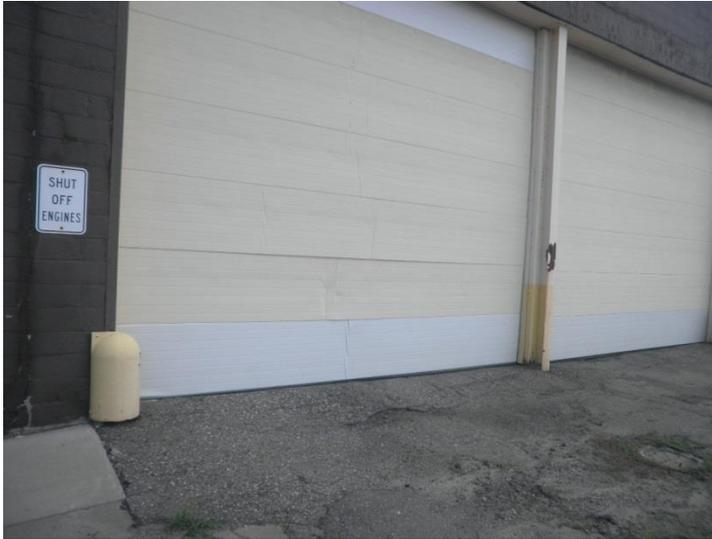
(Picture of deficiency B - B202 Exterior Windows)

- B. **B2030 Exterior Doors: Major System:** Storefront doors are not original but are in fair condition based on age.

Other Systems: Hollow metal and overhead sectional doors are in poor condition based on age.

Reason for Condition Rating: The overhead sectional doors and hollow metal doors appear to be installed in the 1980s. These doors are in fair to poor condition and are showing signs of rust.

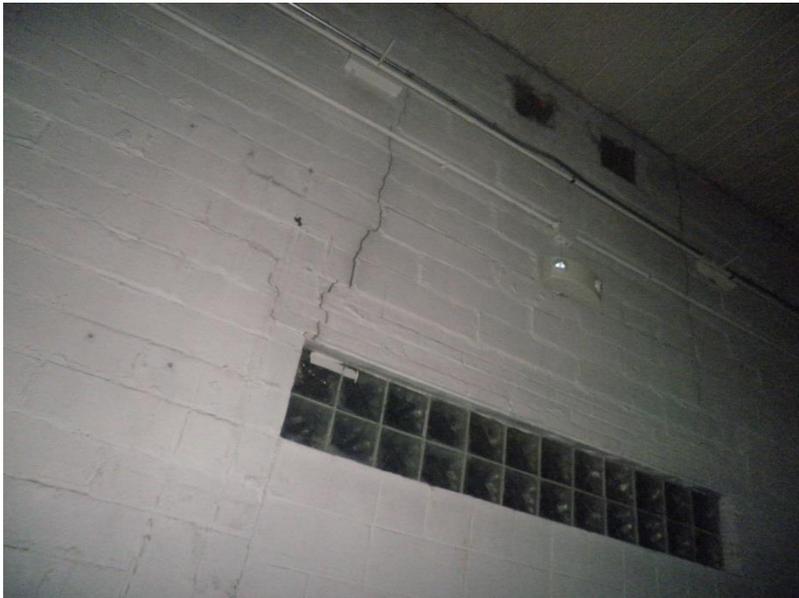
(Picture of deficiency C – C3010 Interior Walls)

- C. **C3010 Interior Walls: Major System:** Standard paint on gypsum and masonry walls. System is in poor condition based on age and damage.

Other Systems: Ceramic tile system is in good condition based on age and damage.

Reason for Condition Rating: Approximately 25% of the paint on CMU walls is seeing water damage, worn or peeling and should be addressed.

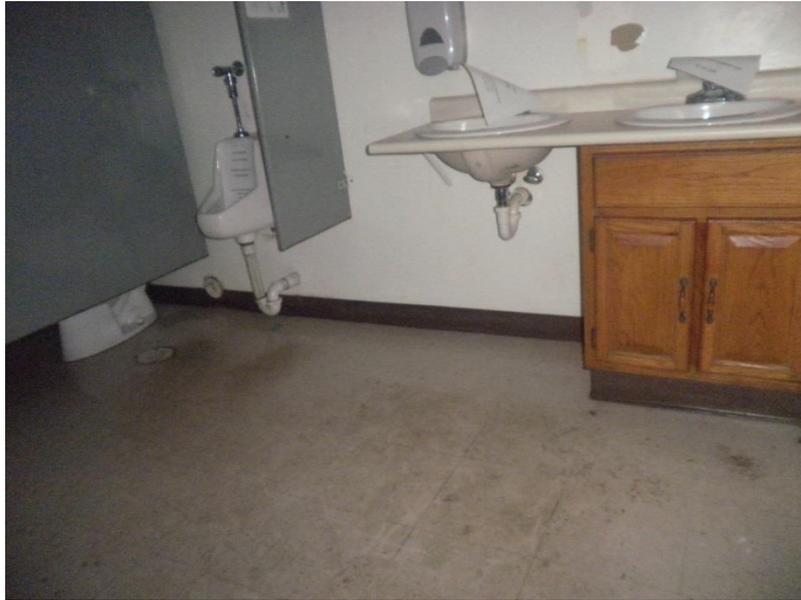
(Picture of deficiency D – D2010 Plumbing Systems and Fixtures)

- D. **D2010 Plumbing Systems and Fixtures: Major System:** Bathroom groups located throughout. Some have been abandoned. Age of fixtures is unknown.

Reason for Condition Rating: The fixtures have exceeded their useful life and should be considered for replacement
