# National Register of Historic Places Registration Form

Historic name: Cuyuna Village Hall

Other names/site number: Cuyuna City Hall, First State Bank

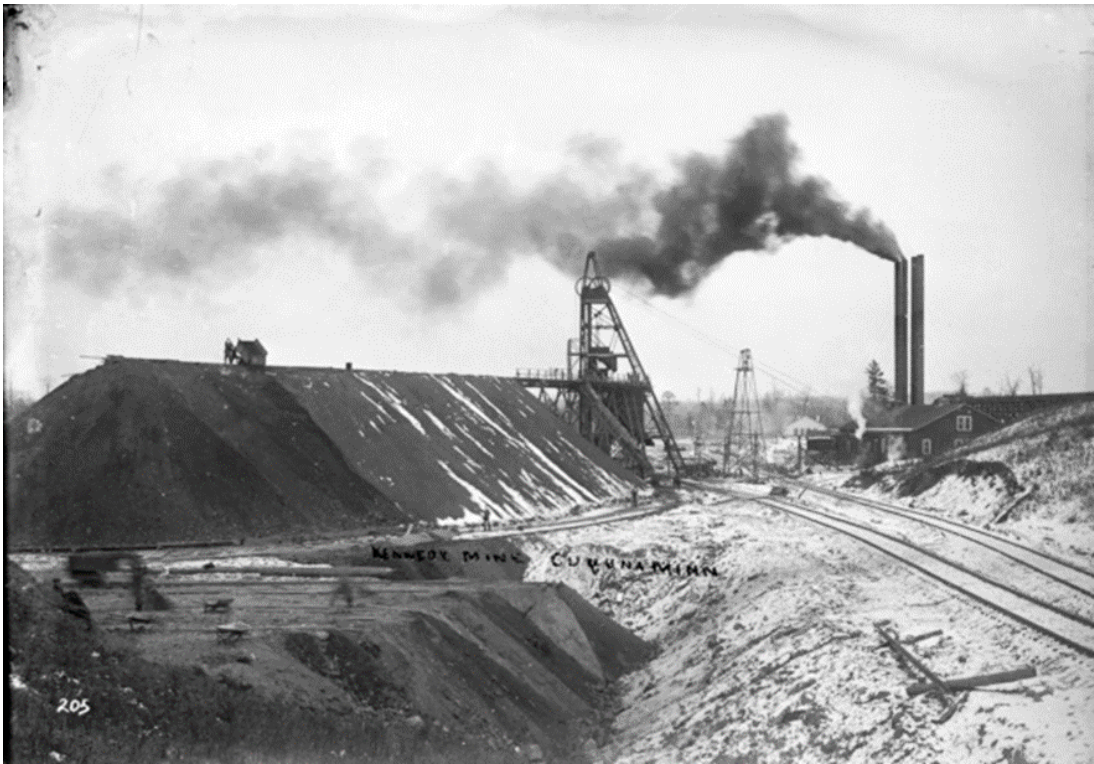
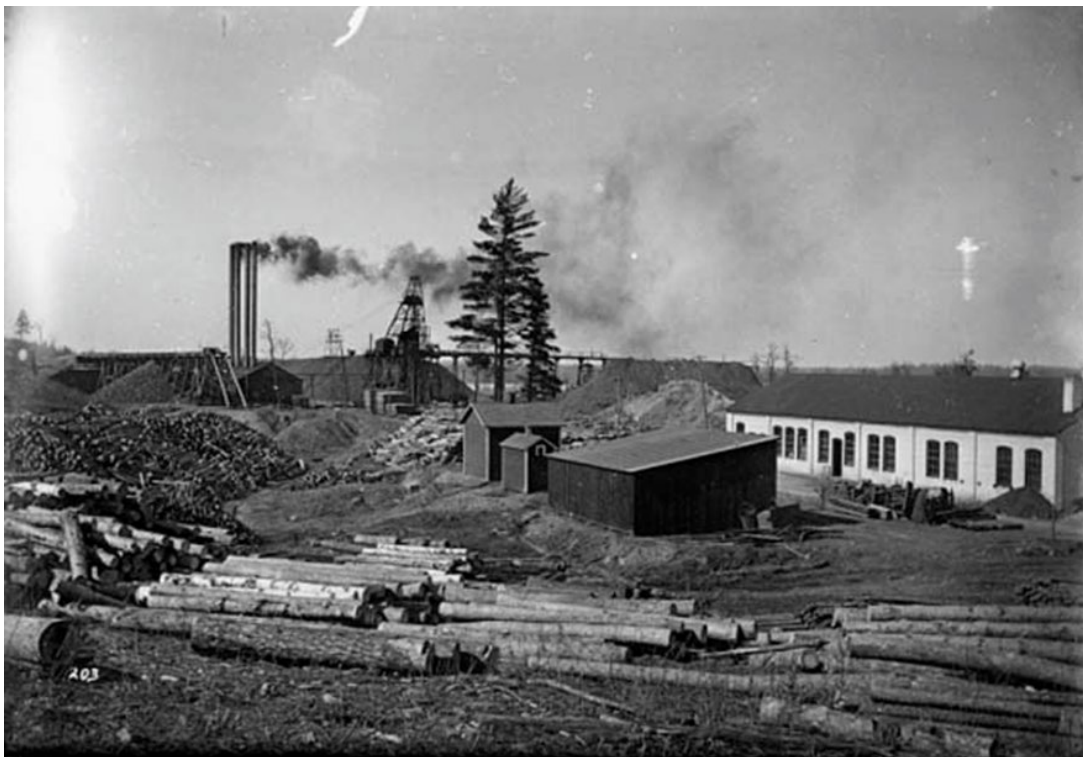
Images 3 and 4. The Kennedy Mine, ca. 1910. Photos Minnesota Historical Society.

By June 1907, Adams and his business partners persuaded S. A. Kennedy, president of the Rogers-Brown Ore Company of Buffalo, New York, to lease and develop the property, which was to become known as the Kennedy Mine, the first active mine on the Cuyuna Range. By the end of December 1907, the new mine had a 60-foot shaft, an engine house, a blacksmith shop, and other buildings. In 1910, a railroad was constructed to the mine in order to transport the ore directly from the mine. The first ore was shipped in April 1911 (Images 3 and 4).<sup>14</sup>

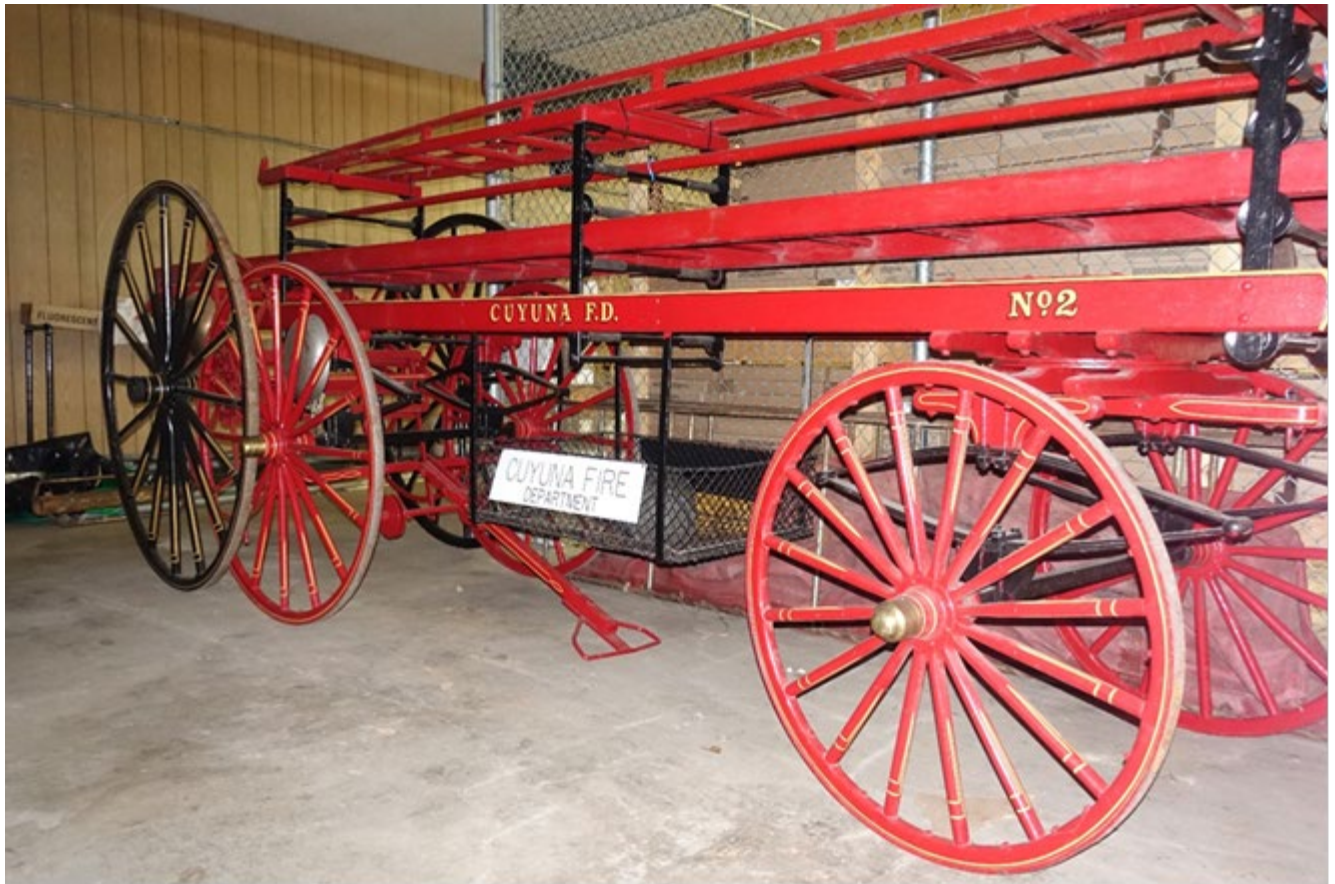
Image 6. Vintage fire wagon that had been stored in the 1978 addition of the Cuyuna Village Hall, 2021. Photo Rolf Anderson.

building was completed in February 1911. The fire department was located at the back of the building. Even before the building was completed, the village purchased fire-fighting equipment including a hand-drawn fire wagon with a 60-gallon chemical tank. The village also purchased a four-wheel hook and ladder wagon. One of the vintage wagons still exists and had been stored in the current village hall (Image 6). The village also purchased a 24-inch, 300-pound bell that was installed in the belfry. It was used for fire calls, curfews, and other emergencies.<sup>19</sup>

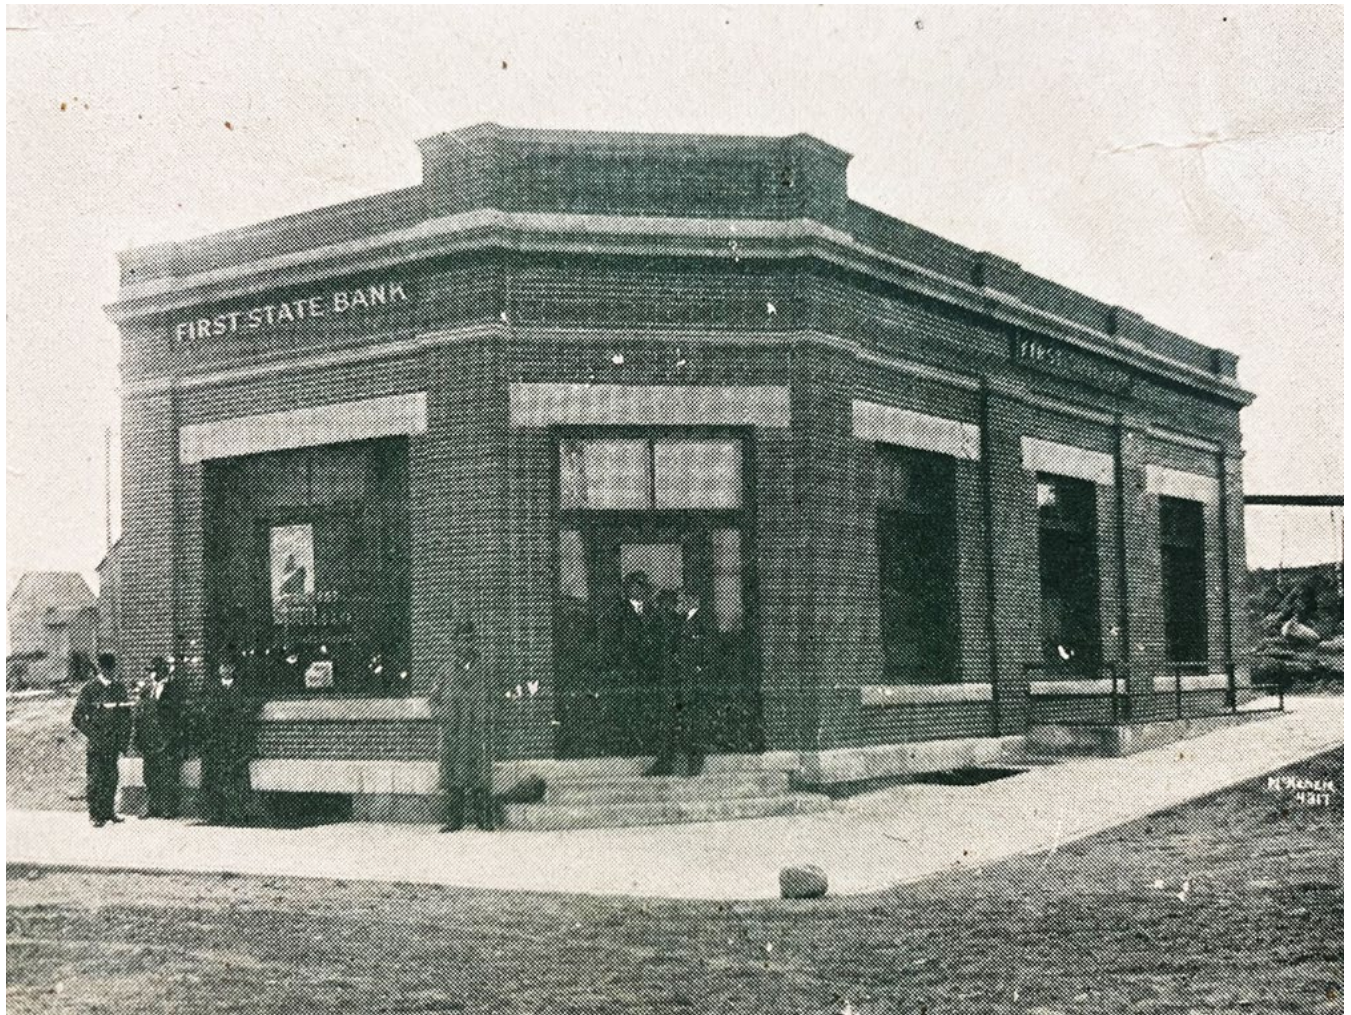
Image 11. First State Bank, ca. 1911. Photo from a brochure published by the Cuyuna Improvement Company. Photo courtesy Cuyuna Iron Range Heritage Network.

The original roof of the 1911 building sloped to the north but was concealed behind the parapet wall. This sloping roof is visible in a 1913 photograph along with the stepped parapet wall on the west side of the building (Image 13). In 2009, the current dark-red metal roof was installed, although the original roof structure remains in place beneath the new roof. The gable roof features broad overhanging eaves with white soffits and forms a hip over the canted entry. The broad eaves rest on the top of the parapet walls along the south and east elevations. However, the parapet wall projects slightly higher above the canted entry. This section of the parapet is enclosed within the new roof and has not been altered. It may be viewed in a historic photograph (Image 11).

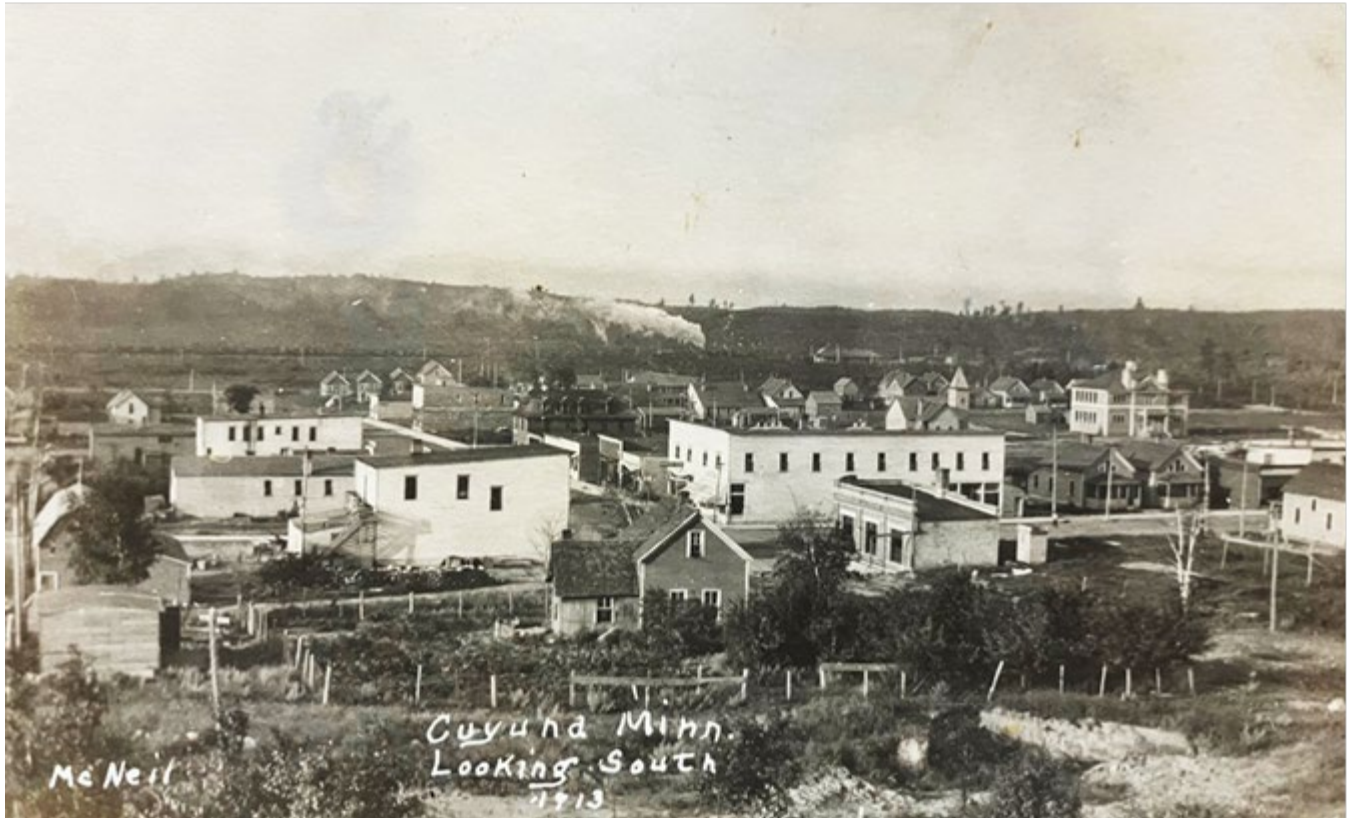
Image 13. 1913 view of Cuyuna from the north with the north and east elevations of the First State Bank seen to the right of center. Photo courtesy Cuyuna Iron Range Heritage Network.

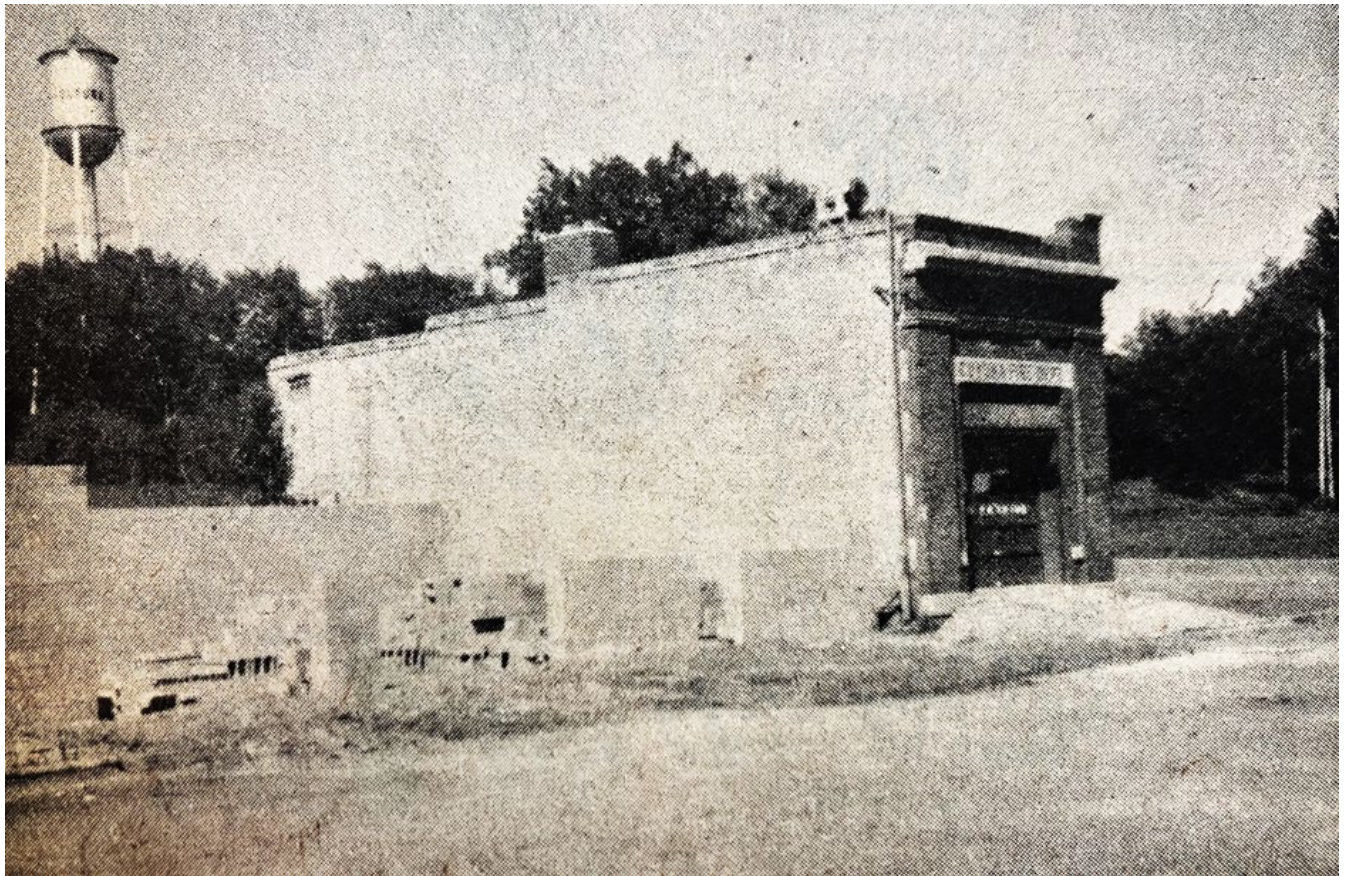
Image 16. Construction photograph of the 1978 addition, which is to the left of the 1911 building. Note the rising sections of concrete blocks that will flank the service and garage doors. Also note the rear wall, which is built into the hillside. Photo courtesy *Crosby-Ironton Courier*.

In 1978, a 50 foot by 32-foot one-story concrete block addition was constructed on the west side of the building to provide additional space for the fire department and for community events (Photo 8). The addition is set back from the 1911 building and is built into the hillside to the north. The addition is covered with a low-pitch gable roof with dark brown asphalt shingles and has a lower profile than the 1911 building. Originally, there was a service door at the east side of the addition followed by two overhead garage doors (Image 17). The service door was later removed and a third overhead garage door was installed in 1980.

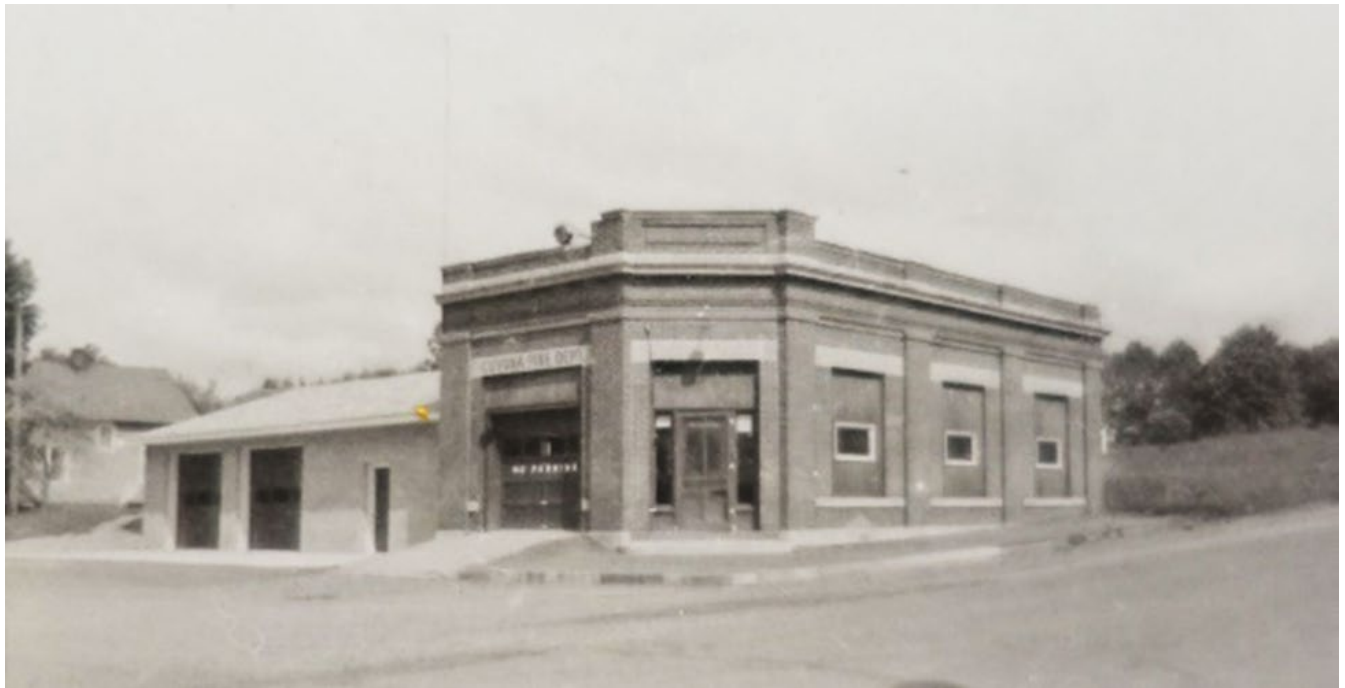
Image 17. June 1979 photo of the Cuyuna Village Hall depicting the 1978 addition at left. Photo by Robert Frame, Minnesota Historic Properties Inventory Form, Contact Sheet 03019, Frame 19, State Historic Preservation Office, Minnesota Historical Society.
