Phase I Environmental Site Assessment

Railroad Avenue Property

Gaylord, Minnesota

SEH No. GAYLO 123854

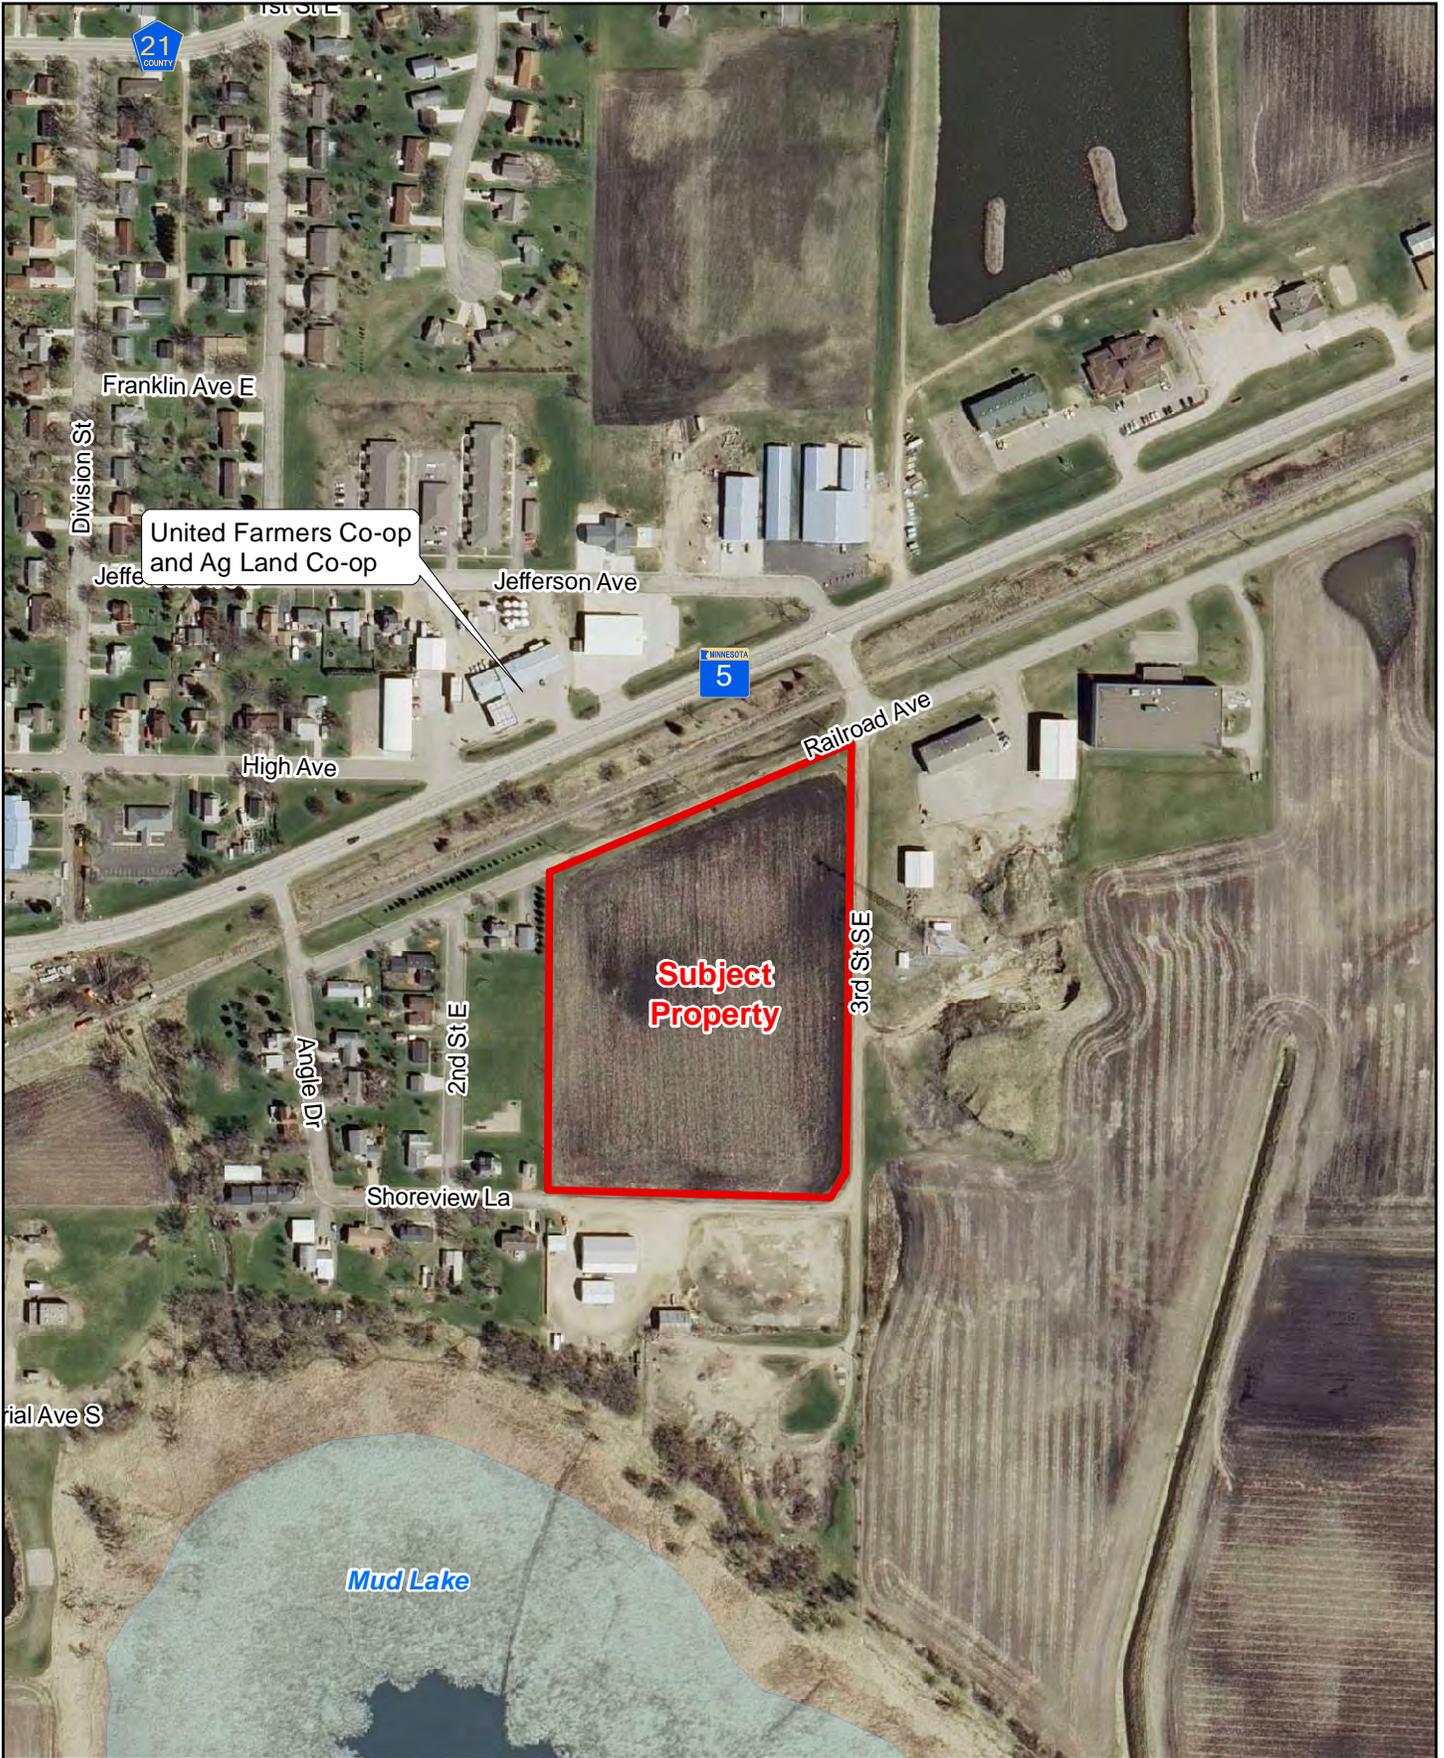
Figure 2 – Site Features

SEH has completed this Phase I ESA, and based on the information presented above, the following known or suspected RECs, HRECs, or *de minimis* conditions were identified for the subject property. The following sites that are identified as **REC's** can be seen on **Figure 2**:

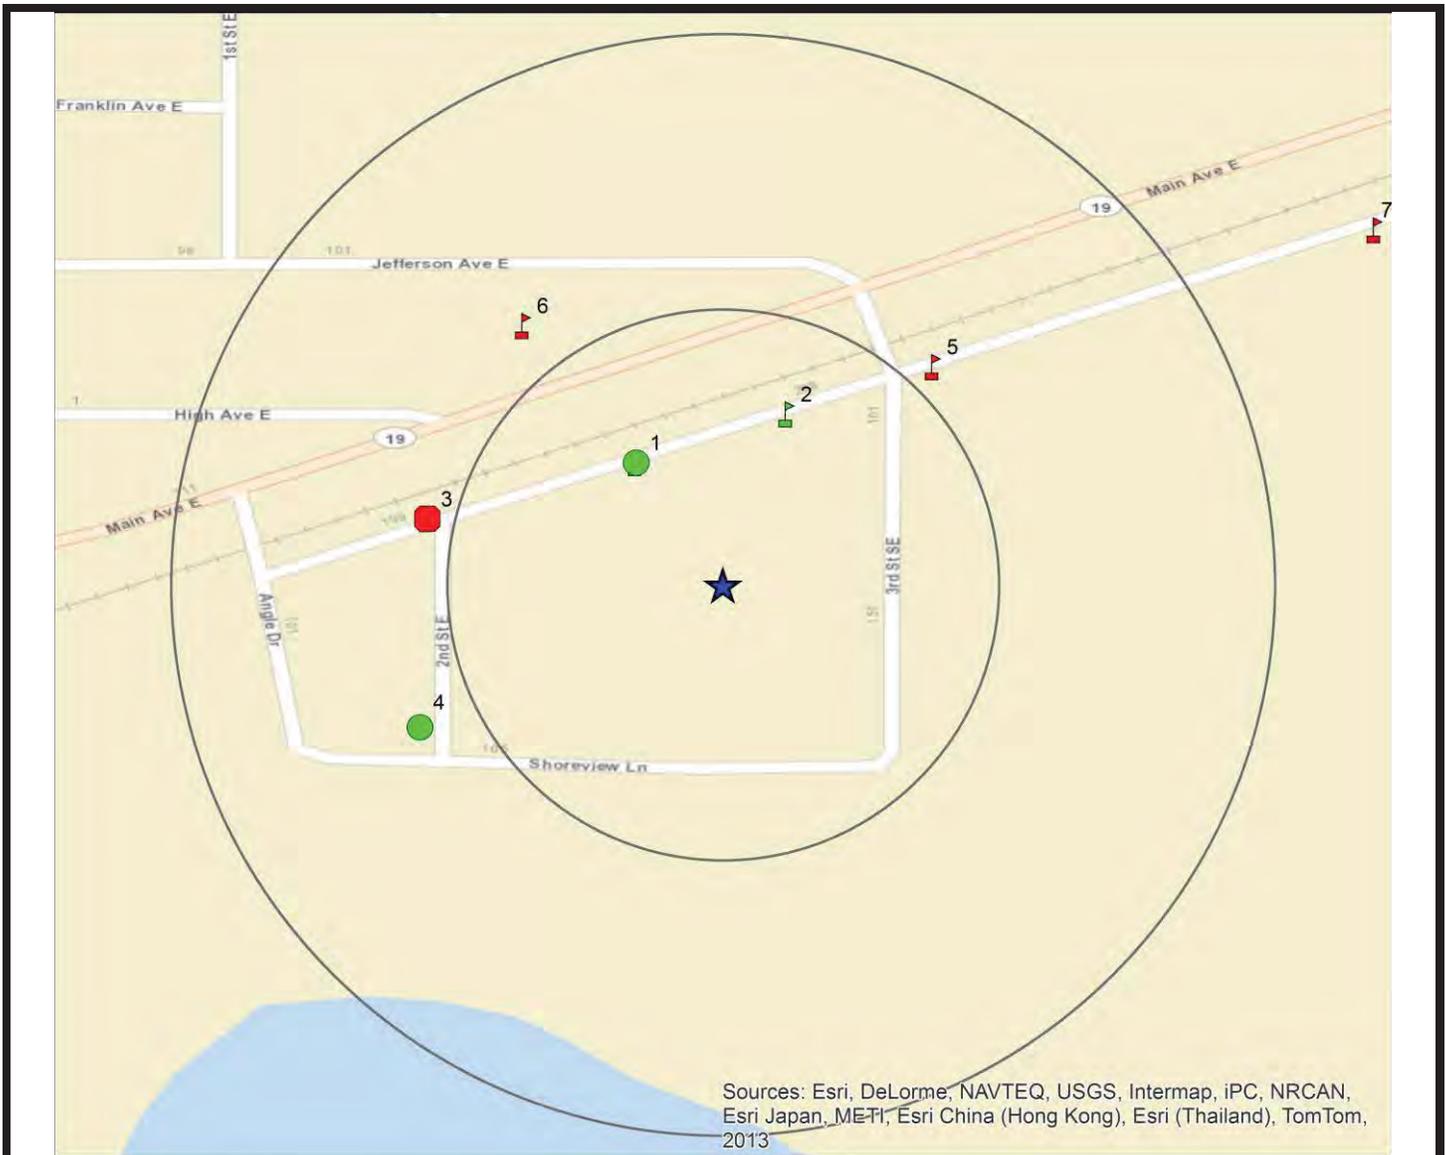
1/4-MILE RADIUS STREET MAP W/OCCURRENCES

All plotted occurrences represent approximate locations based on geographic information provided by the respective agency. Actual locations may vary due to numerous reasons such as: the size of the property, accuracy of the provided location, accuracy of the software used to determine the location, etc. **Occurrences are shown in three colors** to give a visual indication of the potential risk of the listed occurrence based on the type of list and the current status of the occurrence. Occurrences shown in **RED** are locations with known contamination that have not received a "case closed" or "no further action" status. Occurrences shown in **YELLOW** have been listed by the respective agency, but do not always represent an environmental risk. The detailed status information and description of the list should be reviewed for further information. Occurrences shown in **GREEN** are occurrences that have active permits or have had contamination in the past but have received a "case closed" or "no further action" status and therefore do not likely present an environmental risk.

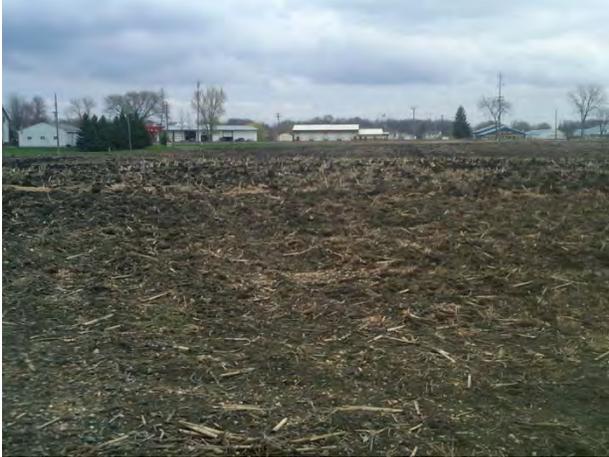
Photo 1. Overview of subject property looking to the north.

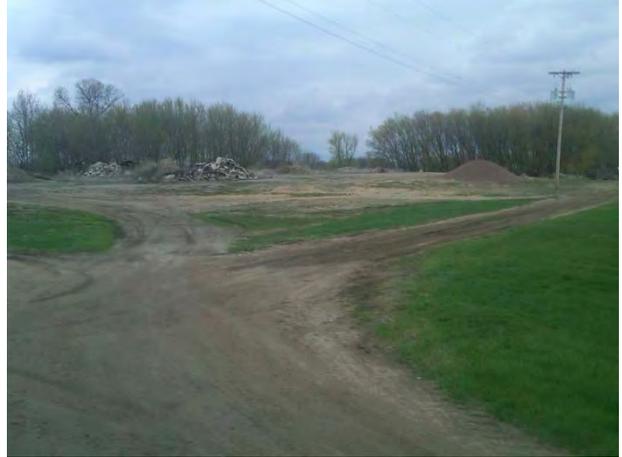
Photo 2. City of Gaylord Compost Site.

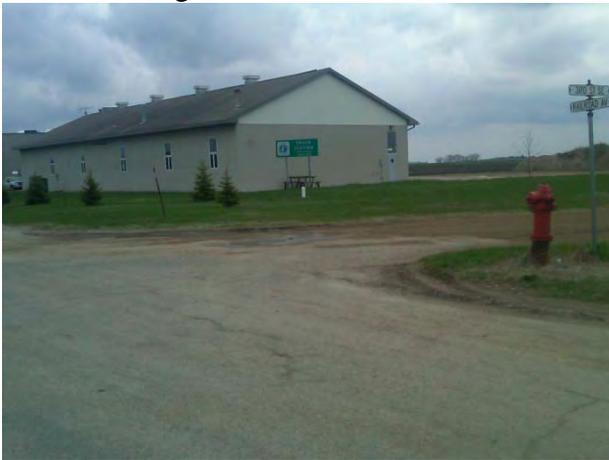
- **MNDOT District 7a Safety Office Gaylord**, 330 Railroad Ave. The site is listed as an active small to minimal quantity generator of hazardous waste (ID: MND982646978), which included 30 pounds of used oil filters for recycling and 65 gallons of used oil in 1995, and parts washer solvent for report years 2006, 2007, and 2010. This site is located adjacent to the north of the subject property on Railroad Avenue. No violations were listed at this site and good housekeeping was observed during the site visit. This site is not a REC.

Photo 3. MnDOT truck station adjacent to the northeast of the subject property.

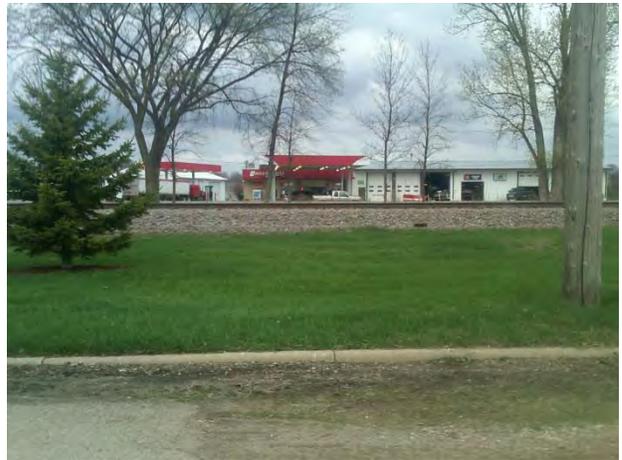
- **United Farmers Co-op and Ag Land Co-op**, 120 E High St. This site is a listed tank site (ID: 9281) and leak site for two occurrences (IDs: 1746 and 7838). The first release was of leaded gasoline and occurred on 10/16/1989. It resulted in groundwater contamination, and was closed on 9/29/1992 with contaminated soil remaining on site. The second release was of an unknown type of gasoline on 9/14/1994, didn't result in groundwater contamination, and was closed 2/24/2006. It was land treated via soil

Photo 4. Gas station located 0.13 miles to the northwest of the subject property (United Farmers Co-op and Ag Land Co-op site).

SEH recommends a review of available MPCA leak files for the identified RECs listed in **Section 8.0**. Additionally, SEH recommends a Phase II investigation be completed for conditions identified during the MPCA file review and potential impacts regarding agricultural chemical use on-site and the adjacent railway.

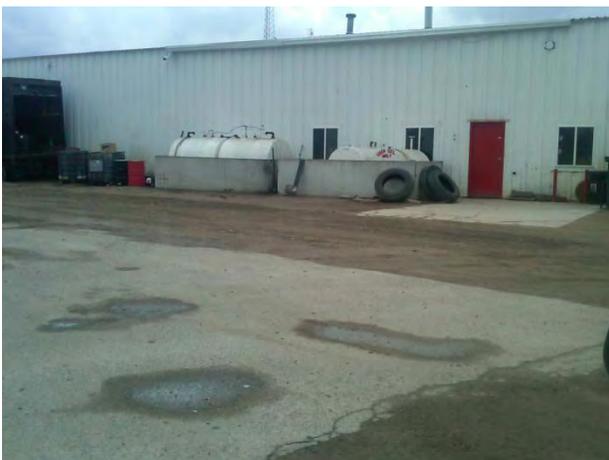
Photo 5. AST's located behind the gas station (United Farmers Co-op and Ag Land Co-op site).

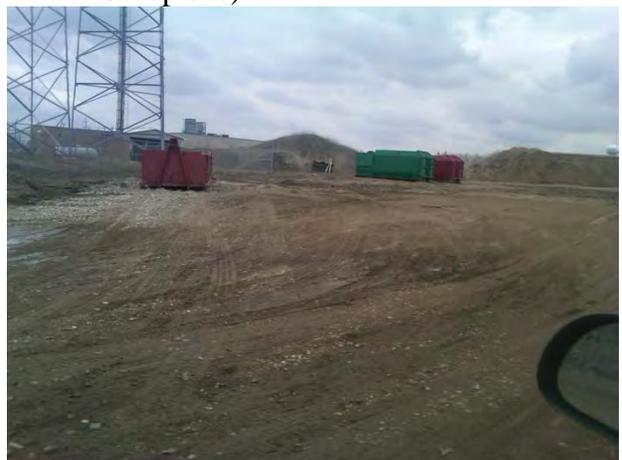
At the time of the site reconnaissance, no landfills or solid waste were observed on or adjacent to the subject property. Small amounts of scattered debris were observed adjacent to roadways, although the amount of debris appeared to be minimal. Dumpsters were observed on the property adjacent to the east of the subject property. .

Photo 6. Dumpsters, above-ground propane tanks located adjacent to the east of the subject property.
