**Section 2.2.4
Second Floor Conditions Assessment
Historic Structures Report**

MINNESOTA STATE CAPITOL
HISTORIC STRUCTURES REPORT
VOLUME 2.2.5

THIRD FLOOR SPACE INVENTORY AND CONDITIONS

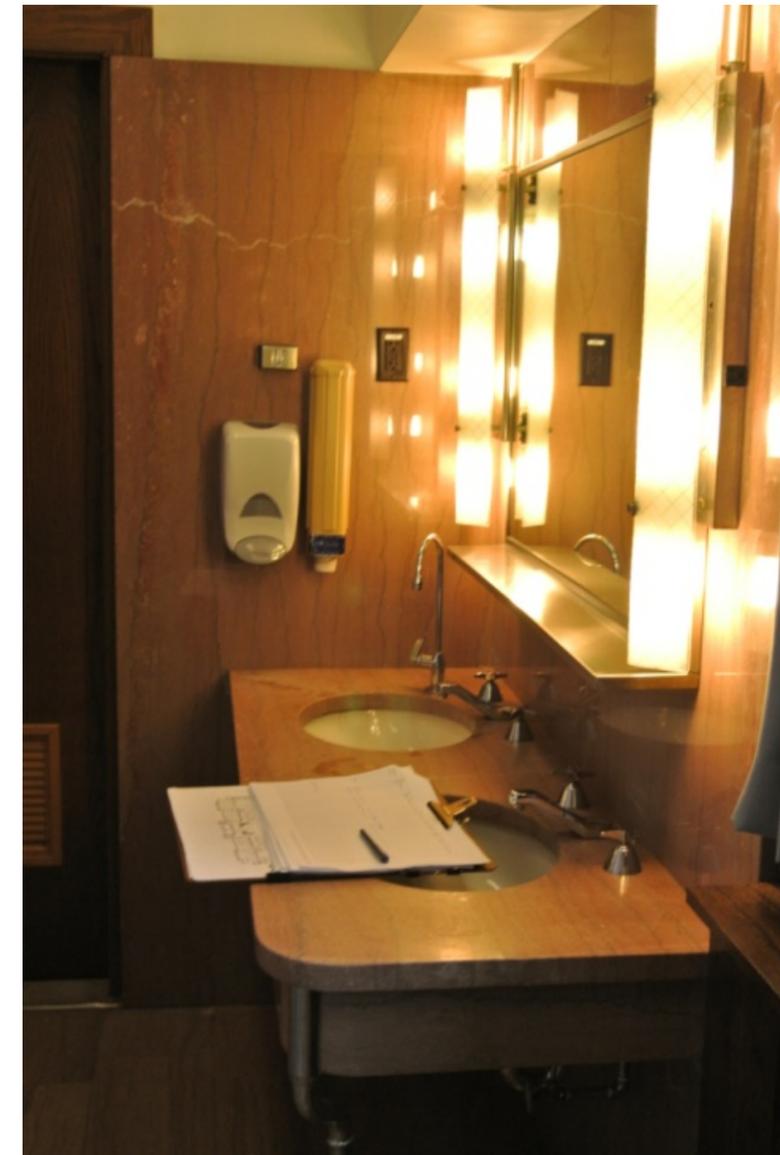
Counter and Mirror

Of the many Restrooms on this floor, only two are public, the Women's Restroom 213 is located next to the Oval Stair. Restroom 215 is a Unisex Restroom off the Rotunda Corridor next to the House. An enlarged stall was added in the Women's room by removing an adjacent stall. Neither room complies with current ADA standards. The other restrooms are reserved for staff and Legislator use and vary in age and accessibility.

Building Element:	Description	Condition of Original Material
Floor	Tennessee Marble	Modified/see description
Walls	Tennessee Marble	Modified/see description
Ceiling/Cornice	Plaster	Modified
Doors/Frame:	Original wood, leather covered	Modified, see description
Hardware	Brass ADA hardware	Not original
Light Fixtures	Varies per room	Not original
Artwork	None	None
Mechanical	Varies	Varies
Trim	Tennessee Marble	Modified/see description

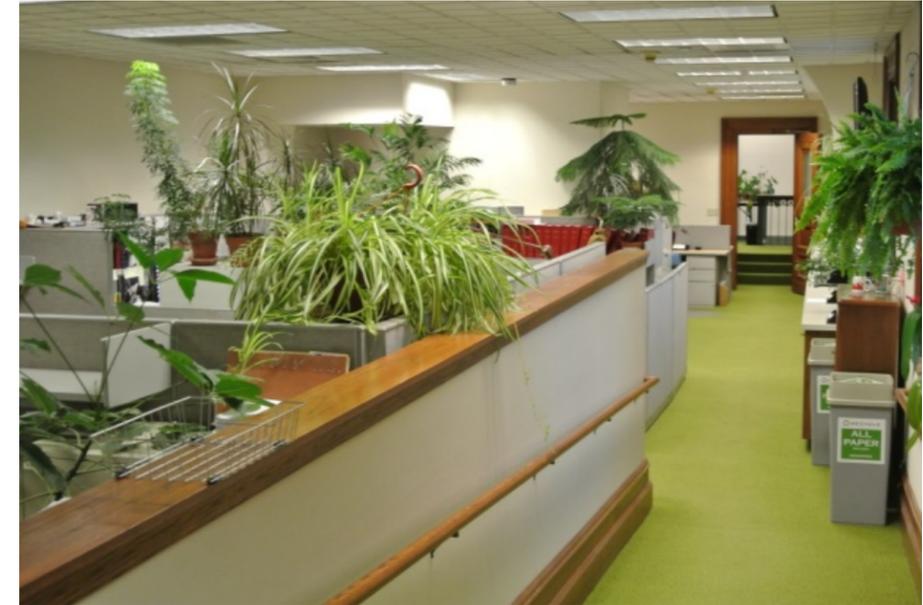
Office

This entry includes the offices above. Like these rooms, they were installed in 1938, and much of the woodwork is of the same quality as the original building.

Building Element:	Description:	Condition of Material:
Floor	Concrete/Carpet	Destroyed
Walls	Plaster	Destroyed
Ceiling/Cornice	ACT	Destroyed
Doors/Frame:	Wood	Intact
Hardware	Original knobs, ADA levers	Some original
Light Fixtures	Lay in	Not original
Artwork	None	
Mechanical	Aluminum louvers	Not original
Trim	Wood	Intact/modified

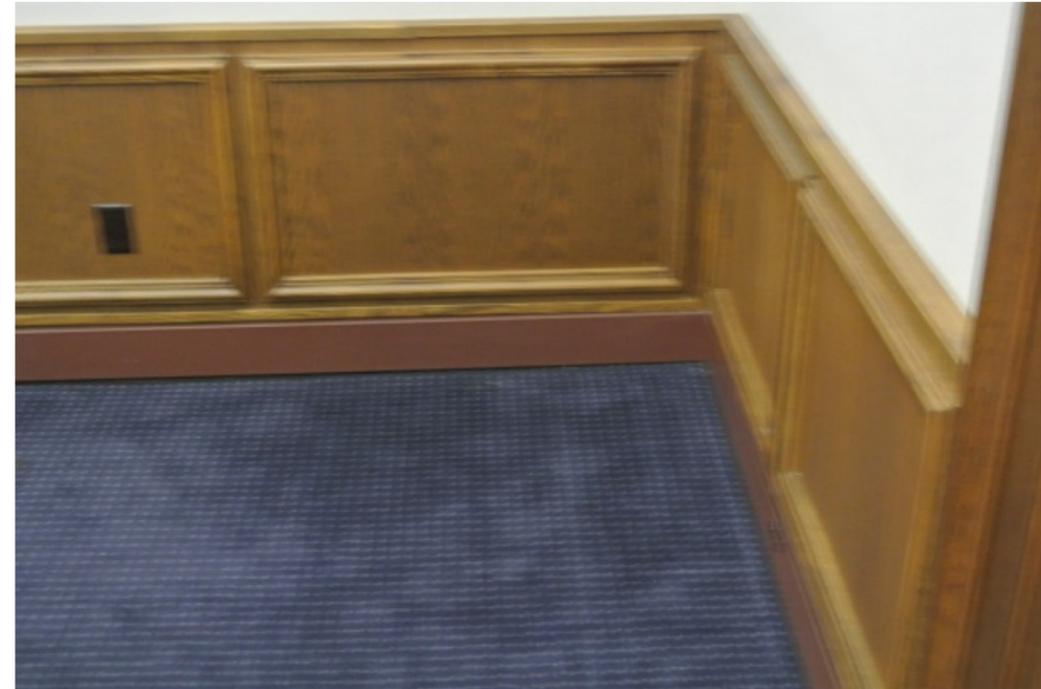
Office Suite
 Formerly Military Offices
 323, 323A-B, 324, 325, 325A, 326,
 326A-B
 Treatment Level: **3**

This Office Suite has received the typical treatment for Senatorial Offices.

Building Element:	Description:	Condition of Material:
Floor	Concrete/carpted	Destroyed
Walls	Plaster/wood wainscot	Modified/not original
Ceiling/Cornice	Plaster/ACT	Unknown
Doors/Frame:	Original wood at corridor, others new	Intact
Hardware	ADA Lever	Not original
Light Fixtures	Wall mounted	Not original
Artwork	None	None
Mechanical	Ceiling distribution	Not original
Trim	Wood	Not original
