CENTENNIAL OFFICE BUILDING Investigation of Exterior Building Envelope

658 Cedar Avenue
St. Paul, MN 55155

Draft Report
March 17, 2015
WJE No. 2014.5607.0

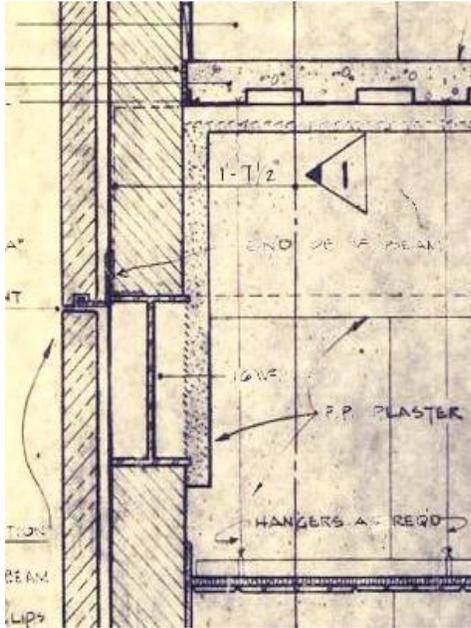
Illustration 1. Original detail at the granite panel joint condition (2/A2-6).

1. The first simulation was modeled to represent the existing conditions at a typical panel joint in the exterior granite cladding as detailed in the original construction set at 2/A-26, shown on the left below. The THERM simulation, shown on the right in the figure below, was based on a detail that was revised by WJE to show the as-built condition that includes furred out interior walls with 1-1/2 inches of insulation, a vapor retarder and gypsum board finishes, as well as 6 inches of batt insulation above the perimeter of the suspended ceiling grid. The simulation was conducted using an interior ambient air temperature of 68°F below the ceiling and 65°F above, with an exterior air temperature of 7° F, which is the average low temperature for Minneapolis in the month of January. At the conditions modeled between the ceiling grid and the deck above, which aligns with the panel joint, the dew point temperature is approximately 39°F. Interior surfaces that are colder than the dew point will be subject to the formation of condensation.

The simulation demonstrates that none of the material surfaces that are exposed to the interior of the building will be colder than the dew point at these conditions. Although the steel wide flange is much colder than the dew point, it is covered with cementitious fireproofing on the interior which protects it from moisture-laden interior air. As a result, condensation on the surface of the steel is unlikely.

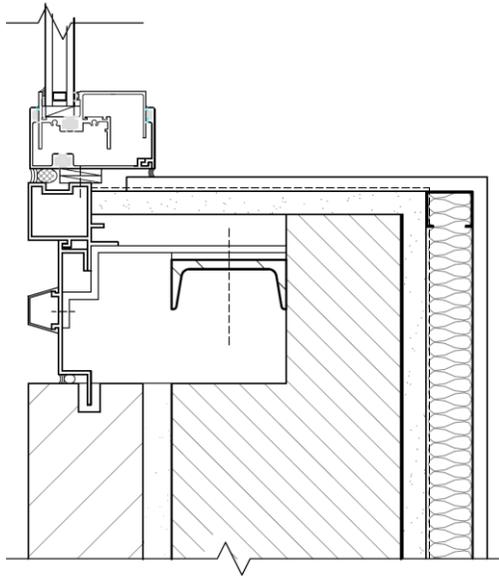
Illustration 4. Existing condition detail at the upper floor window jambs.

3. Another major source of building heat loss was determined to be through the aluminum window frames as detailed in the original construction set at 7/A-35, but subsequently modified to the condition shown on the left below. This as-built condition includes a thermally broken replacement window and the addition of about 2 inches of batt insulation along the inboard surface of the back-up wall. The THERM simulation, shown on the right in the figure below, was conducted using the same temperature and humidity ranges previously described for an average low in the month of January in St. Paul.

As indicated by the simulation, thermal bridging occurs through the window frame because the IGU and the frame isolator bar are not aligned with the wall insulation. While the new window is thermally broken, the adjacent decorative aluminum track is not, and in conjunction with the uninsulated jamb of the backup wall, creates an open cavity for thermal transfer.

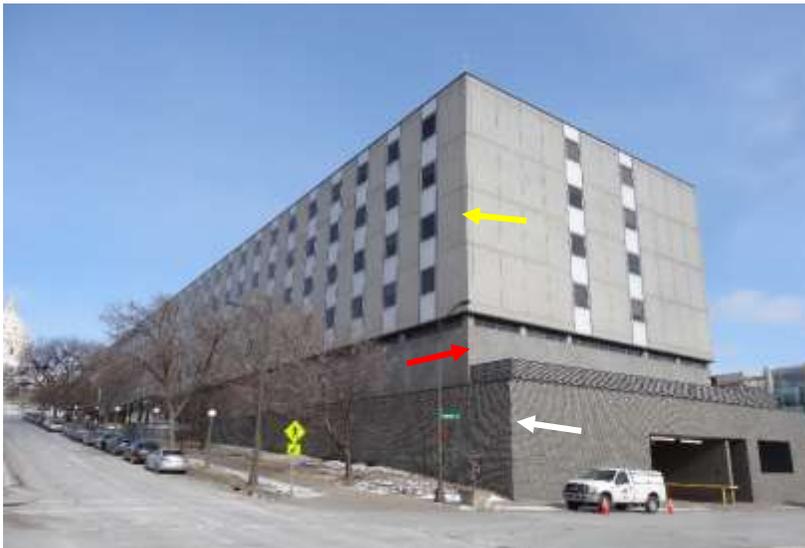
Figure 2. Overall view of the COB from southwest corner of the site. The sub-basement walls are clad in granite-faced precast concrete panels (white arrow), the walls of the basement and first floor levels are clad in polished granite panels (red arrow) and the walls of levels 2 through 5 are clad in flame-finished granite panels (yellow arrow).

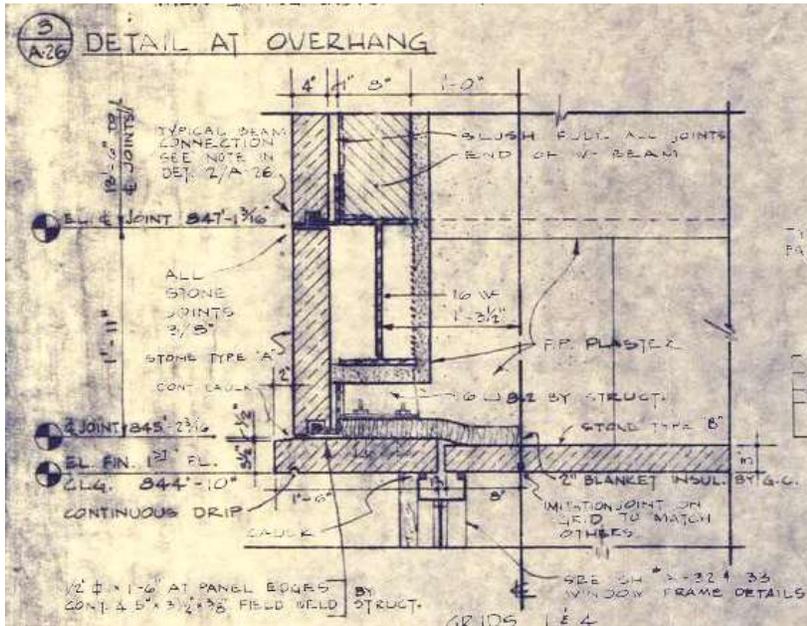
41. The original detail at the clerestory window heads is shown in Figure 5; however, subsequent modifications have resulted in as-built conditions that differ from the original design. The primary difference is that the interior stone soffit shown in the original detail was removed and replaced with a prefabricated metal window shade pocket that allows the blinds to be concealed above the window heads (INCLUDE PHOTO HERE). The placement of the blind pockets appears to have resulted in the removal of some or all of the insulation that was indicated for this area in the initial details, which has created a pathway for thermal transfer that was detected by the IR scans (Figure 13). A suspended grid acoustical tile ceiling was also installed at a later time, and aligns with the bottom of the shade pocket above the window head.

Figure 5. Original CD detail 3/A-26 depicts the soffit / overhang condition at the base of the type A granite wall panels below the second floor level.

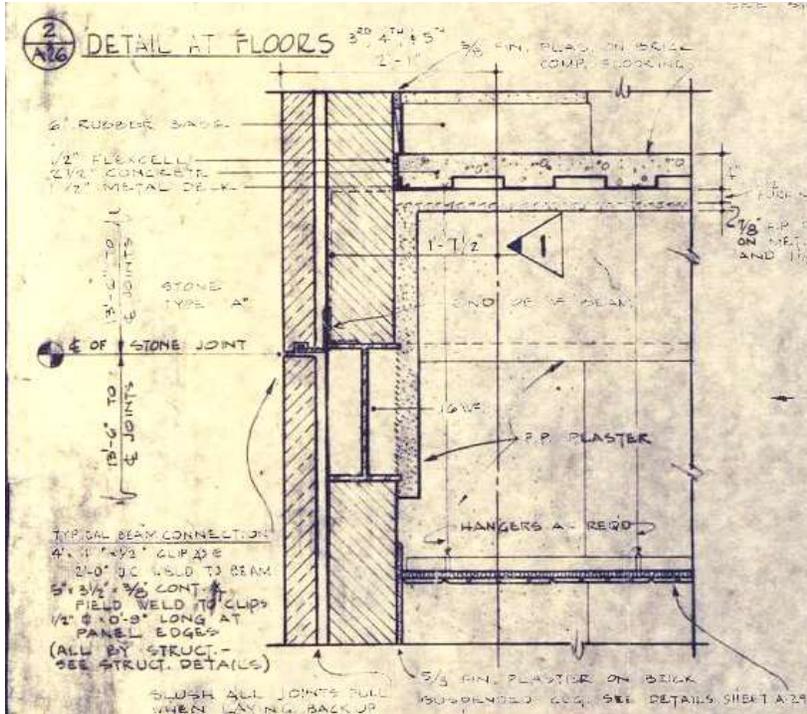
- c. Floors two through five are clad in flame-finished Rockville Beige granite panels (also labeled Type A Stone Facing) that are nominally 4 inches thick. Type A panels at the upper walls are typically 8 feet 5 inches wide by 13 feet 6 inches tall. The panels are indicated to be supported by 5-inch wide segments of back-to-back steel clip angles welded at two foot centers to the top flanges of 16 inch deep wide flange beams that are embedded in the back-up walls approximately 20 inches below each finish floor level (Figure 6).

Figure 6. Original CD detail 2/A-26 depicts the typical bearing condition of the type A granite wall panels.

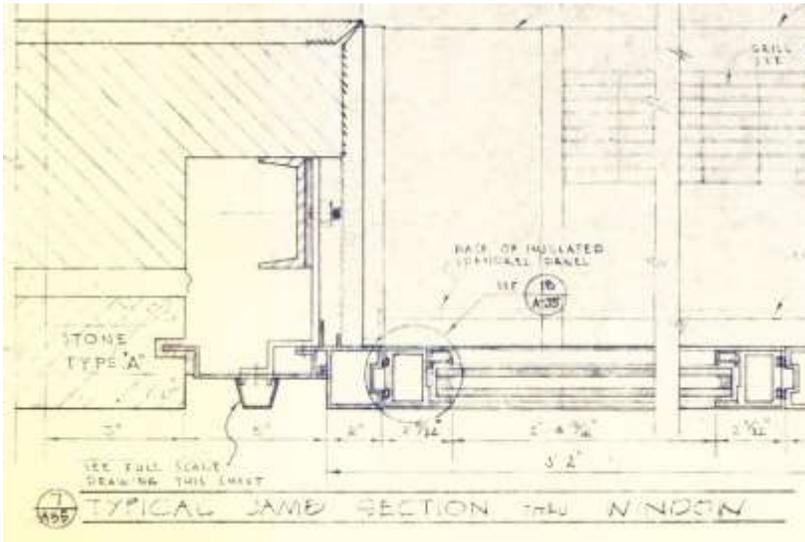
Figure 7. Original CD detail 7/A-35 depicts the original window jamb condition.

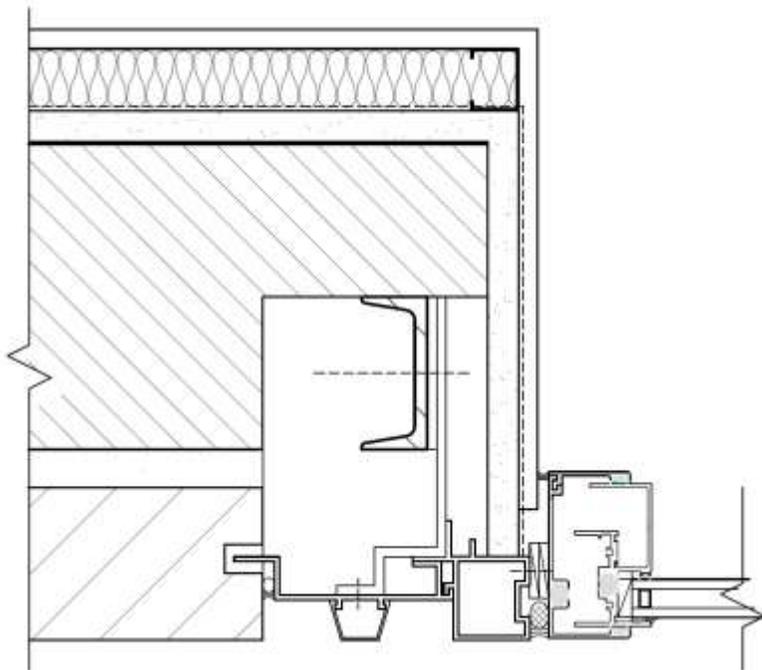
Figure 8. The existing window jamb detail includes replacement windows in a receptor frame, as well as a furred interior finish wall that includes insulation and a vapor retarder.

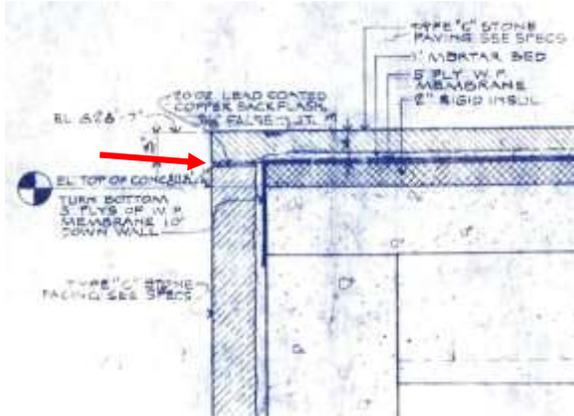
14. The west entry features an elevated terrace that is covered with dark gray colored (type C) granite pavers that match those of the east entry. The existing edge of the terrace features a sealant filled joint that differs from the original detail, which indicated a mortar joint with lead-coated copper flashing to drain incidental water from beneath the pavers. The original detail and the current condition are shown side by side (Figure 29 and Figure 30) for comparison. Water staining was evident at the sealant in this joint, indicating that the sealant is not allowing the paver substrate area to drain to the exterior.

Figure 29. The original terrace edge detail included a through-wall flashing at the edge of the wall (red arrow).
