**Section 2.2.4
Second Floor Conditions Assessment
Historic Structures Report**

MINNESOTA STATE CAPITOL
HISTORIC STRUCTURES REPORT
VOLUME 2.2.5

THIRD FLOOR SPACE INVENTORY AND CONDITIONS

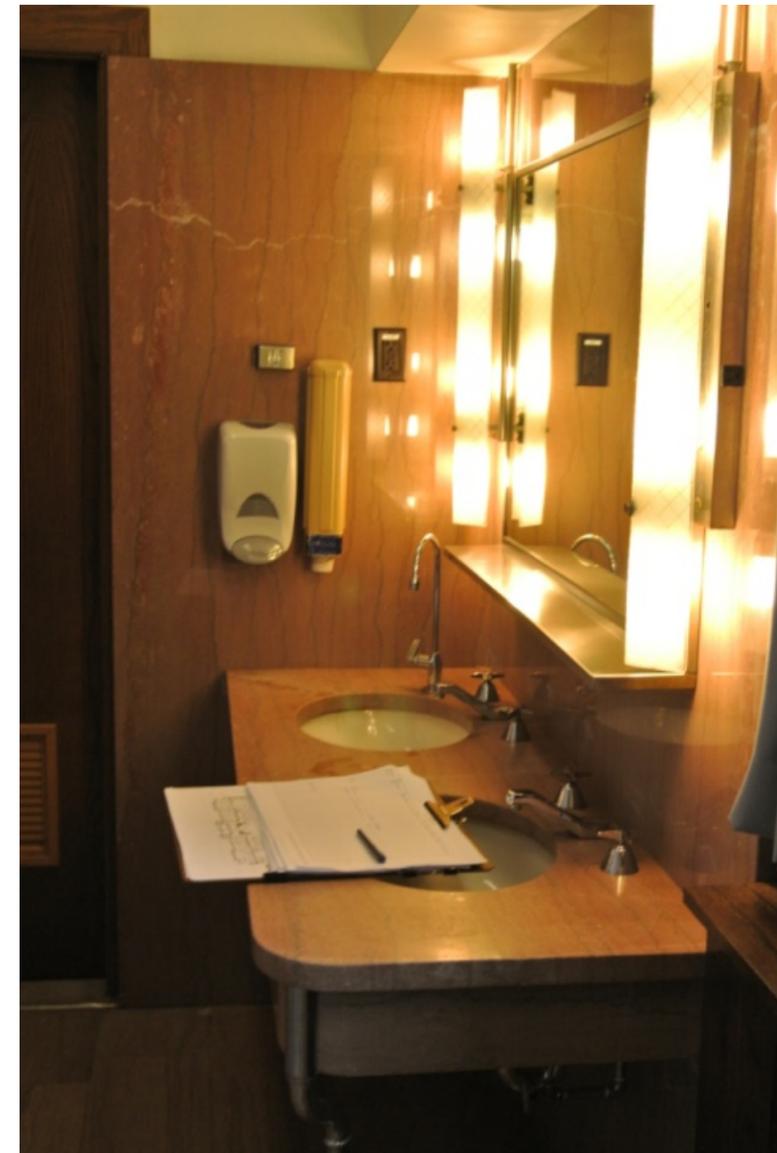
Counter and Mirror

Of the many Restrooms on this floor, only two are public, the Women's Restroom 213 is located next to the Oval Stair. Restroom 215 is a Unisex Restroom off the Rotunda Corridor next to the House. An enlarged stall was added in the Women's room by removing an adjacent stall. Neither room complies with current ADA standards. The other restrooms are reserved for staff and Legislator use and vary in age and accessibility.

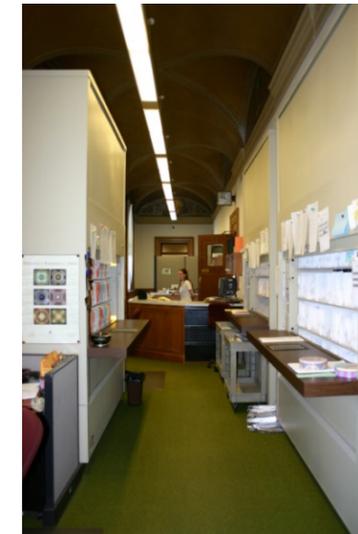
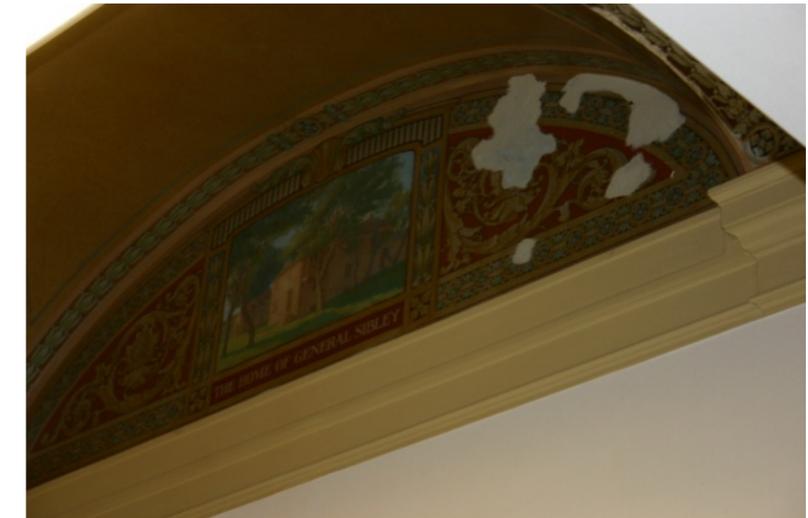
Area has been converted to office space. Floor is carpeted, and walls are covered with vinyl wall covering. Wooden counter and electric filling machine installed in west minor corridor. c.1920 ceiling and lunettes extant in both minor corridors.

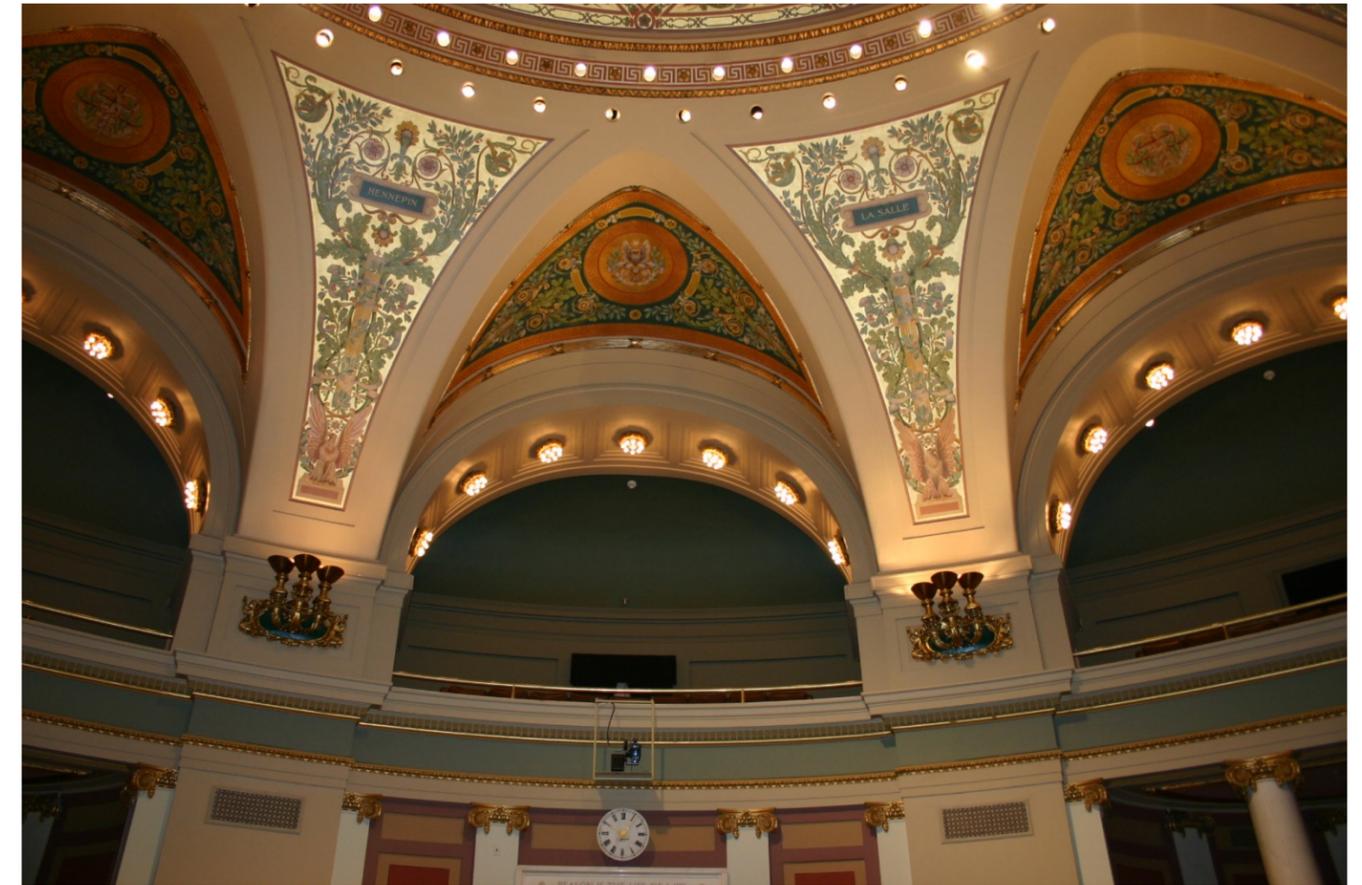
Current Description: The large seating section above the rostrum has been removed, replaced with a wall and a monumental statuary grouping. One of the five remaining sections have had their seats removed, and are now reserved for media use. Another of the sections has had its seating reduced to provide room for wheelchair access.

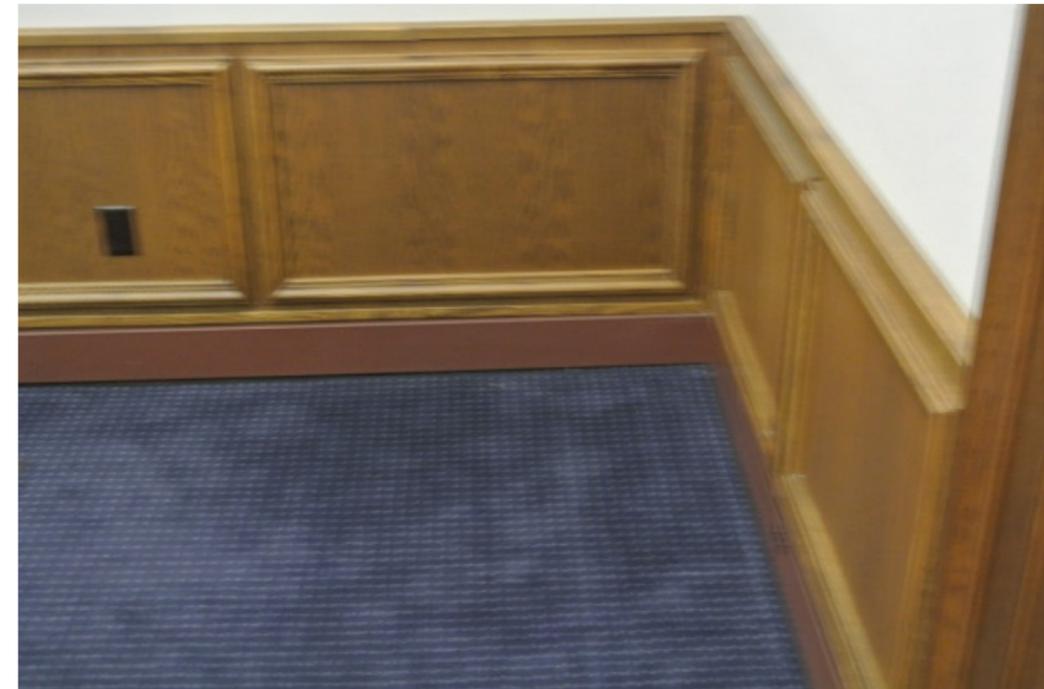
This Office Suite has received the typical treatment for Senatorial Offices.

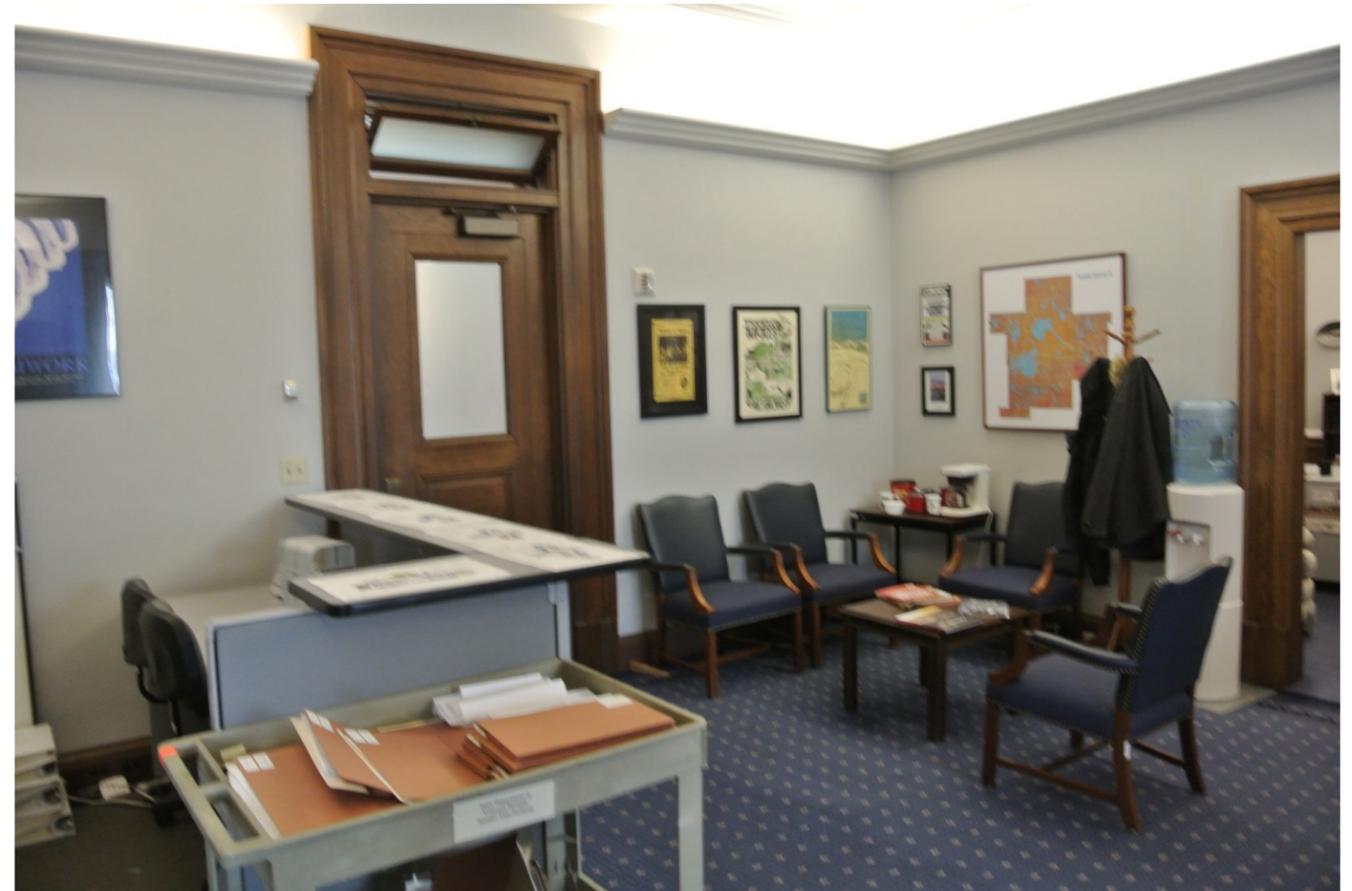
This Office Suite has received the typical treatment for Senatorial Offices.

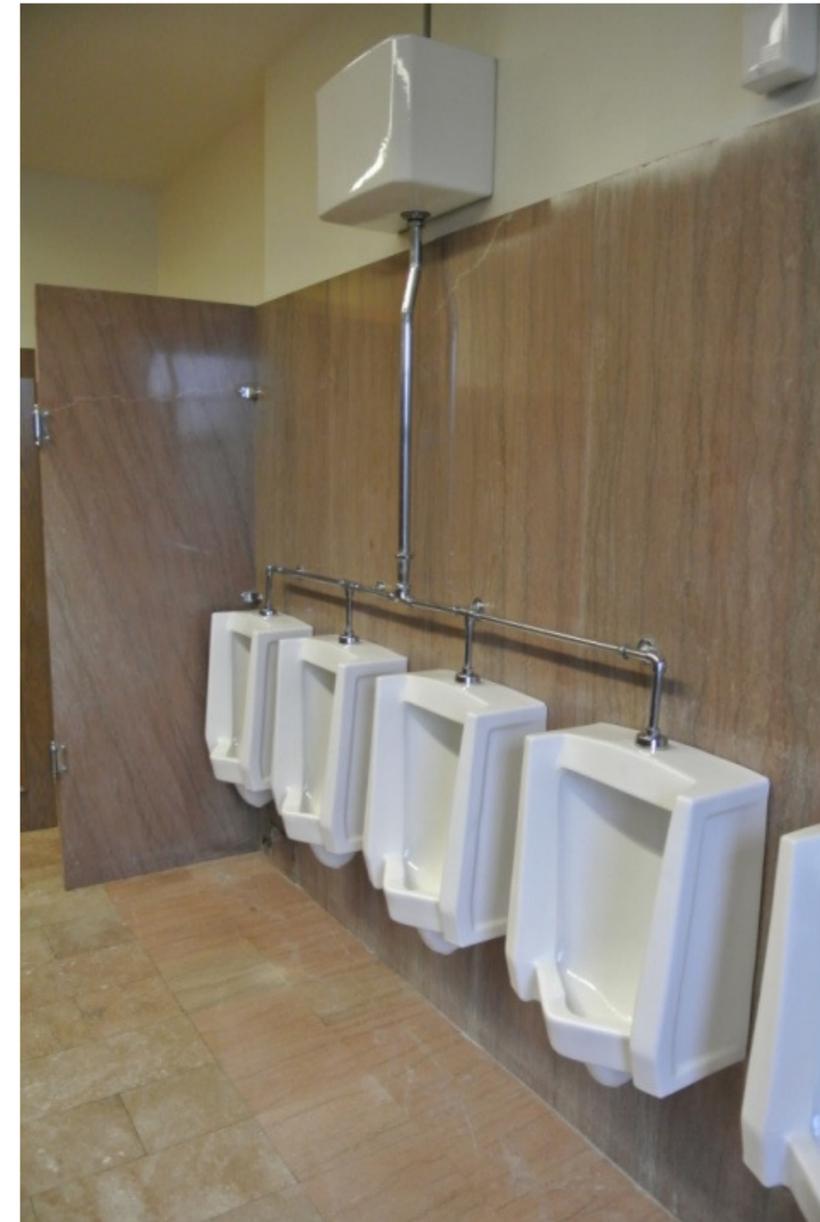
The Men's Restroom 314A is located next to the Oval Stair. The Women's Restroom 310A is located off the North Rotunda Corridor. The Men's Room has an enlarged stall added in the Men's Room by removing an adjacent stall. Neither room complies with current ADA standards.

Building Element:	Description:	Condition of Material:
Floor	Tennessee Marble	Modified
Walls	Tennessee Marble	Modified
Ceiling/Cornice	Plaster	Intact
Doors/Frame:	Original wood	Modified
Hardware	ADA Lever	Not original
Light Fixtures	Wall mounted	Not original
Artwork	None	None
Mechanical	None	None
Trim	Wood	Intact
