3.1.1 General Description of the Capitol.

Section 3.1.1
General Description
Historic Structures Report

Minnesota State Capitol Restoration

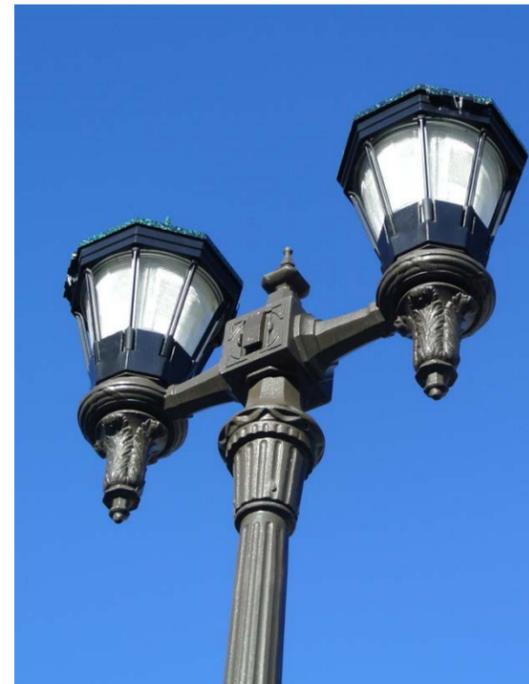
To the north of the Capitol, new light posts have been installed by the Light Rail line. These match the pylons that carry the wires for the trains. They do not match the standard light fixtures for the site.

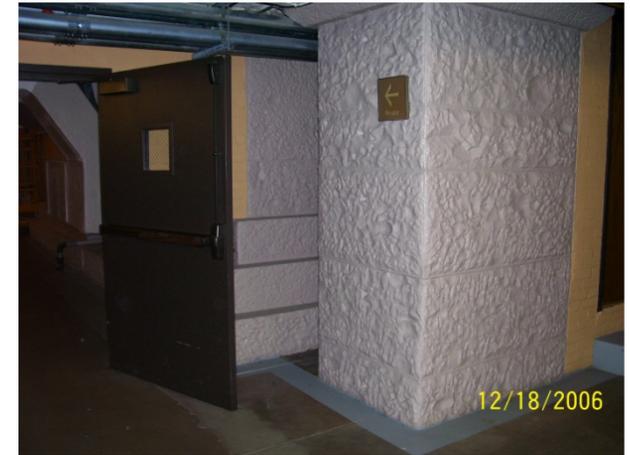
Kettle River Sandstone—Minnesota: This stone is called out for the foundations of the Dome, and does not seem to be visible even at basement level. The column shown supports the rotunda. It is difficult to tell what sort of stone is beneath this paint. Capitol Commissioner’s report does indicate it was delivered and installed on site.³ Kettle river sandstone has a high degree of compressive strength, at 12,295-12799 psi, which makes it well suited for foundations.⁴

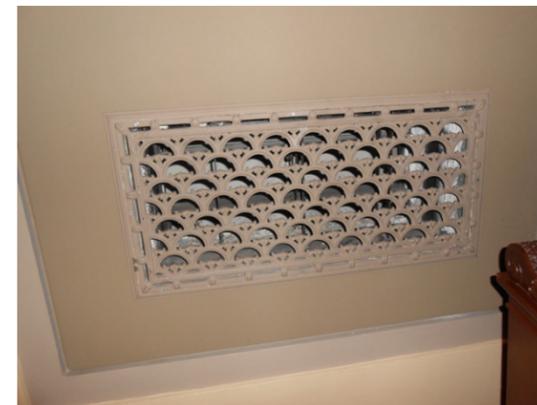
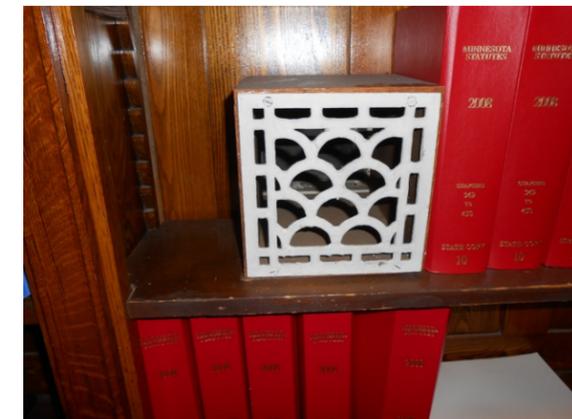
The House has grilles that are original follow the same general fishscale pattern as found elsewhere. A number of non original grilles have been added, following the standard Grecian pattern, except with plain borders. They are painted aluminum grilles. The House retiring has added grilles near the ceiling that appear to be a modern replication of the fishscale pattern in bronze finished metal.

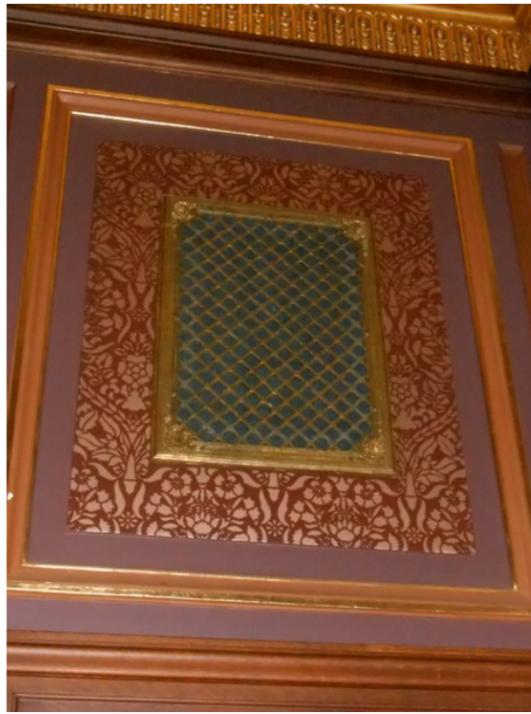
The Senate has curved grilles in the niches surrounding the chamber that follow the standard pattern, and are painted iron. These have been modified to add power and data connections. In the Senate Consulting chamber there are a pair of brass finished grilles with a highly decorative frame.

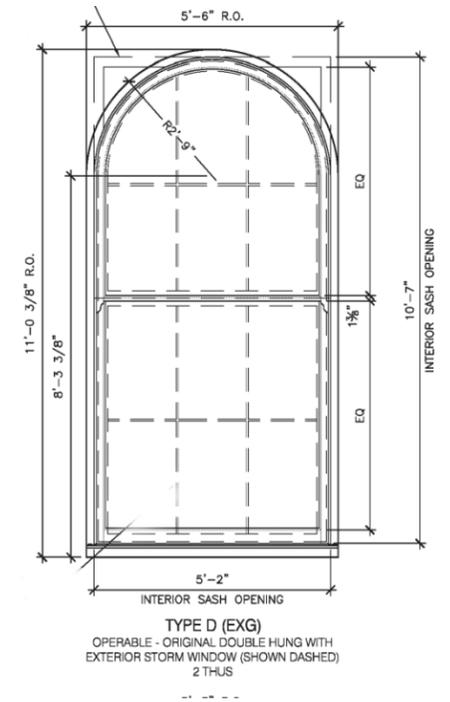
Window Type D (EXG): The two remaining original windows, restored and protected by a new storm window.

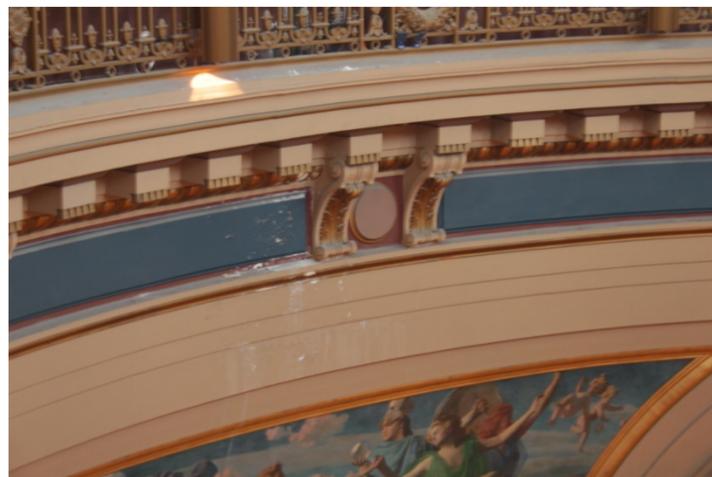
Dome: As early as 1912, plaster in the dome had deteriorated to such an extent that one of the murals fell off the wall.¹ (Murals in the dome are painted on canvas which is adhered to the plaster) This provoked a series of restoration efforts that culminated in 2010 with the Dome Repair Project. Over the course of this project, large amounts of plaster was restored. In addition to the water damage, a strip of plaster was removed, including decorative elements, in order to install a new rain leader. This plaster was restored to its original condition afterwards.

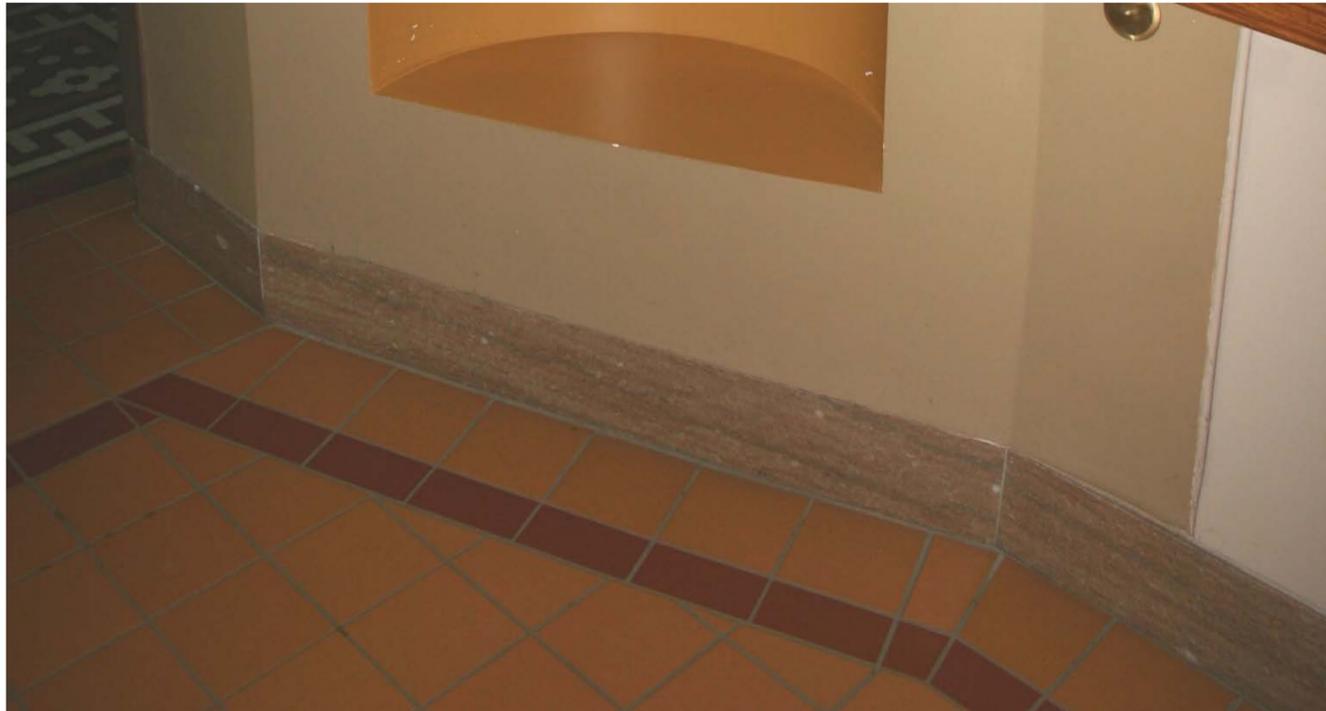
The kitchen areas are finished with a tan quarry tile, with no decoration. The other area of floor tile is the hallway leading down from the cafeteria/restaurant to the rest of the basement. The colors of this tile match the tan and red used in the original tile, adjacent, but the 6" square tile is dramatically out of scale with its neighbor. A color that is pleasant as a border may not be as appropriate as a field.

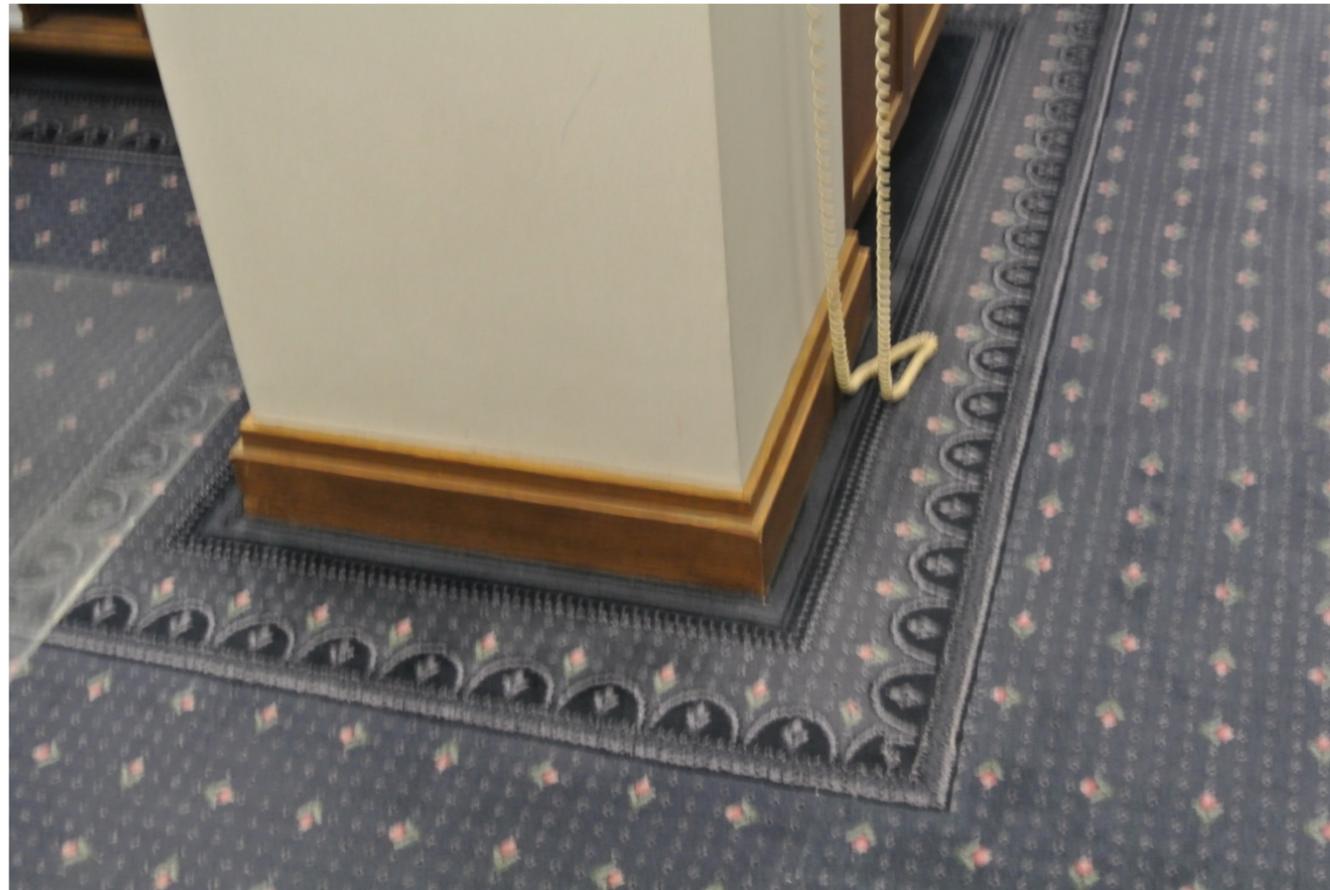
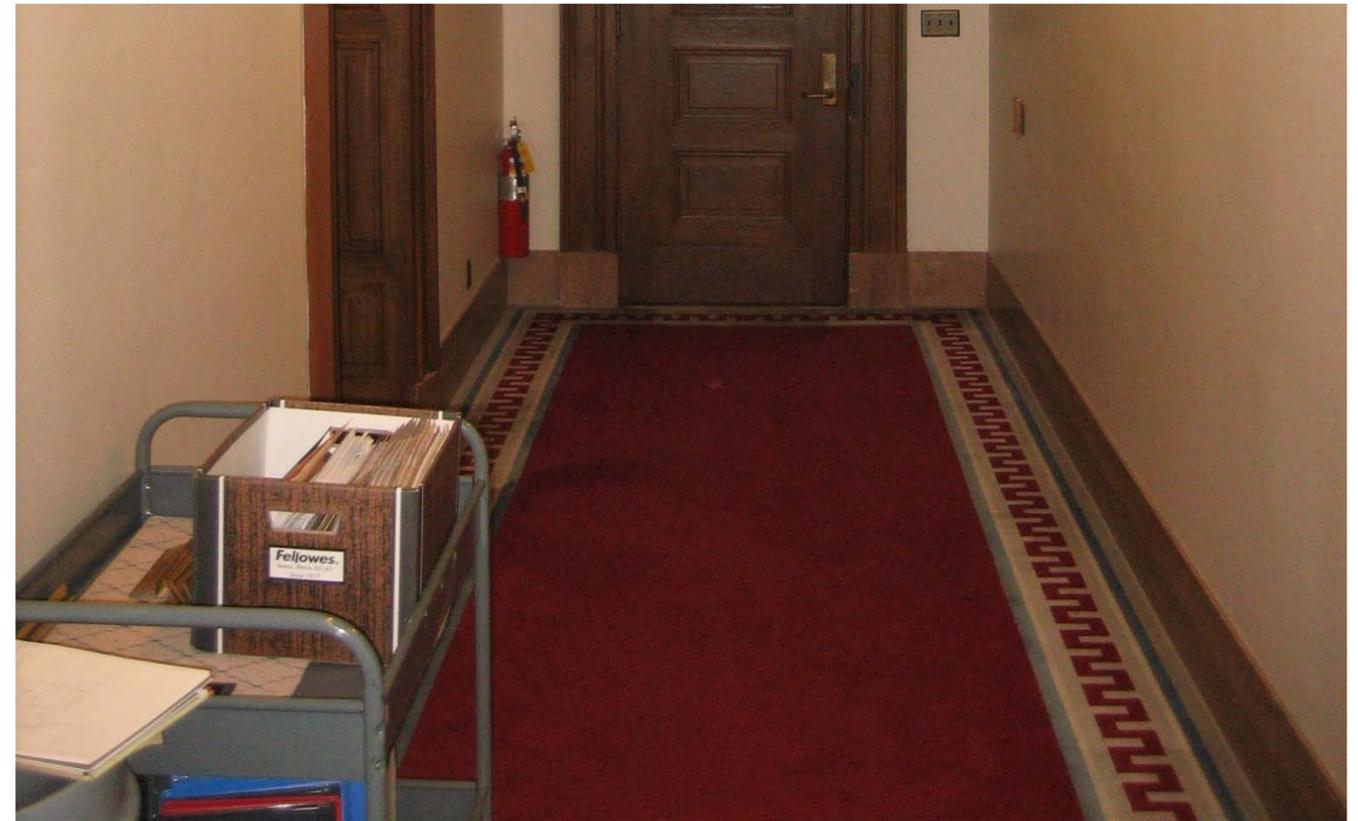
Newer Carpeting: Current carpeting generally dates back to whatever was the most recent renovation. For most of the office spaces, this means the mid nineties. The appearance and quality of the carpets varies, but there does seem to be a standard emerging for carpet of the Senate office spaces.

This example, in the Senate Clerk’s office, is one of the more elaborate installations. The blue field with the grid of contrasting decorations, in this case flowers, is typical. The border is not so typical. The 1989 Furnishing Plan Report concludes that original office carpets were blue with a similar pattern and a border.⁴

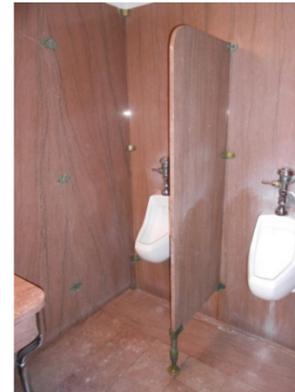
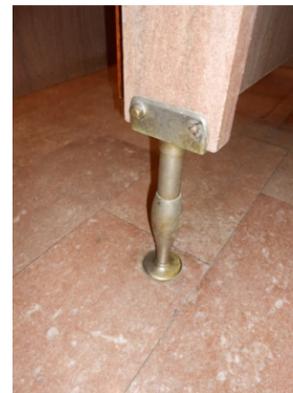
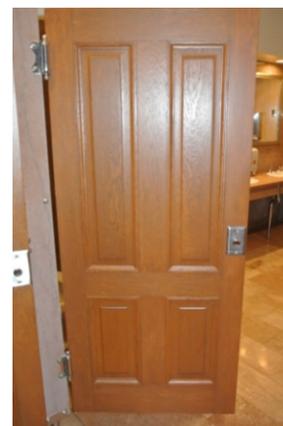
Stone Flooring, Wainscot, Counters and Partitions: All stone elements in the toilets are Tennessee Pink Marble. (see section 3.4, Stone for more information) Original counters are located at 29" AFF. Counters have chrome/nickel legs and have recessed floor beneath to catch small leaks. Floors are similarly recessed at WC locations. Stone wainscot is 84" high and 1" thick in all cases. Stone stall dividers are 1 1/2" thick and stand the same 84" high. Some have 10" spaces beneath them, while some are solid full height. In general, the dividers that divide the stalls from each other have the space while those that divide them from some other function are full height.

Stone in bathrooms is in relatively poor shape, due to frequent renovations, changes in fixtures and need for new access doors.

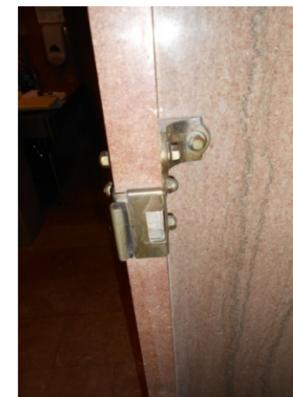
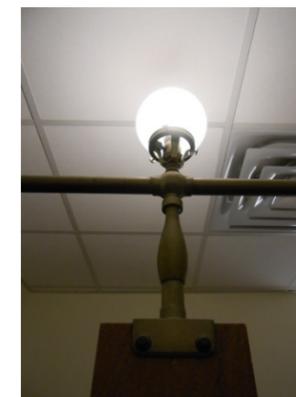
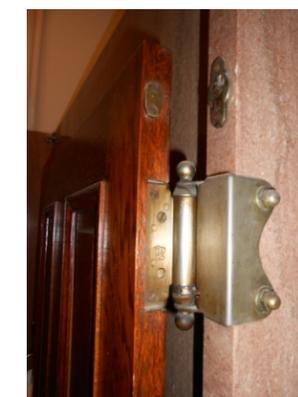
Metal hardware: All original hardware and other metallic items in toilets have a chrome/nickel finish. These include the hinges, latches, strikes, hooks, and other ordinary restroom accessories, but also partition support legs, and a structural pipe system above the partitions which supported the original light fixtures. Only two restrooms retain these, but most of them retain the matching stall and counter legs. There are also brackets at toilet stall dividers with the same chrome/nickel finish. Note that the original specification called for 'bronze' hardware. This was presumably changed during construction to the chrome/nickel finish.

There are several types of hinges and other hardware in evidence. Original hardware can be distinguished from replacement by its yellowish patina, which is a characteristic of nickel. Newer hardware has a much shinier finish.

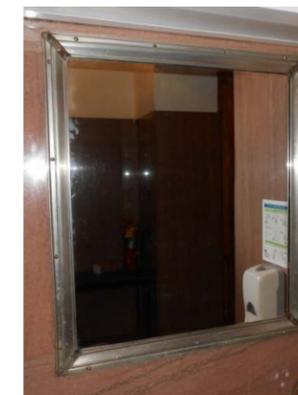
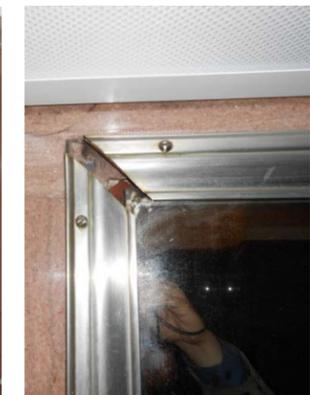
Fixtures: The fixtures have been changed for new. Marks on the wainscot clearly show where original piping was located.

Mirrors: Original mirrors are 35" high, have 2" metal frames, and vary in length from 30 to 120 inches. This particular example is missing its corner piece.
