RIGHT-OF-WAY REQUIREMENTS AND STRIPPING OF TOPSOIL

Construction on flat terrain, hillsides, and across drainages.

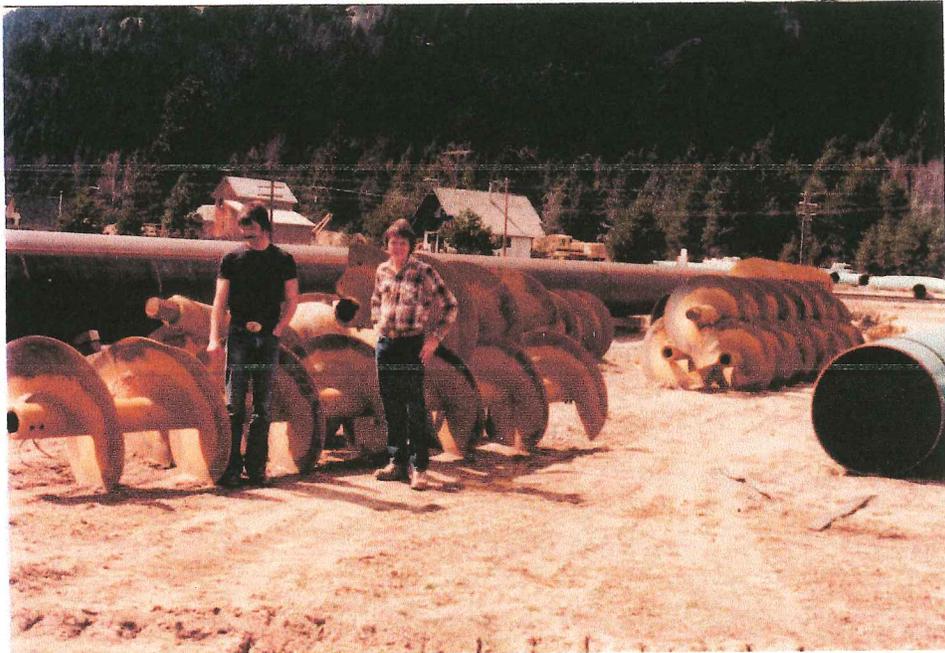
#48 Boring equipment (Idaho).

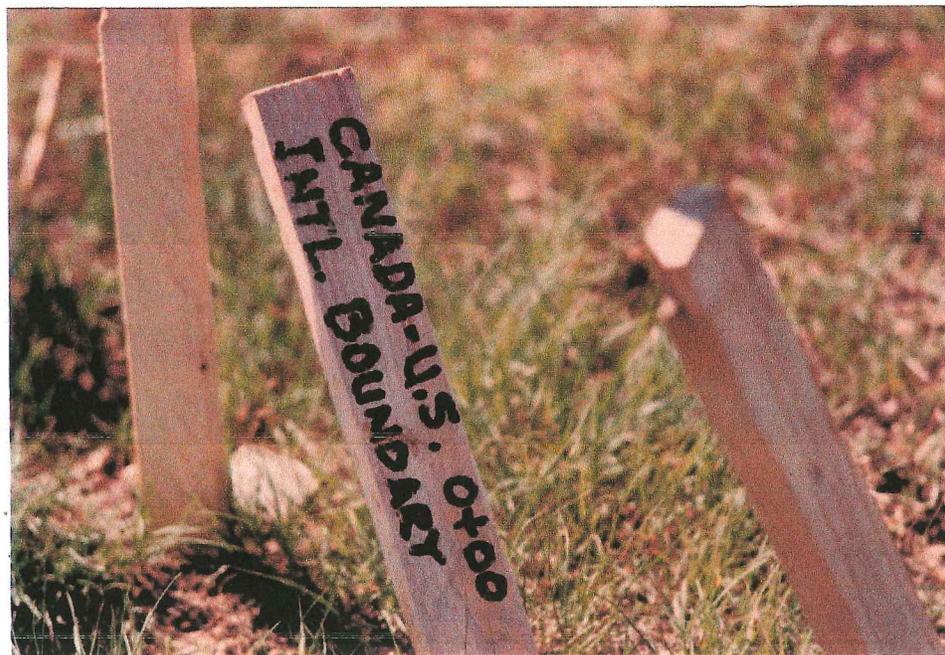
#49 Survey stakes along the r-o-w. Locations are given in the format "0+00". Table 1 gives survey stations for points where the pipeline enters and leaves state lands.

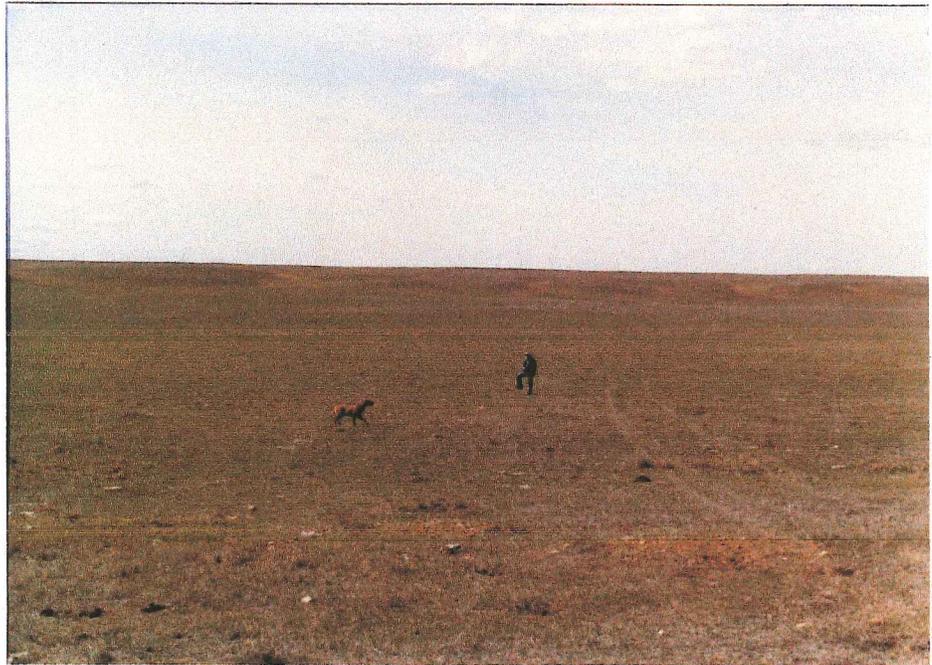
#50 State land parcel VA057 near the west boundary of the Fort Peck Reservation looking west on April 21 shortly before construction began. (see next photo).

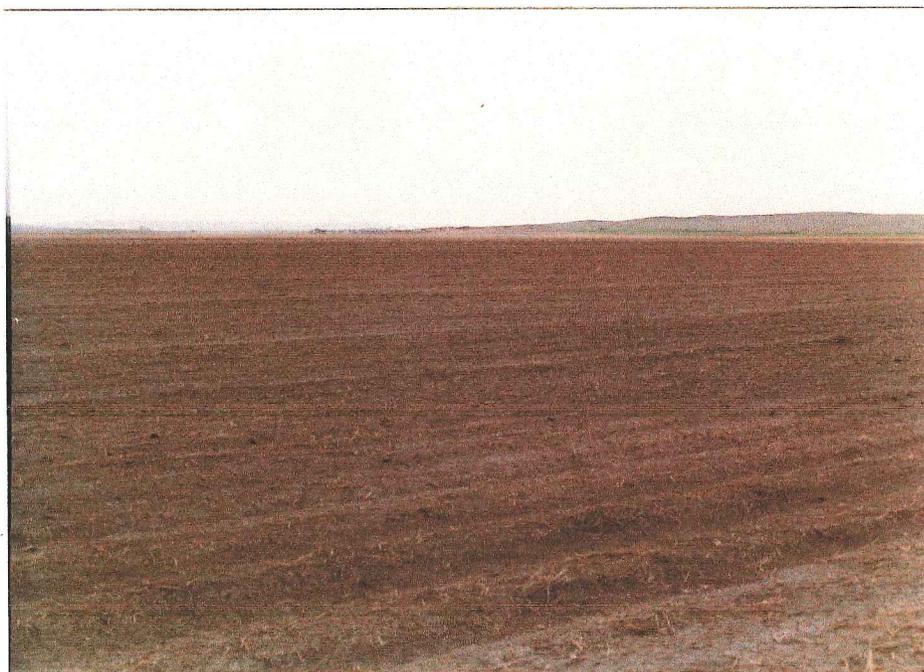
#53 State parcel R0195 southeast of Bainville, looking west on April 21 at an approaching dust storm two weeks before construction began. See next photo.

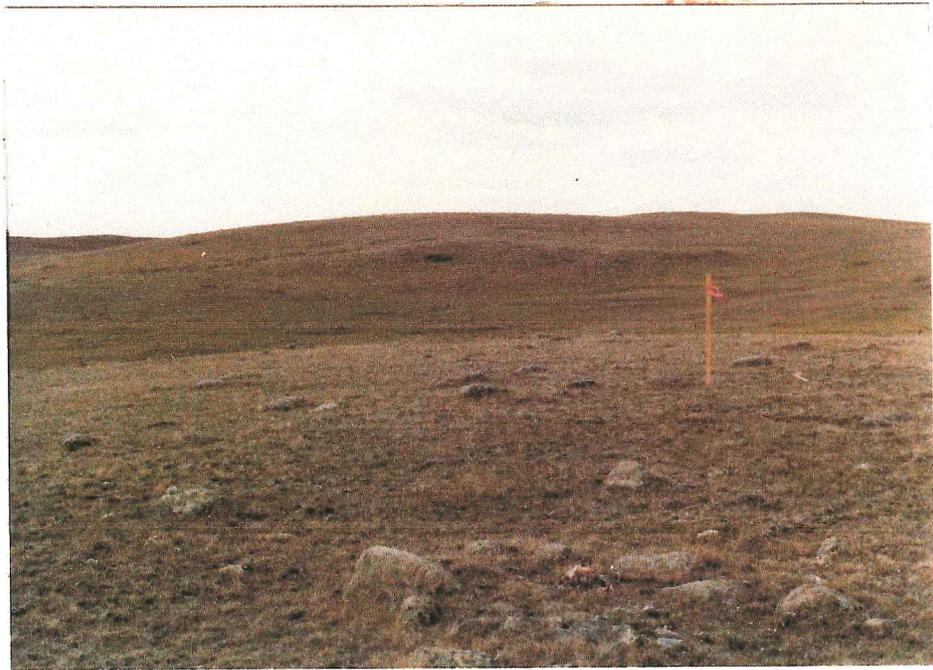
#56 Looking northwest on state parcel PH021 on April 21 before construction began. See next photo.

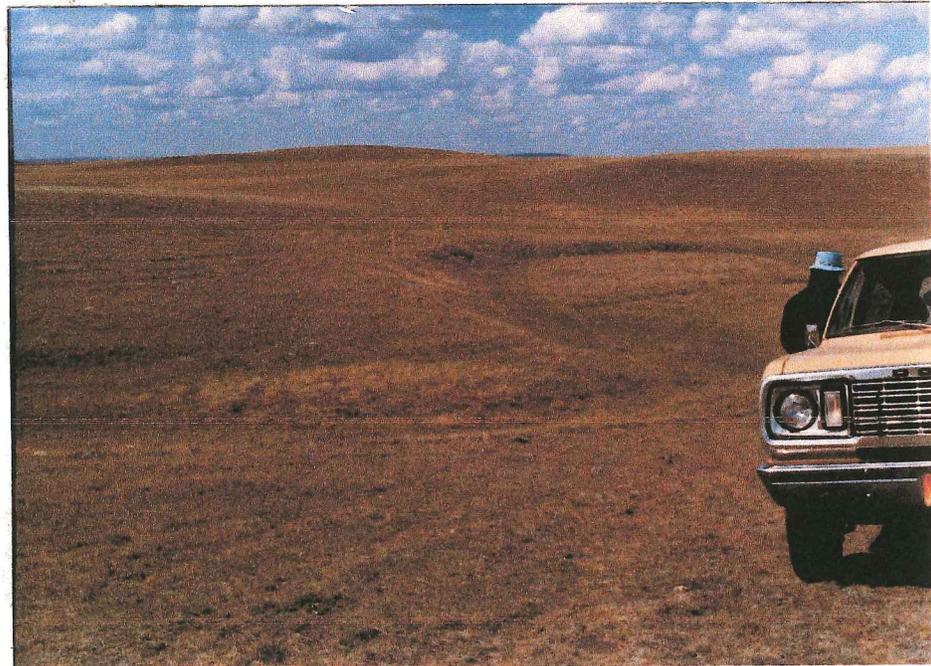
#61 Compare this view with that of #62. Both look west on state parcel PH012 from about the same spot. This photo was taken a few feet downhill from #62 on April 21, shortly before construction began.

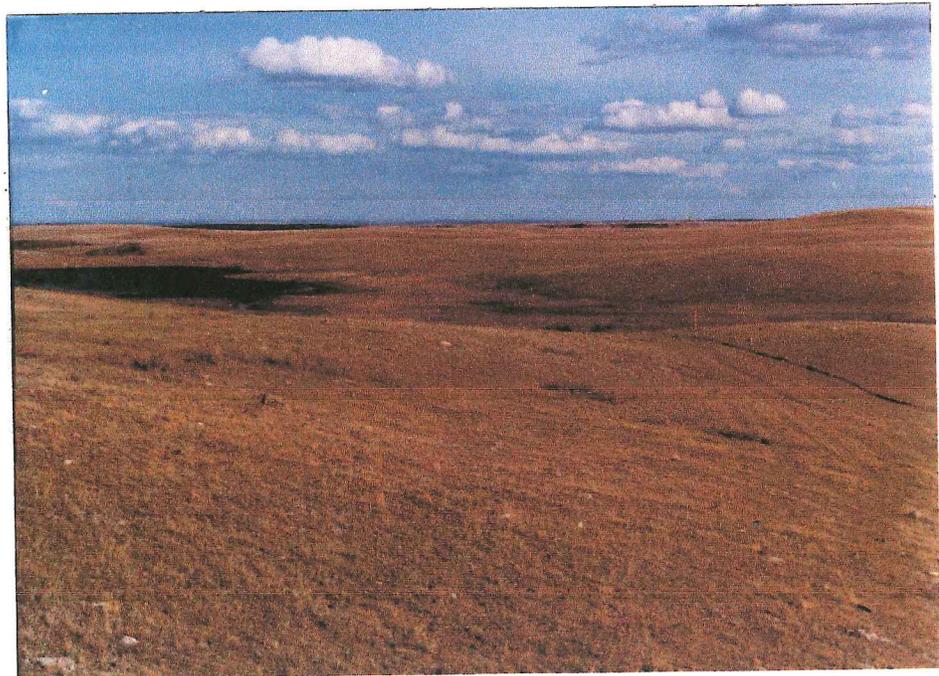
#63 State parcel PH026 on April 21, looking southeast past the reservoir in the middle of the section. See #64, #65, and #66.

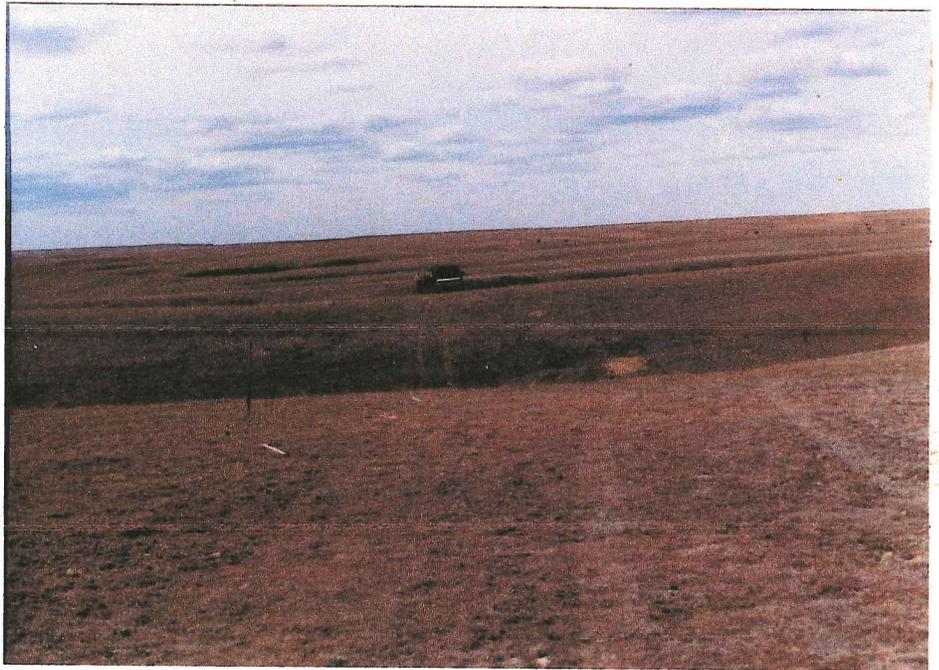
#69 State section VA051 looking west down staked centerline on April 21, 2 weeks before construction began. Compare with #70 and #71. This area is about four miles west of the west boundary of the Fort Peck Reservation.
