Public Buildings Enhanced Energy Efficiency Program

Investigation Results For Bemidji State University

BEMIDJI
STATE UNIVERSITY

5/14/2012

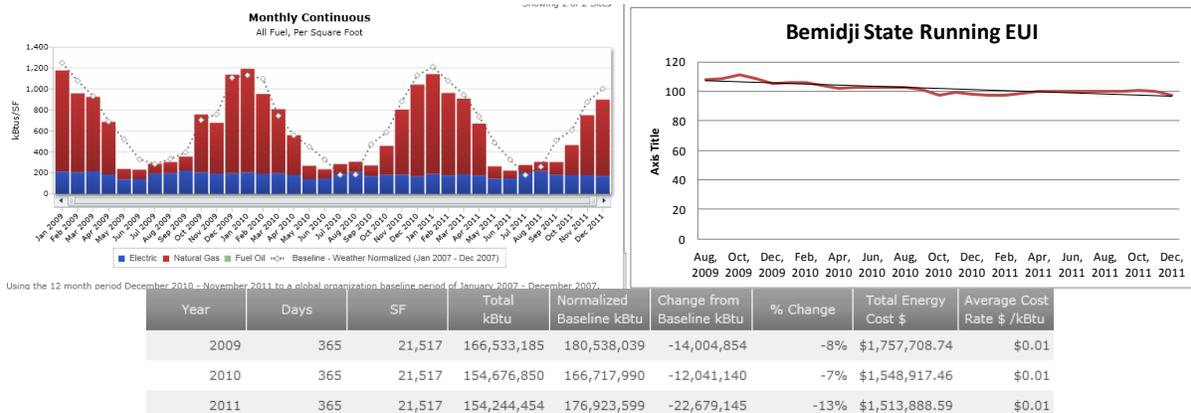
Bemidji State University Consumption Report; total energy usage has decreased 3% over the period of the investigation
