## **Public Buildings Enhanced Energy Efficiency Program**

### **Investigation Report for Riverland Community College – Austin Campus**

**3/15/2012**

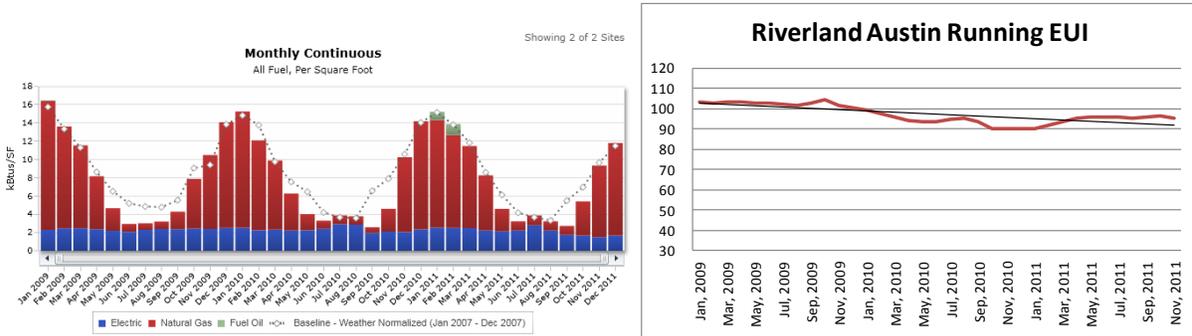
Year	Days	SF	Total kBtu	Normalized Baseline kBtu	Change from Baseline kBtu	% Change	Total Energy Cost \$	Average Cost Rate \$ /kBtu
2009	365	361,379	36,229,328	39,109,437	-2,880,109	-7%	\$523,467.48	\$0.01
2010	365	361,379	32,540,864	37,176,972	-4,636,108	-12%	\$506,003.08	\$0.02
2011	365	361,379	33,608,276	36,223,046	-2,614,770	-7%	\$470,297.90	\$0.01

Riverland Community College Consumption Report  
 The energy use at Riverland Community College dropped approximately 9% over the period of the investigation.
