National Register of Historic Places Multiple Property Documentation Form

Minnesota's German Immigrant Timber Frame Barns, 1865-1925

name/title	Susan Granger and Scott Kelly	/		
organization	Gemini Research			
street & number	15 East 9th Street			
city or town	Morris	state	MN	zip code 56267
e-mail	gemres@info-link.net			
telephone	320-589-3846	date	September 2015

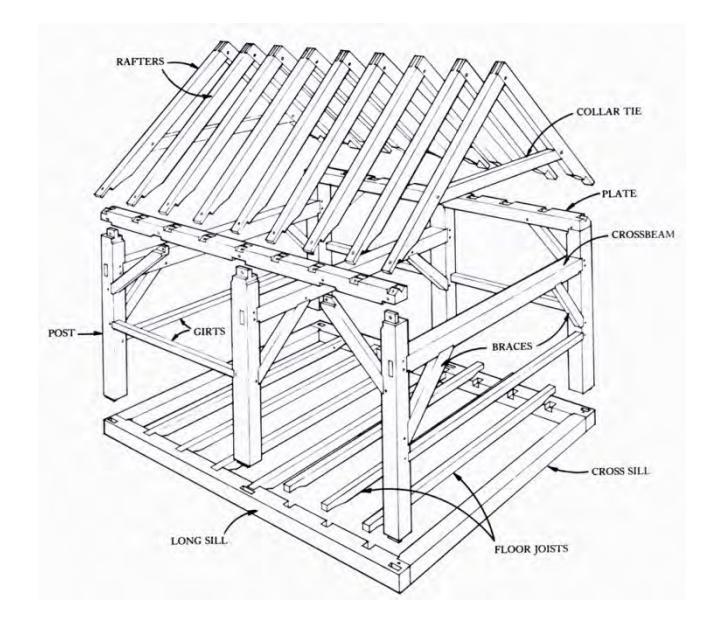
Figure 5. Components of a simple timber frame. Three to five bents, consisting of posts and cross beams, were often assembled on the ground, tipped up into place, and then attached to the sills and wall plates. (Reproduced from Jack Sobon and Roger Schroeder's *Timber Frame Construction: All About Post-and-Beam Building* 1984.)

The superstructure of a timber frame barn is comprised of a series of bents that were typically preassembled on the ground and tipped up into place on a stone foundation. Large timbers ranging from 8" x 8" to 12" x 12" in cross-section were used as principal elements, and smaller timbers were used for braces, girts, and other components. The timber frame was generally assembled with mortise and tenon joints fastened with wooden pegs. Joints were either custom-cut into unique mortise and tenon pairs, or cut with standardized mortise and tenon units that were more interchangeable.

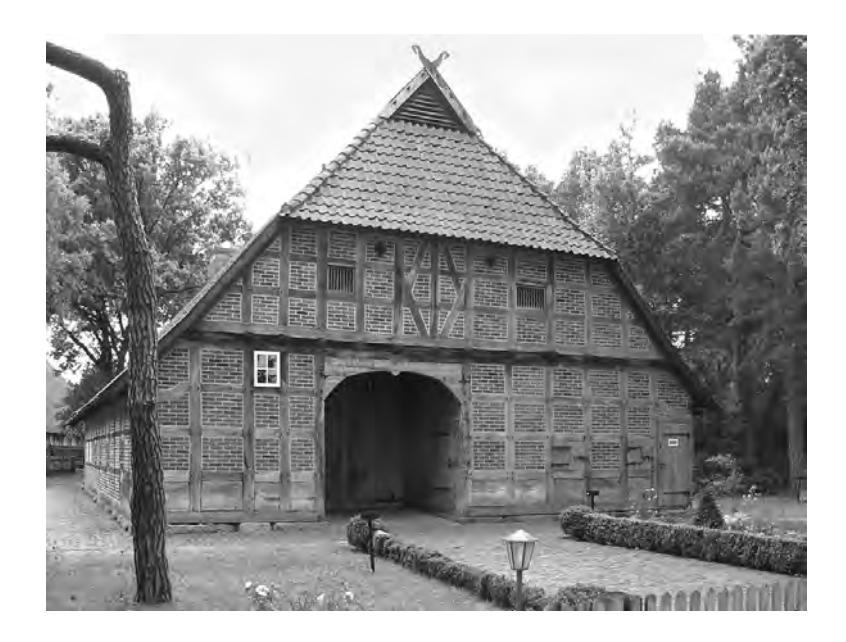
Figure 6. Lower Saxon house barn (*Niedersachsenhaus* or *Fachhallenhaus*) built 1795, located at Winsen Museum Farm at Winsen in northwestern Germany (2009 photo by Axel Hindemith, released to public domain, Wikimedia Commons).

This barn type evidently evolved from the Lower Saxon house-barn found in northwestern Germany (Fig. 6). It is believed to be rare among Minnesota's German immigrant timber frame barns. The type is not discussed in most sources on the development of barns in the U.S. (see bibliography in Section I). Timber frame examples like Minnesota's Dunker Barn that were built fairly early (circa 1900) by farmers of German immigrant stock may be rare nationwide.

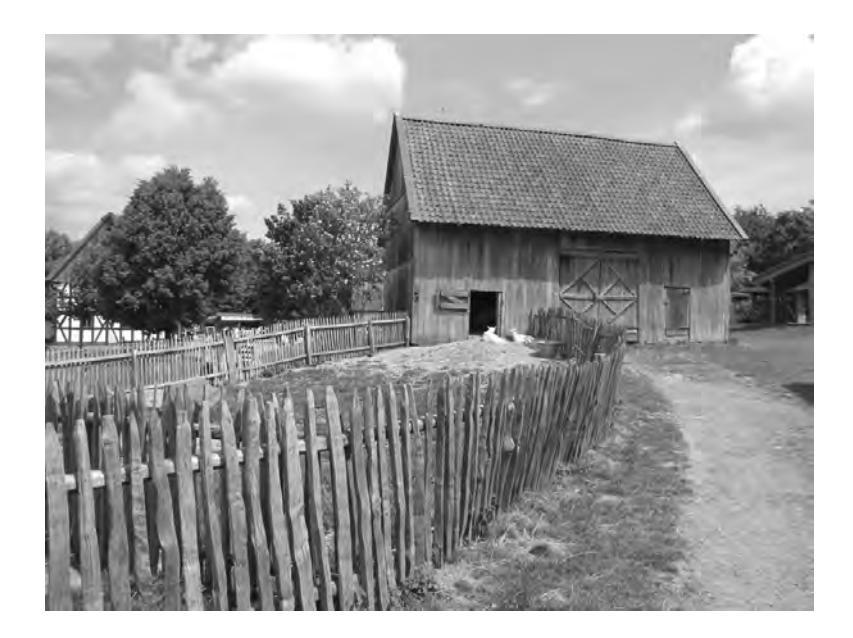
Figure 7. Historic timber frame Ground Barn with vertical wood siding, similar to those in southeastern Minnesota, preserved at Bergisch Open Air Museum at Lindlar in northwestern Germany (2011 photo by Ziko van Dijk, released to public domain, Wikimedia Commons).

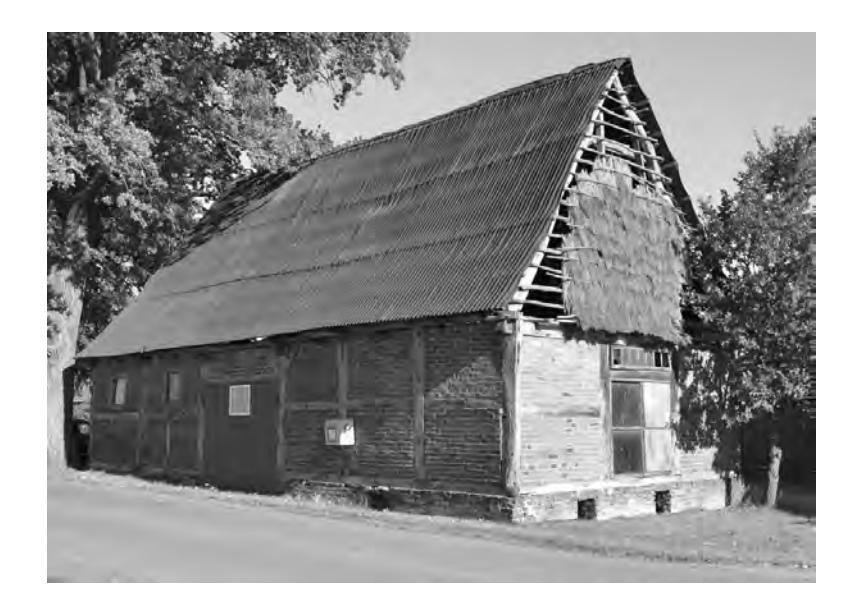
Figure 8. Historic timber frame Ground Barn with square panel framing and brick nogging near Bassum in northwestern Germany (2011 photo, released to public domain, Wikimedia Commons).

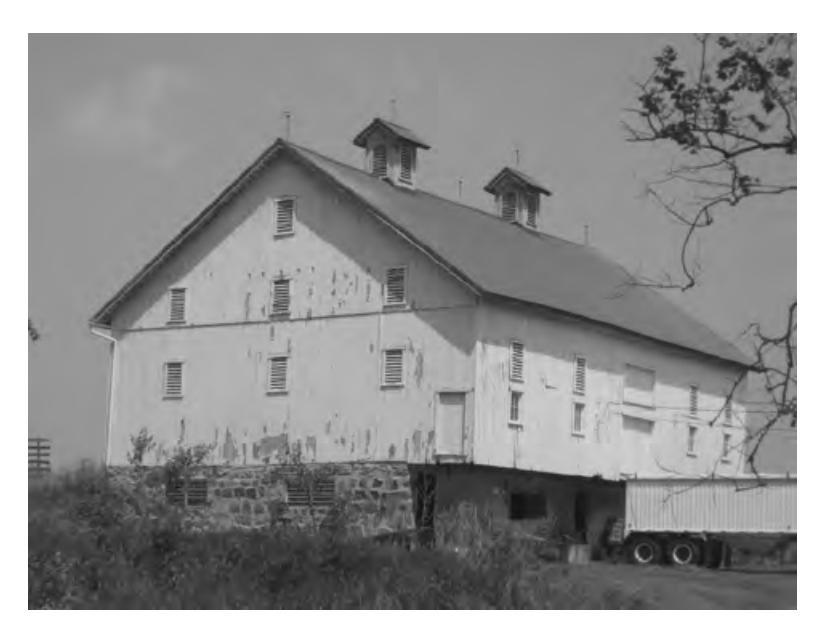
Figure 9. Pennsylvania German bank barn located in Indiana. The distinguishing feature of the so-called Pennsylvania Barn is the mow forebay, at right, which extends over the basement wall. No examples are known to exist in Minnesota, but many were built in Wisconsin (2011 photo by Nyttend, released to public domain, Wikimedia Commons).

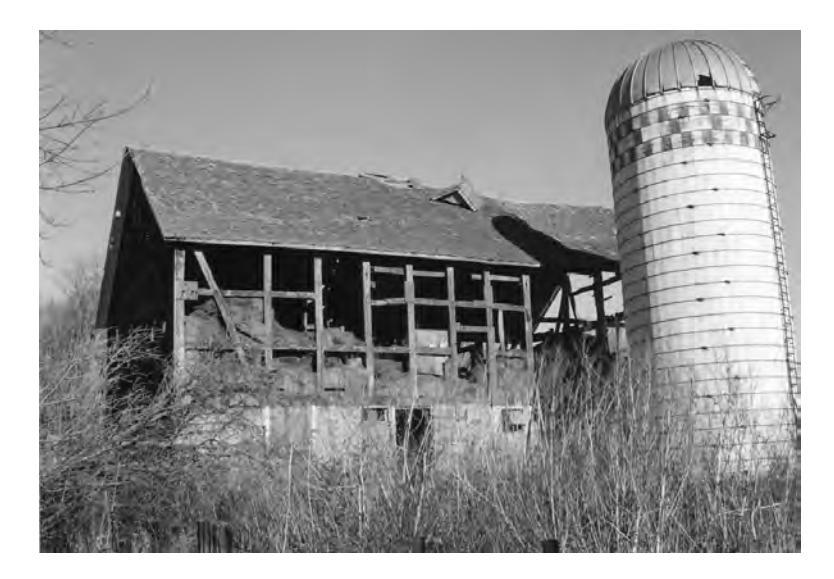
Figure 10. The Poehler Barn is a Basement Barn built ca. 1875. Its German-influenced design has European square panel framing and long diagonal braces. Some of the timbers are irregular or slightly curved. On the roof is the remnant of a gabled ventilator or cupola made of wood. Courtland Twp., Nicollet County (NL-CTT-061) (photo by Dan Pratt, 2005).

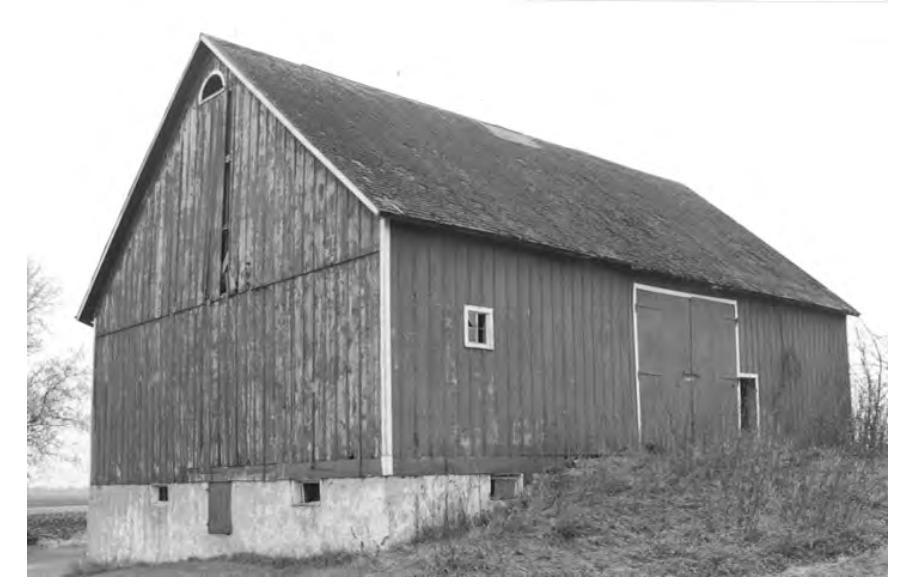
Figure 11. Most of Minnesota's German immigrant-built timber frame barns are Basement Barns. Most, like this example, are built into a natural slope. In early examples the wagon doors typically open outward, seen above, while in later barns they often slide open. Bruns Barn, ca. 1890, Courtland Twp., Nicollet County (NL-CTT-058) (photo by Dan Pratt, 2005).

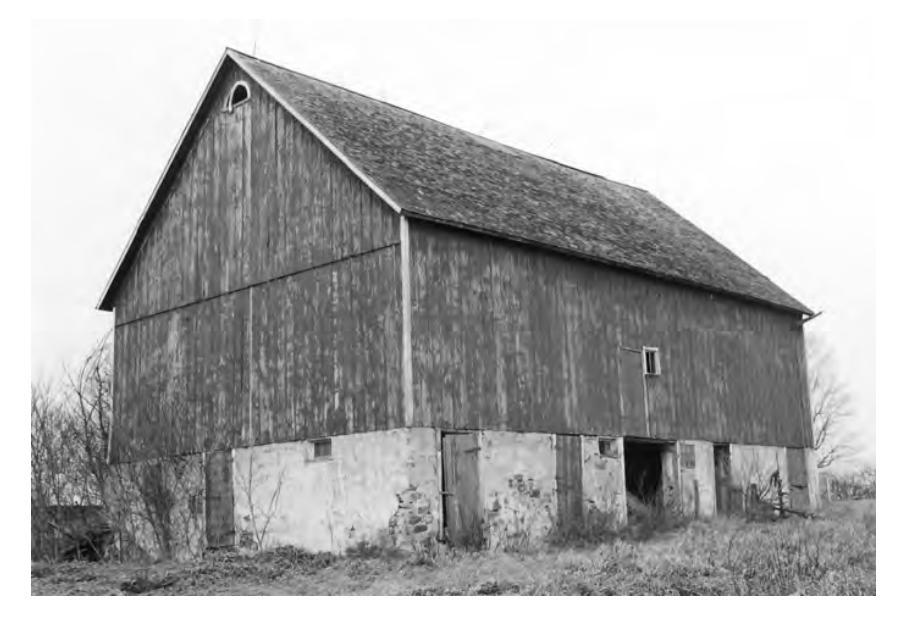
Figure 12. The non-slope side of the same 36' x 56' barn. The stable walls are built of fieldstone parged with concrete. The stable has one large door and about five smaller doors. Bruns Barn, ca. 1890, Courtland Twp., Nicollet County (NL-CTT-058) (photo by Dan Pratt, 2005). (See also Figure 59.)

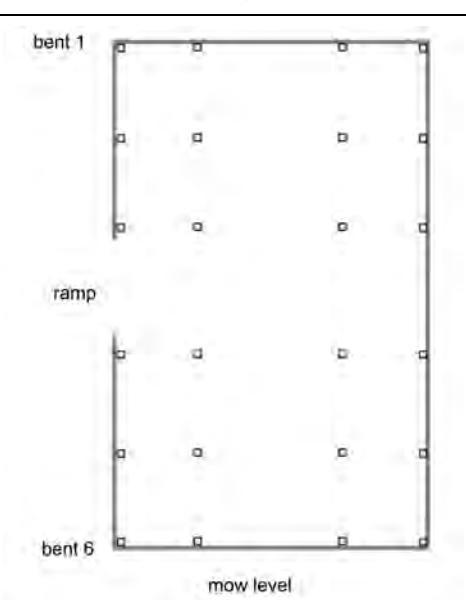
Figure 13. Typical plan of the mow of a Basement Barn. This barn measures 36' x 60'. Most of Minnesota's German immigrant-built timber frame barns have three, four, or five bays. Schmidt Barn, Dahlgren Twp., Carver County (CR-DHL-049) (Gemini Research sketch).

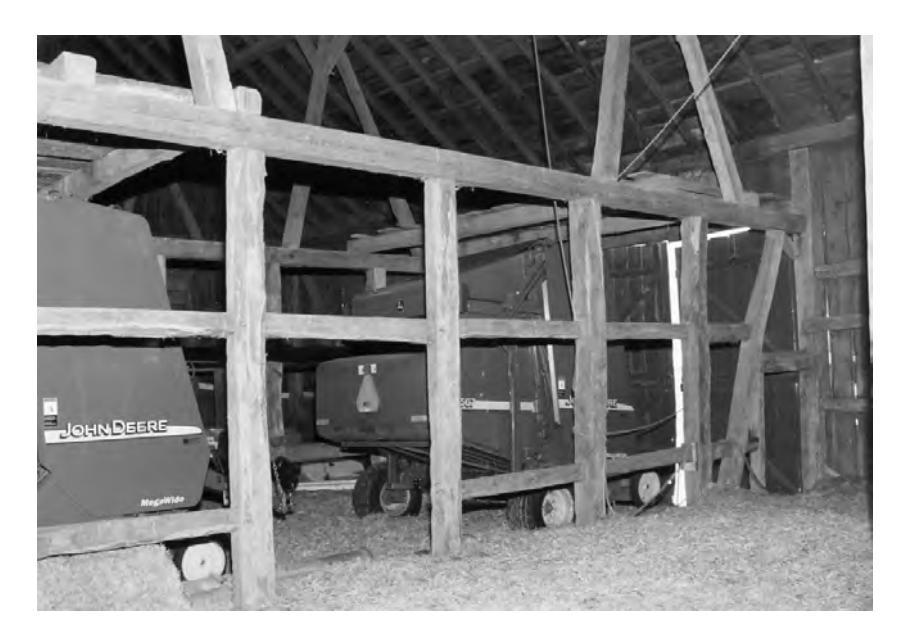
Figure 14. In a Basement Barn, the doors at the top of the ramp open onto a wagon bay, seen here with machinery stored in it. To load the barn with hay, wagons were driven into the bay and the hay was pitched by hand into the flanking storage bays (foreground in the photo). The bays would often be filled nearly to the roof. The wagon was then backed out of the barn and down the ramp. H. and S. Bode Barn, ca. 1875, Nicollet Twp., Nicollet County (NL-NCT-011) (photo by Dan Pratt, 2005).

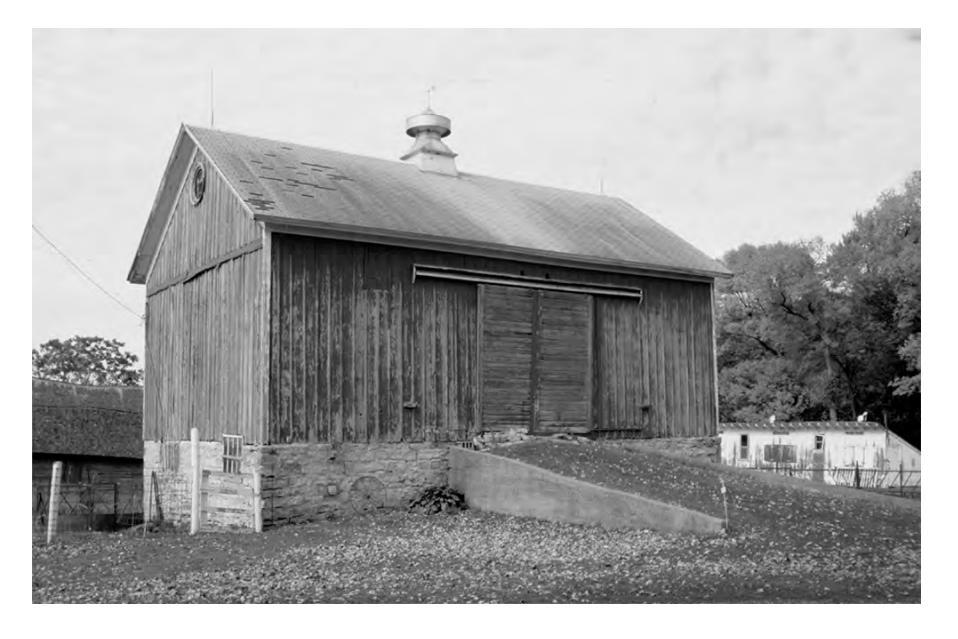
Figure 15. This Basement Barn has a man-made ramp since no natural slope was available. The walls retaining the ramp were originally limestone and replaced ca. 1935 with poured concrete. The leaves of the wagon door, first built of vertical wood and opening outward, were replaced with sliding leaves of horizontal wood. The rooftop ventilator was originally wood and is now a manufactured steel model. Benike Barn, ca. 1875, Farmington Twp., Olmsted County (OL-FRM-020) (photo by Scott Kelly, 2008).

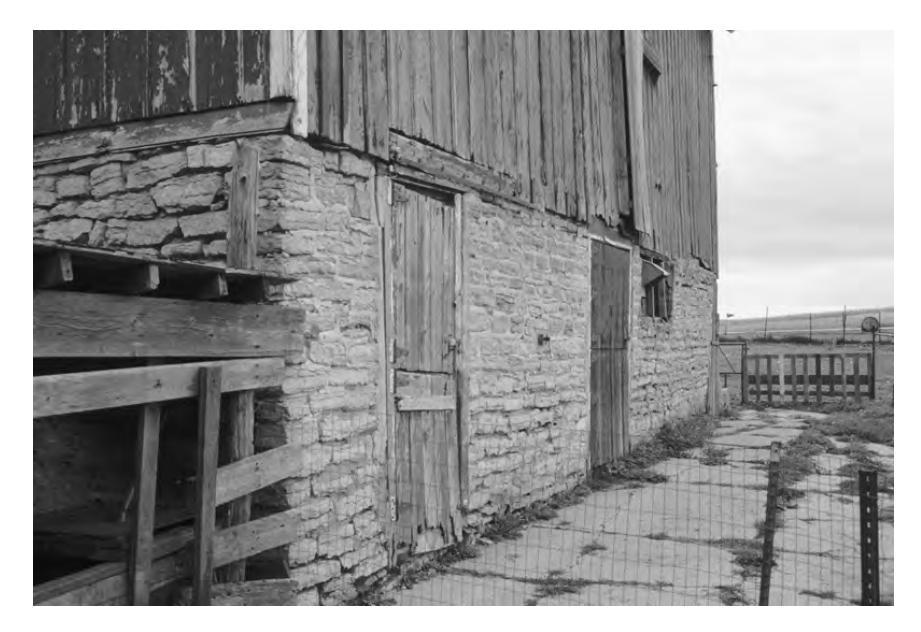
Figure 16. The opposite site of the same barn, which has a 30' x 48' footprint. The limestone was quarried near the farm. Note that the stable doors are split or "Dutch" style. Benike Barn, ca. 1875, Farmington Twp., Olmsted County (OL-FRM-020) (photo by Scott Kelly, 2008). (See several other photos of the Benike Barn herein.)

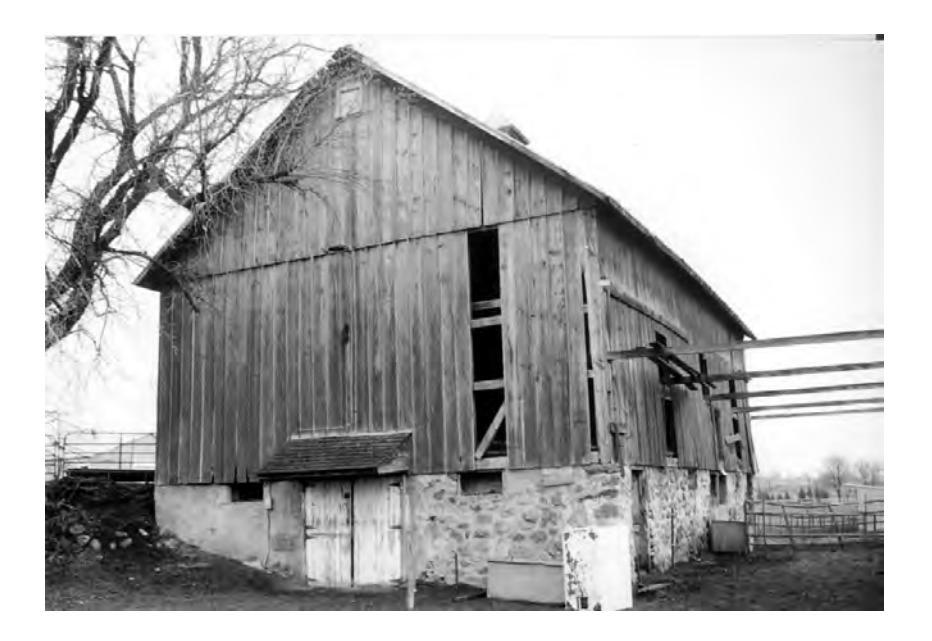
Figure 17. Scholars indicate a pent roof, seen over the door of this basement stable, is characteristically German and related to the forebay and pent roof tradition of the Pennsylvania Barn. Klippstein Barn, ca. 1890, Courtland Twp., Nicollet County (NL-CTT-017) (photo by Dan Pratt, 2005).

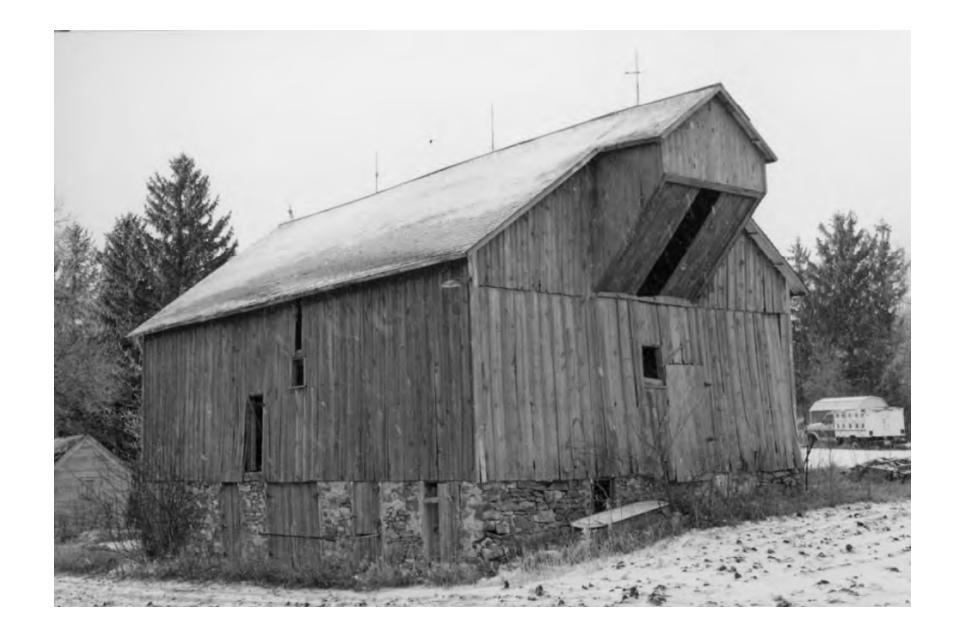
Figure 18. An elaborate enclosed hay hood has been added to this 30' x 50' Basement Barn, built ca. 1875. Meyer Barn, Courtland Twp., Nicollet County (NL-CTT-050) (photo by Dan Pratt, 2005). (See also Figures 43, 51, and 52.)

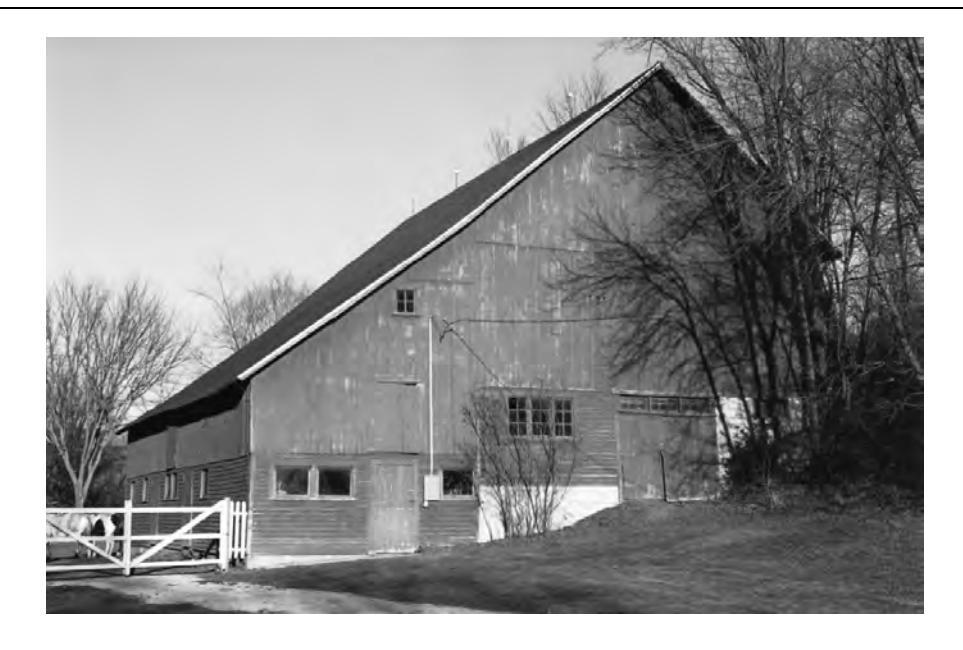
Figure 19. The Heim Barn is a 34' x 60' Basement Barn built in 1907. The left-hand portion is an 18'-wide addition, built ca. 1910 to provide a horse stable and milk room. Courtland Twp., Nicollet County (NL-CTT-026) (photo by Dan Pratt, 2005).

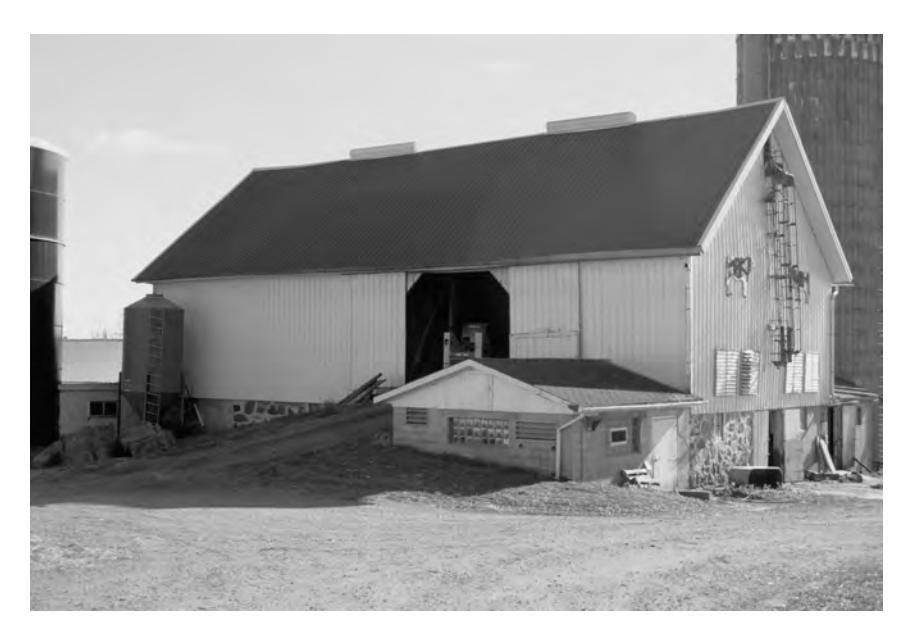
Figure 20. This Basement Barn has several alterations including a milk house addition, modern roof vents, out-of-scale attached silos, a large addition to the basement, and reconstruction of a substantial part of the basement walls. While a barn can sustain a few alterations and retain historic integrity, the cumulative effect of all of these changes makes this barn unable to clearly convey its historic character, function, and significance. Benton Twp., Carver County (CR-BNT-147) (photo by Scott Kelly, 2007).

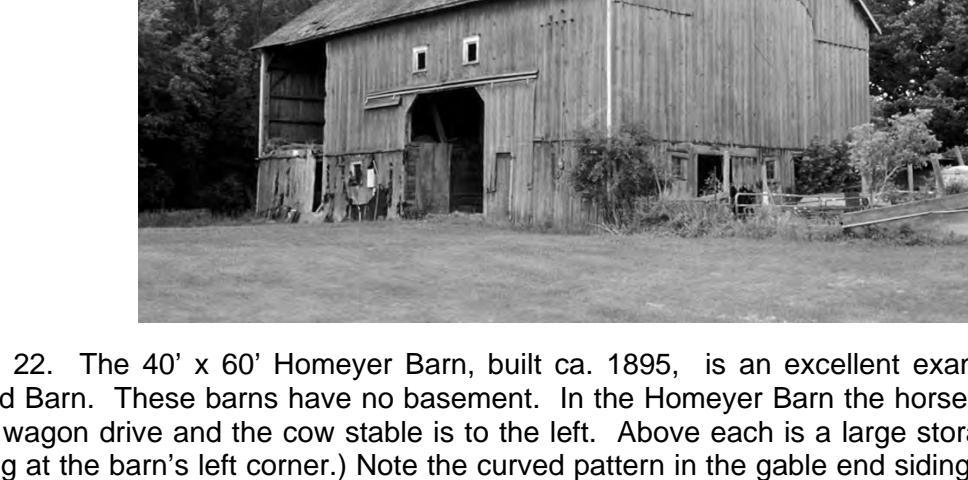
Figure 22. The 40' x 60' Homeyer Barn, built ca. 1895, is an excellent example of a Two-Level Ground Barn. These barns have no basement. In the Homeyer Barn the horse stable is to the right of the wagon drive and the cow stable is to the left. Above each is a large storage mow. (Siding is missing at the barn's left corner.) Note the curved pattern in the gable end siding, which is Germanic. Havana Twp., Steele County (ST-HAV-032) (photo by Scott Kelly, 2007). (For a plan, see Figure 23; see also Figures 46 and 57.)

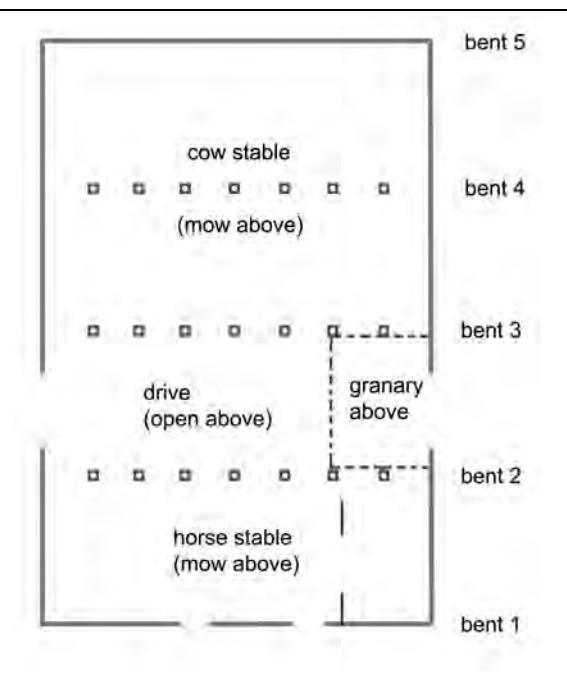
Figure 23. Most of Minnesota's German immigrant Two-Level Ground Barns have a door at each end of the wagon drive, allowing wagons to drive through the barn rather than having to back up. This is a plan of the Homeyer Barn, ca. 1895, Havana Twp., Steele County (ST-HAV-032) (Gemini Research sketch).

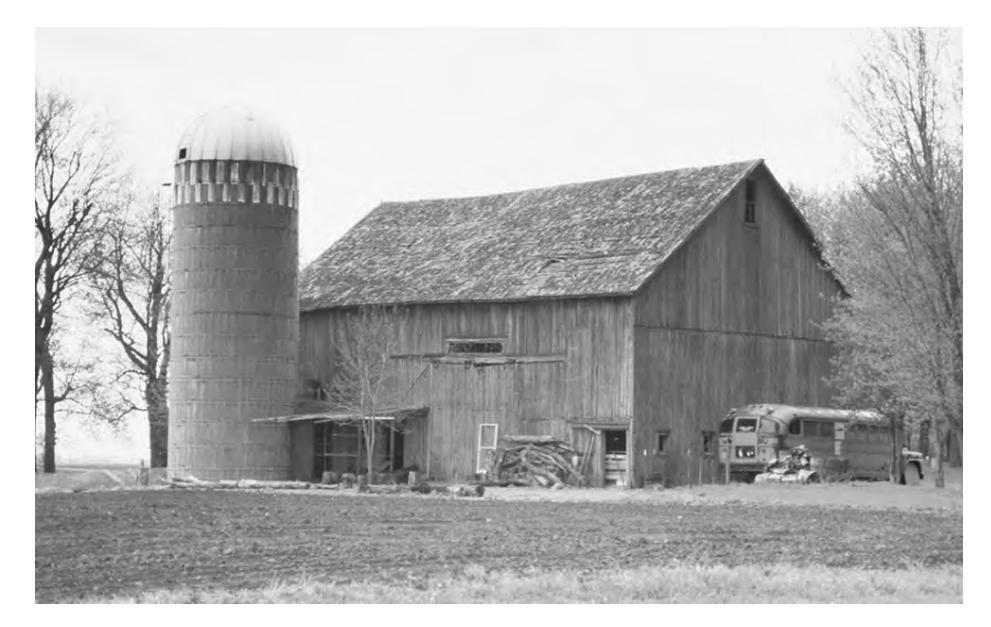
Figure 24. This Two-Level Ground Barn, like the Homeyer Barn, has a large footprint (40' x 60') and is taller than most. The plan is similar to that seen in Figure 23. Note the narrow transom window above the sliding wagon doors. The silo was added ca. 1945. F. and M. Lehmann Barn, ca. 1895, Claremont Twp., Dodge County (DO-CLT-031) (photo by Scott Kelly, 2007). (See also Figures 36 and 40.)

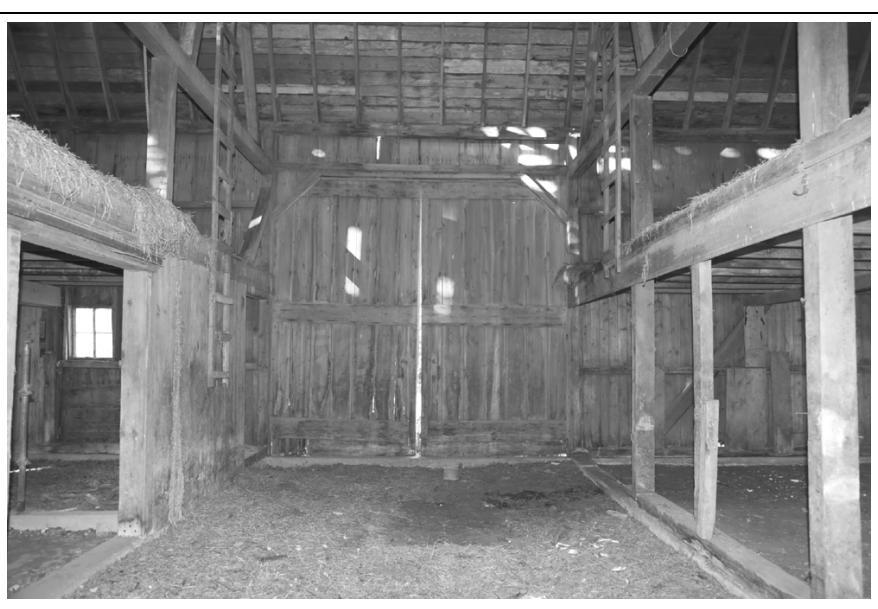
Figure 25. The wagon bay of a Two-Level Ground Barn. The cow stable is at left and the horse stable at right, both with storage mows above. The wagon bay is about 15' wide. A. and L. Lehmann Barn, ca. 1919, Claremont Twp., Dodge County (DO-CLT-047) (photo by Dan Pratt, 2014). (See also Figures 26, 28, 42, 48-50, and 55.)

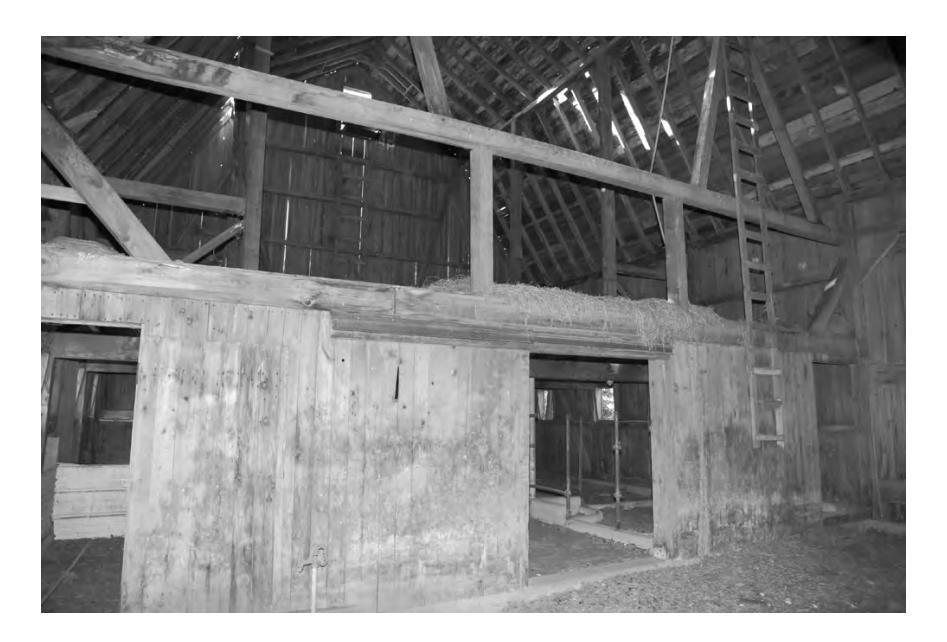
Figure 26. The same barn's cow stable is visible through the doors. The photo was taken from the wagon bay shown in the previous photo. The cow stable's strong ceiling serves as the floor of a large mow. A. and L. Lehmann Barn, ca. 1919, Claremont Twp., Dodge County (DO-CLT-047) (photo by Dan Pratt, 2014).

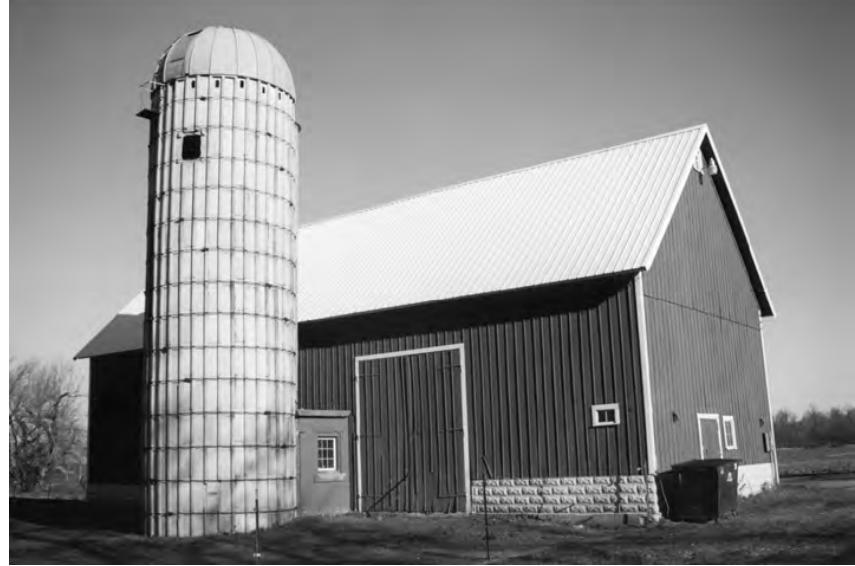
Figure 27. A Two-Level Ground Barn built ca. 1905. It has a 30' x 70' footprint. The lower walls are built of rockfaced concrete block. Studtmann Barn, Courtland Twp., Nicollet County (NL-CTT-047) (photo by Dan Pratt, 2005).

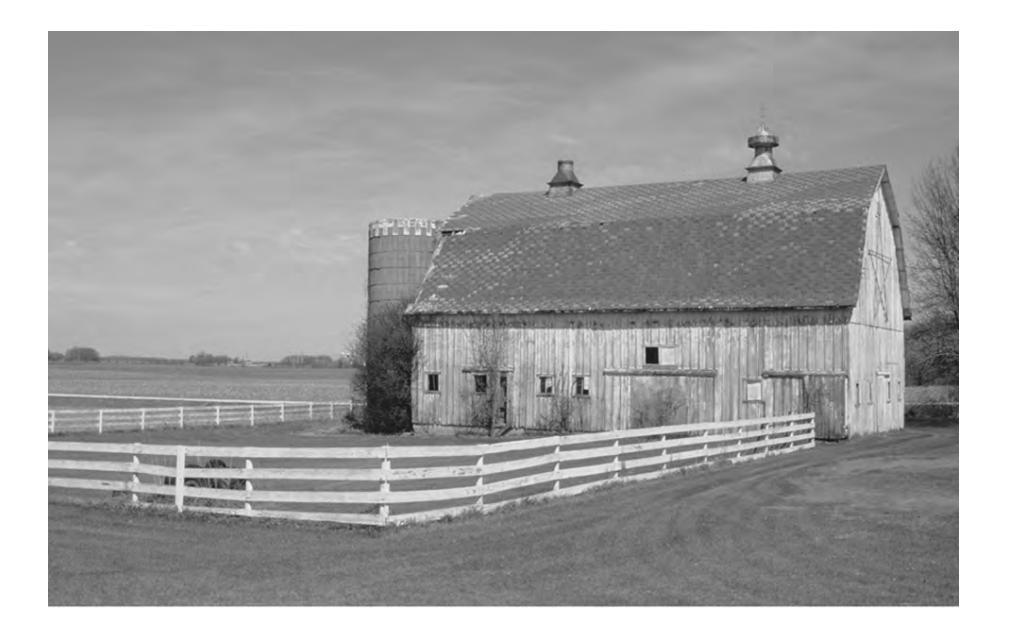
Figure 28. Exterior of the 35' x 60' barn seen in Figures 25 and 26. This is a late, gambrelroofed example of the Two-Level Ground Barn, built ca. 1919. The carpenters were the U.S.-born sons of German immigrants. A. and L. Lehmann Barn, Claremont Twp., Dodge County (DO-CLT-047) (photo by Scott Kelly, 2007).

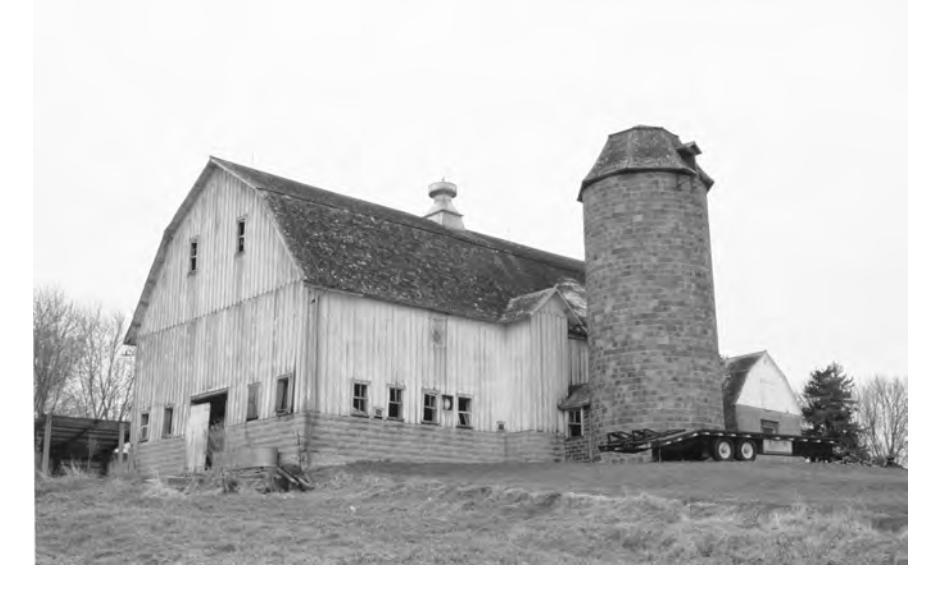
Figure 29. A Stable Barn built ca. 1925. Note the unusual gable-roofed hay chute near the center of the side wall (left of the silo). This 36' x 70' barn was loaded via a hay door high in the gambrel end (opposite the end shown). Feltmann Barn, Young America Twp., Carver County (CR-YAT-004) (photo by Scott Kelly, 2008). (See also Figures 30, 41, and 61-62.)

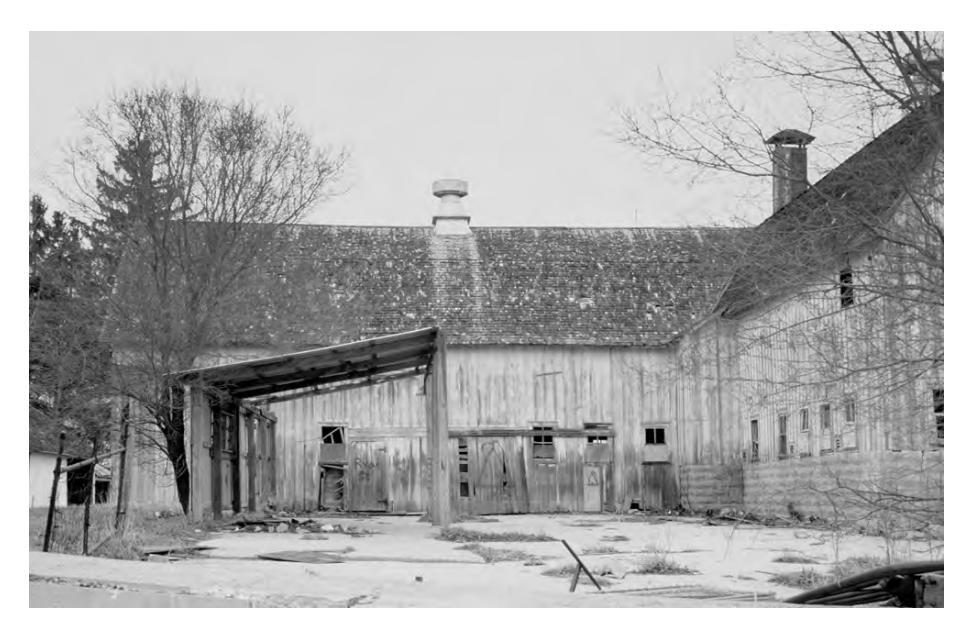
Figure 30. The Stable Barn in the previous photo has an early 30' x 52' addition (at left) perpendicular to the original wing (at right). The addition was built ca. 1930. Note the wooden rooftop ventilator on the original barn. Feltmann Barn, ca. 1925, Young America Twp., Carver County (CR-YAT-004) (photo by Scott Kelly, 2008).

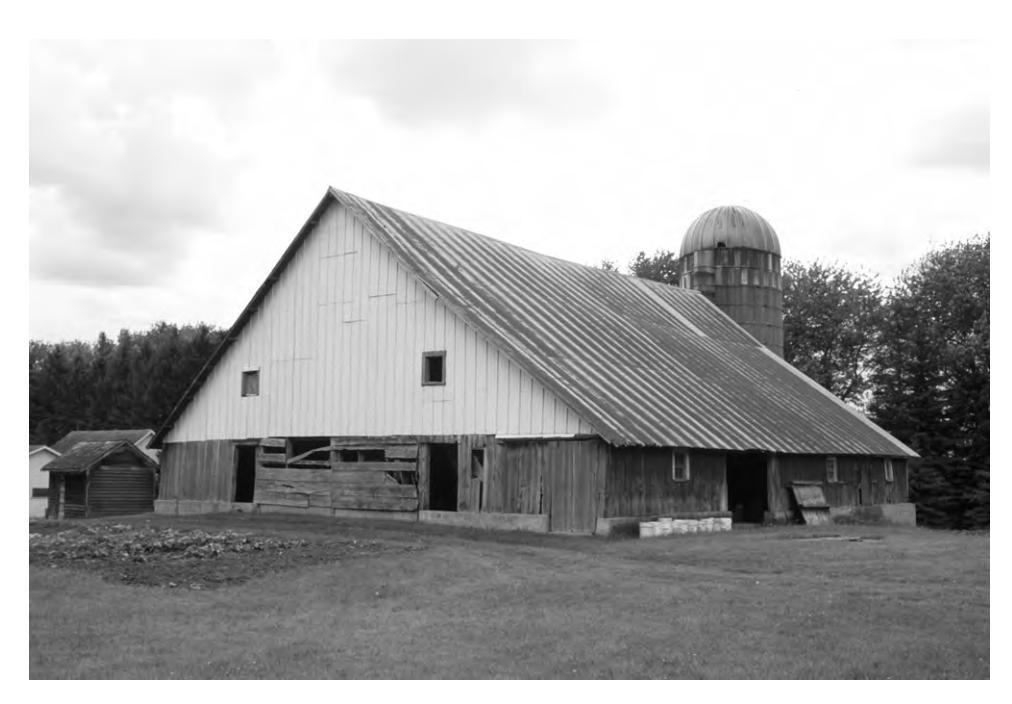
Figure 31. The Dunker Barn has a German- and Dutch-influenced form, called by some scholars the Saxon Barn, which is unusual among Minnesota's German immigrant timber frame barns. Built ca. 1900, the barn measures 48' x 60'. Characteristic are a sweeping gabled roof, low side walls, gable end entrance(s), and a large central aisle (originally open to the roof) flanked by side aisles where the stables were located. The wagon doors on this barn have been moved to the side walls. Havana Twp., Steele County (ST-HAV-035) (photo by Scott Kelly, 2007).

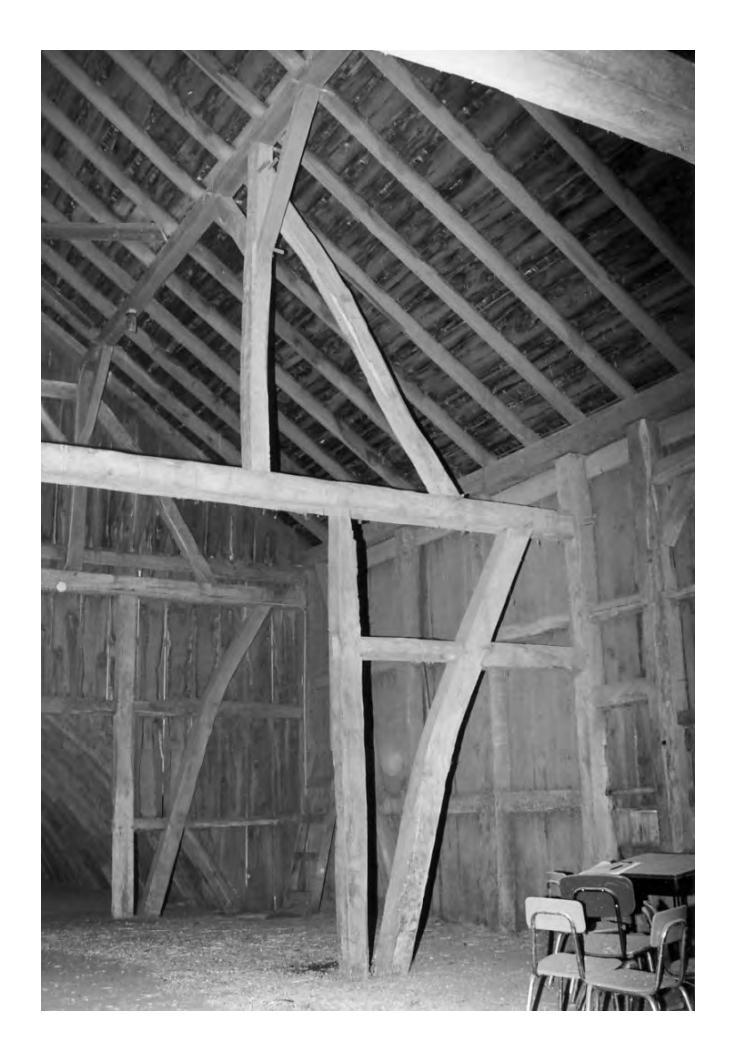
Figure 32. Roughly half of the German immigrant-built timber frame barns forming the basis of this MPDF have bents similar to this ca. 1875 barn, with posts supporting a cross beam, and queen posts on the cross beam supporting purlin plates, which in turn support the rafters. In this example, the queen posts are aligned vertically. Note that the cross beam is connected to the wall post below the top of the post. Note the diagonal braces and the very rare use of crooked timbers. Seeman Barn, Courtland Twp., Nicollet County (NL-CTT-052) (photo by Dan Pratt, 2005). (See also Figure 44.)

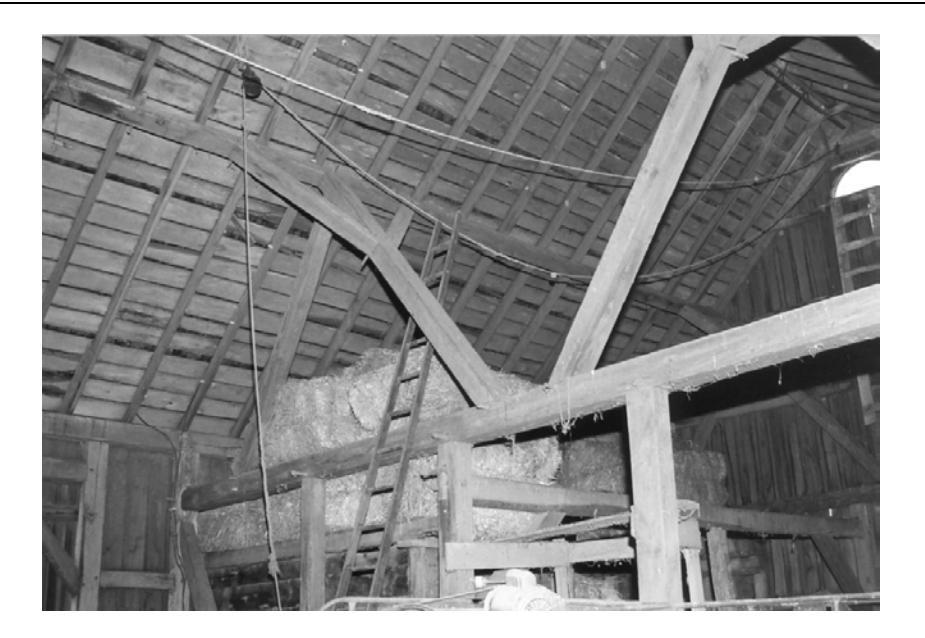
Figure 33. Most of the barns have queen posts that slant outward (i.e., are "inclined" or "splayed") rather than being vertically aligned. This created more room for the operation of hay-moving equipment suspended from the roof ridge. (Note the ropes and pulleys.) Thom Barn, ca. 1890, Nicollet Twp., Nicollet County (NL-NCT-021) (photo by Dan Pratt, 2005).

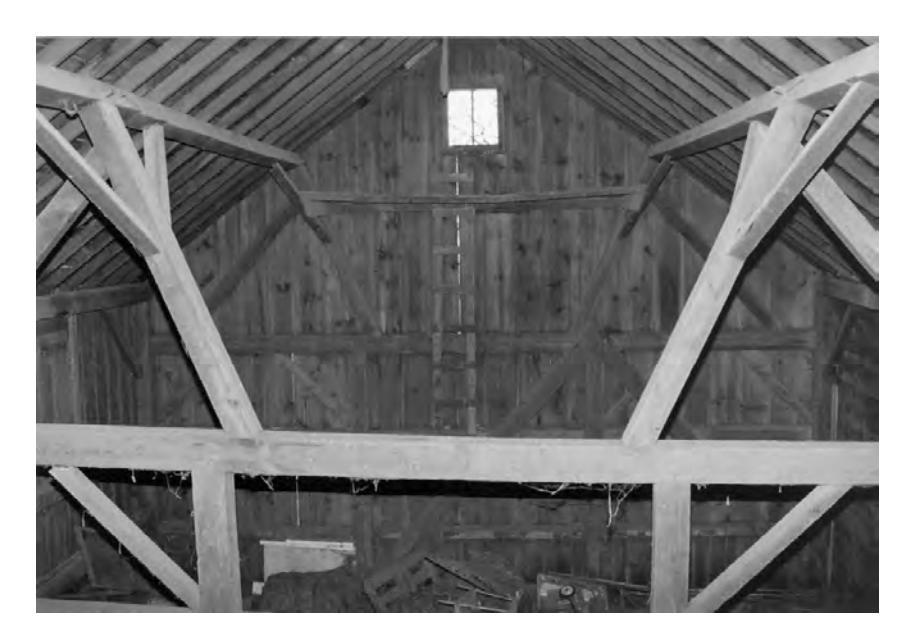
Figure 34. The barn in this photo has inclined queen posts spread farther apart than those in the barn in Figure 33. The wider spacing is more typical. Note that in both barns, the queen posts are stabilized with pairs of opposing sway braces. Arndt Barn, ca. 1890, Courtland Twp., Nicollet County (NL-CTT-031) (photo by Dan Pratt, 2005).

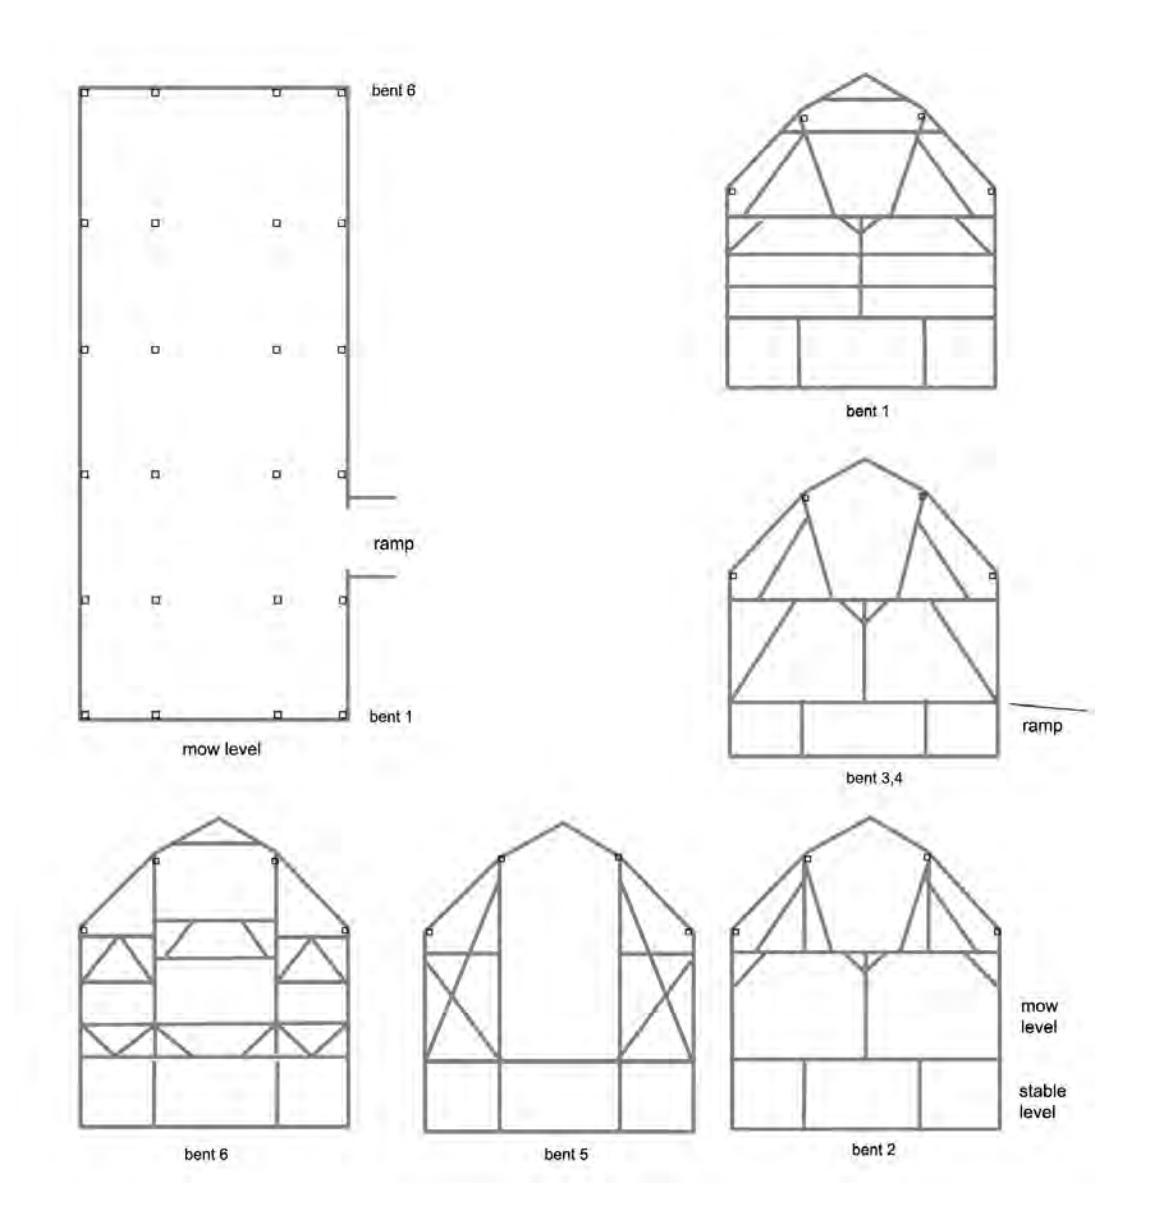
Figure 35. An inclined queen post configuration is evident in the four original bents of this barn (bents 1 through 4), shown in the drawings in the right column. The barn was built ca. 1895 with three bays, a central wagon drive, and a footprint of 30' x 48'. Two more bays (bents 5 and 6) were added ca. 1905, bringing the total barn length to 80'. Buckentine Barn, Dahlgren Twp., Carver County (CR-DHL-045) (Gemini Research sketch).

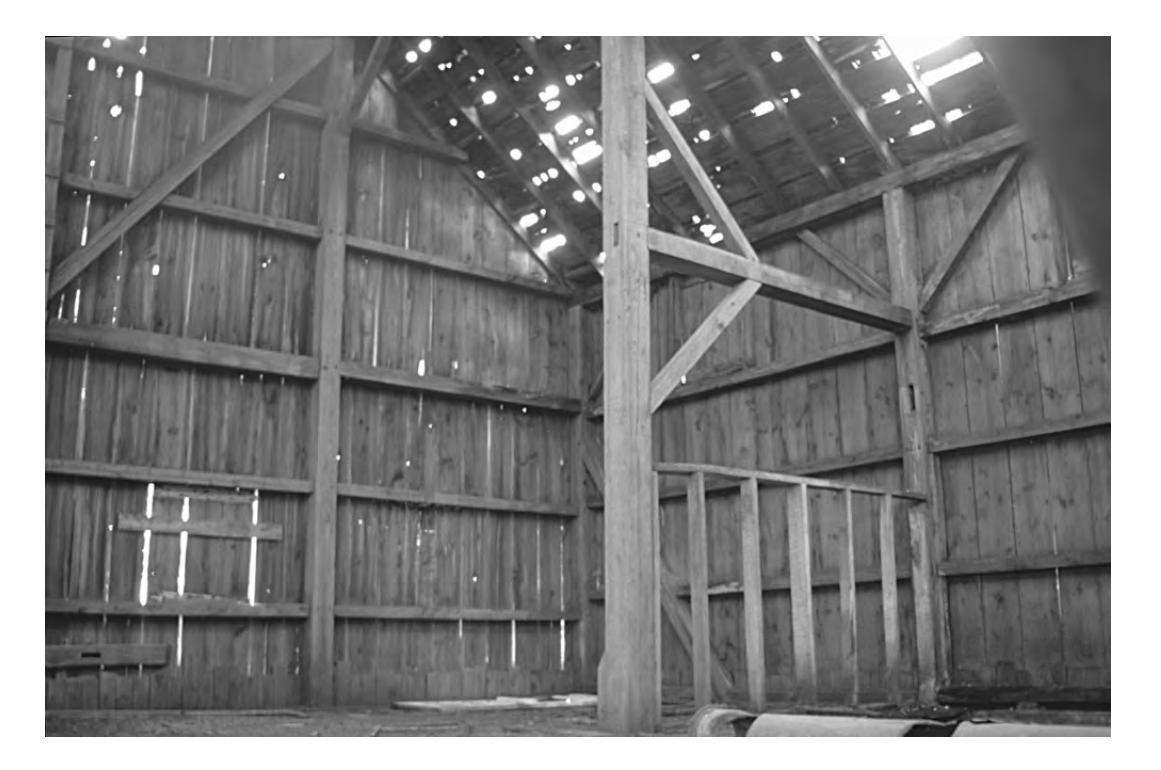
Figure 36. Roughly half of the German immigrant barns forming the basis of this MPDF have a post-to-purlin bent configuration, shown here, rather than the cross-beam-and-queen-post bent shown in Figures 32-34. In the post-to-purlin style, each bent has two very tall principal posts (also called "purlin posts") that extend from the floor all the way to the purlin plates. A cross beam ties the two tall posts together. (That beam has been removed in the barn shown above.) A shorter beam ties each principal post to the bent's wall post. The post-to-purlin bent style could provide a more open mow than the bent style seen in Figures 32-34. Note the empty mortise in the wall post at right which indicates an angled brace has been removed. F. and M. Lehmann Barn, ca. 1895, Claremont Twp., Dodge County (DO-CLT-031) (photo by Scott Kelly, 2007). (See also Figures 24 and 40.)

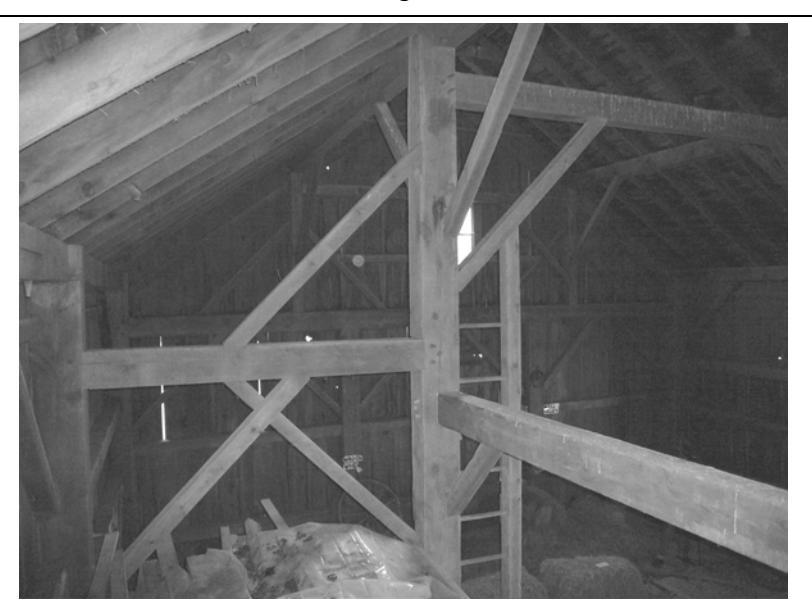
Figure 37. The Benike Barn, built ca. 1875, also has post-to-purlin bents. The lateral beam that joins the two principal posts is seen at upper right. Each post is also tied to the bent's wall posts with three beams (Figure 39). Note the unusual X-bracing and the built-in ladder. The material at lower left is piled on a simple platform that is located over one end of the wagon drive for extra storage. Farmington Twp., Olmsted County (OL-FRM-020) (photo by Scott Kelly 2008).
