National Register of Historic Places Multiple Property Documentation Form

Minnesota's German Immigrant Timber Frame Barns, 1865-1925

name/title	Susan Granger and Scott Kelly	/		
organization	Gemini Research			
street & number	15 East 9th Street			
city or town	Morris	state	MN	zip code 56267
e-mail	gemres@info-link.net			
telephone	320-589-3846	date	September 2015

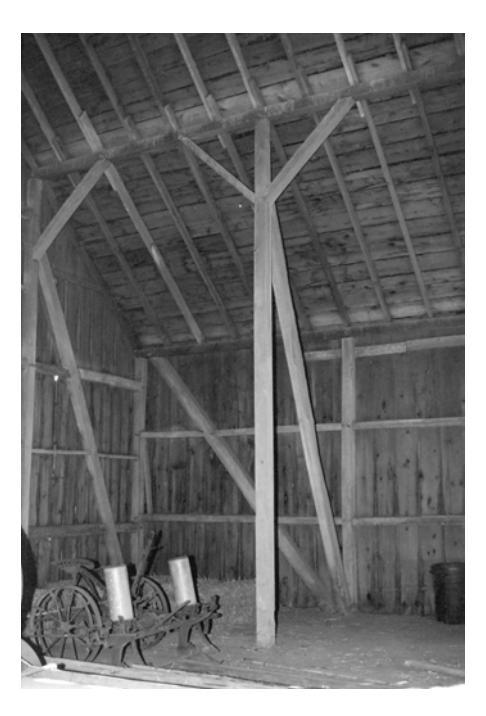
Figure 38. The Heim Barn, built in 1907, also has principal posts that extend from the mow floor to the purlins. Courtland Twp., Nicollet County (NL-CTT-026) (photo by Dan Pratt, 2005).

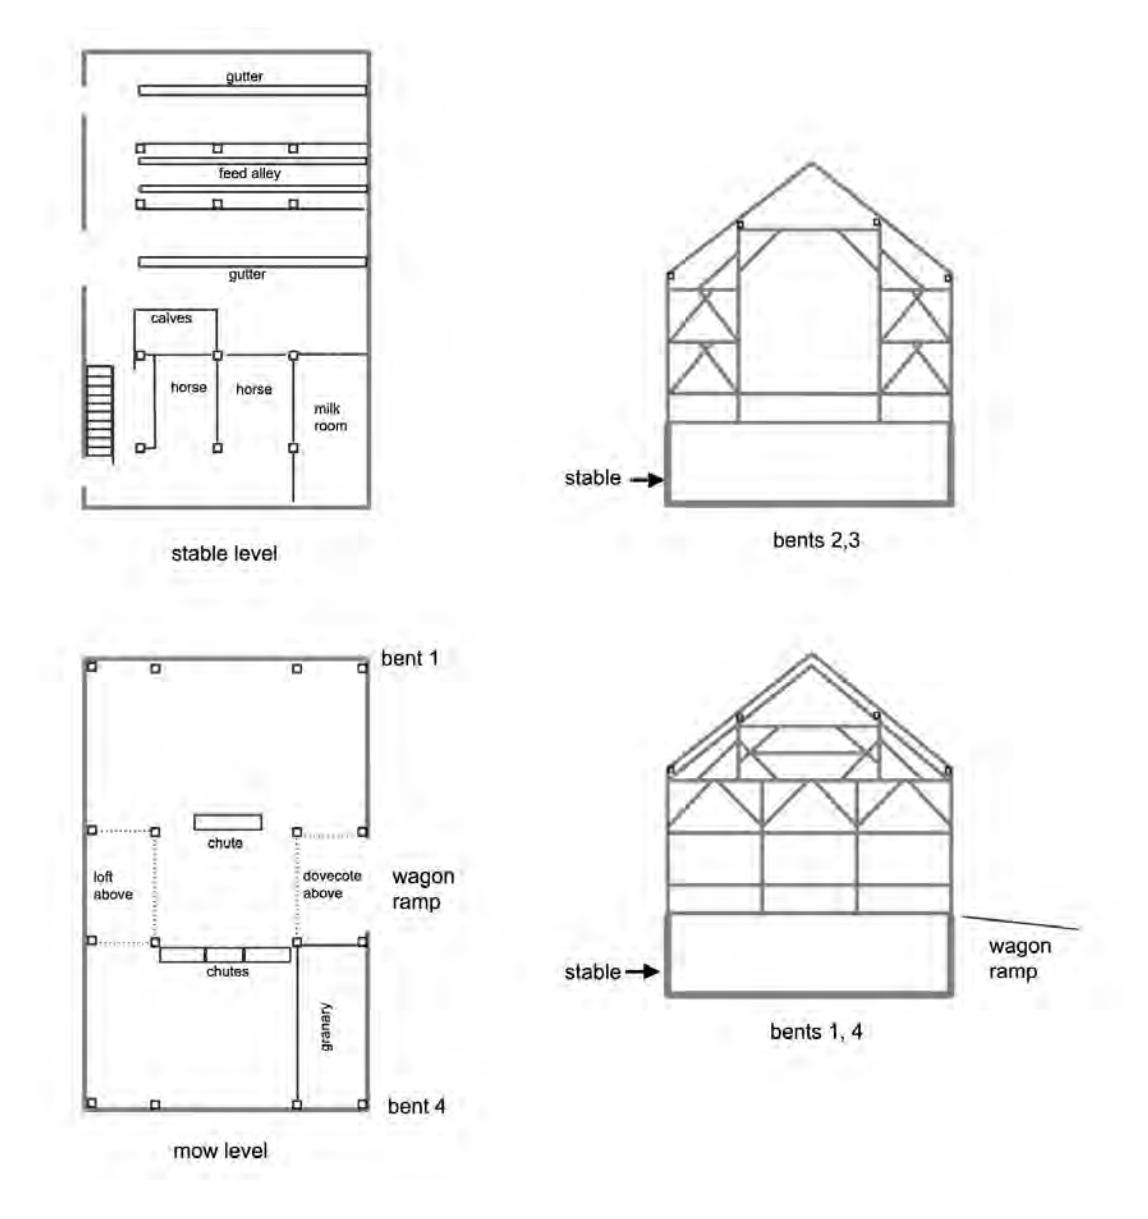
Figure 39. The sketch at upper right shows the interior bents (bents 2 and 3) of the Benike Barn with posts that extend from mow floor to the purlins. The bents of the end walls (bents 1 and 4) are more densely built with a traditional post-supported cross beam. The plan of the mow (lower left) shows a typical three-bay arrangement with central wagon drive. There is an interior granary located in one of the storage mows. Hay was dropped to the basement through narrow chutes with hinged lids. Benike Barn, ca. 1875, Farmington Twp., Olmsted County (OL-FRM-020) (Gemini Research sketch).

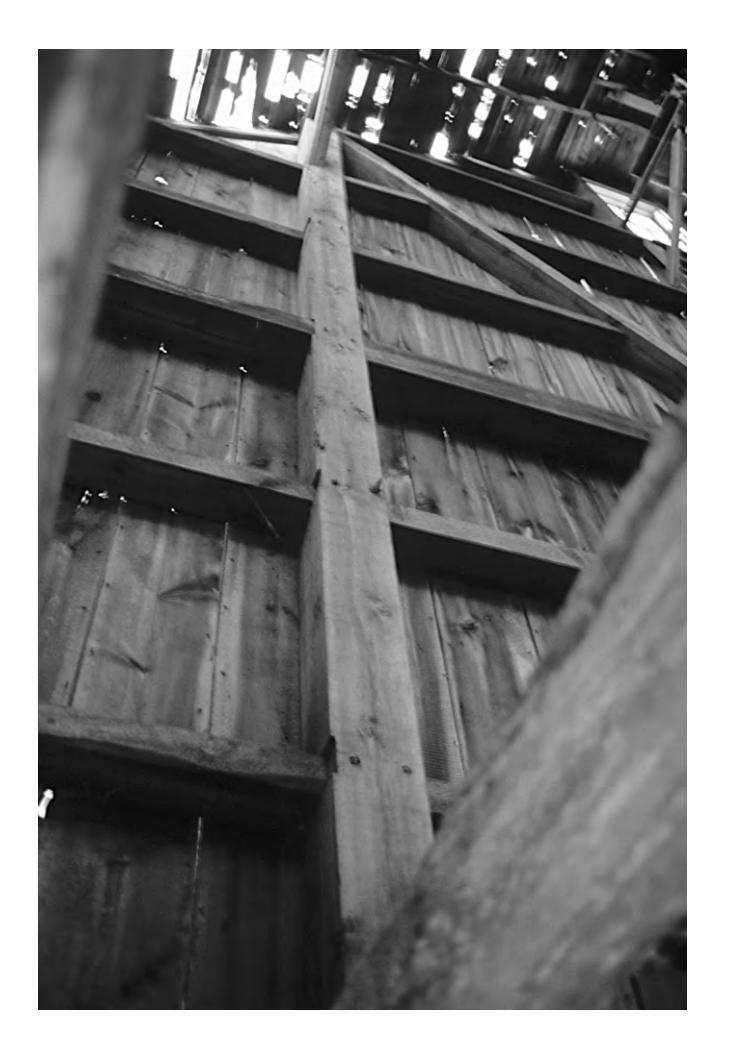
Figure 40. Many of the barns are heavily built. Shown above are posts about 25' tall and 10" x 10" in cross section in the F. and M. Lehmann Barn, built ca. 1895. The Homeyer Barn, about the same age and standing a few miles away, has similar massive posts. Both barns measure 40' x 60'. F. and M. Lehmann Barn, Claremont Twp., Dodge County (DO-CLT-031) (photo by Scott Kelly, 2007). (See also Figures 24 and 36.)

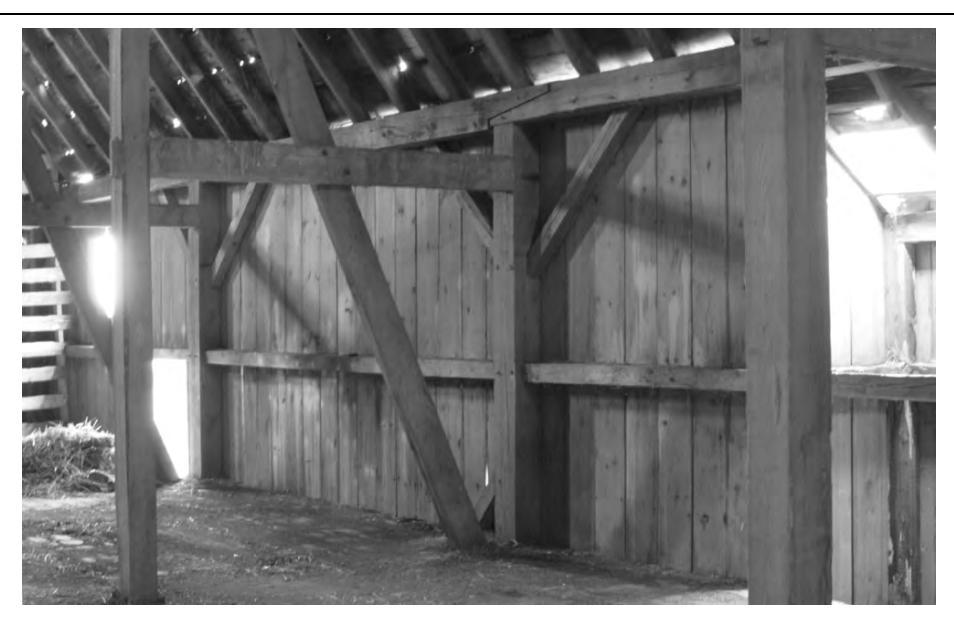
Figure 41. A heavily built mow wall. Note that the tie-beam tenon at upper left projects all the way through the post. Sometimes called a Dutch tenon, this feature is uncommon in Minnesota but is typical in northwestern Germany and the Netherlands. Feltmann Barn, ca. 1925, Young America Twp., Carver County (CR-YAT-004) (photo by Scott Kelly, 2008). (See also Figures 29-30 and 61-62.)

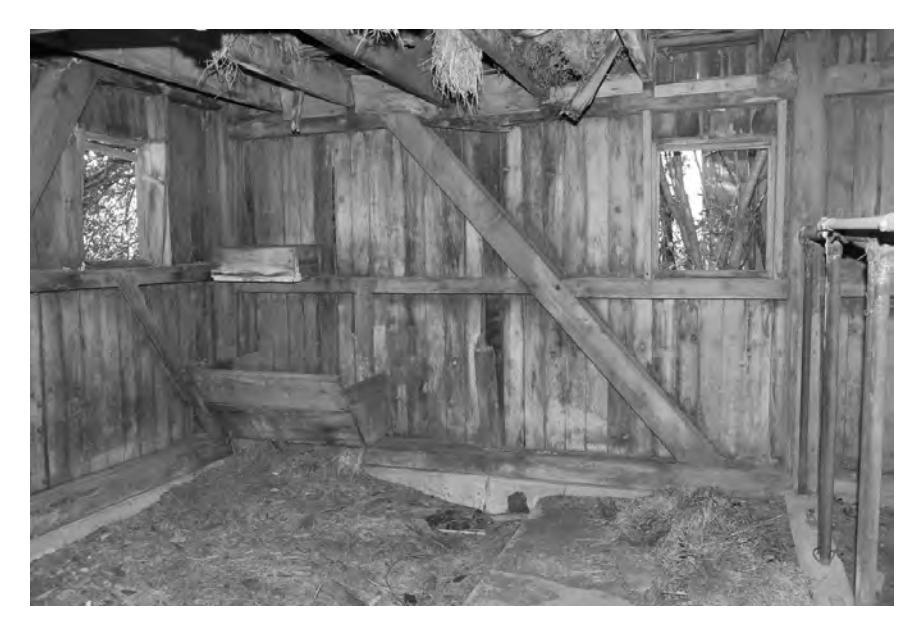
Figure 42. Several of the barns have long diagonal braces, characteristic of German timber frame construction. In this case, the braces are 18' long and extend from a wall post (out of sight above the stable ceiling) to a sill. A. and L. Lehmann Barn, ca. 1919, Claremont Twp., Dodge County (DO-CLT-047) (photo by Dan Pratt, 2014).

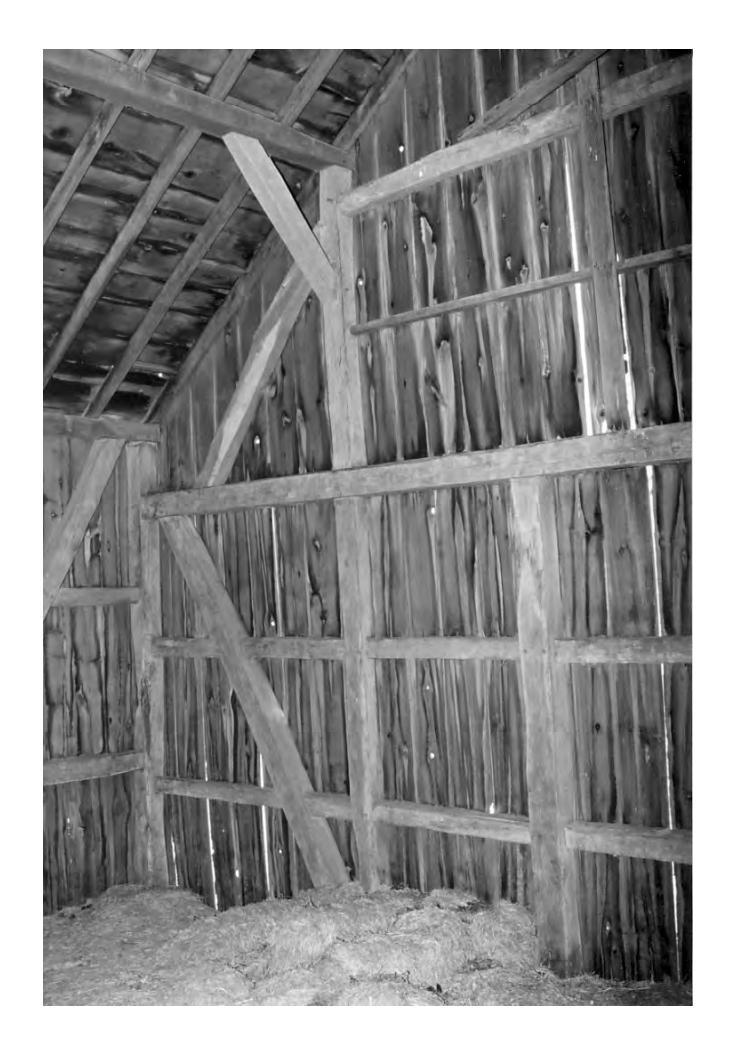
Figure 43. Some of the barns have rare dense European square panel framing. The gridwork of posts and horizontal members forms squarish spaces that are roughly even in size. In Europe and in a few German immigrant communities in the U.S., the panels were nogged with brick, stovewood, or other materials, particularly if the building needed to be insulated. This is a 30' x 50', three-bay, Basement Barn built ca. 1875. Note that some of the diagonal braces are made of curved or crooked timbers, also very rare. Meyer Barn, Courtland Twp., Nicollet County (NL-CTT-050) (photo by Dan Pratt, 2005). (See also Figures 18 and 51-52.)

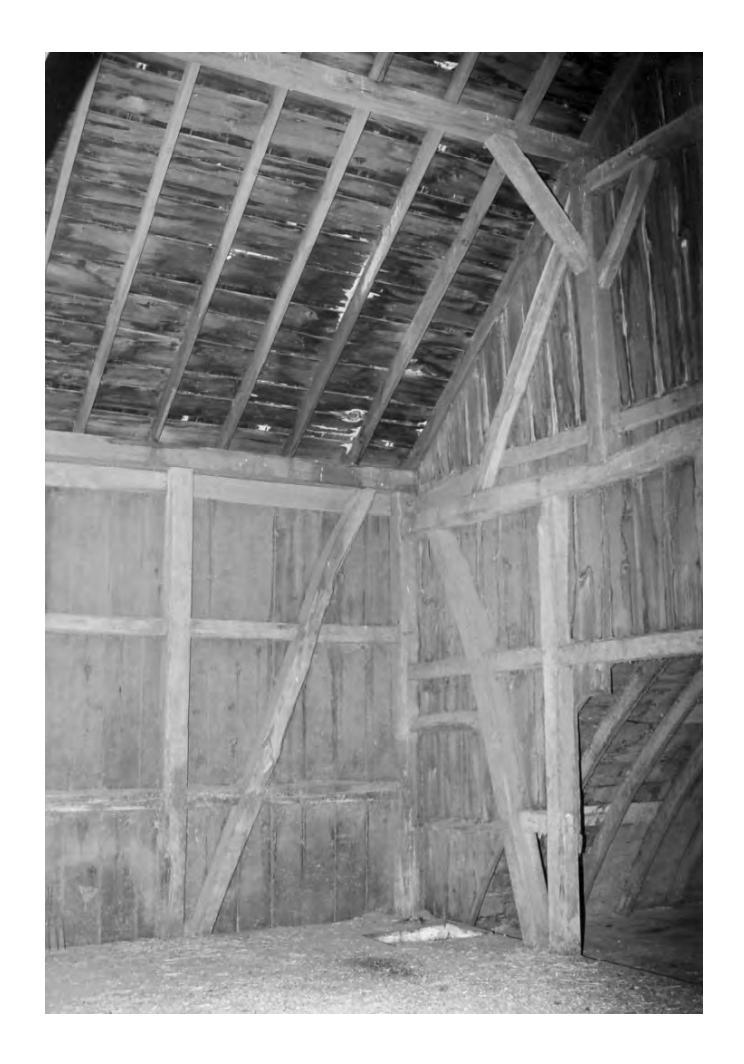
Figure 44. Another Nicollet County barn with European square panel framing, long diagonal plate-to-sill braces, and the use of irregular, curved, or crooked timbers. This barn is 36' x 50' and is a Two-Level Ground Barn. It has an addition, whose curved rafters can be seen at lower right. Seeman Barn, ca. 1875, Courtland Twp., Nicollet County (NL-CTT-052) (photo by Dan Pratt, 2005). (See also Figure 32.)
National Register of Historic Places Continuation Sheet

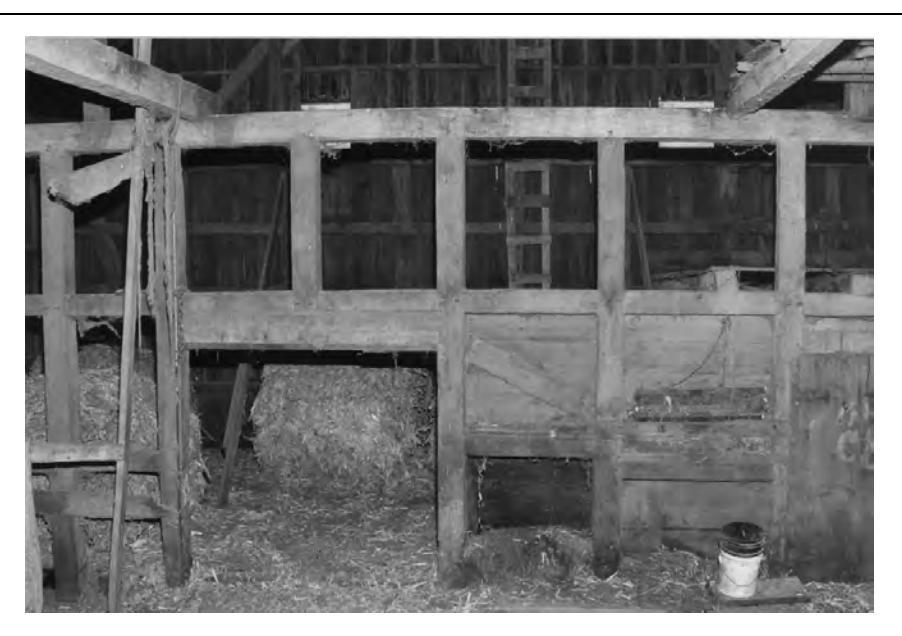
Figure 45. Dense European square panel framing in an interior bent. This Basement Barn has four bays and a 40' x 70' footprint. K. and L. Bode Barn, ca. 1875, Nicollet Twp., Nicollet County (NL-NCT-008) (photo by Dan Pratt, 2005).

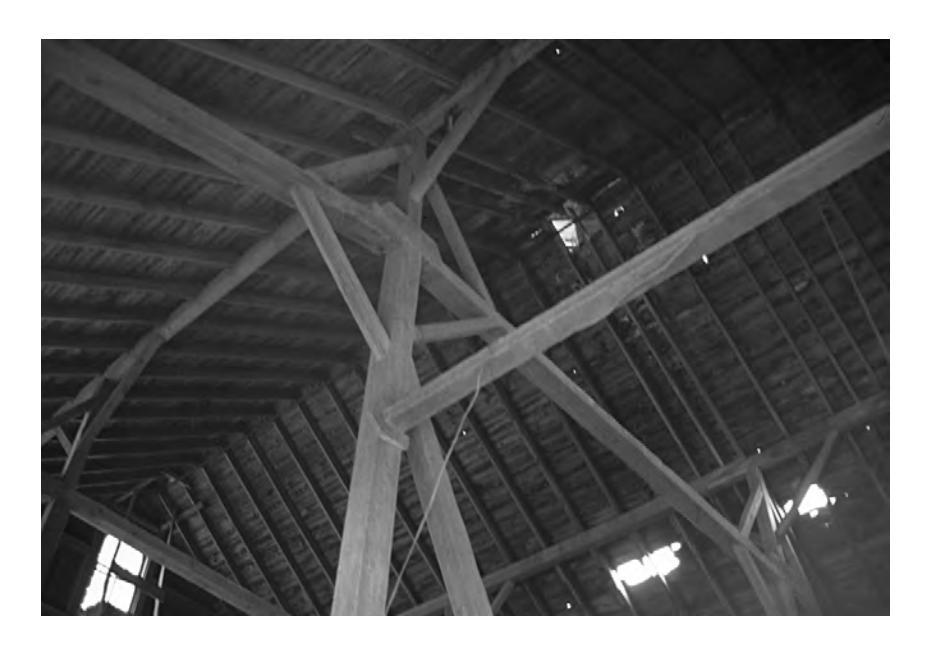
Figure 46. Unusual, complex bracing in the Homeyer Barn, ca. 1895. Havana Twp., Steele County (ST-HAV-032) (photo by Scott Kelly, 2007). (See also Figures 22-23 and 57.)

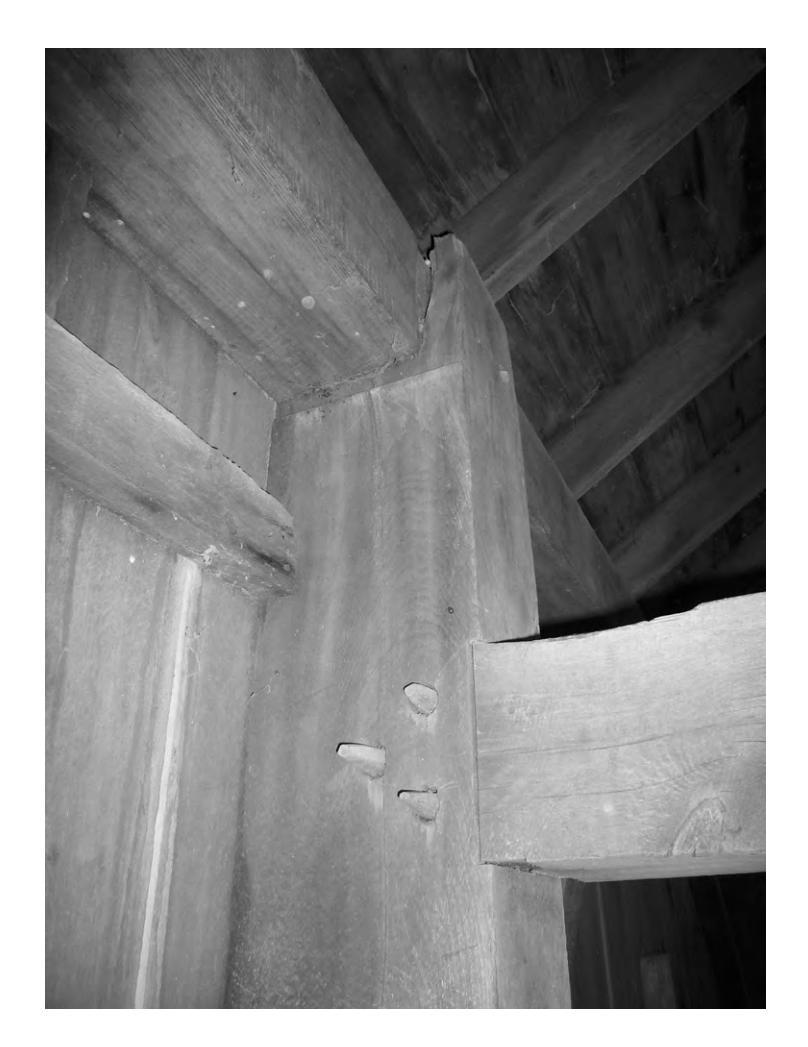
Figure 47. In the Benike Barn, built ca. 1875, the wall plate at the top of the photo is let into the wall post rather than resting on top of it. Farther down on the post, the wooden pegs securing the mortise and tenon joint at the cross beam are clearly visible. The barn was built by members of the extended Benike family. The patriarch, Carl Ludwig Benike, was born near Brandenburg in northeastern Germany and worked as a cabinetmaker and carpenter before emigrating. Farmington Twp., Olmsted County (OL-FRM-020) (photo by Scott Kelly, 2008).

Two basic bent configurations, described below, have been observed in the Minnesota barns. In most of the barns, regardless of bent configuration, the wall or end posts of each bent are tenoned into the wall plates that they support (Fig. 32). The Benike Barn (OL-FRM-020), built circa 1875, is unusual. It has an interesting variation in which the plate does not rest on top of the posts, but is let into it (Fig. 47).

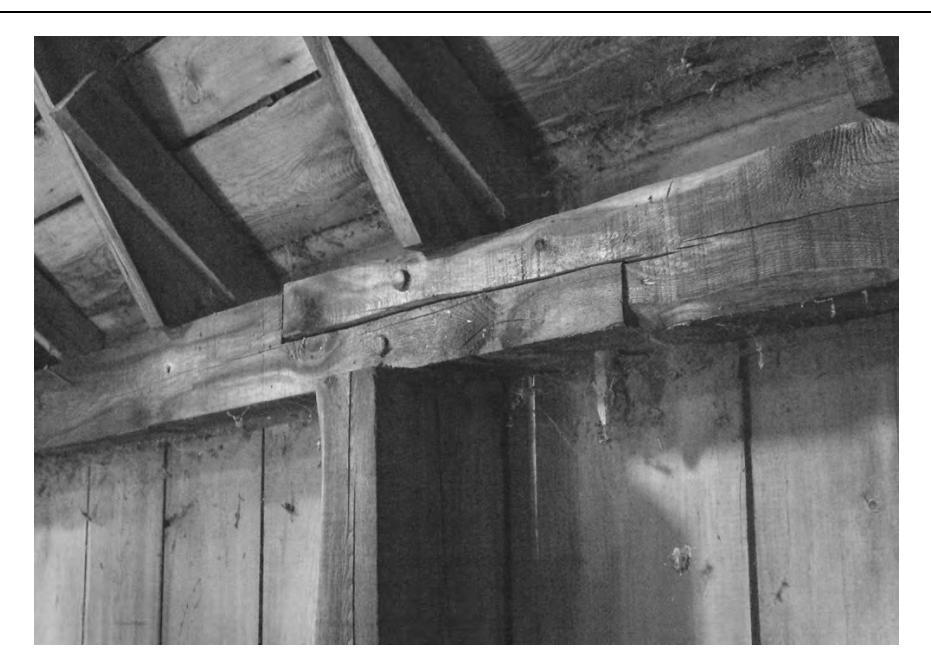
Figure 48. Long members such as wall plates are typically made of two or three timbers joined together. This wall plate is made of lap-joined timbers. A. and L. Lehmann Barn, ca. 1919, Claremont Twp., Dodge County (DO-CLT-047) (photo by Scott Kelly, 2007).

In most of the Minnesota Germanic barns, the longest elements – sill beams, wall plates, and purlins – are made of two (or sometimes three) timbers joined end to end with, for example, a lap joint to create one very long member. In a few of the Minnesota barns, unusually long timbers were observed. For example, the W. and M. Bode Barn, built circa 1875 in Nicollet County (NL-NCT-015), has a 46'-long beam.

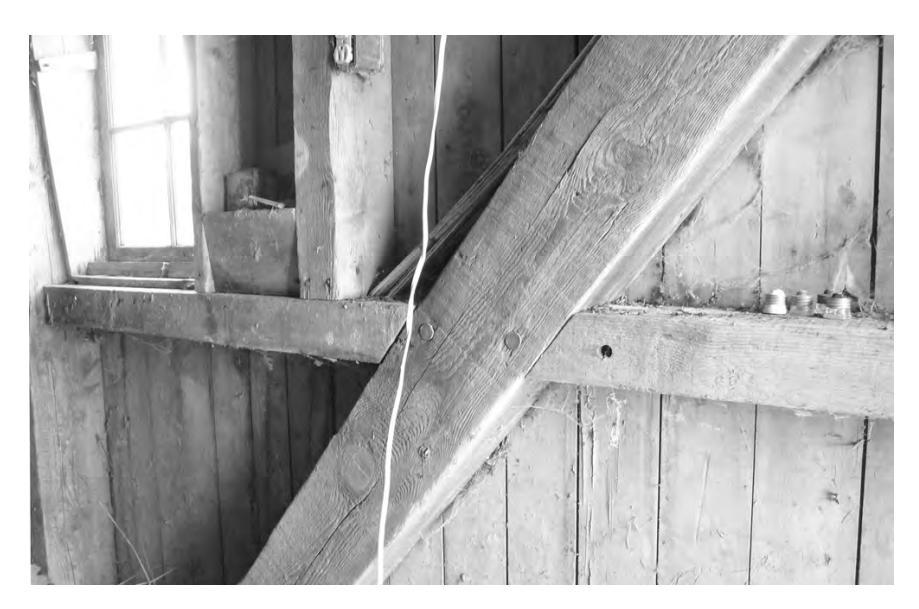
Figure 49. Mortise and tenon joints connect wall girts to a long diagonal brace in the wall of a stable area. The walls of this stable have an inner lining of 6"-wide tongue-and-groove boards, seen above, installed beneath the exterior's 12"-wide board and batten siding. A. and L. Lehmann Barn, ca. 1919, Claremont Twp., Dodge County (DO-CLT-047) (photo by Scott Kelly, 2007).
