## **Hotel Energy Efficiency**

### **Market Potential for Minnesota's Hospitality Sector**

**Conservation Applied Research & Development (CARD)  
FINAL REPORT**

**Prepared by: Michaels Energy**

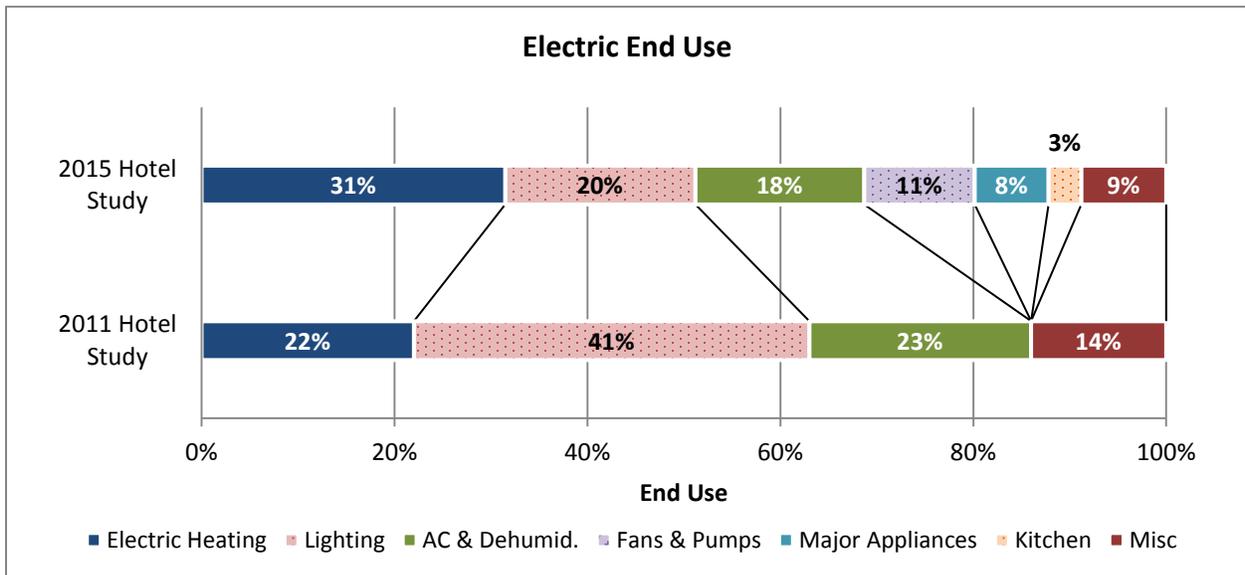
**Figure 2: Electricity End Use**

The data between the two studies compares favorably, although there are some differences. One such difference is that more electricity was allocated to lighting in the MnTAP study. This is most likely due to improved efficiency in lighting as hotels moved away from T12 and incandescent lighting.

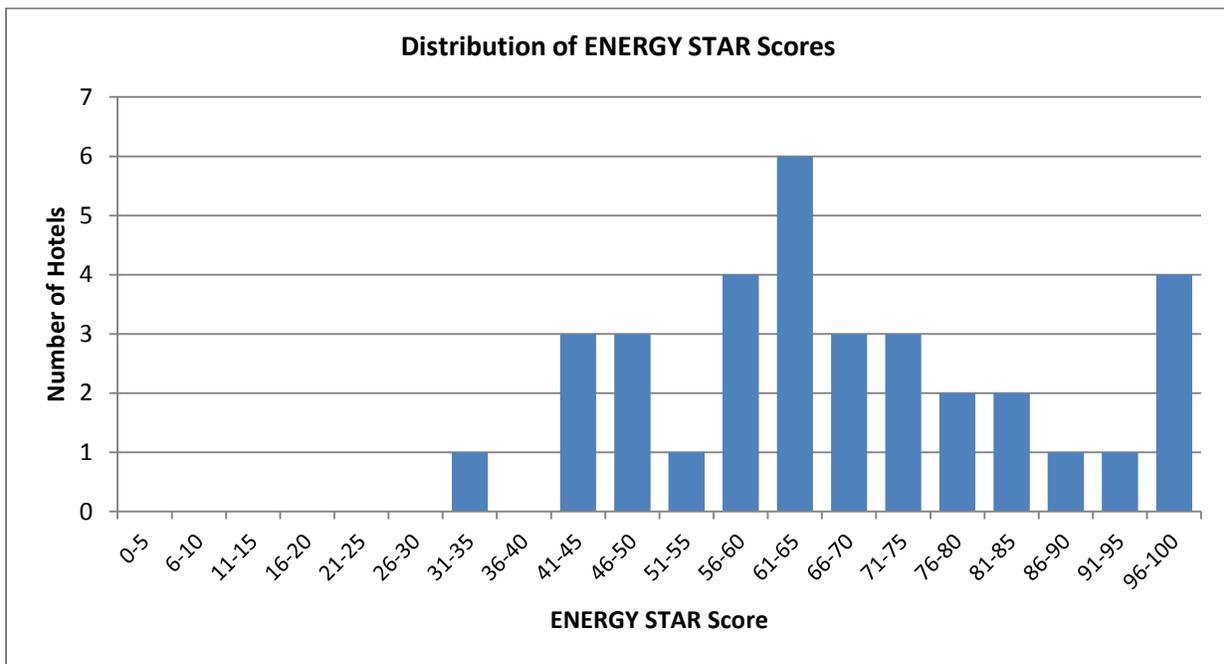
Figure 4: Hotel ENERGY STAR Score Distribution

An ENERGY STAR score of 50 designates a hotel is in the 50<sup>th</sup> percentile in terms of energy performance, so the expected distribution would be flat. The median score of the pilot hotel group in this study was 64.5, and the mean score was 68, with no hotels scoring below 25. According to this data, in Minnesota, as in Lake Wobegon, it’s possible for nearly all the hotels to be above average. During this study, the team aided one hotel in obtaining ENERGY STAR certification and hotels that scored below 50 were given additional attention and support.

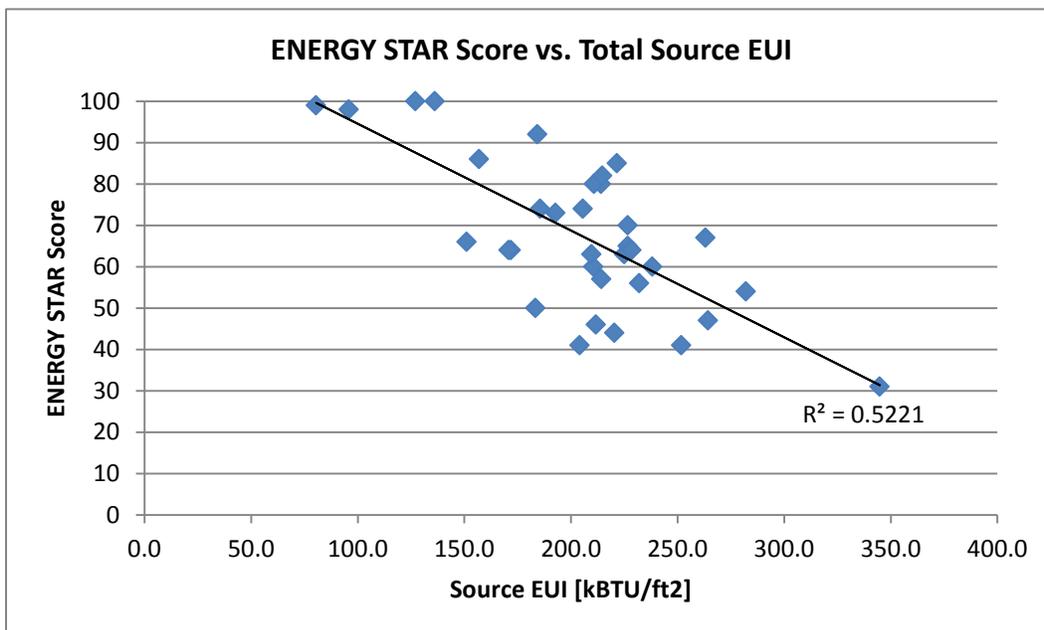
**Figure 10: ENERGY STAR Score versus Source EUI, in Total kBTU Per Square Foot**

This strong relationship between source EUI and the ENERGY STAR score misleads the user because hotel occupancy is not accounted for in the ENERGY STAR calculation. Hotels with low occupancy (under 55% average occupancy annually) are precluded from application for ENERGY STAR building certification, but the software interface still produces a score for those properties.

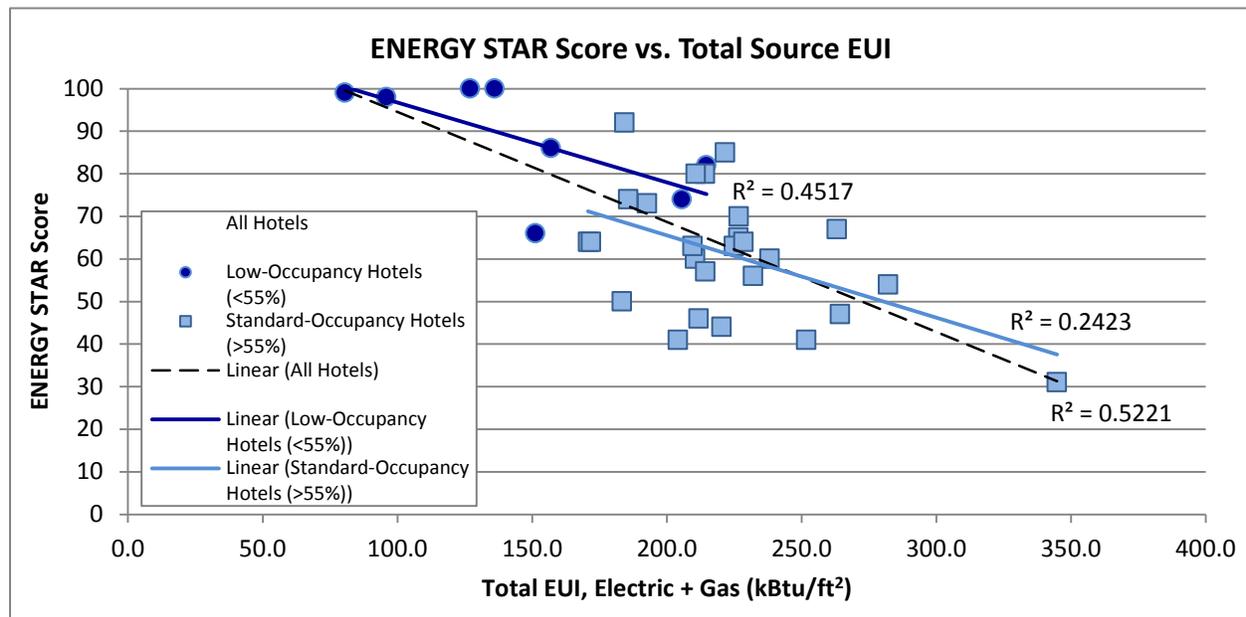
Figure 11: ENERGY STAR Score versus Source EUI, Low and Standard Occupancy

ENERGY STAR’s value relies on peers within a group being similar. In this case, given the stark divide in ENERGY STAR scores between the two groups, the inclusion of low-occupancy hotels worsens the comparability of the hotel peer group. Perhaps ENERGY STAR could not remove low occupancy hotels because they didn’t have occupancy information in their data set. It is clear they recognize the issue because they preclude low-occupancy hotels from certification. An implication is that the top ENERGY STAR scores are pegged to hotels with low-occupancy. This creates an unfair goal for standard occupancy hotels to try to match.

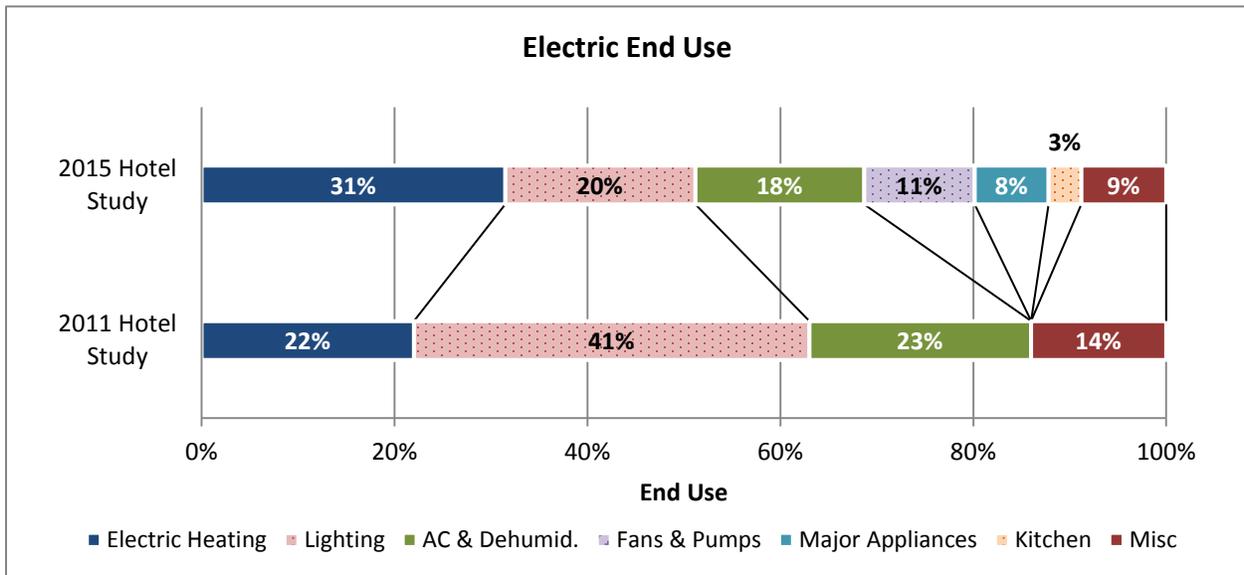
Figure 14: Electric End Use

Although the end use breakdowns differ slightly, they are comparable. In both studies, lighting and electric heating constitute the majority of electricity use. Electric heating was the greater of the two for the hotels the project team analyzed, while the MnTAP study attributed the highest use to lighting. Part of this discrepancy could be credited to the fact that four of the six hotels in this study used PTAC units to heat guestrooms, which rely solely on electric resistance heat. However, a large number of hotels in the overall pilot group used heat pumps to deliver guestroom heating, which use less energy than electric resistance heat alone. MnTAP's study population could have included more heat pumps and thus documented lower electricity use for heating. Additionally, the end use for pilot hotels was subdivided into several additional categories that were not included in the MnTAP study; it is possible that with fewer categories the percentage of energy would more closely match ("miscellaneous" electricity constitutes 9% for the pilot hotels, while MnTAP attributes 14% electricity to the category). Finally, the MnTAP data was collected between 2008-2010 and lighting efficiency gains since may account for the difference between end use in the lighting categories.

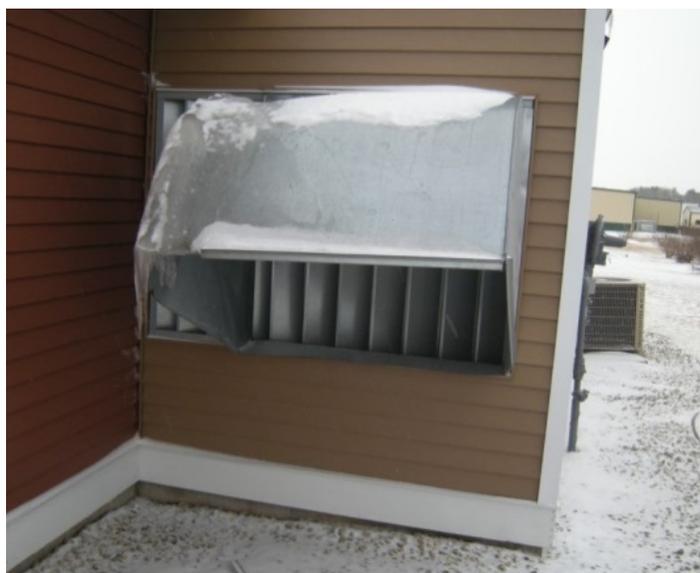
**Figure 16: Outdoor Air Damper at 100%**

Figure 16 shows the outdoor air intake for the pool room with an outdoor air dilution system. Upon closer inspection, the damper was 100% open on a day when the outdoor temperature was about 10°F. Another hotel was maintaining room temperature at 79°F, relative humidity between 75-85%, and the pool log showed that pool water temperature was maintained at 86°F. This indicates there were problems with the sensors or control set points. All these issues need to be addressed to maintain energy efficiency.

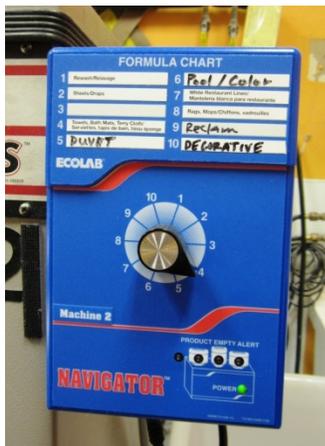
Figure 19: Washer Programs

The laundry process in hotels is highly automated. The washers typically are programmable and detergents and chemicals are provided by a chemical supplier on a regular basis. For the majority of hotels, the chemical supplier was either Ecolab or Proctor & Gamble (P&G). The capabilities of programmable washers include adjustments to water temperature, water level, extraction speed, wash time and amount of chemical added. As shown in Figure 19, the machines can have up to 10 different wash cycles, each programmed for a specific linen type.

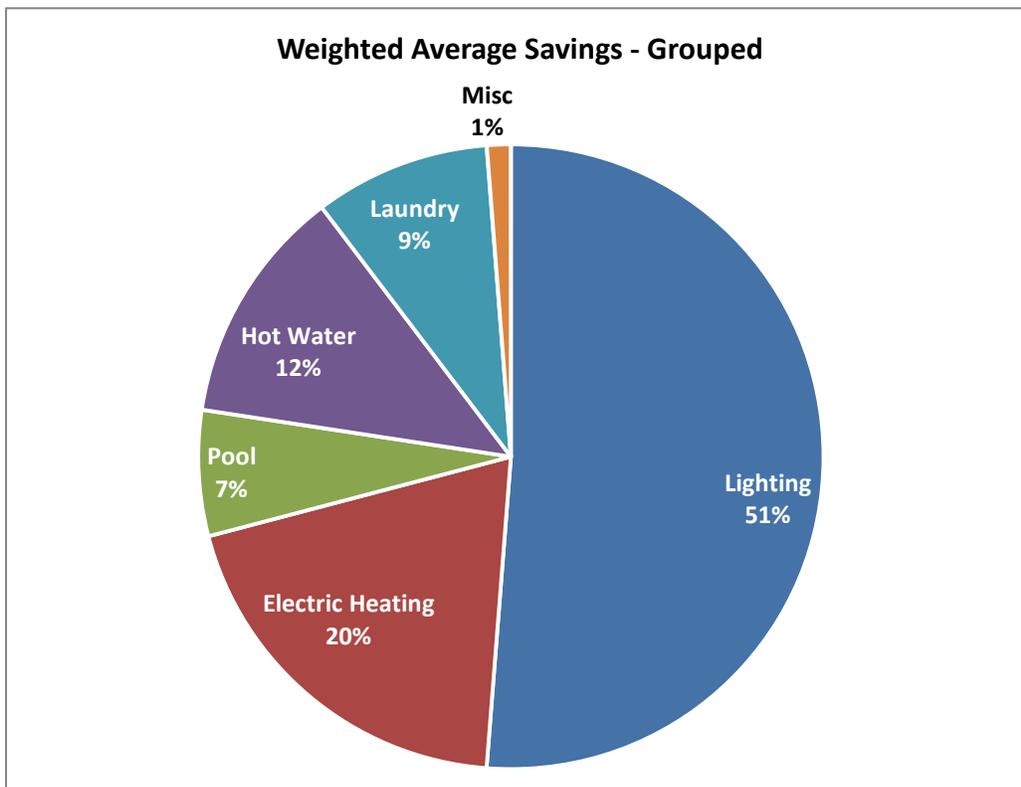
Figure 20: Weighted Average Energy Savings

Lighting measures comprise about 50% of the savings identified in this sector. The technology gain in LED lighting coupled with the long hours of operating in the hotel sector result in large savings opportunities for lighting. Upgrading PTAC units to heat pumps only accounts for 20% of savings when weighted for the opportunity in the sector. If a given hotel needs to upgrade their PTAC units, that individual hotel is likely to capture closer to 40% of their savings from that measure; however, PTHPs are becoming the industry standard and so fewer hotels have

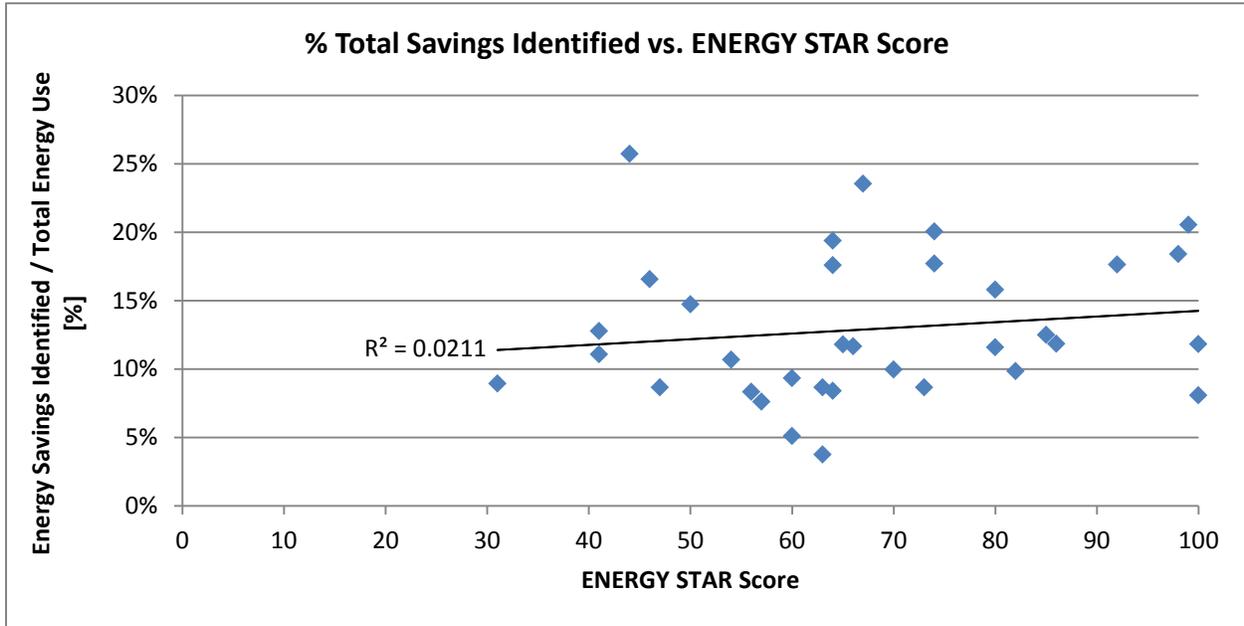
Figure 22: ENERGY STAR Score versus Percent Energy Savings Identified

There is an important caveat to this analysis. The audits performed in this study were designed to target the most likely savings opportunities for the hotel sector, not to exhaustively dissect every savings opportunity possible for a given property. As a result, some extremely out of the ordinary properties (very large, unusual controls or equipment, poor building envelope, or significant amount of non-hotel space usage) were not audited in a way to capture all the savings potential. But all that said, it still seems unlikely that ENERGY STAR, given the lack of occupancy sensitive analysis, can be the preferred tool for benchmarking this sector.

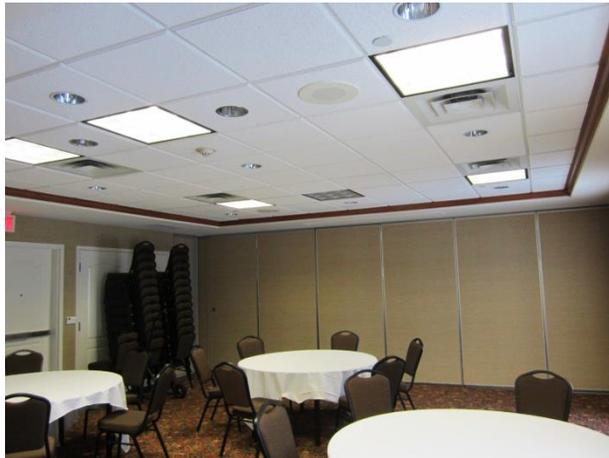
**FIGURE 6: CONFERENCE ROOM LIGHTING**

Replacement product and labor costs were provided by Premier Lighting.

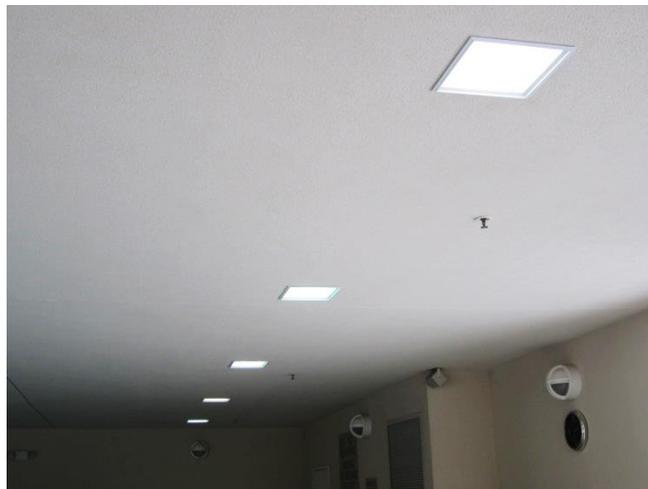
**FIGURE 8: POOL AREA LIGHTING**

Replacement product and labor costs were provided by Premier Lighting. This measure is supported by prescriptive rebates from their electric utility.

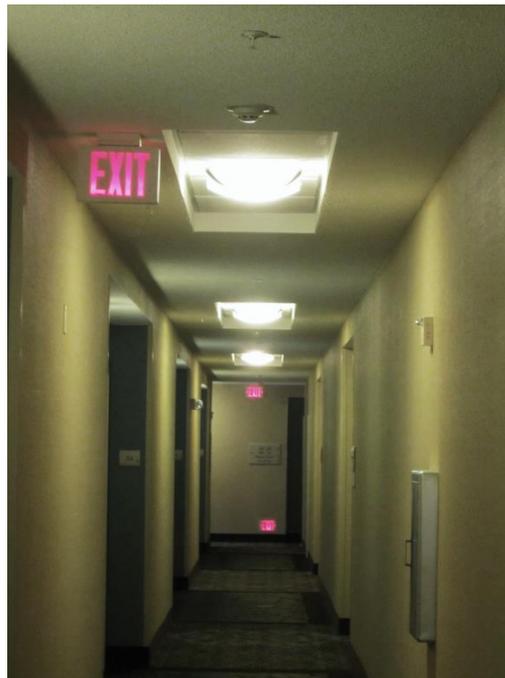
**FIGURE 9: HALLWAY FIXTURES**

Replacement product and labor costs were provided by Premier Lighting. This measure is supported by prescriptive rebates from their electric utility.

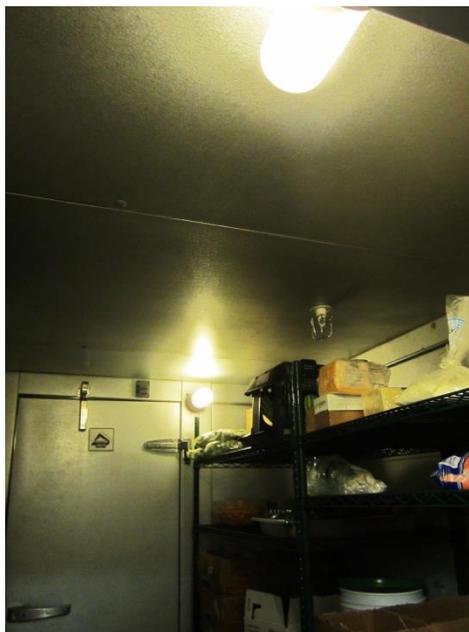
FIGURE 10: WALK-IN COOLER LIGHTING

This lighting measure is covered by prescriptive rebates through their electric utility.

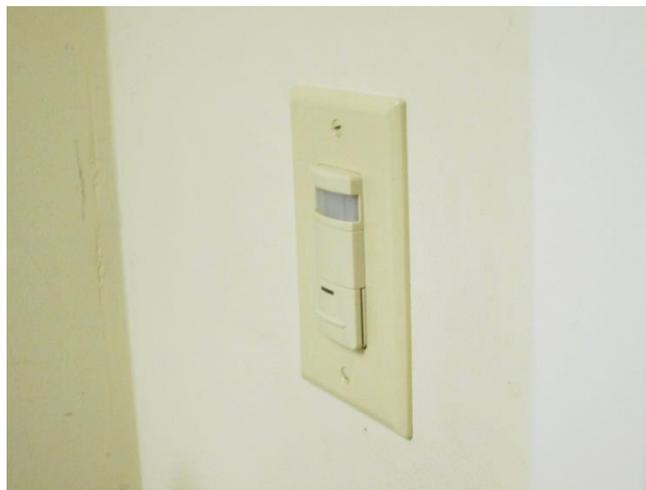
**FIGURE 11: EXISTING OCCUPANCY SENSOR**

This lighting measure is covered by prescriptive rebates from their electric utility.

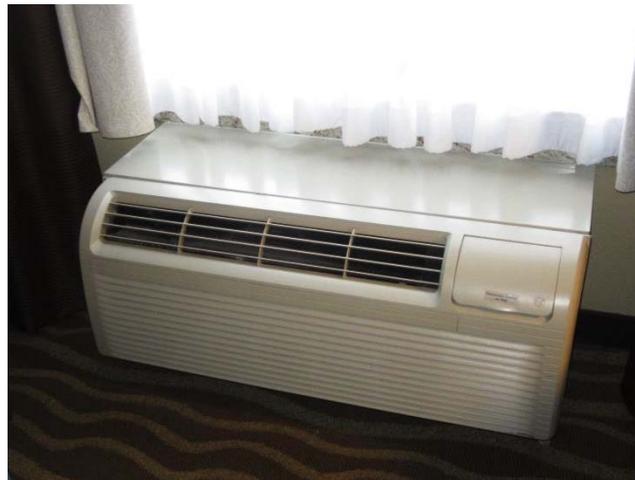
FIGURE 12: GUESTROOM PTAC

The incremental cost of buying a PTHP is roughly \$100 per unit. Their electric utility offers a rebate that covers the majority of the incremental cost of upgrading to a PTHP.

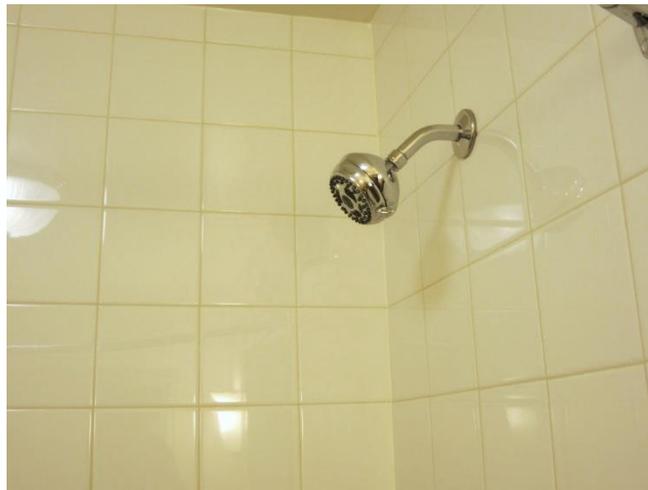
FIGURE 14: GUESTROOM SHOWERHEAD

This measure may be supported by a custom rebate from their gas utility.

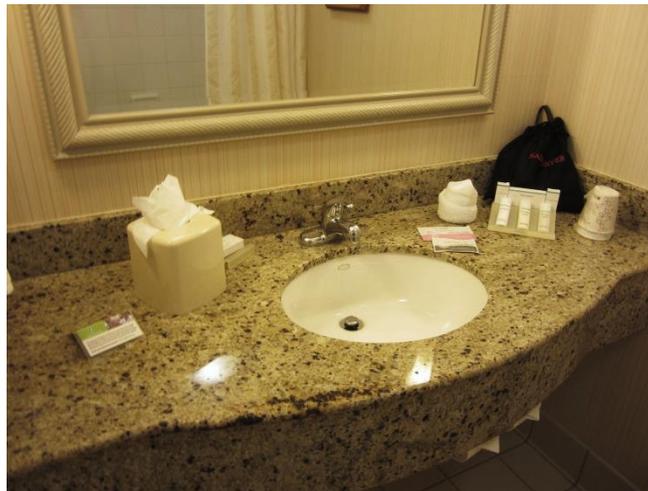
**FIGURE 15: GUESTROOM SINK**

This measure may be supported by a custom rebate from their gas utility.

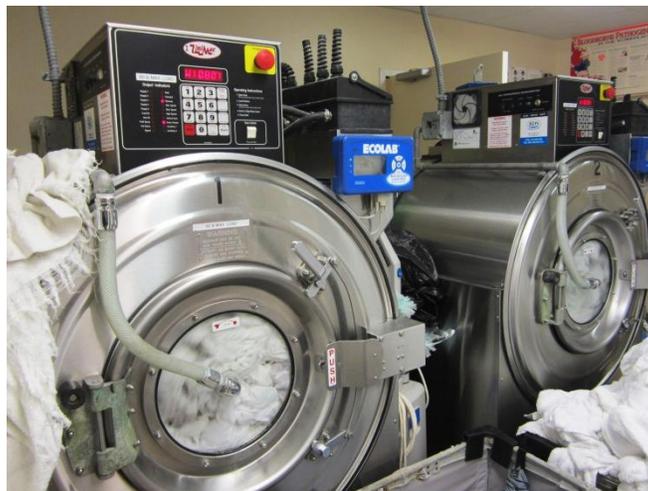
FIGURE 16: LAUNDRY EQUIPMENT

This hotel has already undergone the transition to the “Aquanomic Laundry Program”. The savings is based on processing approximately 400,000 pounds of laundry per year, an average wash water temperature of 125°F, an initial consumption of 1.07 gallons of hot water per pound of laundry processed, and 47% savings on hot water usage in laundry operations.

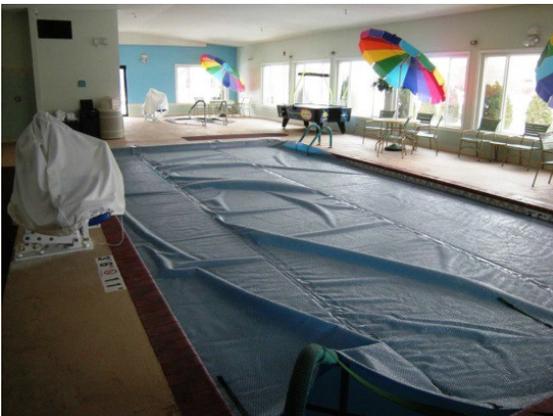
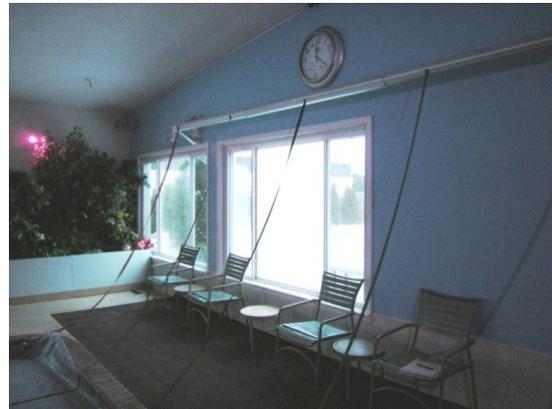
**FIGURE 1: SOLID POOL COVER AND PULLEY SYSTEM USED TO RETRACT POOL COVER**

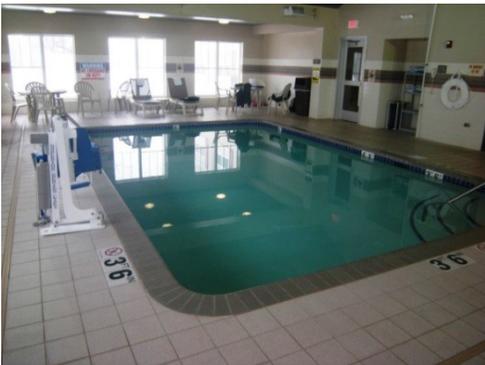
FIGURE 2: STILL POOL SURFACE

The chemical forms a transparent seal on a still pool surface as shown in Figure 2, and is therefore not effective when swimmers are using the pool. Typical hotel pools are open from 7 am to midnight or 70% of the time. During the week, hotels often have mostly business travelers and the pool is rarely used. On weekends, the pool can be occupied by families the entire open period. Between those two extremes, it is conservative to estimate that these pools are in use at most 10 hours per day on average. Using this number, the pool surface is still and the liquid pool cover can be effective about 14 hours per day, or 60% of the time. This can be compared to a traditional pool cover which is only in place approximately 30% of the time.

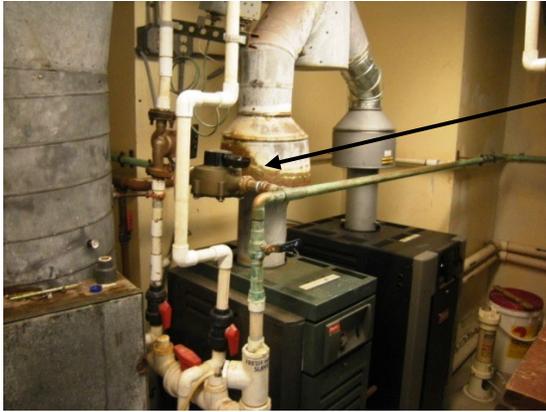
Water meter installed on supply line to pool.

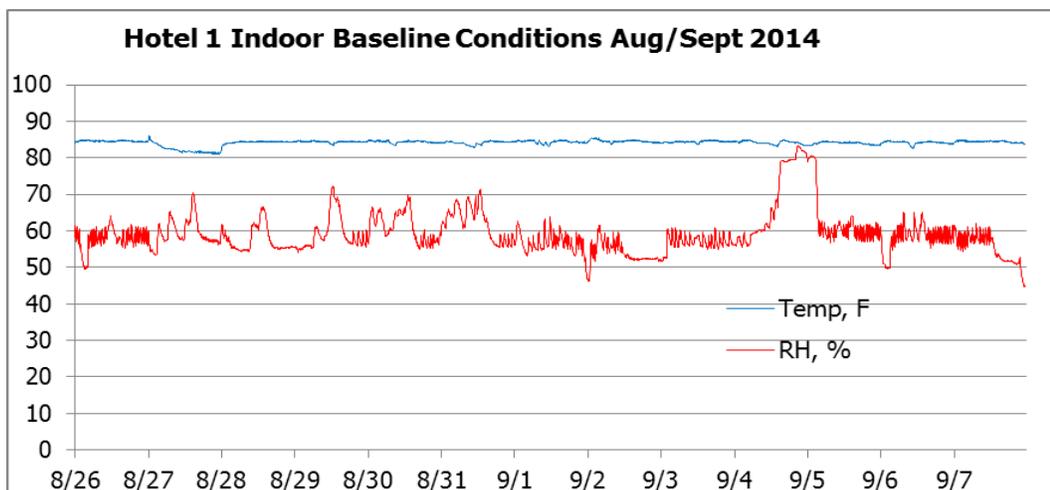
FIGURE 5: INDOOR BASELINE CONDITIONS HOTEL 1 IN AUG/SEPT 2014

This shows how quickly humidity can rise if the HVAC system is not running.

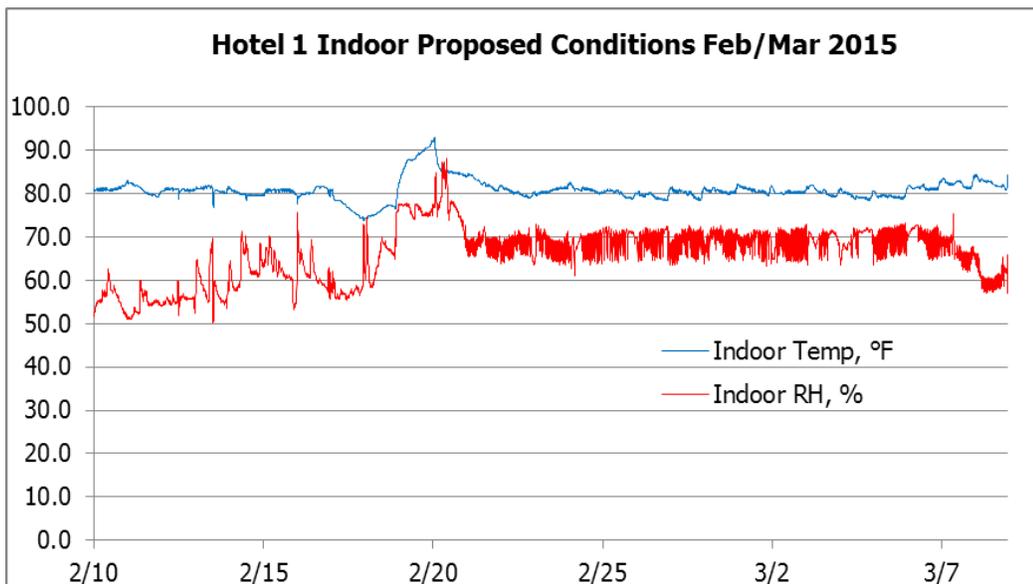
**FIGURE 6: INDOOR PROPOSED CONDITIONS HOTEL 1 IN FEB/MAR 2015**

The most in-depth testing for the liquid pool cover was conducted at Hotel 1. The staff was very detailed in their recordkeeping and allowed a second period of data logging in the winter months in the proposed condition with the liquid pool cover in service. Figure 6 shows the poolroom conditions in Hotel 1 in the proposed condition during the winter of 2015. The average room air temperature was 81°F. Relative humidity wasn't consistent until it stabilized at approximately 69%. Based on conversations with hotel staff there were operational problems with the HVAC system during the test period. The system was adjusted at the end of the test period to lower relative humidity to levels closer to 60%. This data was not used in the calculations for energy savings.

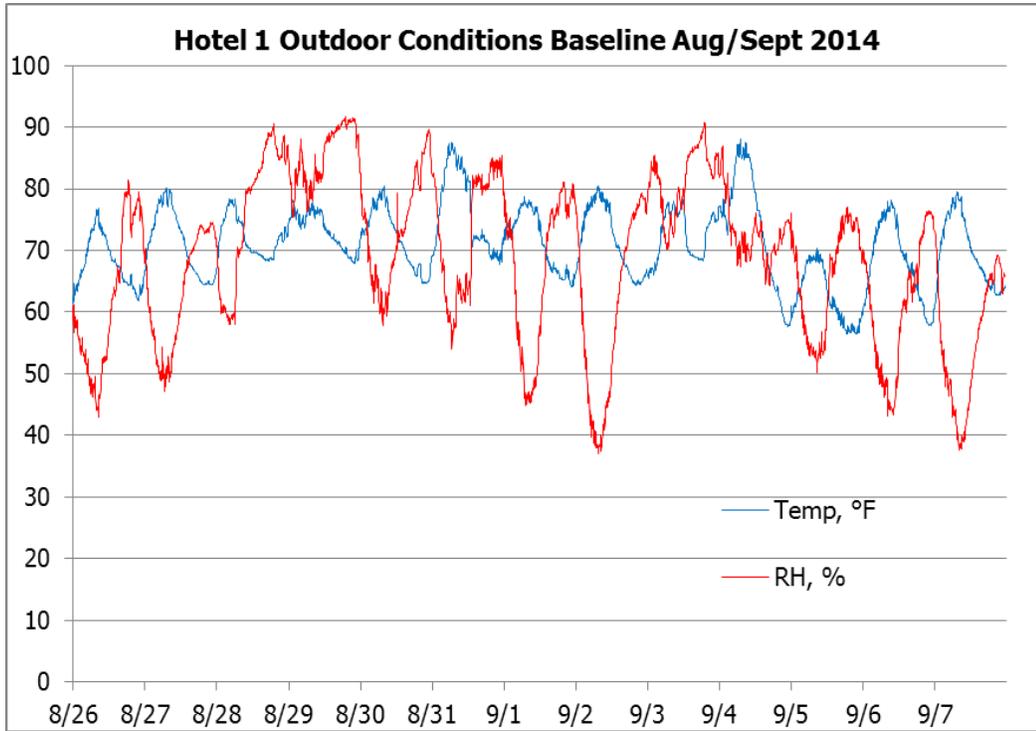
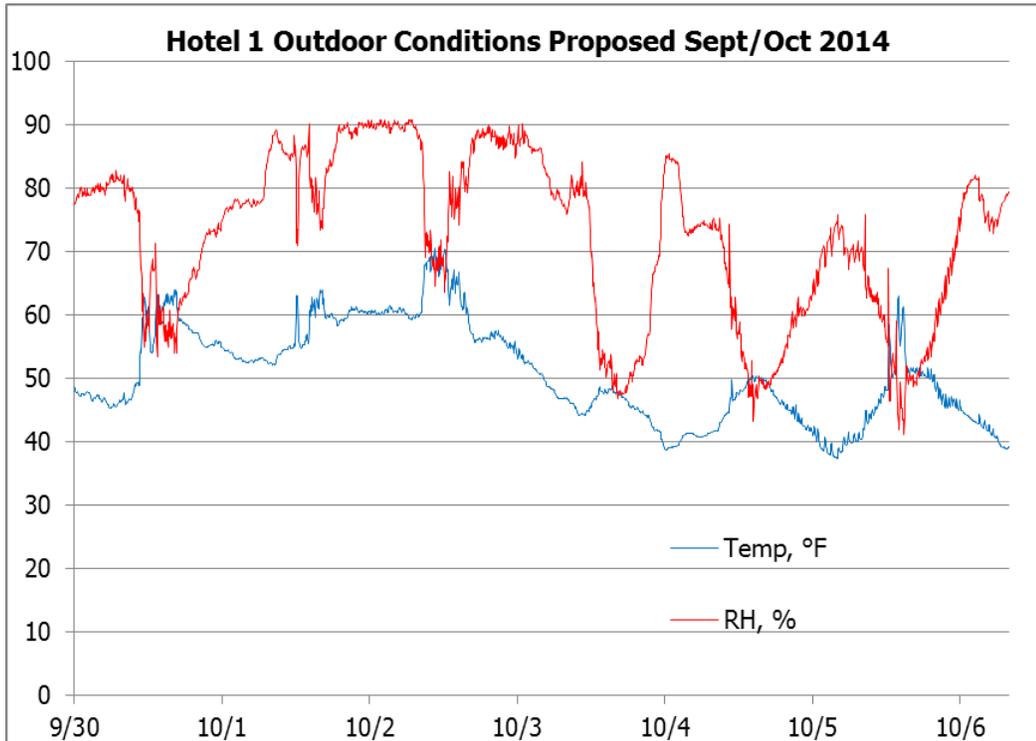
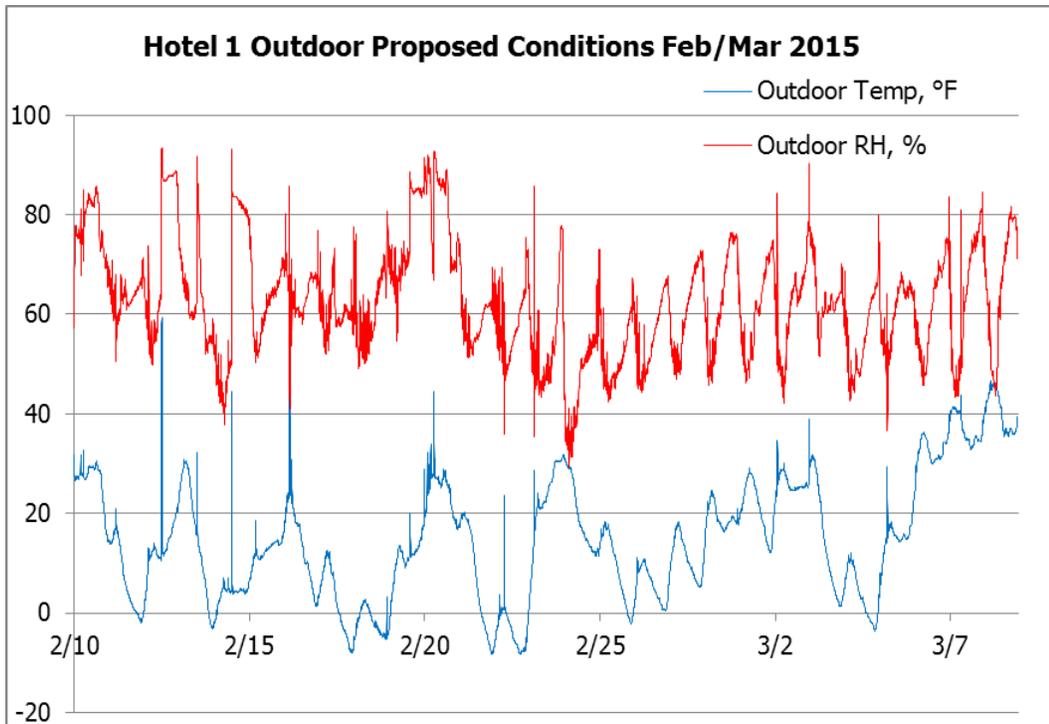
Figure 7, Figure 8 and Figure 9 show the outdoor conditions for all three periods observed. The baseline period had an average temperature of 71°F and average relative humidity of 69%. The proposed period in the fall months had an average temperature of 50°F and relative humidity of 73%. The proposed period in the winter months had an average temperature of 15°F and relative humidity of 62%. These all appear to be reflective of typical outdoor conditions in Minnesota.

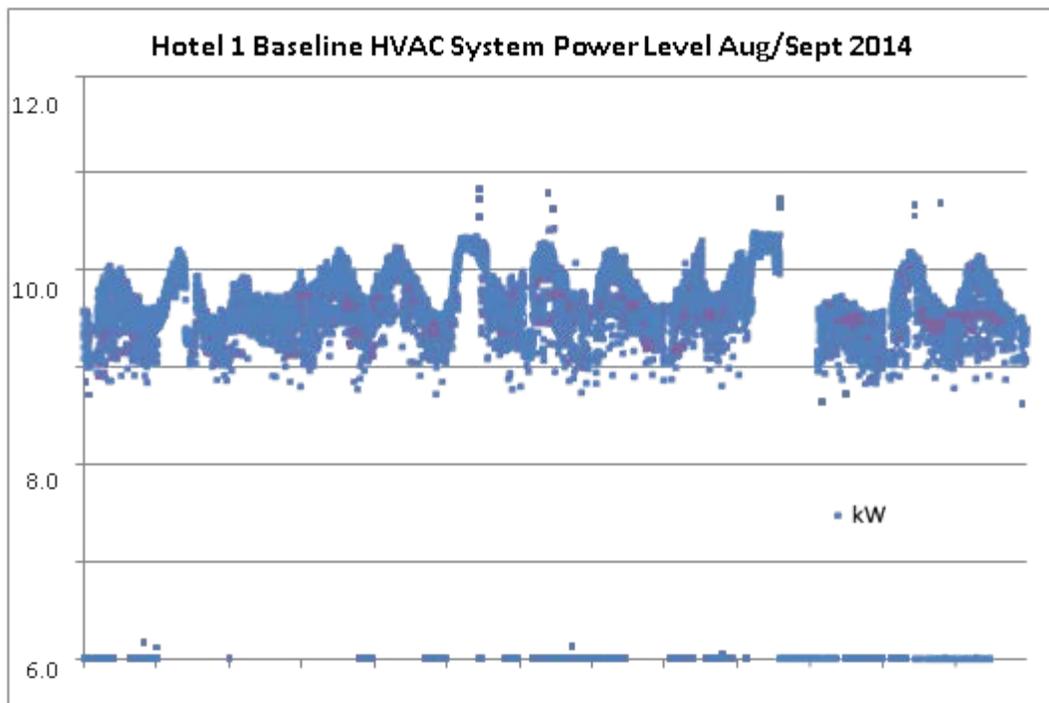
FIGURE 10: BASELINE HVAC POWER LEVEL AUG/SEPT 2014

proposed condition in the month of September, the average kW load was 5.4 kW. In the proposed condition during February and March of 2015 the average kW load was 5.5 kW. Since outdoor air conditions were different no conclusions can be made about whether this data indicates energy was saved.

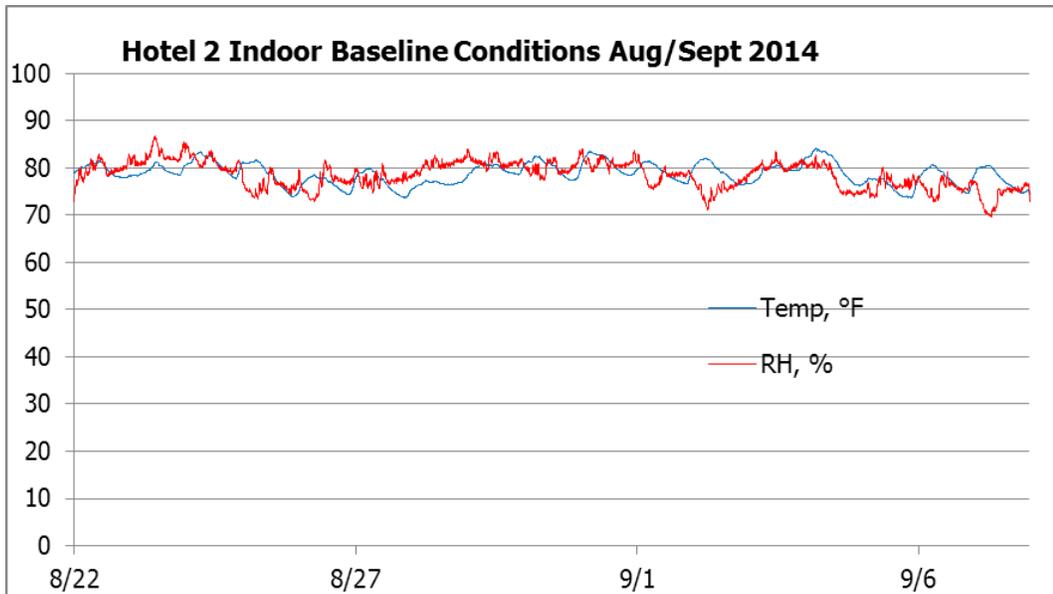
FIGURE 13: INDOOR CONDITIONS BASELINE AUG/SEPT 2014

Figure 13 shows the poolroom conditions in the baseline condition without the liquid pool cover. The average room temperature was 79°F and the average relative humidity was 79%. The pool water temperature, which was manually recorded, was 86°F. This is an example where the pool room was not being operating in an energy efficient manner. Appendix 2 provides a summary of data recorded by hotel staff. This hotel was much less engaged in the testing process so it was not easy to make adjustments to the systems.

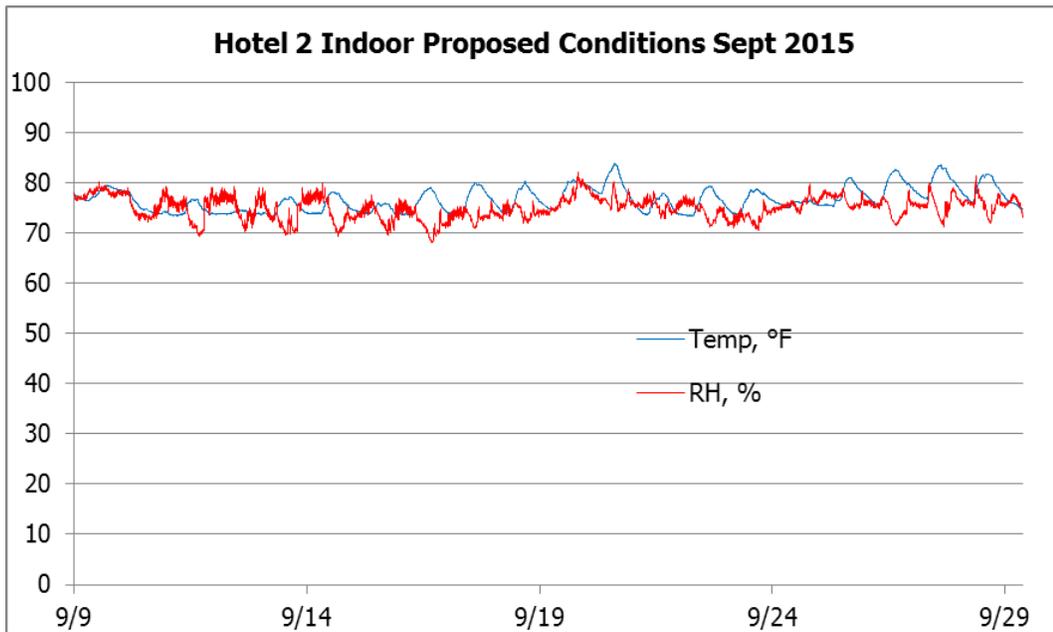
FIGURE 14: INDOOR CONDITIONS PROPOSED SEPT 2014

Figure 14 shows the poolroom conditions in the proposed condition with the liquid pool cover in use. The average room temperature was 77°F and the average relative humidity was 75%.
