# National Register of Historic Places Registration Form

Historic name: Church of the Incarnation and Rectory

Street & number: 3801 – 3817 Pleasant Avenue

City or town: Minneapolis State: Minnesota MN County: Hennepin

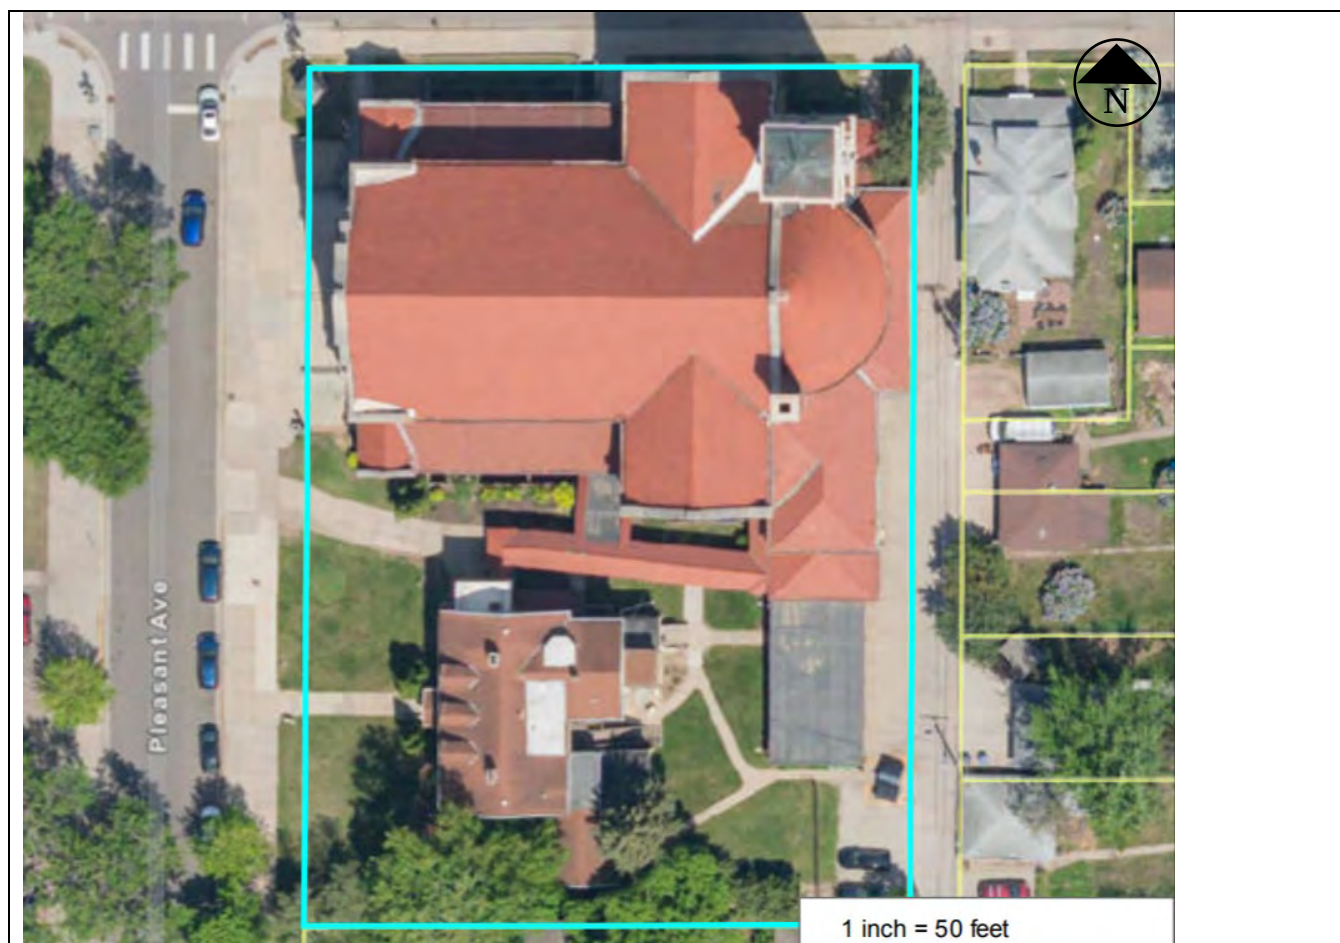
**Figure A** Aerial photograph of the Church of the Incarnation depicting site boundaries, c. 2020. Courtesy of Hennepin County.

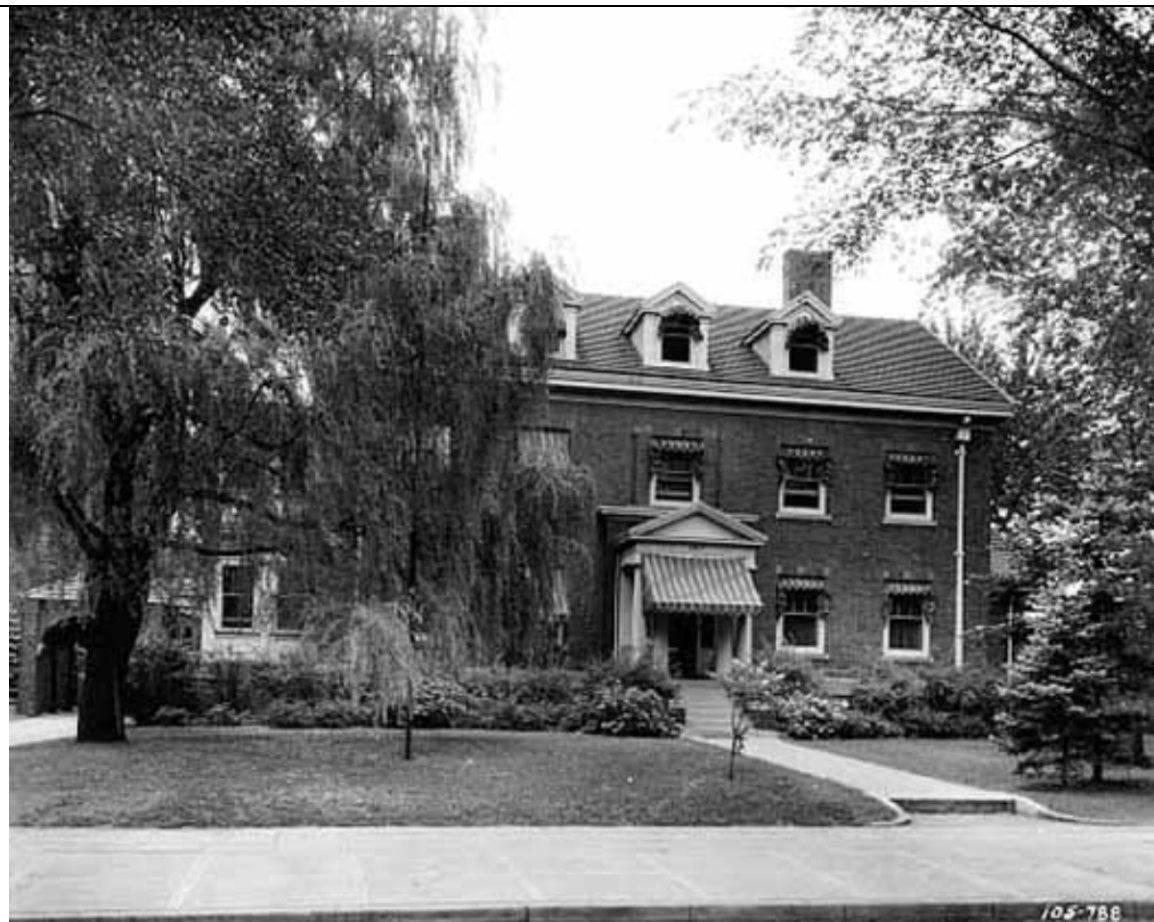
**Figure D** Rectory of the Church of the Incarnation, 1934.  
Minnesota Historical Society Collections Online.

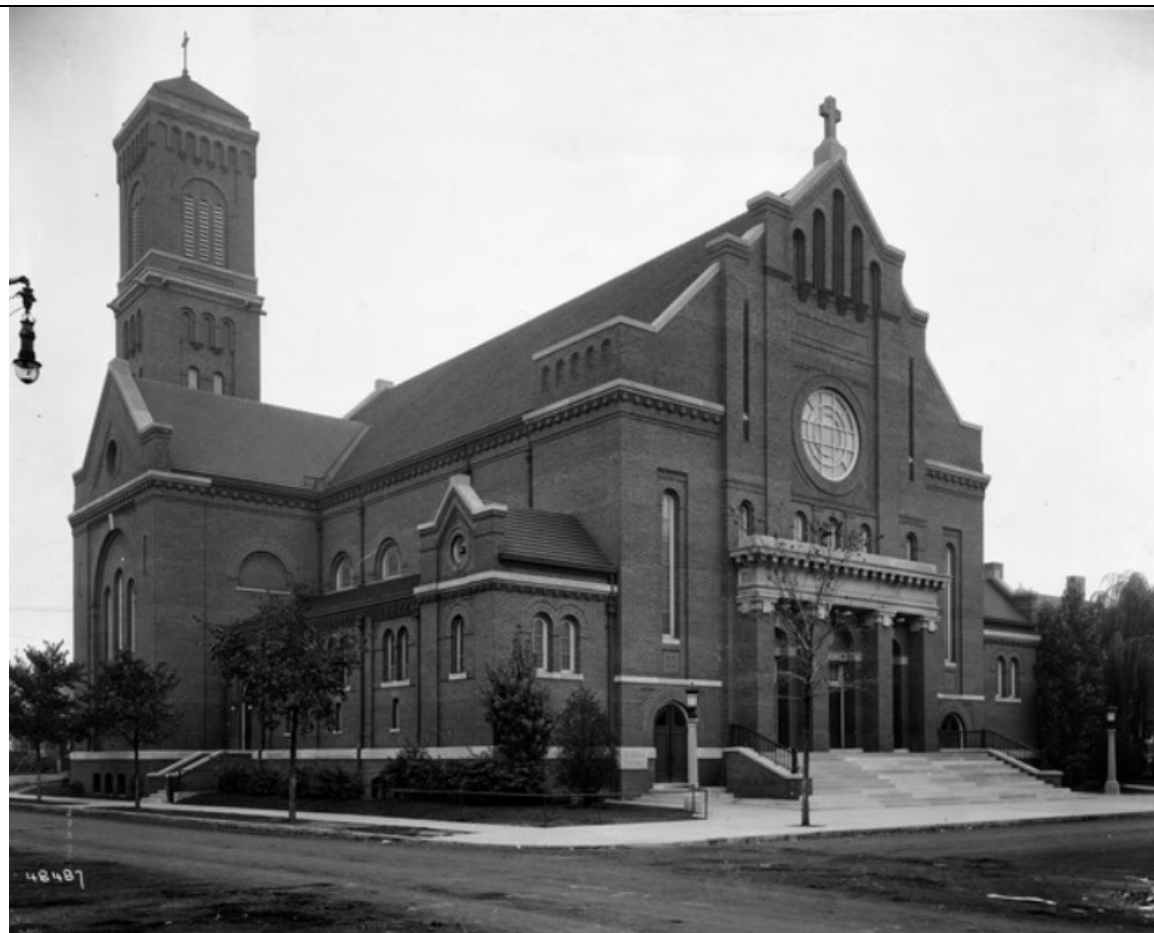
**Figure E** Church of the Incarnation, c. 1920.  
Minnesota Historical Society Collections Online.

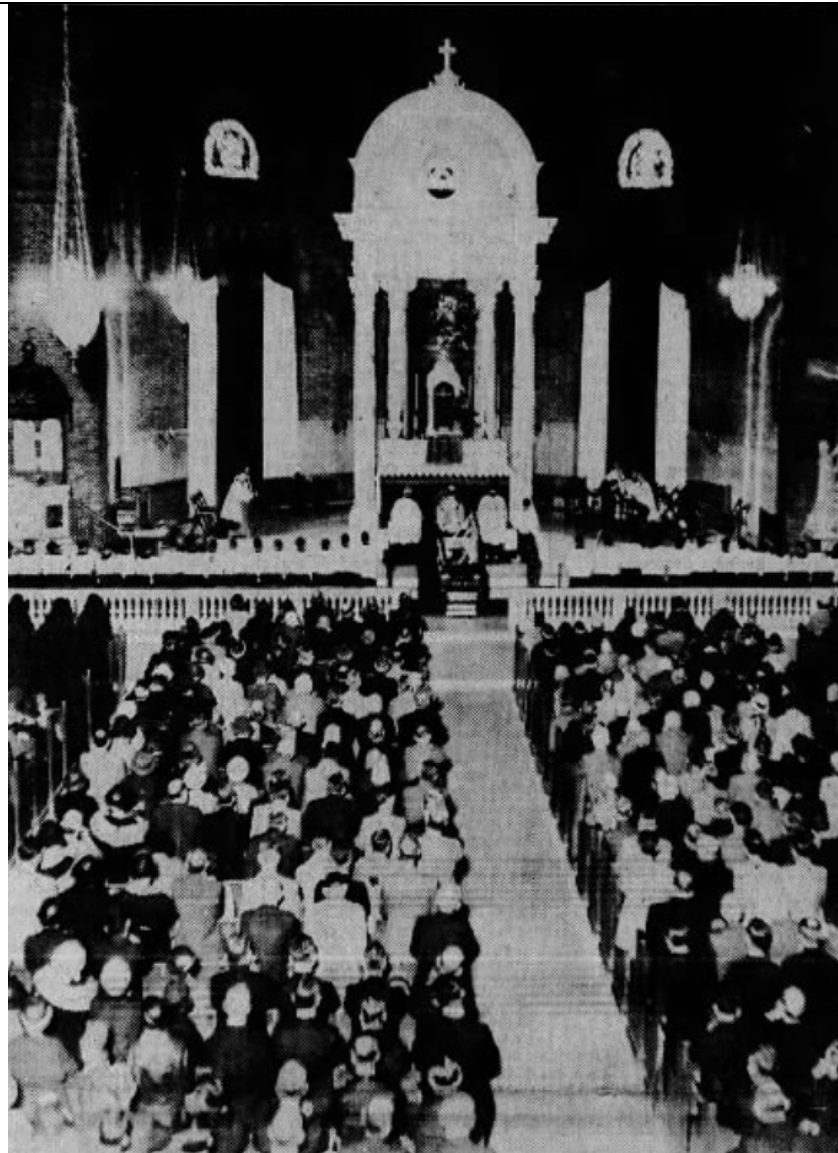
**Figure K** Interior of the Church of the Incarnation, looking east towards the apse, 1933.  
"As Requiem Was Said for Their Pastor," *Minneapolis Star*, May 29, 1933.

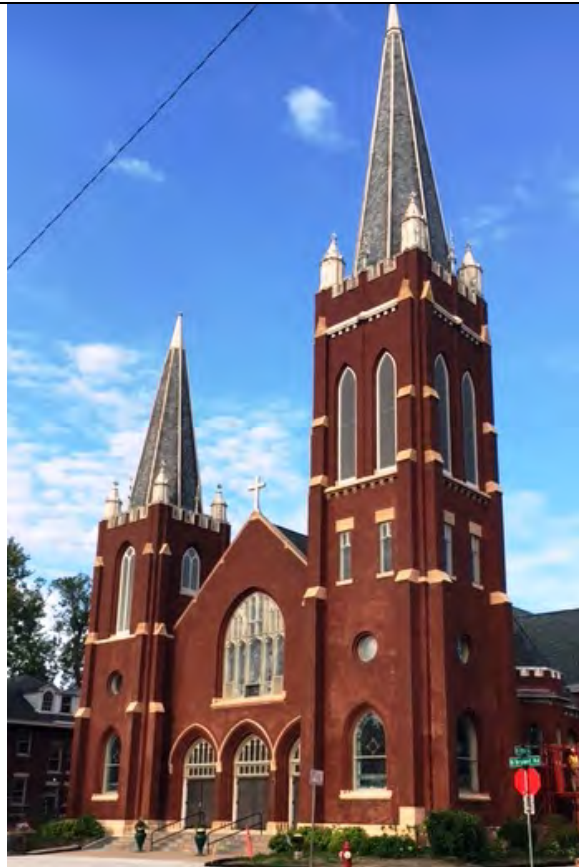
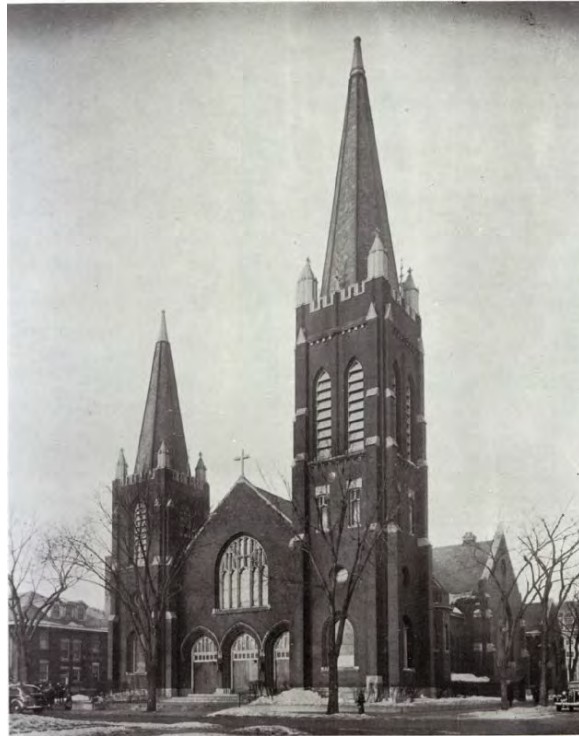
**Figure L** Church of the Ascension, 1732 Bryant Avenue Northeast, 2019 and c. 1940. Placeography, [http://www.placeography.org/images/5/55/Tdlindberg--Church\\_1940\\_cropped.jpg](http://www.placeography.org/images/5/55/Tdlindberg--Church_1940_cropped.jpg) and Industrial Louvers, Inc., <https://www.industriallouvers.com/ascension-church-renovation/>.

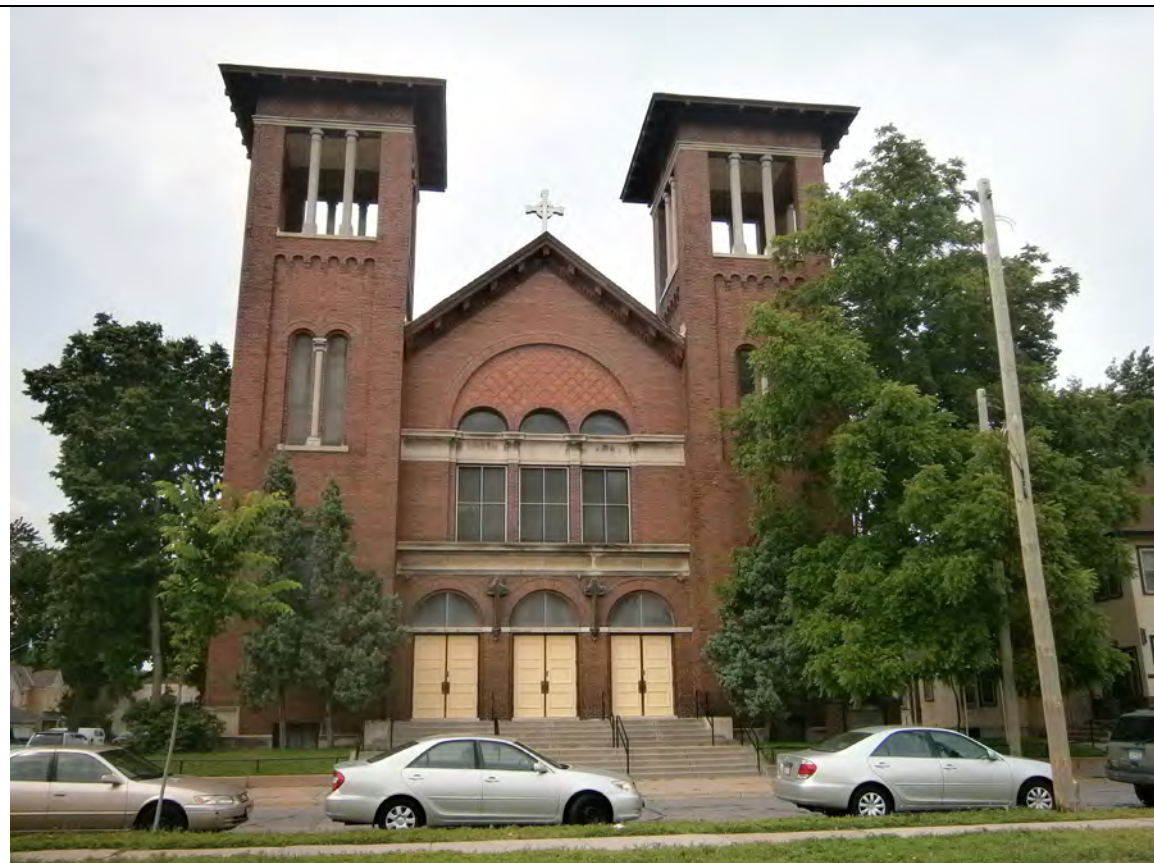
**Figure M** Church of St. Clement, 901 24th Avenue Northeast, 2013.  
Twin Cities Houses of Worship, 1849 – 1924,  
<https://housesofworship.umn.edu/node/488>.

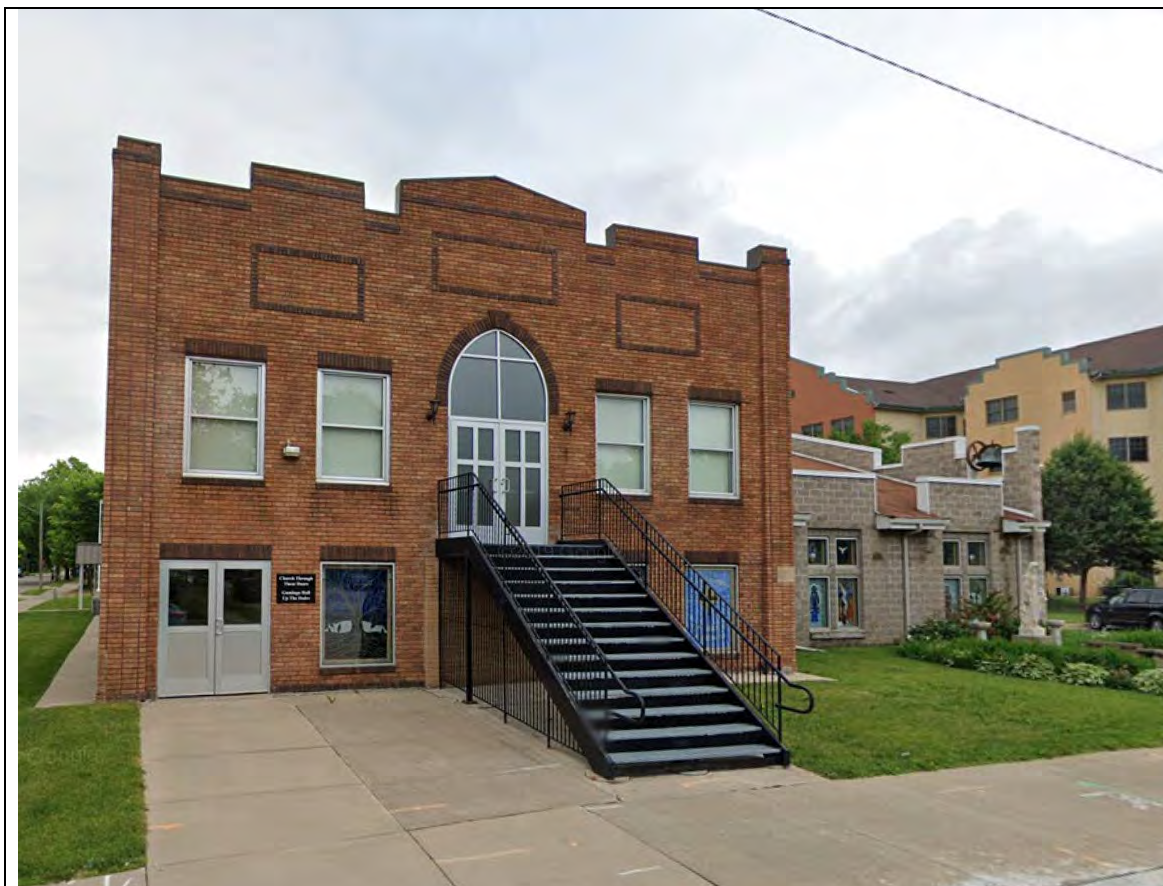
**Figure N** Church of St. Hedwig, 129 29<sup>th</sup> Street Northeast, 2019.  
Google Maps.

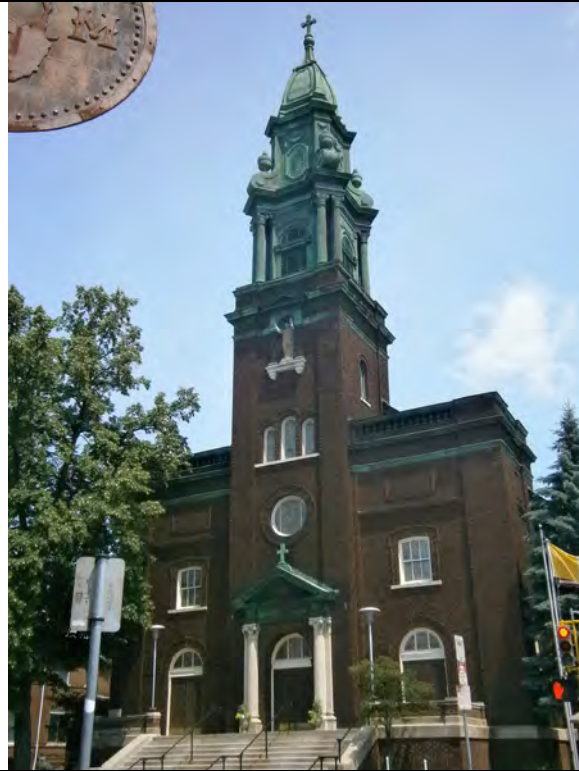
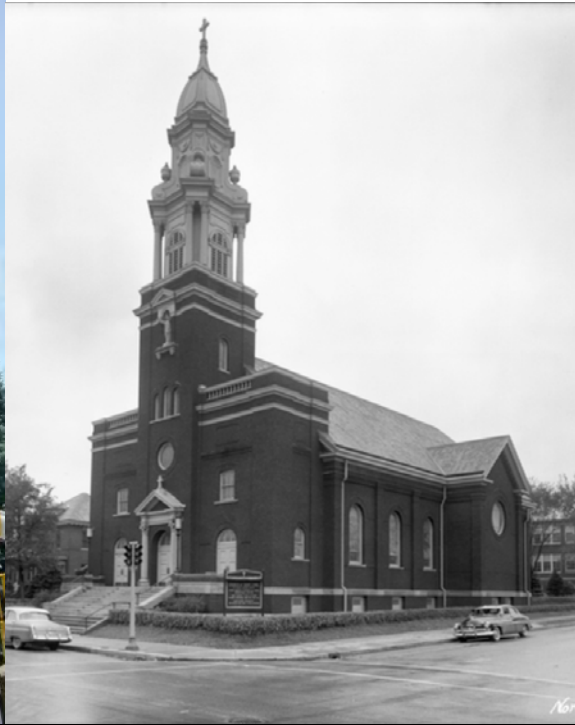
**Figure O** St. Cyril & Methodius, 1305 2<sup>nd</sup> Street Northeast, 2013 and 1957.  
Twin Cities Houses of Worship, 1849 – 1924,  
<https://housesofworship.umn.edu/node/496> and Minnesota Historical Society  
Collections Online.

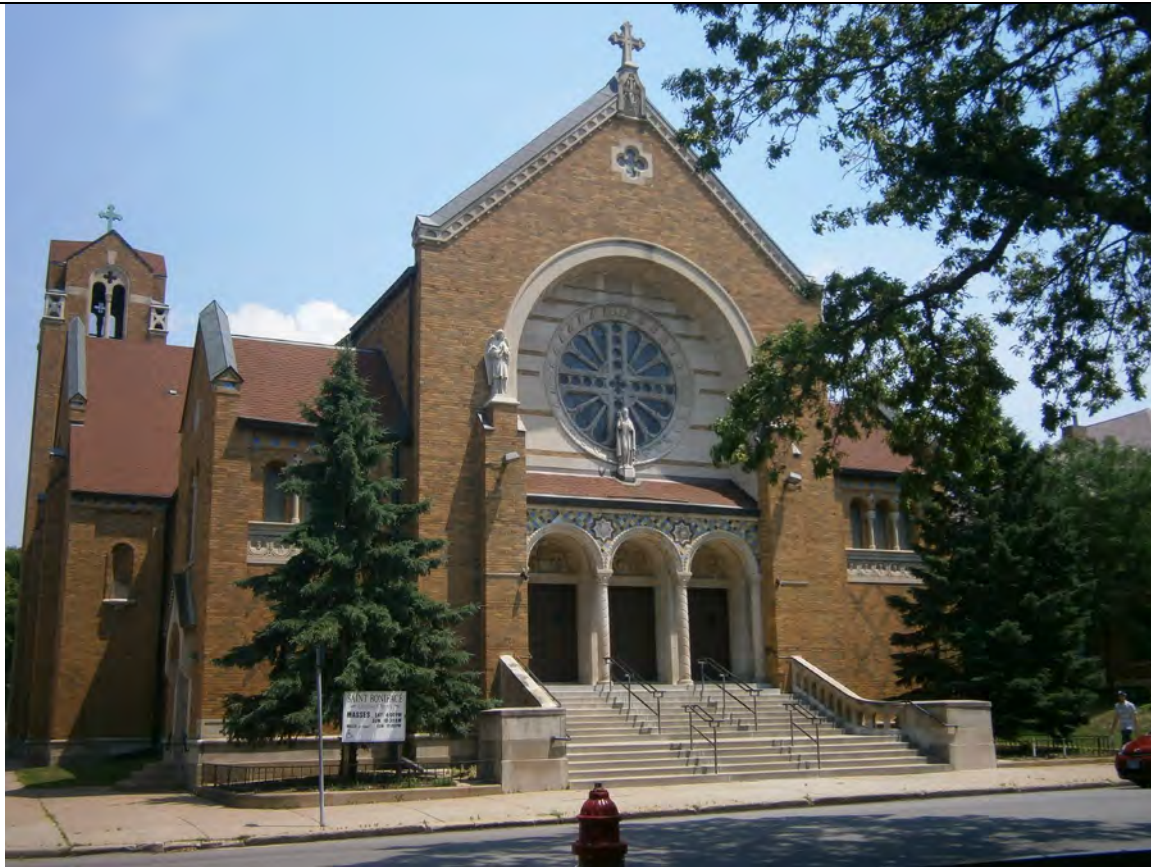
**Figure P** Church of St. Boniface, 629 2<sup>nd</sup> Street Northeast, 2013.  
Twin Cities Houses of Worship, 1849 – 1924,  
<https://housesofworship.umn.edu/node/491>.

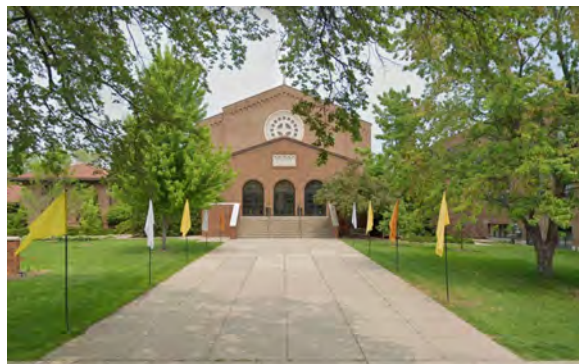
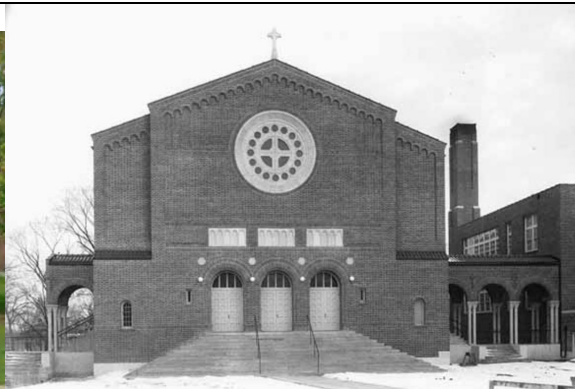
**Figure Q** Church of St. Thomas the Apostle, 2914 44<sup>th</sup> Street West, 2019 and 1928.  
Google Maps and the Minnesota Historical Society Collections Online.

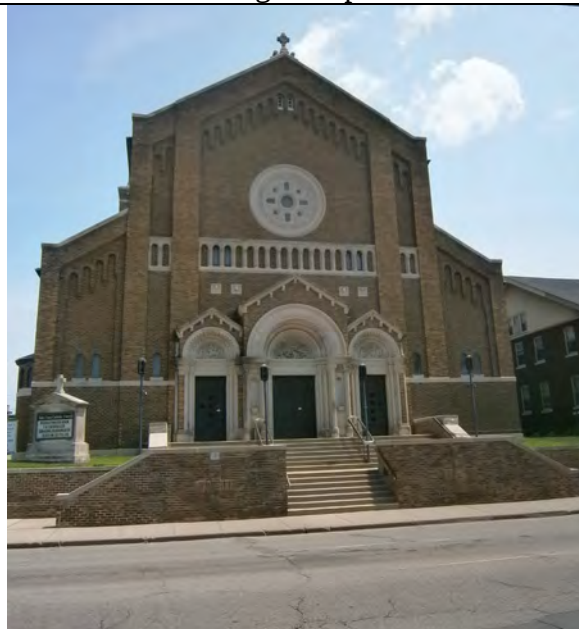
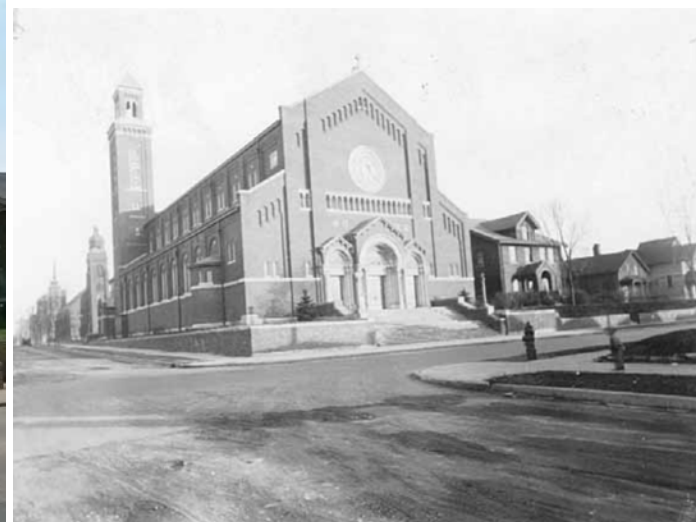
**Figure R** Church of the Holy Cross, 1621 University Avenue Northeast, 2013 and c. 1930  
Twin Cities Houses of Worship, 1849 – 1924,  
<https://housesofworship.umn.edu/node/490> and Minnesota Historical Society  
Collections Online.
