# Minnesota State Capitol Window Restoration Project

## Preliminary Planning Phase Conclusions

Second Revision, September 11<sup>th</sup>, 2012

Hammel, Green and Abrahamson + Schooley Caldwell Associates

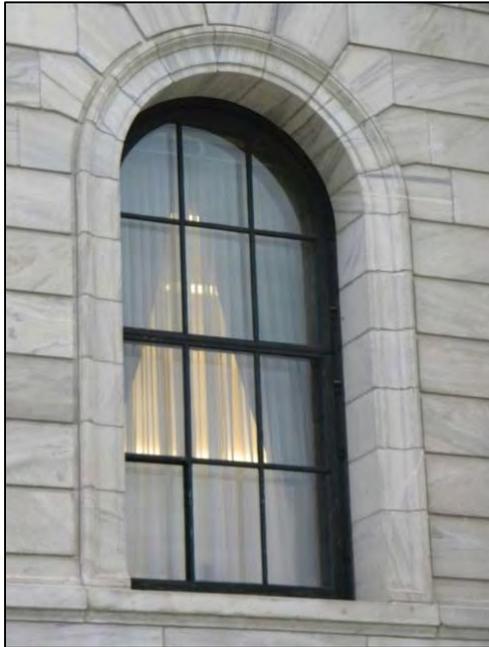
Figure 3: Storm windows currently installed at the Attorney General's office

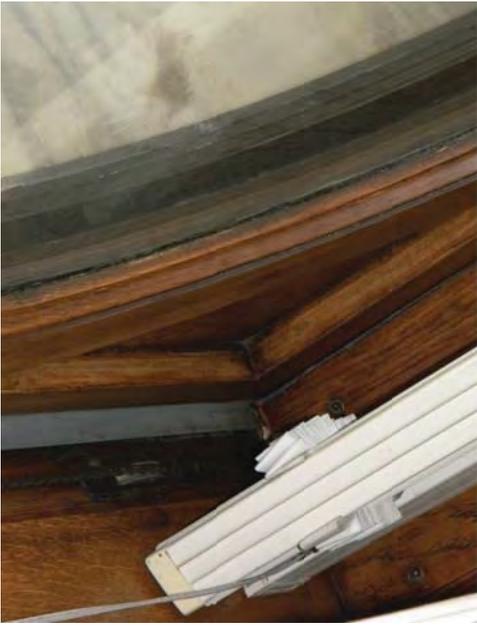
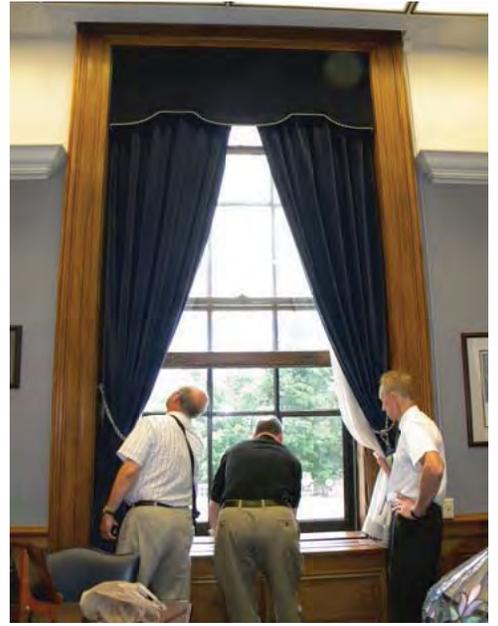
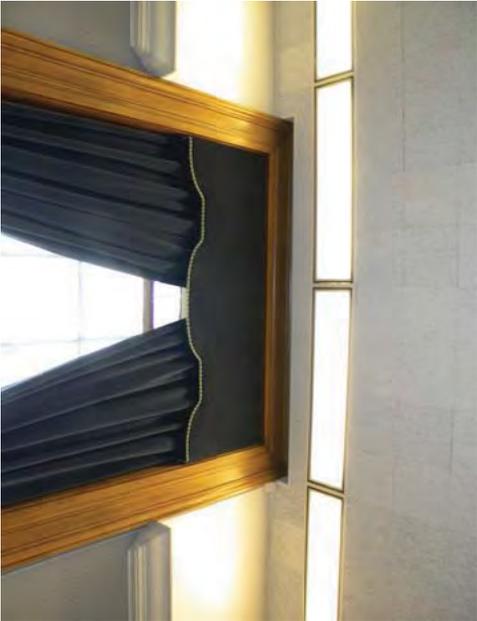
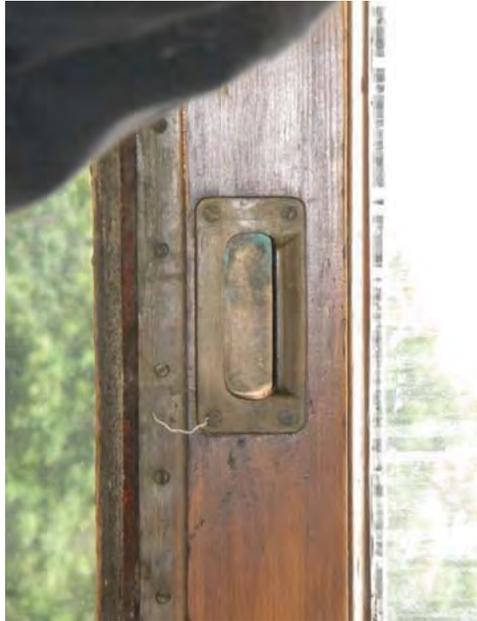
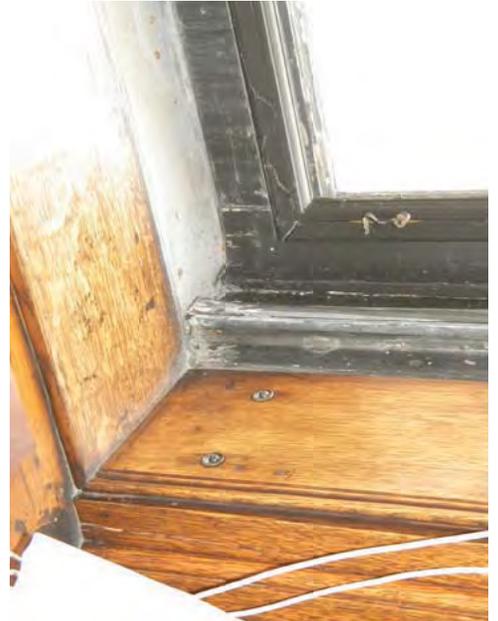
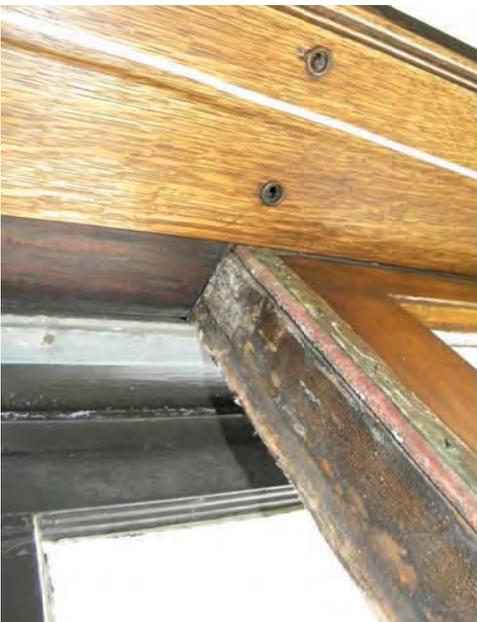
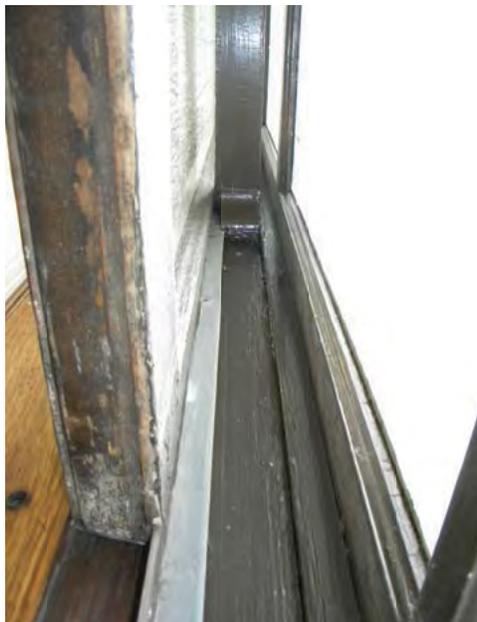
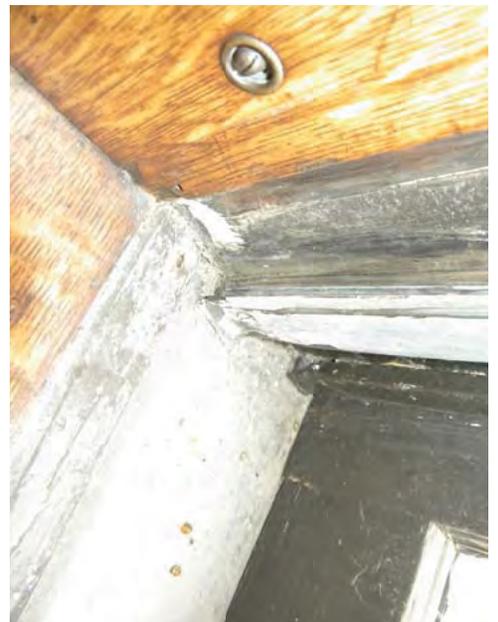
Photos: Attorney General's Office

The two windows in the Attorney General’s office and the two windows in the Governor’s office have not been replaced with aluminum windows. The two windows in the Attorney General’s office are original sash and frame and are in good condition. The historic hardware is intact and operating effectively, including the weights, chains, and pulleys. Figures 5, 6, and 7 are photos of the original wood windows in the Attorney General’s office. Refer to Appendix B Exhibit 2 (page 97) for additional photos. The two windows in the Governor’s office are original frame and a replacement wood clad steel sash for incorporating ballistic laminated glass (see figures 8 and 9). Refer to Appendix B Exhibit 3 (page 101) for additional photos.

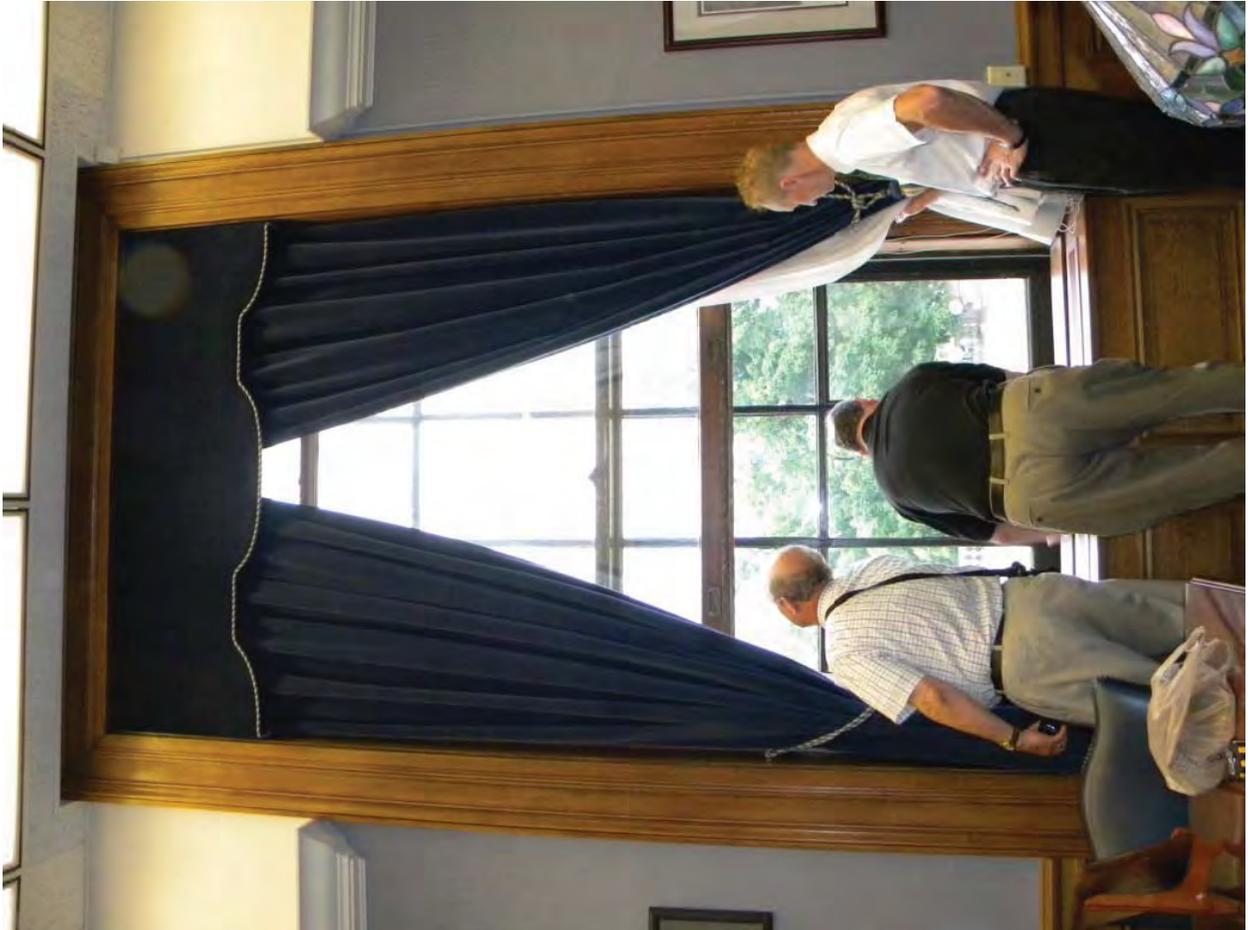
2 original windows remain in the Attorney General's office

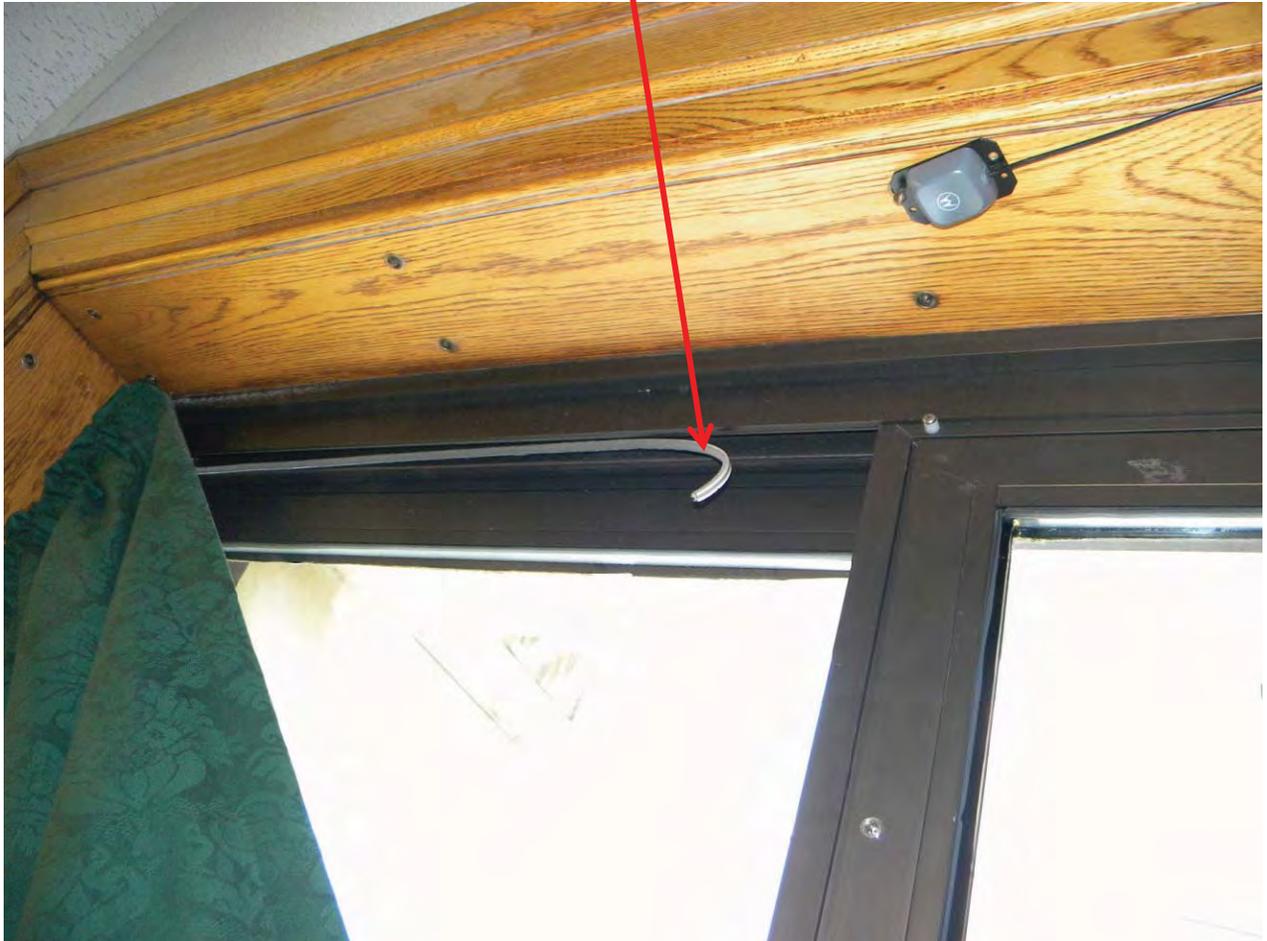
Loose weather stripping

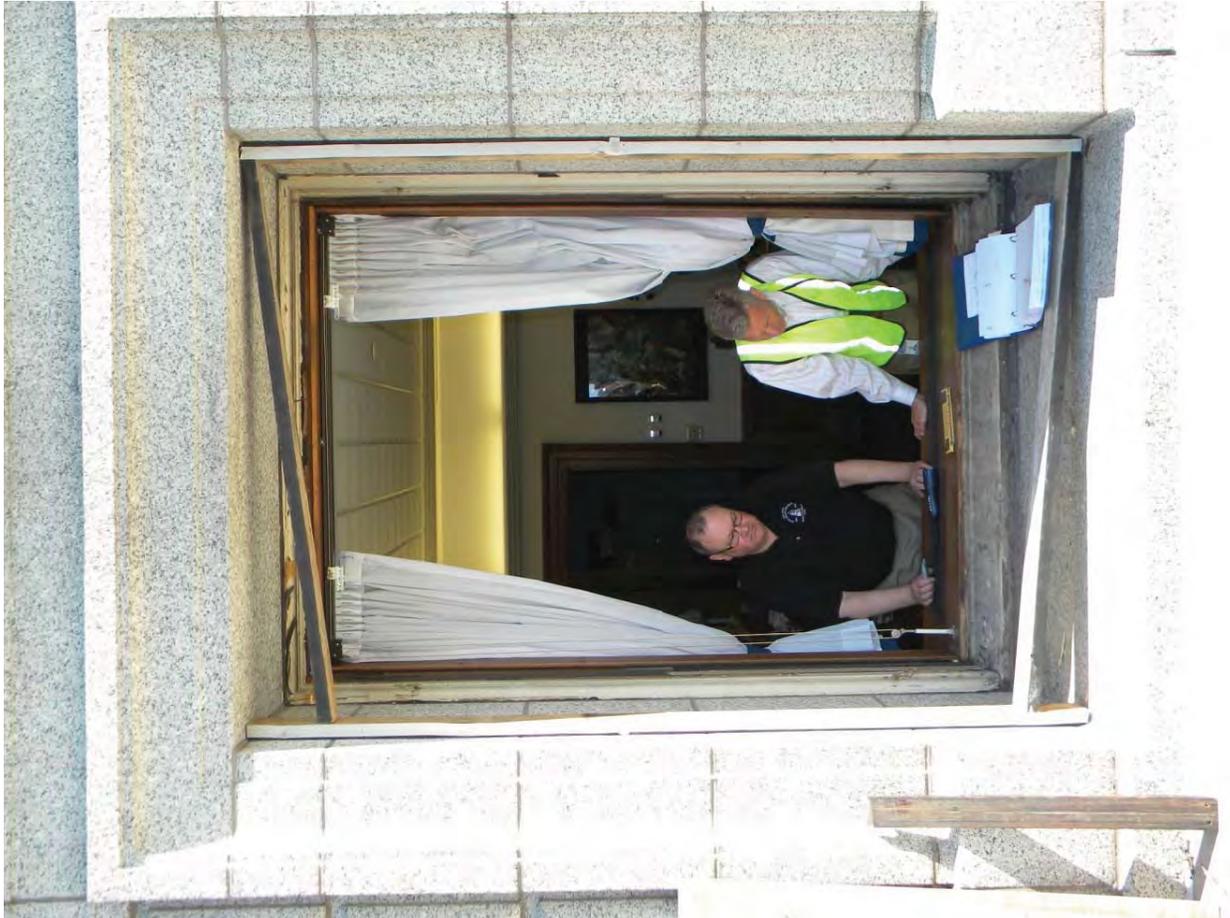
6 windows were temporarily removed. Each window was a different type and represented the various floor levels and orientations

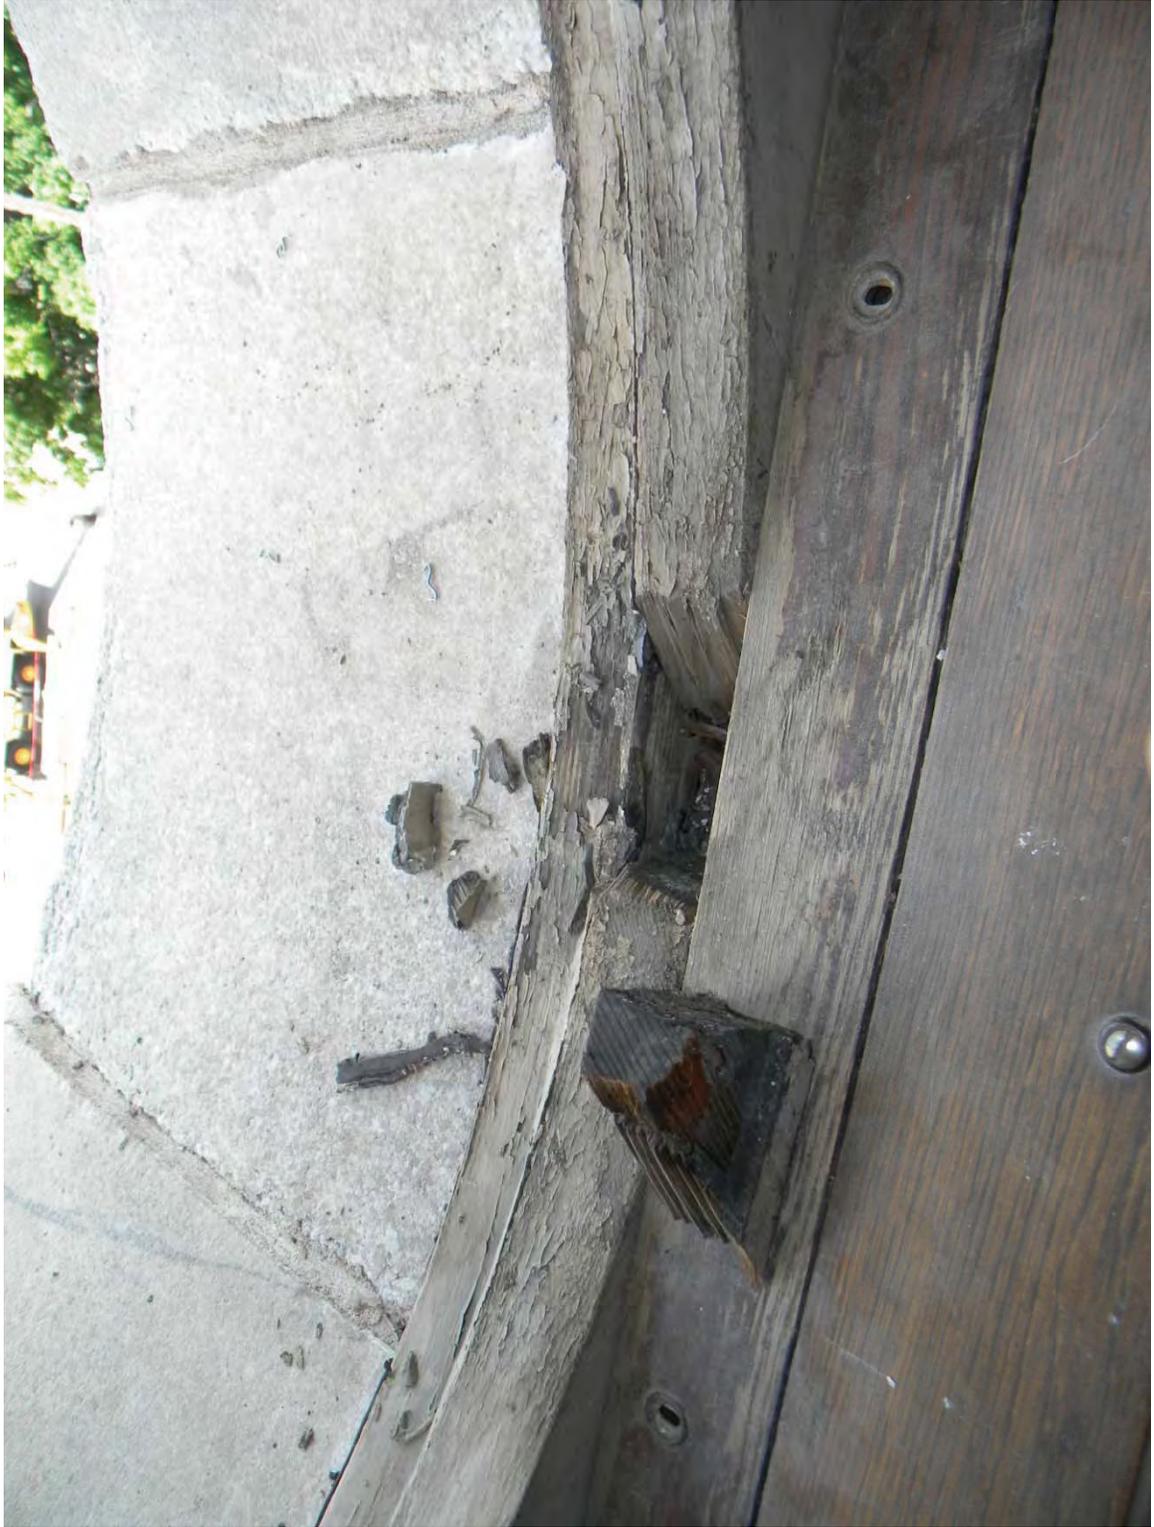
Round Window

- Original wood frames are in relatively good condition underneath the existing aluminum windows
- Original weights and pulleys have been completely removed
- Exterior sealant between brick mold and marble contains asbestos and will need to be abated
- Original interior finish of sashes, frames, and trim was clear
- Frame & sashes – pine
- Trim - oak
- Original exterior finish was a dark colored paint
